Experimental Fatigue Test for Pre-Qualification of Repair Mortars Applied to Historical Masonry

Alessandro Grazzini

Keywords: strengthening mortars, historical masonry, durability, fatigue test, plaster detachment

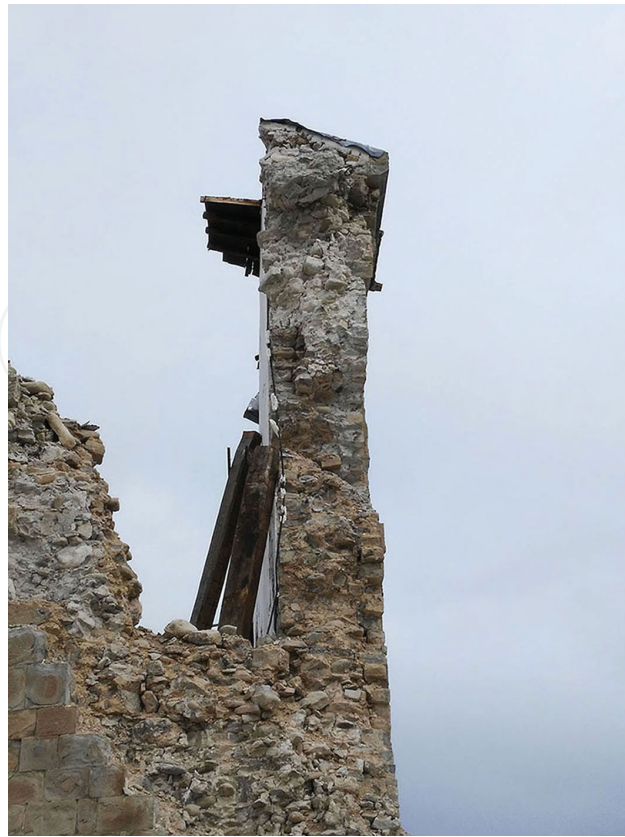
Figure 1. Collapse of the St. Agostino church in Amatrice after the Central Italy earthquake 2016 (image courtesy of the Curia of Rieti).

Recent earthquakes have shown the clear failure of restoration work performed with the use of concrete materials, the excessive stiffness of which has completely distorted the original characteristics of historical masonry buildings. **Figure 1** shows the ineffectiveness of the cementitious insertion materials inside historical walls of the St. Agostino church, collapsed during the last great Italian earthquake of Amatrice, just in correspondence with the previous stitching made by cement injections.

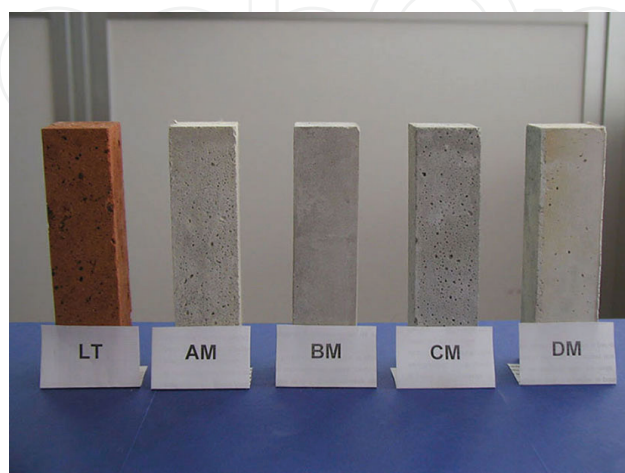
Figure 3. Single specimens.

To determine the main mechanical characteristics of the individual materials, that is, the compressive strength and the elastic modulus, six specimens $40 \times 40 \times 160$ mm were manufactured for each single material. Four different types of mortars were tested (codified as “A,” “B,” “C,” “D”), suitable for the following restoration techniques: reinforcement by structural plaster (A; C), joint closing (A; D), jacketing of masonry walls or reinforcement of vaults (D), consolidation by grout injection (B). In addition to these, six more specimens $40 \times 40 \times 160$ mm made from historic bricks of the Royal Palace of Venaria were tested (**Figure 3**). Each mortar test piece was labeled with “XM” where “X” stands for the code of the relative mortar (A–D); the brick test piece was labeled with “LT.”

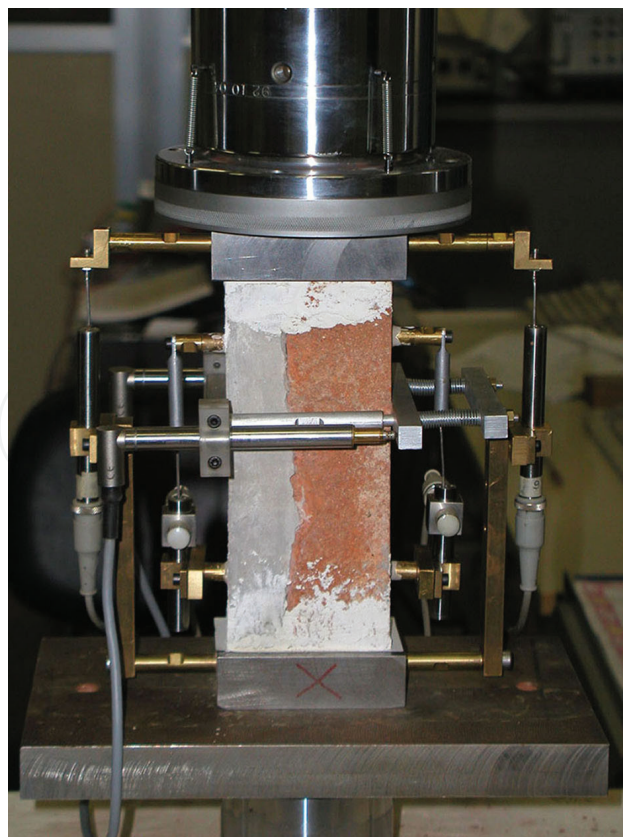
Figure 4. Mixed brick-mortar test pieces.

The next step of this experimental procedure was the manufacturing of particular mixed brick-mortar specimens measuring $223 \times 57 \times 83$ mm (**Figure 4**). The mixed specimens were made from historical cut on which a 30 mm thick layer of strengthening mortar was applied. The brick surface was treated by means of a drill to facilitate the mortar’s adhesion. The treatments simulate roughness and irregularity of the masonry surface that in the real executive

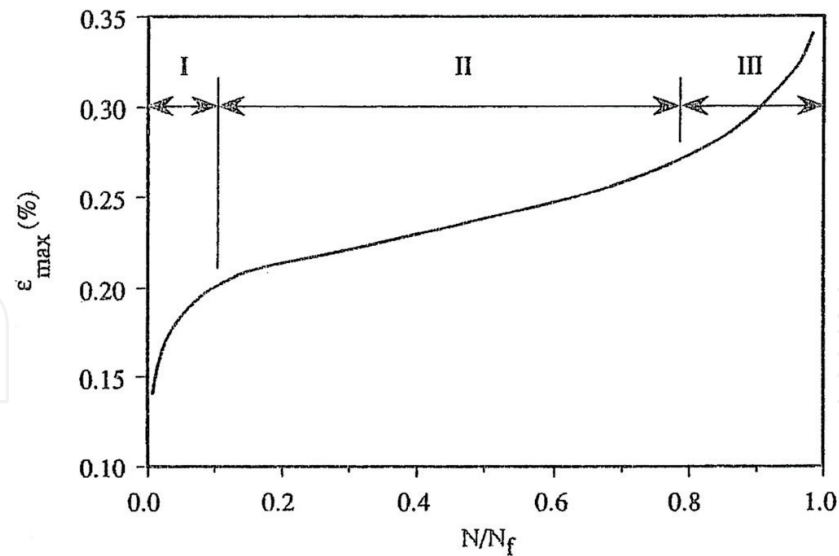
Figure 5. Monoaxial cycles compression test σ - ε curve.

In the curve of a cyclic fatigue test (**Figure 5**), it is possible to identify three distinct stages:

- Stage I: Deformations are seen to increase rapidly (accounting for approximately 10% of the service life of test piece);
- Stage II: Deformations increase gradually at a virtually constant stress (10–80% of test piece life);
- Stage III: Deformations increase rapidly until failure [2].

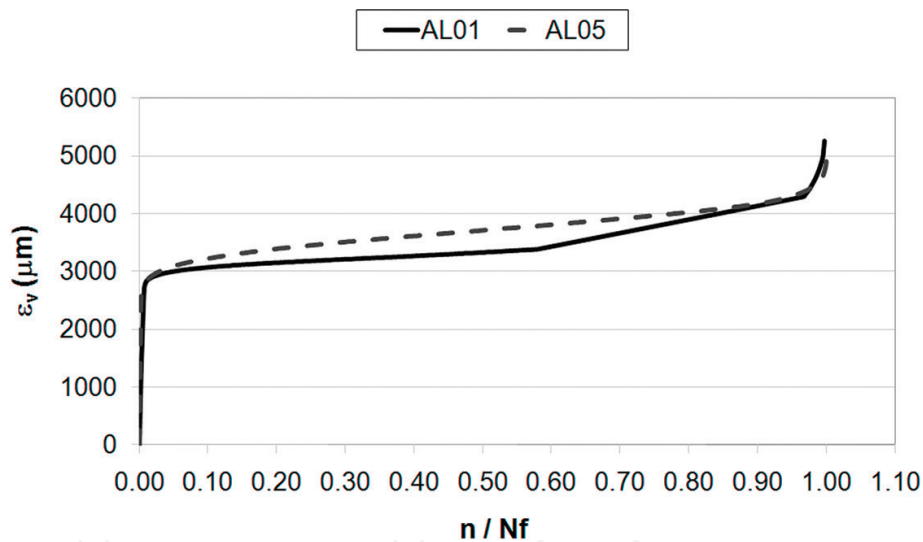
Figure 6. AL series cyclic tests: max vertical deformation.

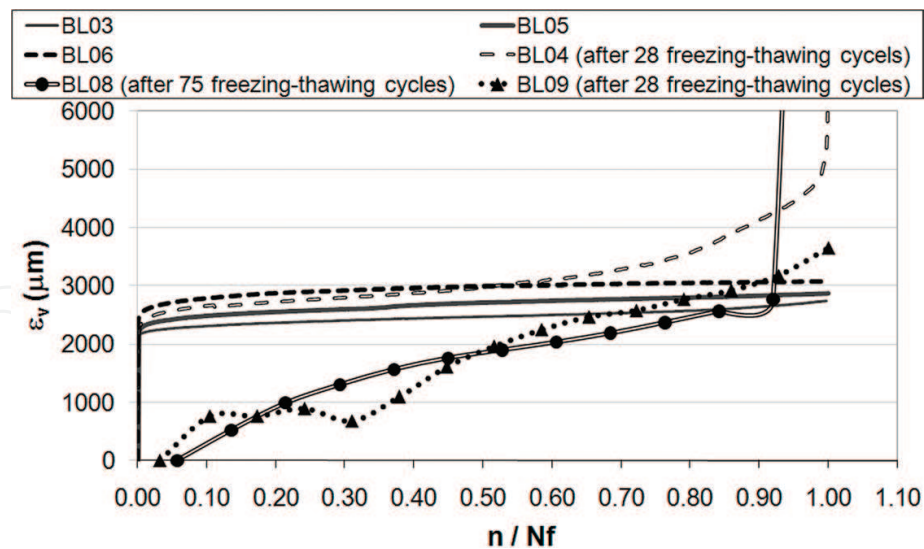
Figure 7. BL series cyclic tests: max vertical deformation.

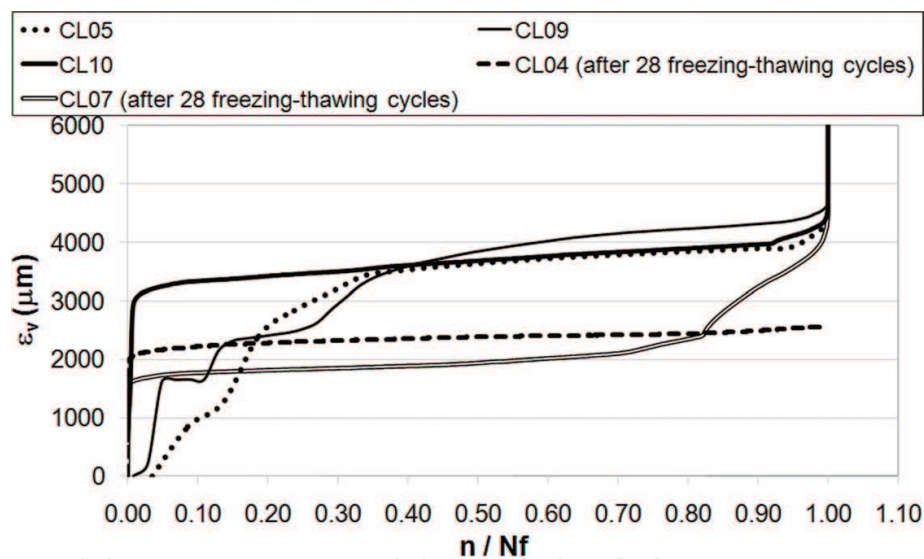
Figure 8. CL series cyclic tests: max vertical deformation.

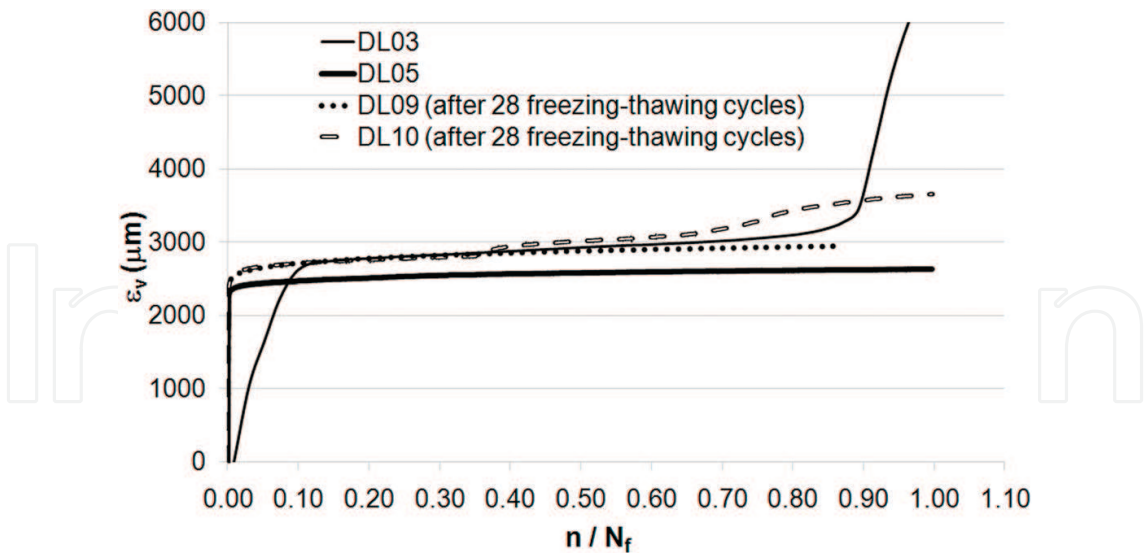
Figure 9. DL series cyclic tests: max vertical deformation.

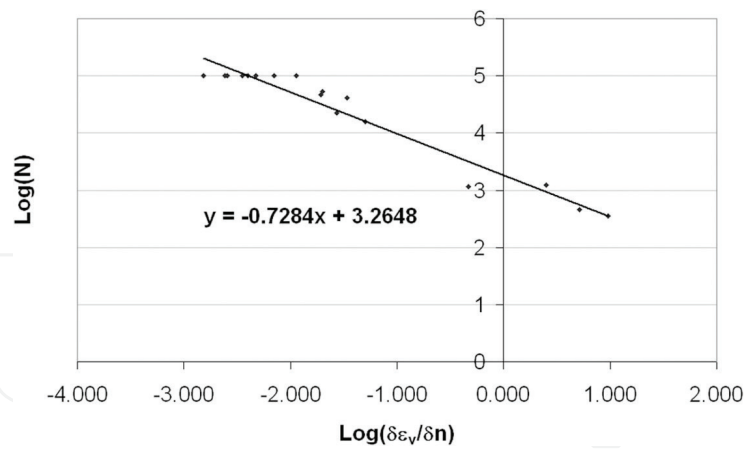
Figure 10. Fatigue life of mixed test pieces $\delta\epsilon_v/\delta n$ chart.

Fatigue life of a material subjected to cyclic loading tests is linked to the evolution of the deformations during stage II [4–7]. By analogy with the method suggested for concrete [8], the evolution of vertical deformations over time was recorded for evaluating fatigue strength of material. The goal is to ascertain whether fatigue life of the mixed brick-mortar system also depends on the rate of increase of vertical deformations during stage II (termed secondary creep rate). **Figures 6–9** shows that the broken test pieces (before 1,00,000 cycles, as shown in **Table 7**) displayed a steeper slant in the stage II section of the curve, followed, at ca 80–90% of test piece life, by a sudden increase at stage III (failure). Conversely, the diagrams of the mixed specimens that passed 1,00,000 cycles mark displayed a lesser slant, reflecting an effective behavior still far from failure. From these results of cyclic tests, through linear interpolation between 20 and 80% of secondary creep values (**Figure 10**), derivatives $\partial \varepsilon_v / \partial n$ (i.e., the

variations in the deformation versus time curve during stage II) were calculated. Through a linear regression on logarithmic scale, it is possible to plot the data in a diagram in order to obtain an analytical relationship (1) between secondary creep variations, $\partial\epsilon_v/\partial n$, and the number of cycles (N) to fatigue failure:

$$N = 1839.92 \cdot \left(\frac{\partial\epsilon_v}{\partial n} \right)^{-0.7284} \quad (1)$$

A valid correlation was established between secondary creep rate ($\partial\epsilon_v/\partial n$) during stage II and fatigue life (number of cycles to failure, N). By performing a certain number of cycles on the material until deformations increase at a constant rate, it is possible to predict fatigue life with a good degree of approximation [9–11].

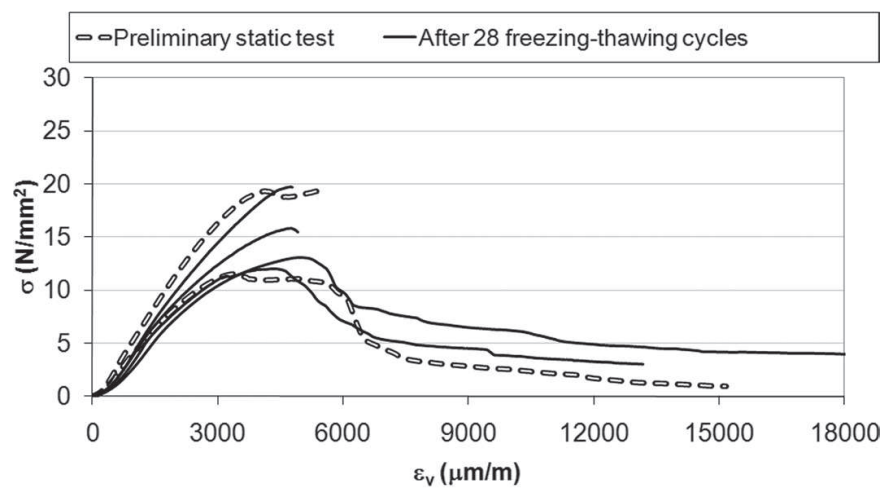
Figure 11. AL series static tests.

In some samples, the theoretical value of cycles to failure N_{the} was found to be lower than that obtained from laboratory tests (**Table 7**). After the final value of cyclic test, the relationship (Eq. (1)) was useful to predict the failure on the detachment surface between brick and repair mortar. The measure of the volumetric deformations is in agreement with the theoretical value obtained from Eq. (1): the time when the volumetric deformations shifted to negative sign (propensity to bulge due to poor vertical collaboration or detachment at the interface between the two materials) was the failure time of the mixed brick-mortar specimen. The methodology and the numerical analysis proved very sensitive to the initial signs of weakening in the brick-mortar system, indicating clearly the onset of a crisis due to fatigue. **Figures 11–14** illustrate the static tests performed on mixed test pieces.

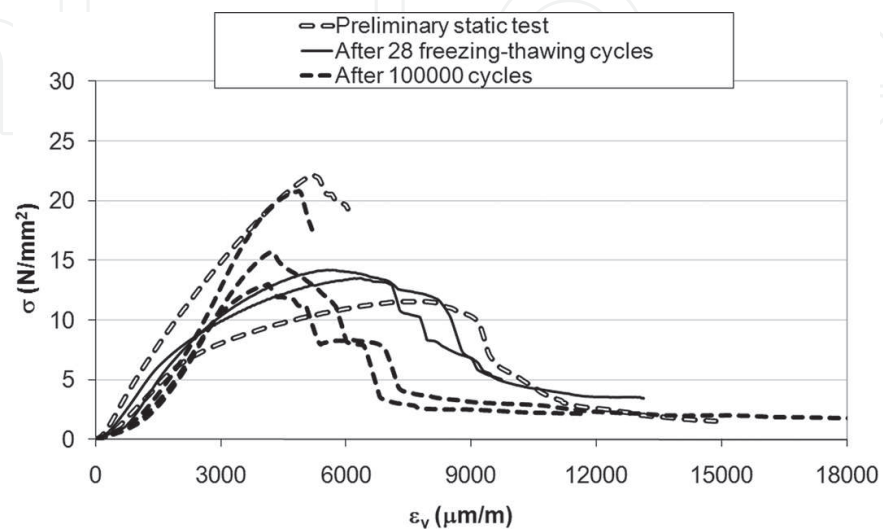
Figure 12. BL series static tests.

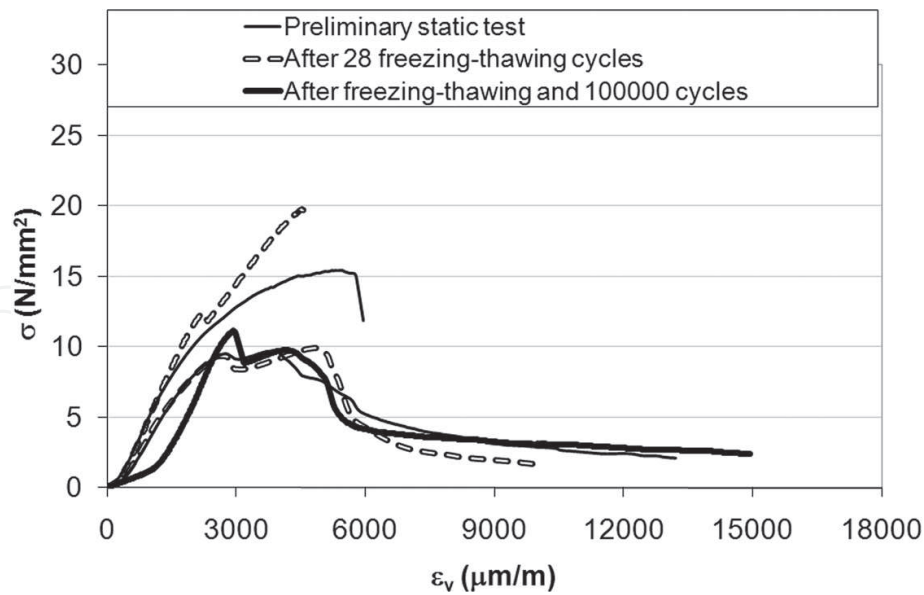
Figure 13. CL series static tests.

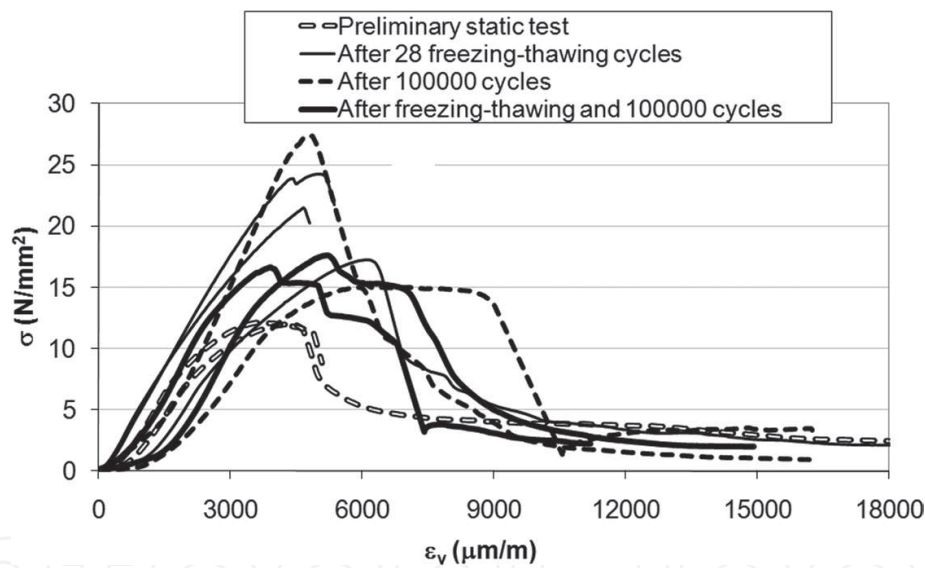
Figure 14. DL series static tests.

The values obtained for a majority of the series remained within the average of the two preliminary tests, save for the series DL (Figure 14), which displayed a considerable increase in strength. In most cases, static curves after freezing-thawing revealed a more brittle behavior. Test pieces of BL and DL series that passed 1,00,000 cycles mark were tested to failure: the DL series displayed a noticeable increase of their mechanical properties. Some CL and DL test pieces were subjected both to freezing-thawing test and to cycling loading: CL maintained a static behavior similar to the weakest preliminary test result; instead in the DL series, an appreciable increase of strength was mated to a lesser degree of brittleness compared to the test pieces subjected to cyclic loading only.

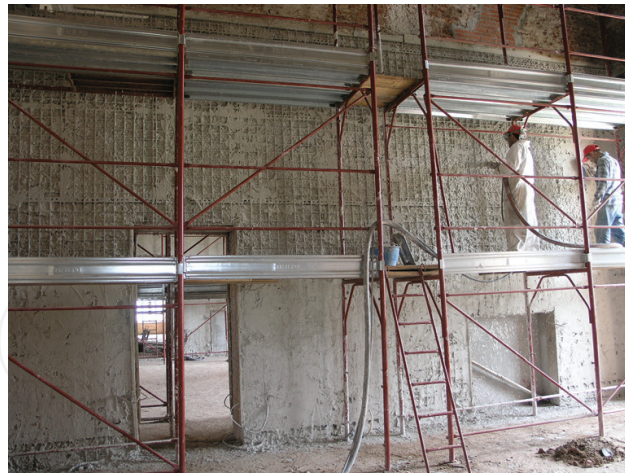
Figure 15. Application of mortar D as the reinforced plaster to Venaria's masonries.

came from the real application of mortar D as reinforced plaster retrofitting of some walls of the Royal Palace of Venaria (**Figure 15**). After 10 years, this plaster does not present any pathology of incompatibility.

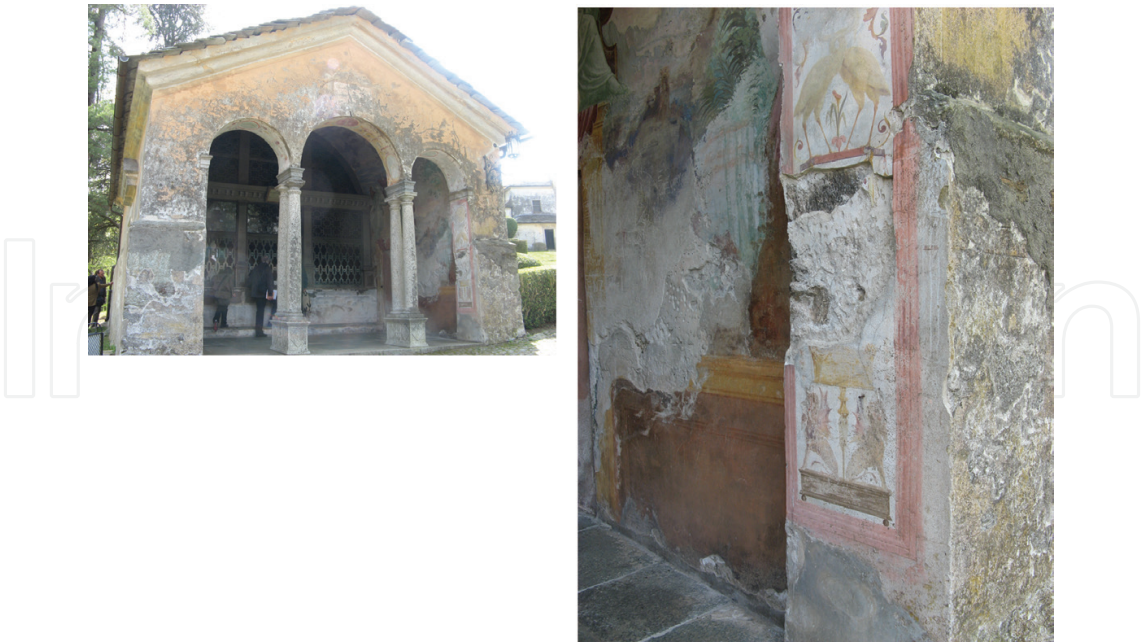
Figure 16. Decay of historical plasters because of the rain infiltrations (Sacro Monte of Varallo).

An innovative laboratory procedure, developed at the Non-Destructive Testing Laboratory of the Politecnico di Torino, is described for test mechanical adhesion of new repair mortars. Compression static tests were carried out on composite specimen stone block-repair mortar, which specific geometry can test the de-bonding process of mortar in adherence with a stone masonry structure. The methodology is being used at Sacro Monte di Varallo Special Natural Reserve. Situated at the top of the hill above the town of Varallo in Piedmont (Italy), Sacro Monte is an artistic-religious complex consisting of 45 chapels, which contain with frescoes and sculptures that tell the story of the life of Christ (**Figure 16**).

The main problem of historical plasters' preservation is linked to the rain infiltrations and to the freezing-thawing cycles that compromise their adhesion to stone masonries. Through compression static tests on stone-mortar composite specimens, it was possible to prequalify the dehumidified mortar with greater durability guarantees. Sometimes the long-term detachment determined the failure of the restoration work. The test validates the mechanical

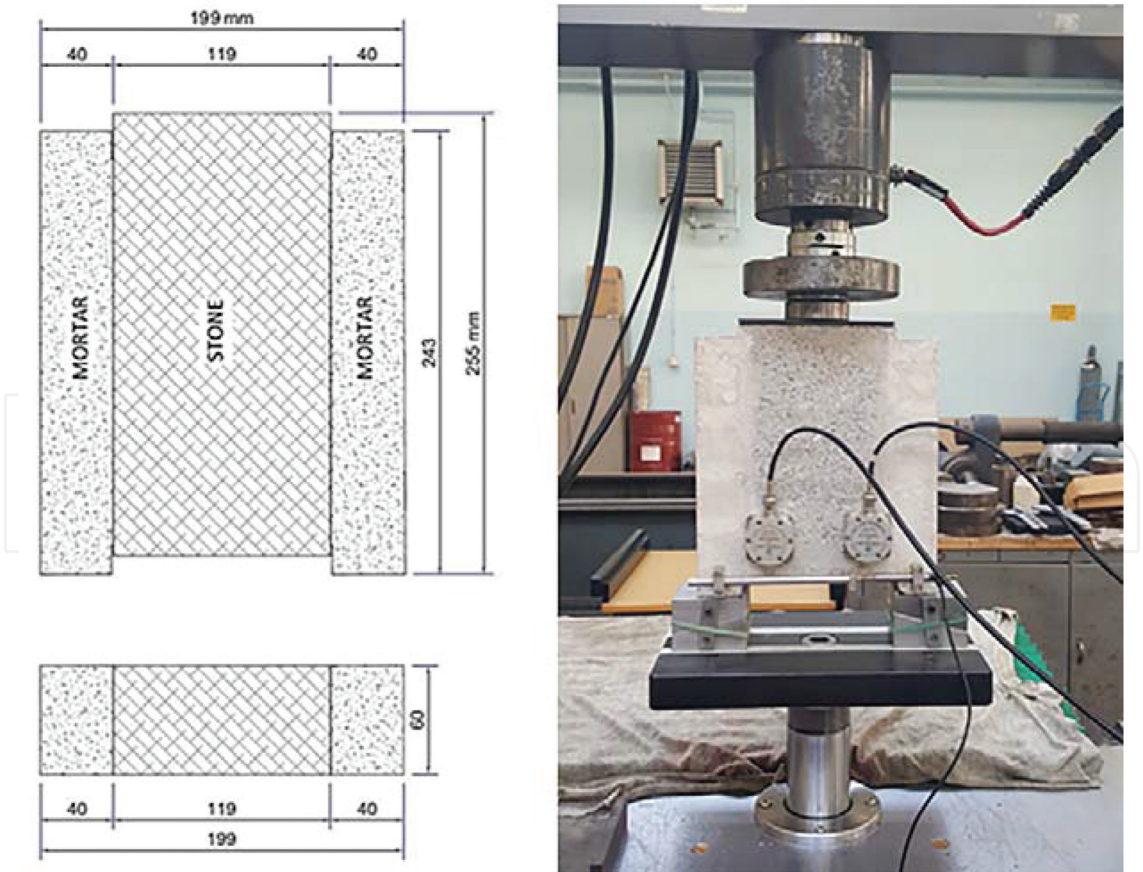
Figure 17. Geometry of composite specimen and test setup.

For carrying out tests, a particular geometry of the composite specimen has been proposed. Four mixed specimens were made, applying a 40 mm mortar layer to both shorter faces of the stone brick suitably cut with the dimensions shown in **Figure 17**. The mechanical characteristics of the repair mortar and the stone brick were chosen equivalent to those of the stone masonry at the Sacro Monte di Varallo. The experimental test can carry out also by masonry brick, if the historical walls were made by bricks. The hydraulic lime mortar was a pre-blended transpiring product, for dehumidifying repair work on historical masonry

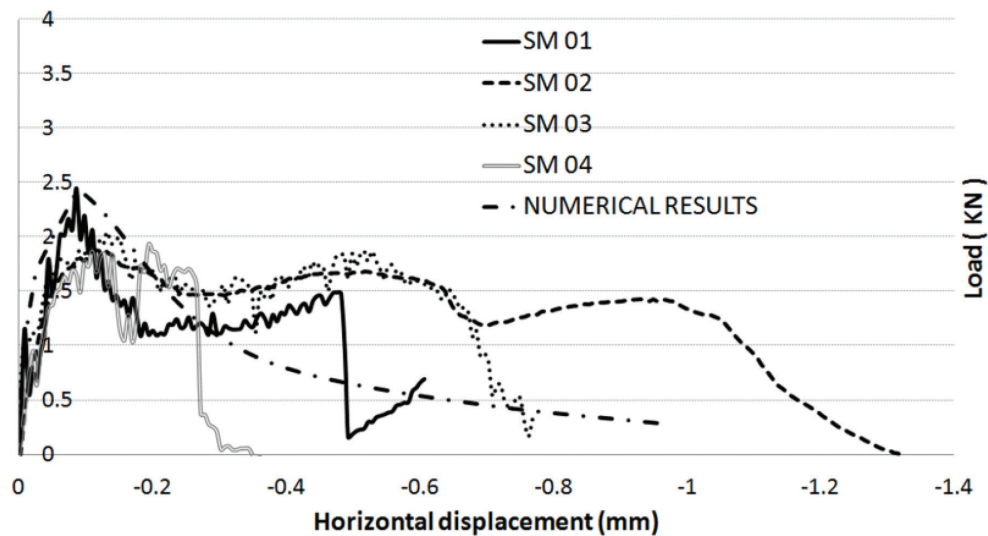
Figure 19. Load-horizontal displacement curves of static tests.

The results of compressive static tests are shown in **Figure 19**. A numerical simulation based on the cohesive crack model was used to follow the experimental data, in order to describe the evolutionary phenomenon of de-bonding as a function of a small number of parameters [13–15]. The composite specimen stone-mortar displayed four stress singularity points: two notch tips at the specimen's top, and two at the specimen's bottom. These points were the weakest planes involved in the singular stress fields. Because of the wedges, the cracks that start from the bottom of the specimen showed greater velocity than the cracks that start from the top of the specimen. To exception of SM 04, the other composite specimens were displayed a ductile behavior keeping a residual load and displacement after the peak load. That is a fundamental requirement for a durable service life of repair plasters subjected to thermo-hygrometric cycles stress as rising damp effects. The specific geometry of the composite specimens has allowed to test the adherence between dehumidified repair plaster and masonry structures, in order to prequalify the durability of the repair product. The notch tips have put to the test the adherence of the repair plaster applied to the stone support, simulating the fatigue loads that can compromise the restoration work.

The Teflon sheet, inserted at the contact surface between the upper and lower wedge, was able to reduce the friction and to stabilize the load curves. The static compressive tests represent a rather fast laboratory procedure useful for analyze the delamination of the dehumidified repair plasters applied to the historical masonry of the Sacro Monti di Varallo. The next step of this experimental research, at the moment in progress, is to carry out the cyclic compressive tests in order to simulate the fatigue stress between the masonry stone and the repair mortar.
