Microscopical Methods for the In Situ Investigation of Biodegradation on Cultural Heritage

Verginica Schröder, Daniela Turcanu Carutiu, Adina Honcea and Rodica-Mariana Ion

Keywords: microscopy, epifluorescence, biodeterioration, microbiota, stone surfaces, Matia-Fresco Loggia, Corvin Castle

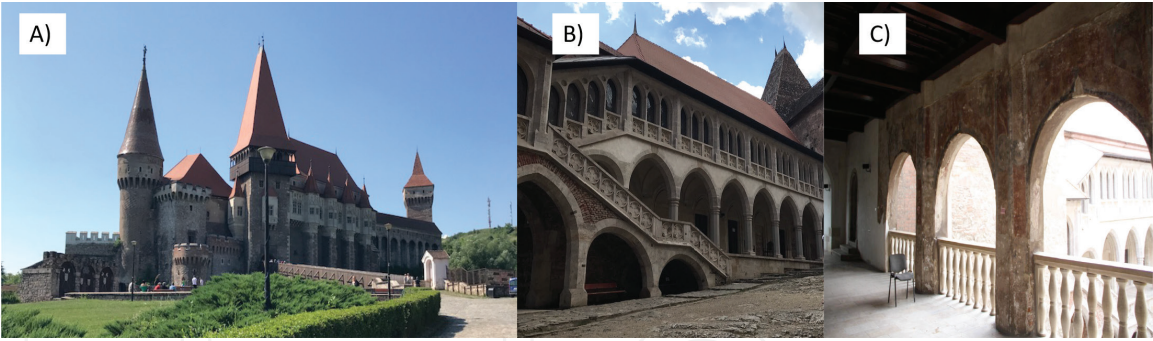
Figure 1.
The locations of sampling points. (A) Corvin Castle—general view; (B) Matia Loggia—outside view; and (C) Matia-Fresco-Loggia—inside, two pillars view.

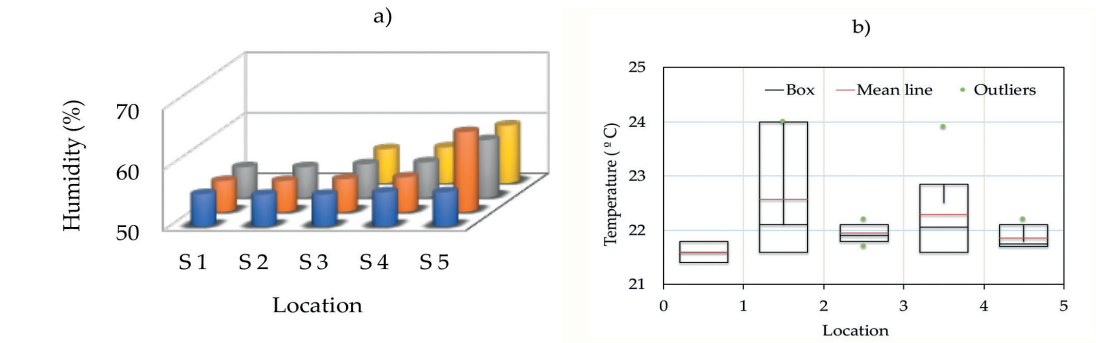
Besides all of these investigations, it is important to ascertain the humidity migration and circulation inside of the Matia Loggia. The local measurements revealed higher humidity values at the external position (higher air circulation) of the loggia and lower humidity values at the internal positions (**Figure 2a**).

The deterioration of stone usually takes place at higher relative humidity, above 65%, and for external walls, it is more accentuated for porous building materials where it is caused by the excessive moisture content [61]. Changes in temperature induce a thermal gradient (**Figure 2b**) between the surface layer and the inner layer of materials which may result in the degradation of the mechanical properties of the material and can lead to the formation of fine cracks.

Figure 2.
(a) The changes of the humidity and (b) the variations of temperature with the location: S1—the innermost; S5—the most outward.

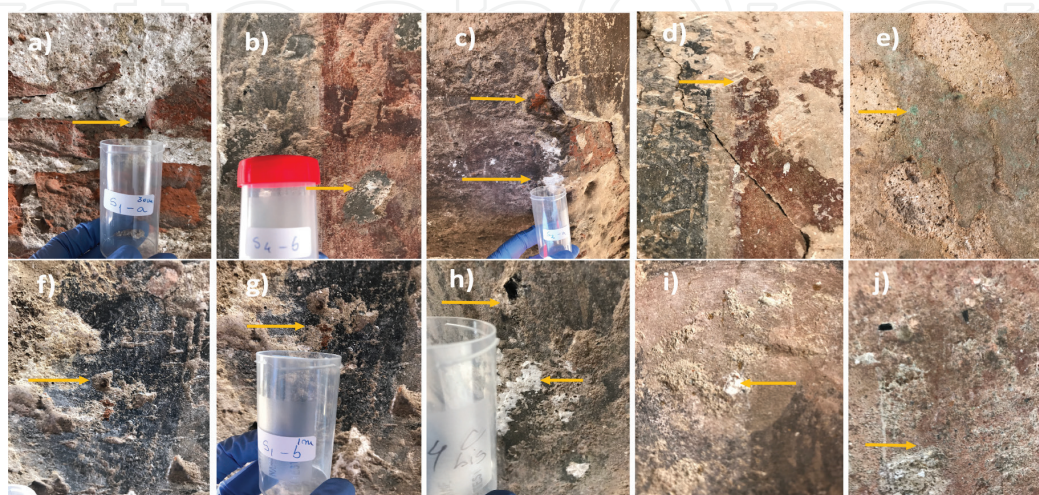
Studies on the degradation of fresco areas have been done at macro- and microscopic level. The in situ analysis (22 samples), performed for the first time in the fresco area, highlighted several aspects that concur with the phenomenon of degradation: the existence of materials with high porosity which favor moisture maintenance and increase the potential for biodegradation in the case of restored areas (**Figure 3a**), the presence of extensive deterioration over the entire painted surface, including depigmented areas (**Figure 3b** and **i**) and cracked portions (**Figure 3c** and **d**) and the existence of biogenic pigments green, reddish brown (**Figure 3f** and **g**) or black (**Figure 3h** and **j**).

The harvesting of biological samples on the surfaces indicating a visible degradation phenomenon was done by means of a sterile needle, by the removal from fresco areas of a few millimeters. The harvesting of the samples was done in sterile plastic containers (**Figure 3**). After scraping, the samples were processed and studied in the laboratory.

Figure 3.
 Sampling and indicating areas of high degradation of the material (yellow arrows): (a) the materials with high porosity in restored areas, (b) depigmented areas, (c) cracked portions, (d) deterioration areas with fissures and cracks, (e) green pigment portions, (f, g) biogenic reddish-brown pigment, (h) black pigment, (i) deterioration with depigmented areas, and (j) black pigment and extensive deteriorations areas.

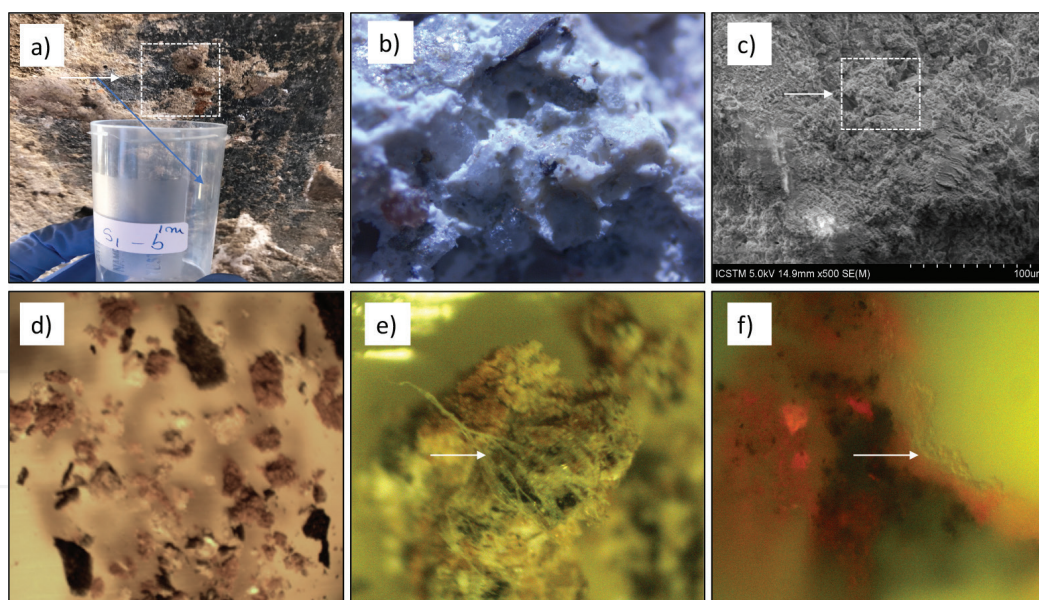
Figure 4.

Sample 1 was collected at a height of about 1 m to the soil, from painted portions with visible degradation elements (**Figure 4**) on the respective surfaces. Macroscopic and microscopic observations have identified porosity and high brittleness of materials. Dark brown biogenic pigmented areas and depigmented portions that are easy to detach are highlighted (**Figure 4a**). At the morphological level, there are different structural components with (**Figure 4b** and **c**) uneven

Evaluation from macroscopic to microscopic level of the degraded surface; (a) direct visual evaluation, surface details light microscopy 400×, (c) electron microscopy (SEM) 7000×, (d) stereomicroscopy 40×, light microscopy 400×, and (f) epifluorescence microscopy 400×.

At this level, porosity is very fine, with ordered microspheres suggesting biogenic origin. In the sample analyzed with the optical microscope, during the first minutes after harvesting, very intense bacterial activity was revealed. The very large number and mobility of bacteria is evidence of the intense colonization of these microgalleries of the substrate. Extemporaneous samples also surprised fungal filaments (**Figure 4e**) adhering to the substrate and the stratification of the biofilm (**Figure 4f**), aspect suggesting the existence of anoxic conditions at the microhabitat level.

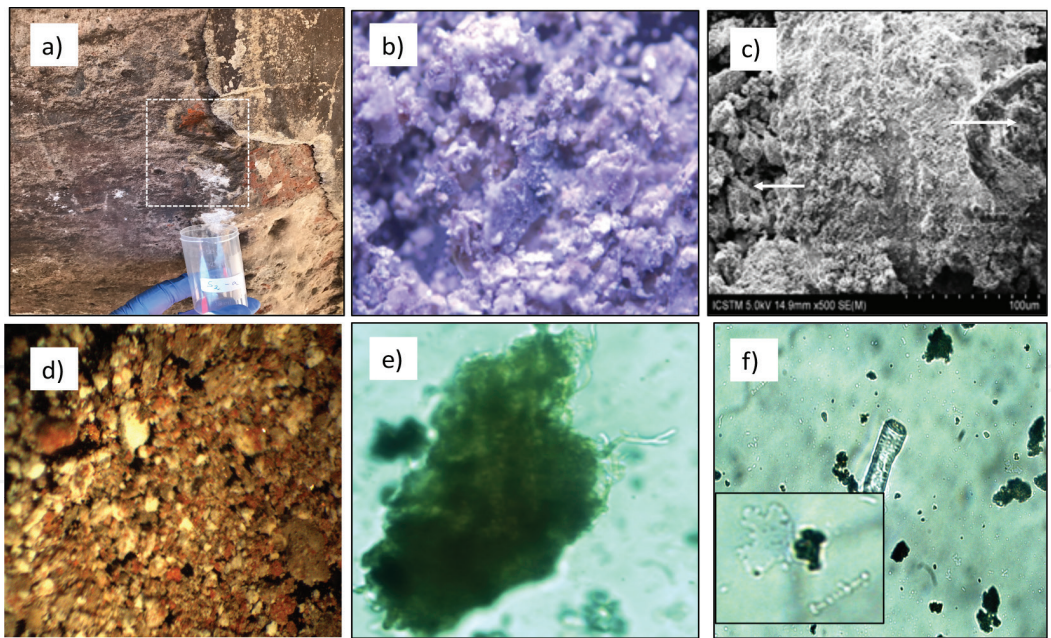
Sample 2 was collected at 1.50 cm to the soil, from an area with fine cracks (**Figure 5**), where superficial layers are easily detached.

Direct observation (**Figure 5a**) of the area of sample collection indicates that the zone was intensely degraded, with excavations likely induced by the shredding of the material and a mosaic appearance as a result of depigmentation. Microscopic analysis reveals fine granulation and mixtures of mineral elements with different chromatic appearances and porosities (**Figure 5b** and **d**). Shredding degradation is also visible in SEM analysis (**Figure 5c**). The study of wet microscopic preparations indicates fungal agglomerations (**Figure 5e**) and bacterial activity evidenced by intense mobility. Several bacterial morphotypes and clusters of the type of hulls found in clusters of irregular or filamentous forms were visible (**Figure 5f**).

Figure 5.
Evaluation from macroscopic to microscopic level of the degraded surface; (a) direct visual evaluation, (b) light microscope 400×, (c) electron microscopy (SEM) 7000×, (d) stereomicroscopy 40×, (e) light microscope 400×, and (f) light microscopy 1000×.

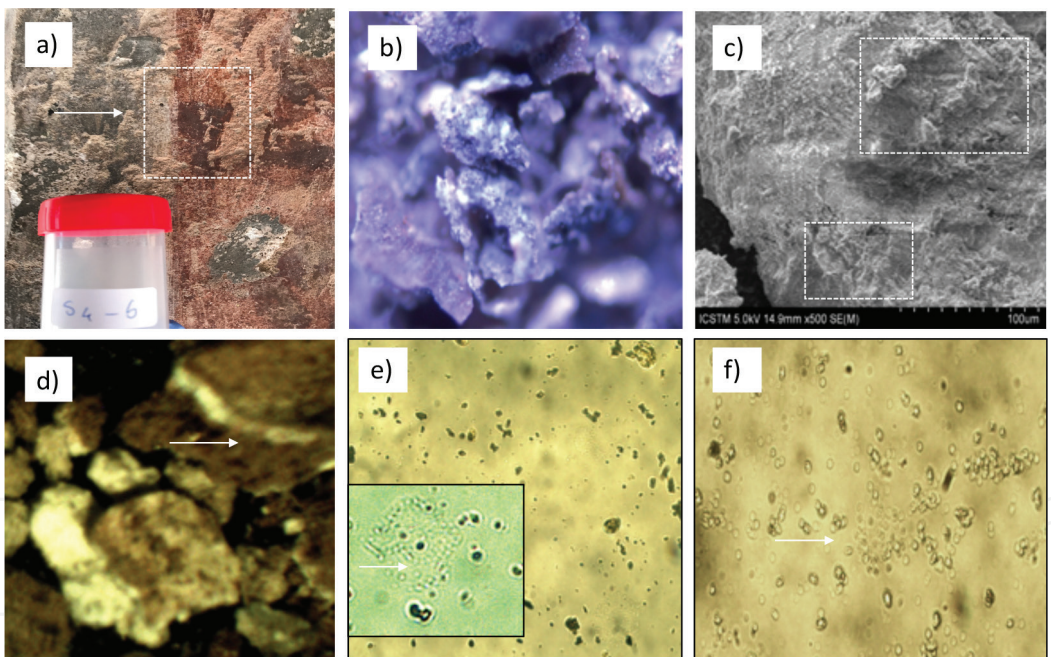
Sample 3 was collected at 1.70 cm from the ground, painted with obvious bumps and dents, with a modified chromatic look (**Figure 6a**), possibly paint overlays overlapping previous restoration attempts. Microscopically, we found components that are different in shape and color (**Figure 6b**) arranged in layers with variable porosity and chromatic sequence (**Figure 6d**). From a biological point of view, the surfaces are intensely colonized (**Figure 6e** and **f**) of very large density micrococcus forms.

Figure 6.
Evaluation from macroscopic to microscopic level of the degraded surface; (a) direct visual evaluation, (b) optical microscopy 400×, (c) electron microscopy (SEM) 7000×, (d) stereomicroscopy 40×, (e) optical microscopy 1000×, and (f) optical microscopy 1000×.

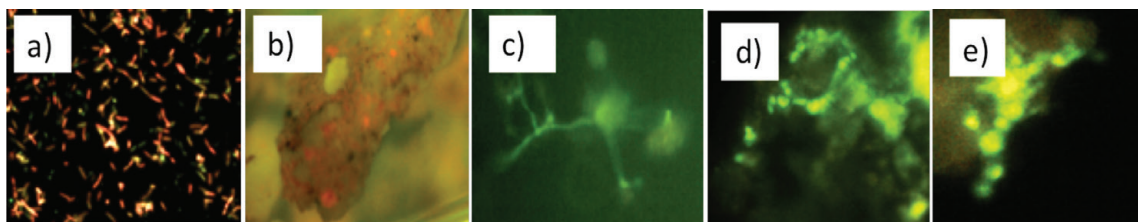
Figure 7.

The analysis with specialized microscopy with epifluorescence highlighted the activity of the biota within the analyzed system. Live bacteria with an emission in

orange shades have been noted in the presence of fluorochrome AO in an acid pH (**Figure 7a**). On inorganic surfaces, live components such as free-flowing filaments (**Figure 7c**) or filaments attached to the substrate (**Figure 7b, d and e**) were identified by this technique.

Metabolic activity is also noted through acidification phenomena marked by red emission on the carrier particles, probably caused by the death of some components of the microbial complex (**Figure 7b**).

In situ observations using the epifluorescence microscopy technique and AO stain: (a) bacteria in suspension sample, (b) biofilm at substrate, and (c–e) fungal hyphae, (magnification 400×).
