Connection Node Design and Performance Optimization of Girder Truss

Ze-li Que, Liu-liu Zhang, Fei-bin Wang, Yi-fan Gao,
Wei-zhen Cai, Xin-meng Wang and
Chang-tong Mei

Abstract

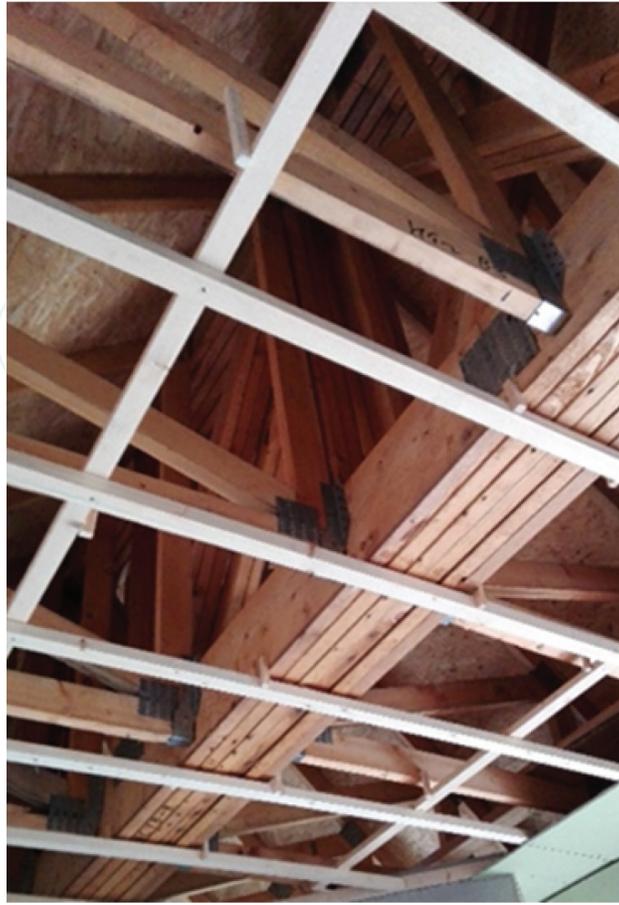
Figure 1. Application of girder truss in building structure.

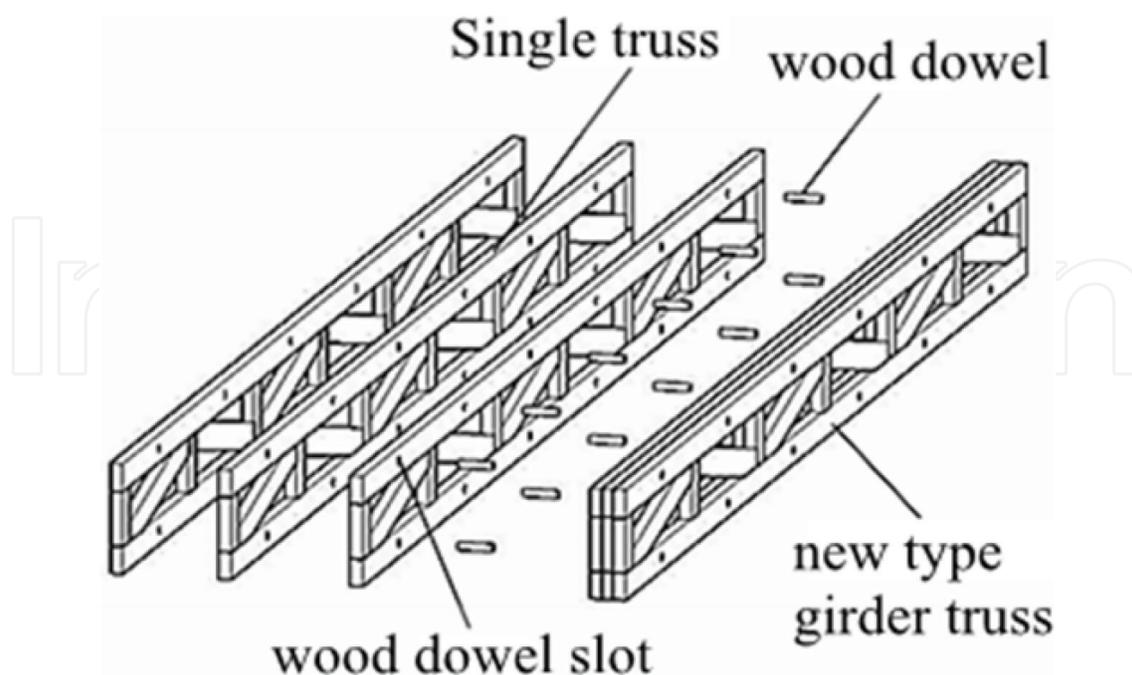
In response to the problems with connection modes of girder truss, this chapter proposes a new type of connection modes of girder truss, which replaces traditional iron connectors with wooden connectors. The specific scheme is as follows: all the single trusses that make up the girder truss are preassembled and temporarily fixed, then predrilled at specific positions of all the trusses and finally inserted into a wood or bamboo round dowel, which is a wood dowel connector (see Ref. [15]) (as shown in **Figure 2**).

Figure 2. A new type of girder truss.

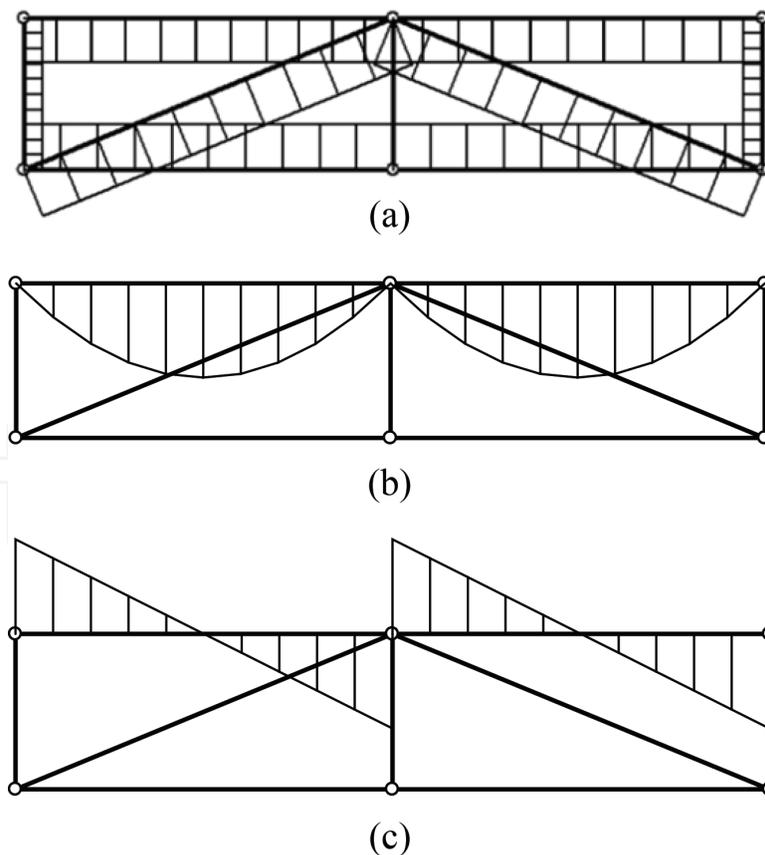
upper and lower chords of the truss. The upper chord is under pressure and the lower chord is subjected to tension, but the web only plays a supporting role. **Figure 3** shows the internal force diagram of the light wood truss supported by the upper uniform unit. It can be seen from the internal force diagram that if the parallel chord truss is regarded as a static combination structure, which means the chord is broken and both ends are hinged. Under the uniform load, the middle bending moment value of each chord is the largest and the shear force is at least zero. The use of wood dowel connectors requires predrilling the upper and lower chords of the truss, thus reducing the net cross-sectional dimensions of the chord. The shear force calculation formula of the structural member is:

A represents the sheared net cross-section of the sheared member. The decrease in A means an increase in the shear stress in the member. Therefore, the position of the connector must be placed in where the chord shear force is the smallest, which is the middle of every two nodes of the chord.

Figure 3. Internal force diagram of parallel chord truss. (a) Parallel chord truss axial force diagram; (b) parallel chord truss bending moment diagram; (c) parallel chord truss shear force diagram.

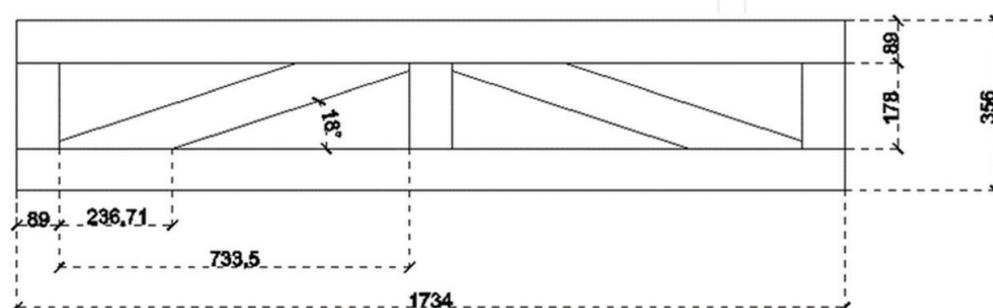
Figure 4 shows the structural form and specific dimensions of the test piece used in this test. The girder trusses used in the experiment are all composed of this single truss.

Figure 4. Module's size of girder truss (unit: mm).

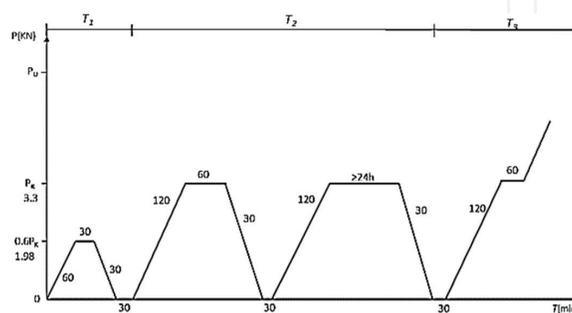
Figure 5. Loading system.

preliminary experiment, we found that the girder truss had more than twice the ultimate bearing capacity of the single truss. So during the loading process, the load of each stage was also doubled to 0.132 kN. If the girder truss is composed of three single trusses, the load per stage was also tripled to 0.198 kN. The specific loading system diagram is shown in Figure 5.

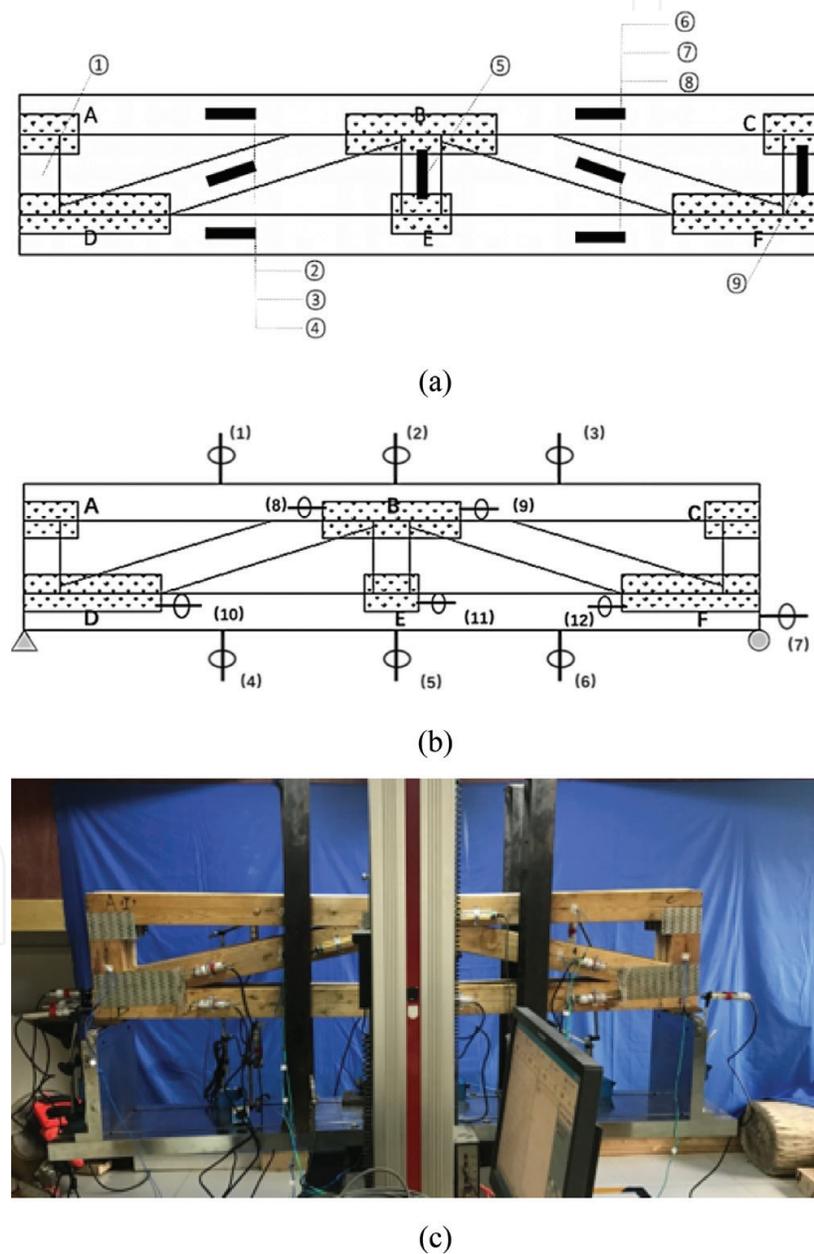
Figure 6. Layout of strain gauges and displacement gauges. (a) Layout of strain gauge; (b) displacement gauge; (c) universal mechanical testing machine.

of girder truss for different dowel diameters should also start from the aspects of ultimate bearing capacity, deformation resistance, failure form and mechanism. Therefore, similar to the static load test of large-span wood trusses, it is necessary to track the displacement changes of various nodes of different types of wood trusses continuously. In this experiment, a small-range displacement sensor was also arranged between the chord and tooth plate for measuring the relative slip of the tooth plate relative to the chord. In addition, strain gauges were arranged at the important chords to measure the strain at various stages of the chords. The specific measuring point layout is shown in **Figure 6**.

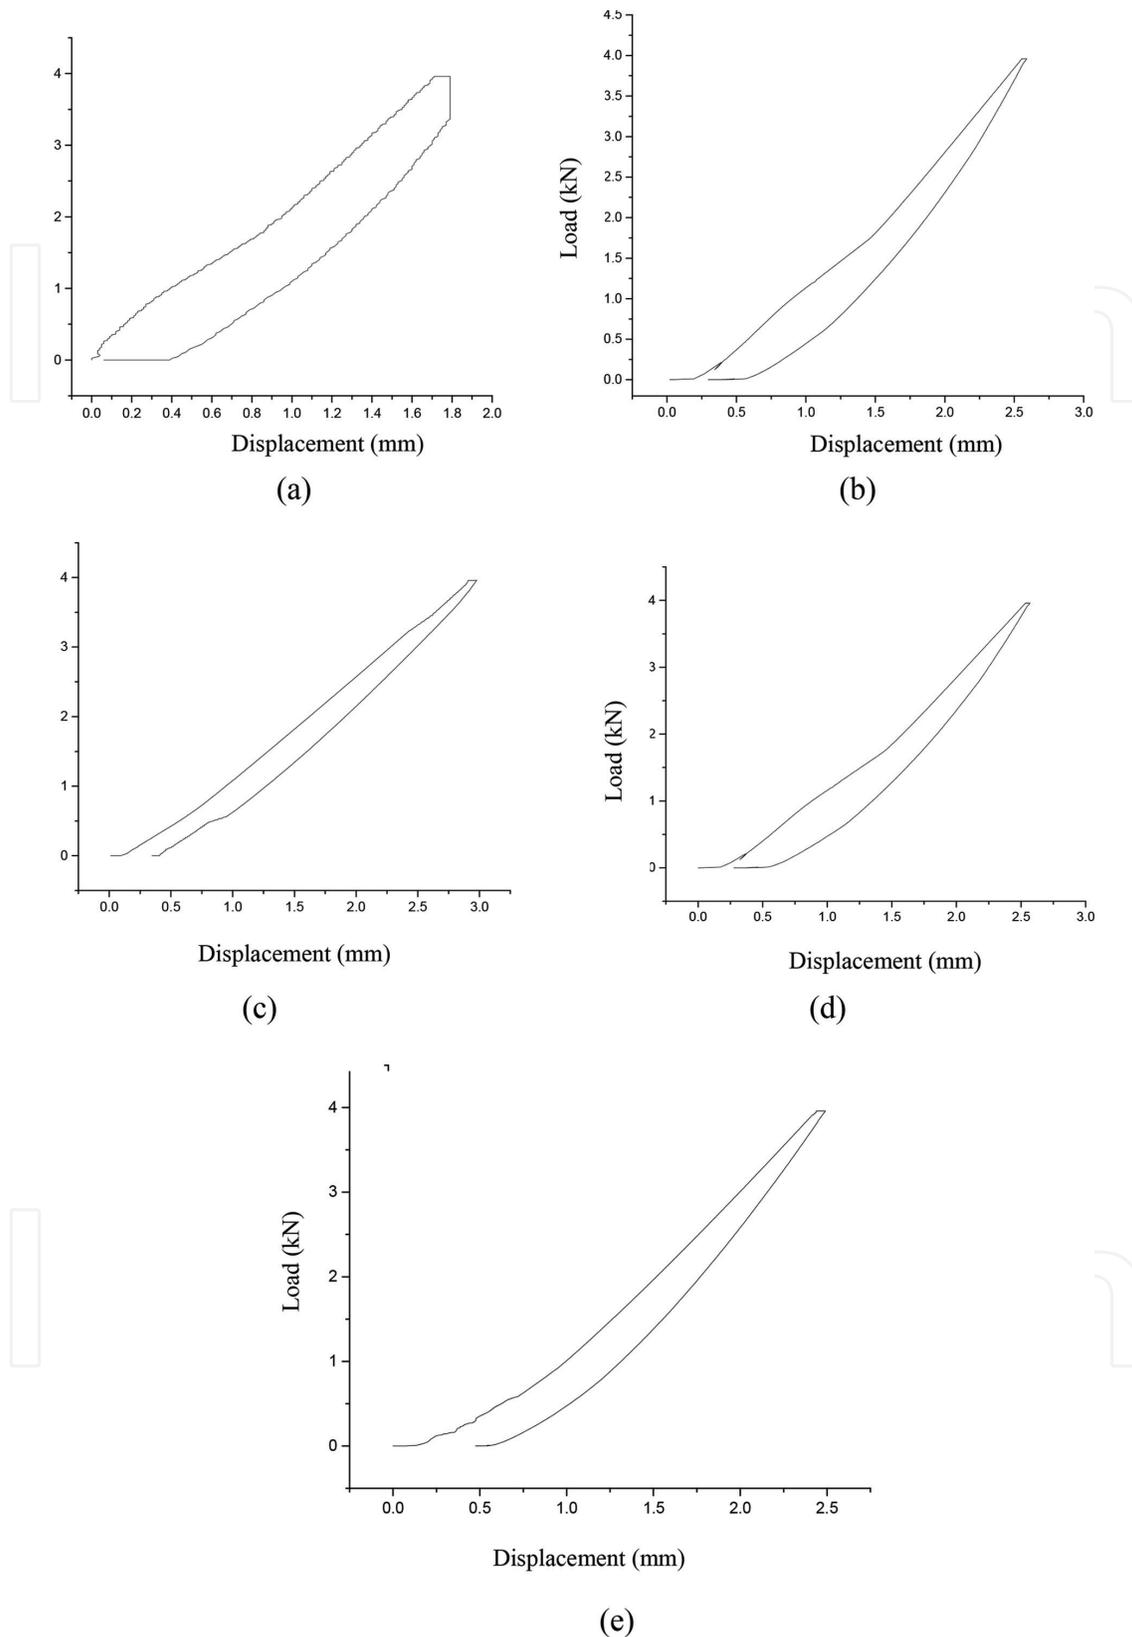
First, during the preloading of the T_1 stage, the truss did not produce significant changes. After 30 minutes of loading, all types of trusses produced very small residual deformations. Especially, the girder truss could achieve full elastic recovery. From the load-displacement curve of the T_1 stage in **Figure 7**, a certain creep value appeared in the single truss during the preloading phase. The creep variables of other girder trusses were negligible. The use of dowel connectors of different diameters had little effect on the performance of the girder truss.

Figure 7. Load-displacement in T_1 stage. (a) SPT-S; (b) SPT-N; (c) SPT-G2-12 (d) SPT-G2-16; (e) SPT-G2-20.

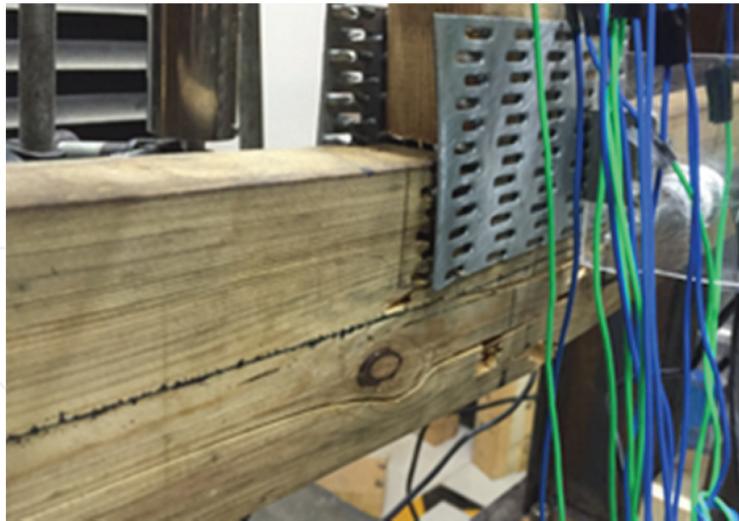
Figure 8. The lower chord cracks accompanied by tooth extraction test process of SPT-S1.

In addition, many experiments have found that the overall damage of the truss is destroyed by the destruction of the lower chord. The knot of the lower chord also directly affects the force performance. **Figure 10** shows the actual photo of destruction in lower chords of trusses. When processing the truss, the experimenters must pay attention to the selection of the lower chord and try to avoid too many specifications with the knots. However, the upper chord and the web of the truss had obvious shear damage and the chord did not have obvious damage. Therefore, when the wood truss is processed, the grade of the processing material can be appropriately reduced.

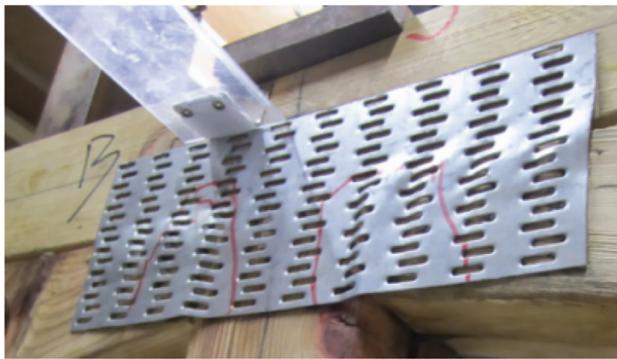
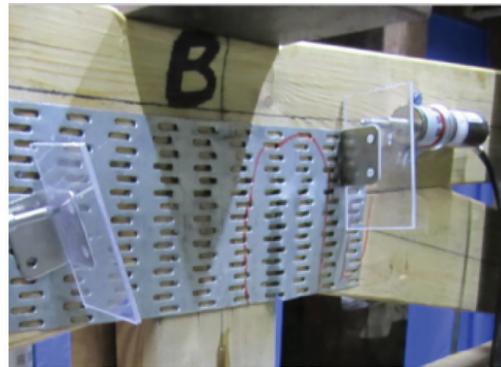
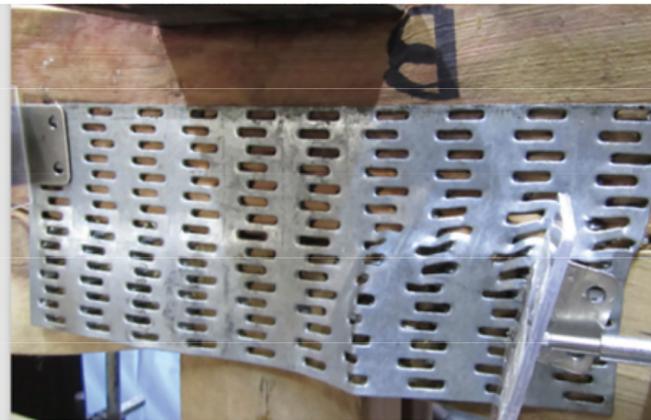
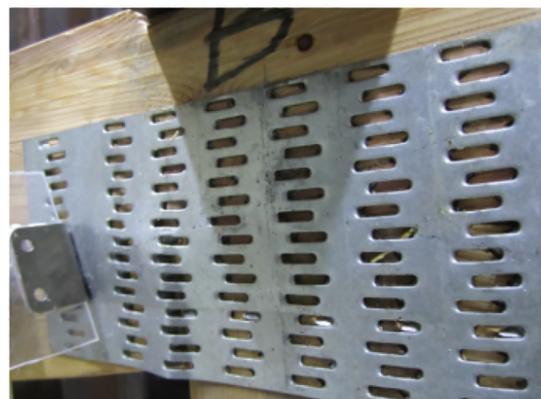
As the test progressed, there was no significant test phenomenon for each truss from the 24-hour holding load to the initial T_3 stage. However, when loading to $5 P_k$, the test phenomenon began to occur in the span of the truss and there was no obvious phenomenon at other nodes. For example, a slight truss plate bulge occurred in the upper B node of the SPT-S and the lower chord appeared cracking near the knot (as shown in **Figure 8**). At other stages, other girder trusses were similar to the test phenomenon of single trusses, and the phenomena of destruction were also concentrated in these two places. In particular, the truss plate of the central B node of the upper chord bulged (as shown in **Figure 9**). This is mainly related to the force mechanism of parallel chord truss. When the parallel chord truss is subjected to the upper concentrated load, the upper chord is under compression and the lower chord is under tension. Combined with the analysis of structural mechanics, the diagonal web of the truss will generate a lateral force at the B node in order to resist the upper concentrated load. Therefore, the B node was subjected to the shear stress, and the stress environment was very complicated. Combined with the final failure form of the truss plate, the truss plate at the B node eventually appeared as a form of shear compression failure.

Figure 9. Shear compression failure of mate plate in B node. (a) SPT-G2-N; (b) SPT-G2-12-1; (c) SPT-G2-16-2; (d) SPT-G2-20-2.

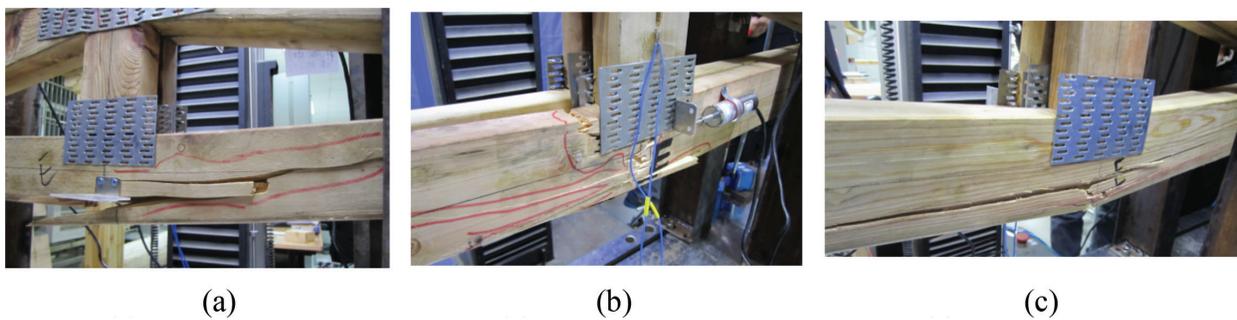
Figure 10. Destruction in lower chords of trusses. (a) SPT-G2-N; (b) SPT-G2-12-2; (c) SPT-G2-16-1.

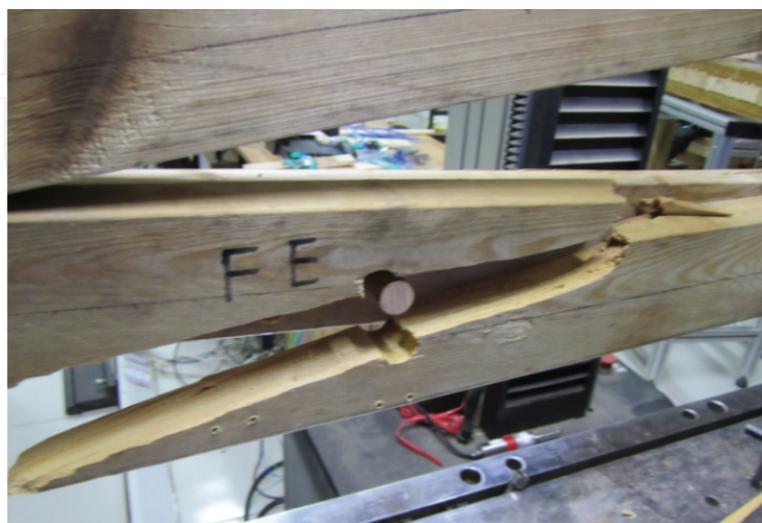
The destruction of the lower chord of the girder truss SPT-G2-20 was due to different reasons. The SPT-G2-20 had a 19.5-mm diameter hole in its upper and lower chords. The opening of the lower chord was too large, destroying the fibers in the direction of the wood and also reducing the net cross-sectional area of the truss chord. Under the condition of constant force, reducing the net cross-sectional area of the rod will increase the stress on the chord. The tensile strength of large-sized wood is less than the compressive strength, so the lower chord is easily damaged. **Figure 11** shows the real photo of the girder truss SPT-G2-20 chord

Figure 11. Failure phenomenon of SPT-G2-20-1.

failure. The lower chord crack started from the wood dowel joint and run through the entire chord. This ultimately led to the overall destruction of the truss, yet there was little damage to dowel.

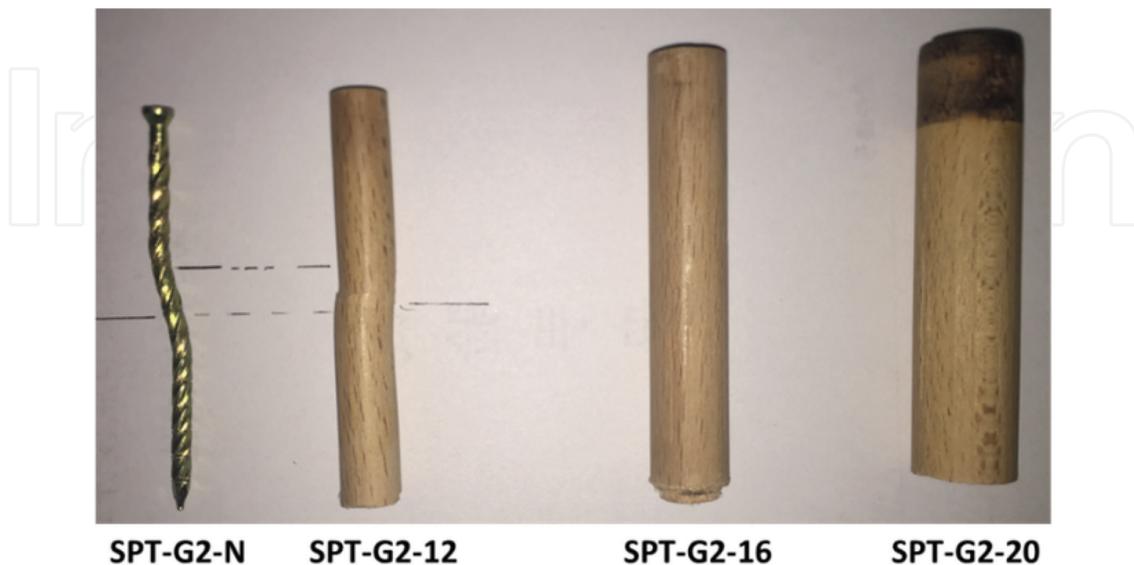
The previous section described the node failure mode of a girder truss connected by a 20-mm diameter dowel between the single trusses of girder truss. The final damage was caused by the destruction of the lower chord, but the dowels showed almost no deformation. The size of the dowels and the nail connectors was damaged to varying degrees. **Figure 12** shows the connector removed from the truss after the final destruction of each girder truss connector.

From **Figure 12**, the deformation caused by the nail connection was large. Similar to the long-span nail connection girder truss, a plastic hinge appeared in the middle of the nail. When the truss was loaded to the later stage, a more obvious dislocation occurred between the single trusses that make up the girder truss. Different diameters of dowels produced different forms of deformation or damage. First, similar to the nail, a 12-mm diameter wood dowel also produced a plastic hinge. However, the amount of deformation was less than the nail connection. The diameter of the wood dowels affected its stiffness. The dowel deformation of a large diameter was small. The dowels with a diameter of 20 mm showed almost no deformation. Wood dowels were almost unaffected by truss damage. The deformation of the wood dowels with 16 mm was also not obvious. The cross-sectional loss of the chord was reduced while providing sufficient joint strength. The relationship between the diameter of hole and dowel of the truss member also had an effect on the connection performance. The black color at the end of the 20-mm diameter dowel in **Figure 13** is the result of carbonization when dowel was screwed into the slot. When the hole diameter of the chord was less than 0.5 mm of the diameter of the

Figure 12. Failure form of connectors.

wood dowel, the wood dowel screwed in the rod was carbonized by the high-speed rotation heat generation and the carbonized layer formed on the surface of the dowel, which protected the surface of the wood dowel. The surface strength was improved. Therefore, it is necessary to select the connectors well and fit the appropriate size of predrilling from the perspective the durability of girder truss.

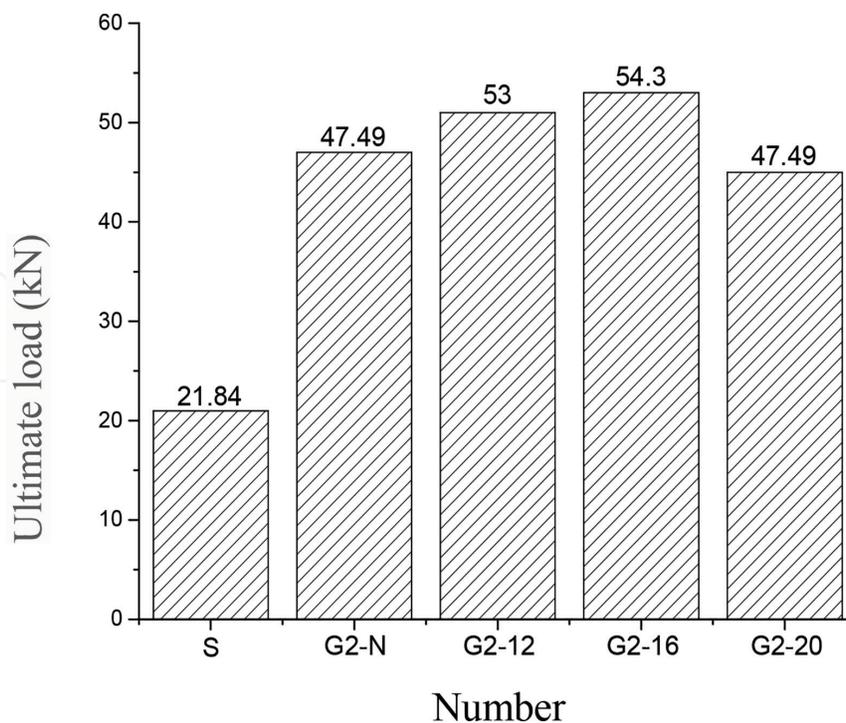
Figure 13 is a comparison of the ultimate bearing capacity of a category five trusses. Among them, the new wood dowel-joined girder truss takes the average of two tests. It can be seen from the figure that the ultimate bearing capacities of all kinds of wood trusses are much higher than its theoretical calculation value, so reducing the span of the truss will effectively improve its carrying capacity. In addition, the ultimate bearing capacities of various girder trusses are much larger than that of single truss, but the ultimate bearing capacities of the various girder trusses have little different from each other. The 12-mm and 16-mm wood dowel-joined girder trusses have a relatively high ultimate bearing capacity. The nail connection girder truss affected the synergy of girder truss due to the mutual dislocation between its single trusses, thus reducing its bearing performance. The girder truss with a wood dowel diameter of 20 mm had a large opening area at the lower chord of the truss, which reduced the net cross-sectional area of the tension member, thereby reducing the load-bearing performance of the truss.

Figure 13. Ultimate bearing capacity of trusses.

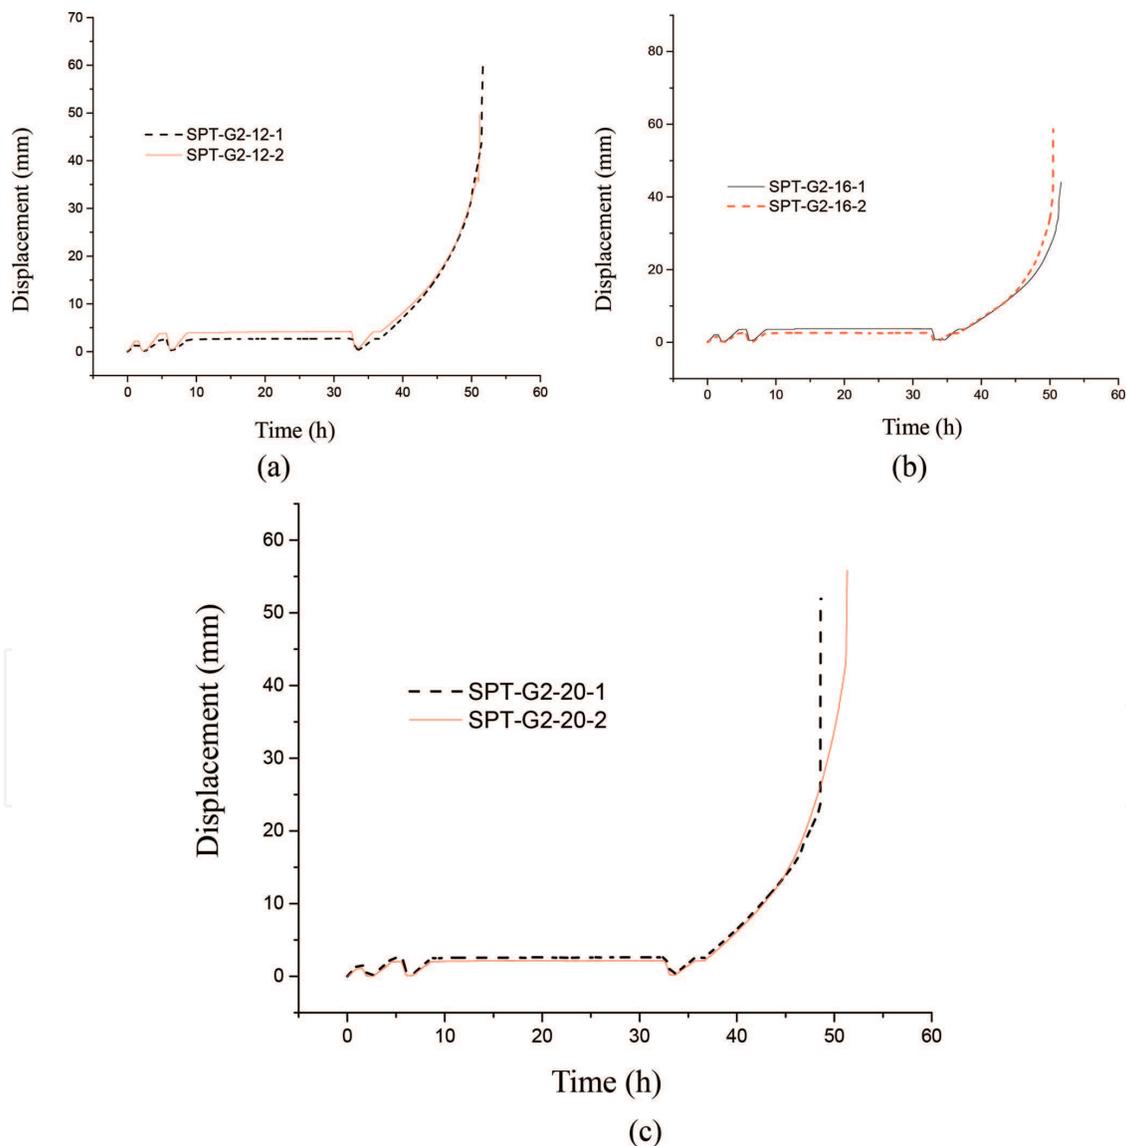
Figure 14 is a deflection diagram of the lower chords of three girder trusses using two different diameter wood dowel connections. It can be seen from the figure that the three types of trusses show good consistency in the first two stages of loading. The truss enters the nonlinear stage when it enters the failure stage, and the results of the two tests will vary due to the variability of the wood. **Figure 17** shows the variation of the overall deformation of the truss during the loading process. The image shows that it is difficult to distinguish the influence of different connection methods on the creep resistance, elastic recovery performance and deformation resistance of the truss on small-span truss specimens. Only in the stage of truss failure, the deflection curve can be distinguished and different failure modes and mechanisms of various trusses can be analyzed.

Figure 14. Time-deflection of new girder trusses from start to finish. (a) SPT-G2-12; (b) SPT-G2-16; (c) SPT-G2-20.

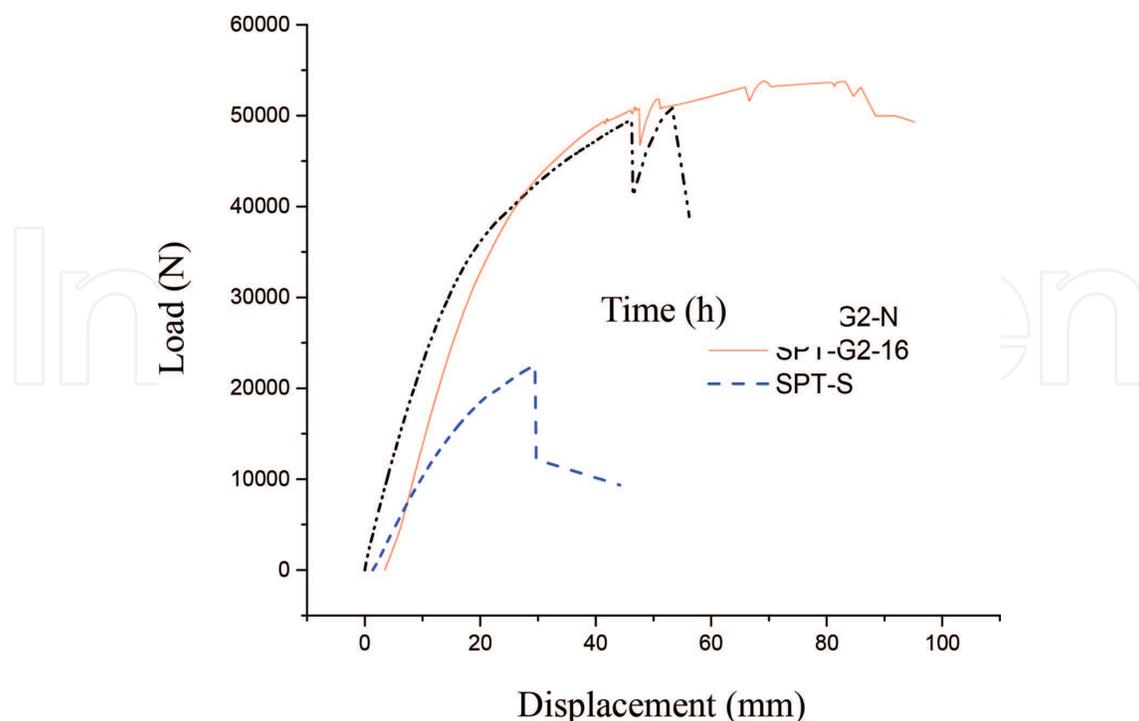
As shown in **Figure 15**, the load-deflection curves of the single truss, the girder truss of the nail connection, and the girder truss of the wood dowel connection are selected in the failure stage. It can be seen from the figure that different types of trusses exhibit different failure modes and mechanisms. Single truss showed obvious characteristics of brittle failure. There was no obvious sign in the vicinity of the failure. A crack occurred near the knot of the lower chord (as shown in **Figure 8**). Then, the crack continued to increase. Eventually, the overall failure of the truss was caused by the sudden fracture of the lower chord.

The ductility of the two girder trusses is significantly better than that of single truss. In the middle and later stages of truss failure, the load-displacement curve often shows a twist at one end. The reason for the twists and turns is that one single truss in the girder trusses was destroyed first. Since the other truss still had the carrying capacity, it would quickly bear the upper load. However, it would also be destroyed quickly because only one single truss was stressed. Due to the different connections between the selected single trusses of girder trusses, the above situation would be different. Although the shear span ratio was reduced, the girder truss of the nail connection still exhibited in-plane instability at the later stage of loading. Larger span trusses were not very obvious. There was mutual dislocation between the upper trusses. The girder truss would be obvious that one single truss were destroyed first and then another truss would be destroyed quickly. Therefore, the nail connection girder truss did not produce the expected effect of "one plus one is greater than two." The girder truss connected by wood dowel could still maintain good synergy between the loaded trusses. Therefore, SPT-G2-16 also had its first wave where SPT-G2-N had its twists and turns. However, it can be seen that the drop in displacement was very limited, indicating that the truss had not been

Figure 15. Load-deflection curve of trusses.

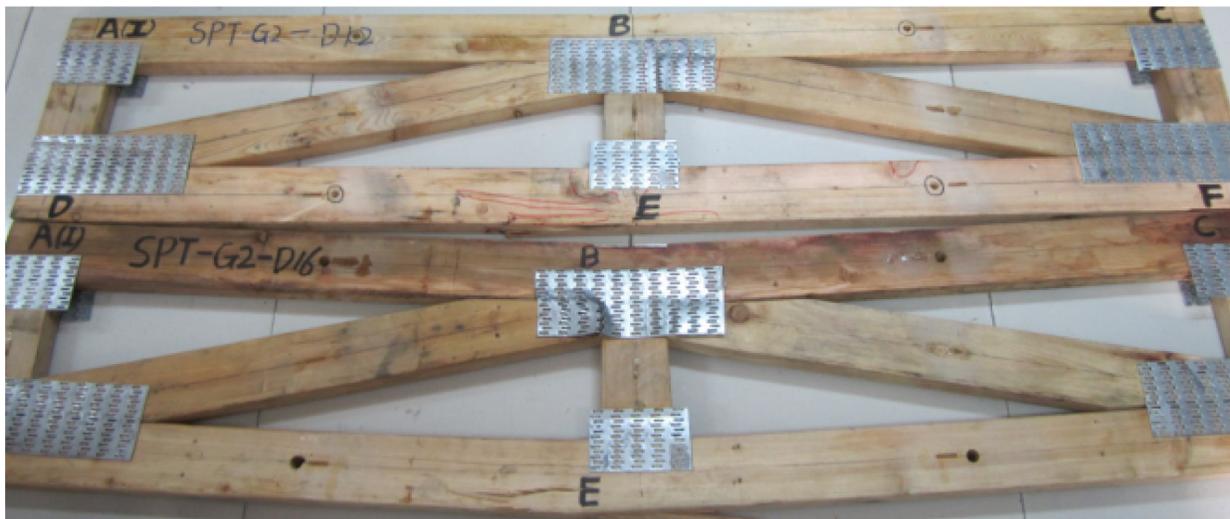
Figure 16. Failure phenomenon of SPT-G2-16.

completely destroyed. As the load continuing to increase, the curve appeared three or four small twists. Eventually, the cracks that was generated at the bottom of the two lower chords of the truss were excessive and completely penetrated (as shown in **Figure 16**), resulting in failure of the truss.

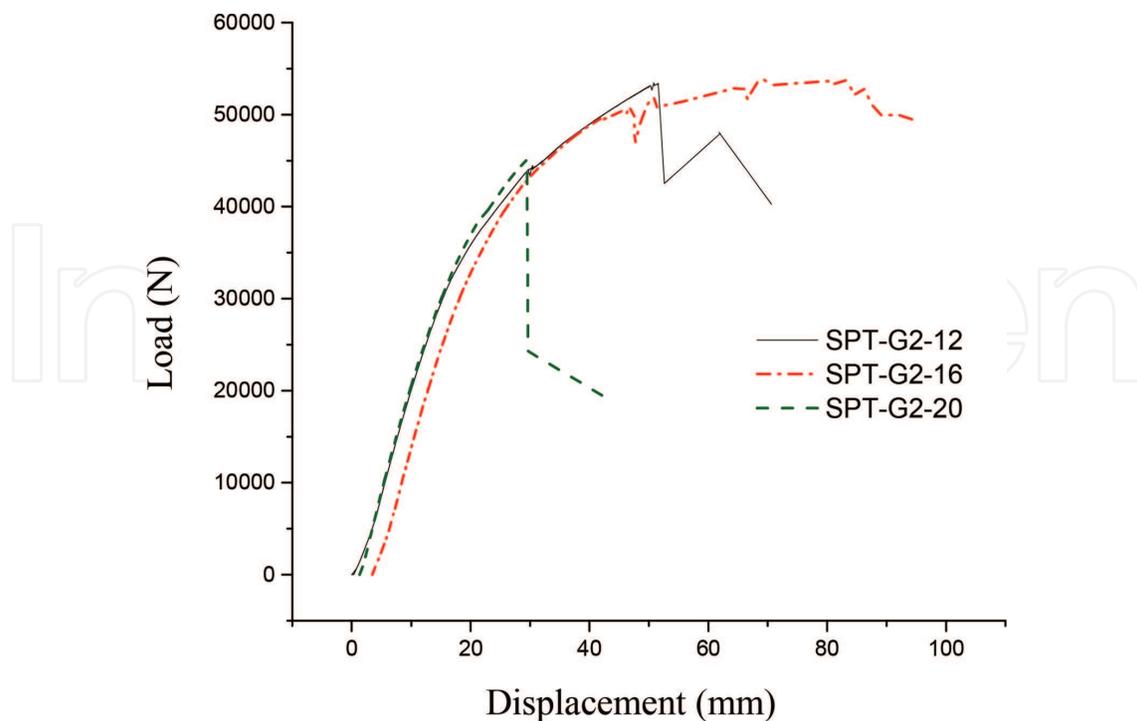
Figure 17 shows the load-deflection curves of three new girder trusses with different diameters of wood dowel as the connection between single trusses. It can be seen from the

Figure 17. Load-deflection curve of new girder trusses.

figure that the load-deflection curves of the three girder trusses show different shapes. The girder truss with a wood dowel diameter of 20 mm had a similar failure mode of single truss, which was brittle failure (as shown in **Figure 10**). The lower chord was broken under the combined action of tension and shear. The 12-mm diameter dowel connected girder truss was similar to the nail-connected girder truss. Although the load-displacement curve had undergone a twist, the truss did not show good synergy. Finally, a plastic hinge appeared similar to the wood dowel and the nail. Therefore, the dowel connected girder truss showed a better mechanical performance with a 16-mm diameter wood dowel.

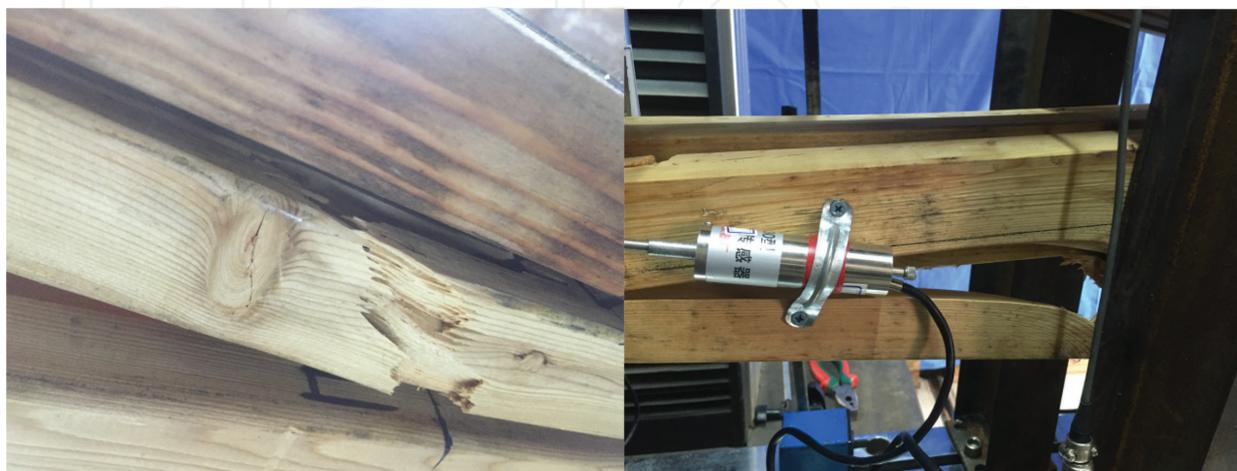
Figure 18. The failure of SPT-G3-16.

shear environment, resulting in the destruction of the truss. As shown in **Figure 18**, the middle truss first appeared as cracks at the lower chord. The increase in force resulted in an overall failure of the intermediate truss, with only two trusses being stressed, but girder truss had lost synergy at this time. Then, the wood dowels of the lower chord were also destroyed (as shown in **Figure 19**). The lower chord of the single truss on the outside of girder truss was completely cracked in the direction of the grain. The truss failed as a whole. As shown in **Figure 20**, the load-displacement curves of the two girder trusses in the final failure stage, it can also be found that the two girder trusses have very similar failure modes and both exhibit good ductility.

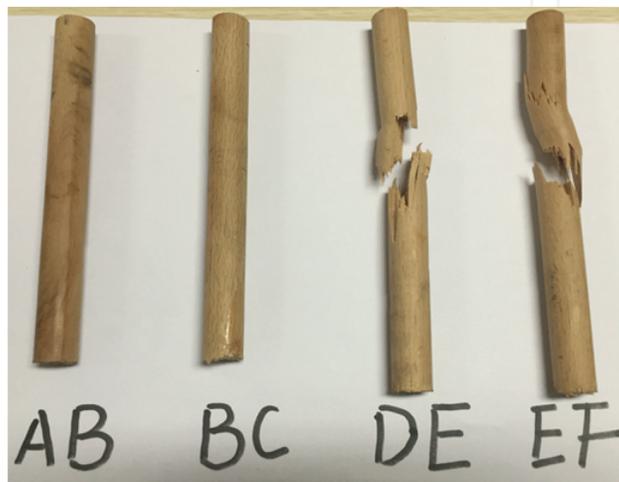
Figure 19. Failure of connectors in SPT-G3-16.

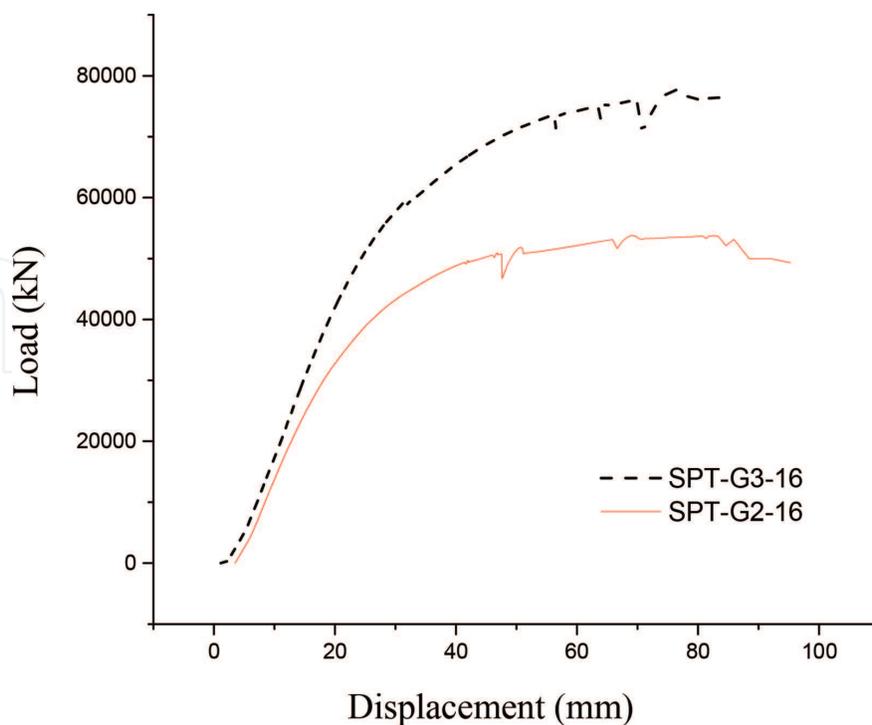
Figure 20. Load-displacement curve in failure stage.
