# Multicomponent Alloys for Biomedical Applications

*Lucien Reclaru, Lavinia Cosmina Ardelean,  
Alexandru Florian Grecu and Catalin Adrian Miu*

## Abstract

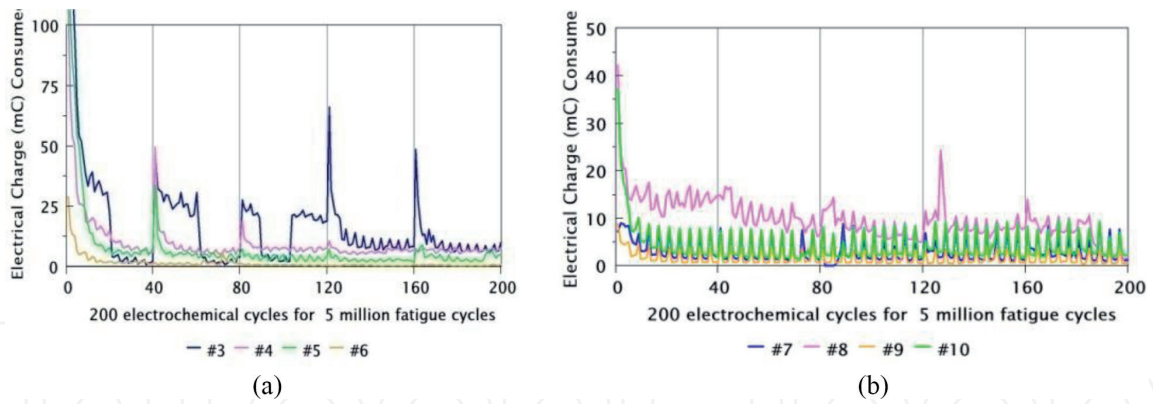
Behavior to localized corrosion of samples #3, #4, and #5 (series 1) during 5 million mechanical fatigue cycles is shown in **Figure 5a**.

Behavior to localized corrosion of samples #7, #8, and #10 (series 2) during 5 million mechanical fatigue cycles is shown in **Figure 5b**. Sample #6 and #9 were evaluated for corrosion resistance without cyclic dynamic forces but under a load of 100 kg (**Figure 5**). The comparative behavior to localized corrosion for samples #6 and #9 is presented in **Figure 6**.

**Figure 5.**  
Behavior to localized corrosion of tested samples. (a) Behavior to localized corrosion of samples #3, #4, #5, and #6 (series 1-cyclic fatigue dynamic test) and (b) behavior to localized corrosion of samples #7, #8 #9, and #10 (series 2-cyclic fatigue dynamic test).

It should be noted that the curves presented in **Figure 5a** and **b** are very different from one series to another. The harmonic shape of the series 2 curves is probably due to the surface treatment.

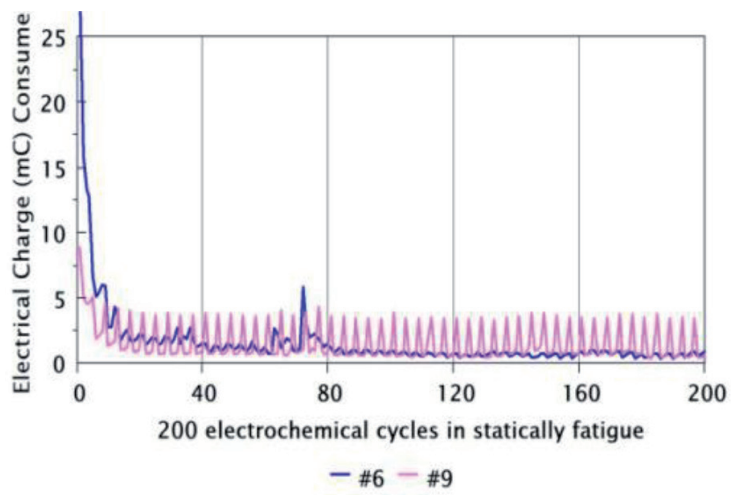
**Figure 6.**  
Behavior to localized corrosion of samples #6 and #9 (static).

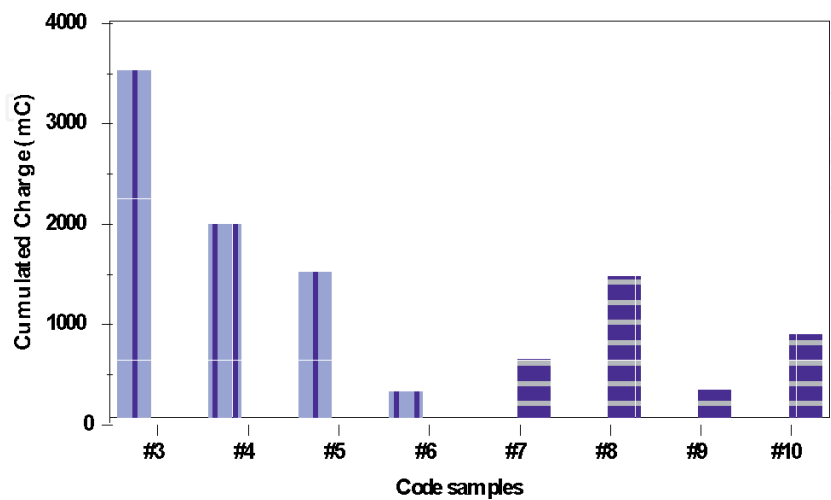
**Figure 7.**  
Electrical charges accumulated during testing.

By analyzing the sum of the accumulated charges during the total duration of the test, we note a worse behavior of the series 1 samples compared to series 2 (**Figure 7**) (samples #6 and #9 were tested under a stress of 100 kg).

In case of series 1 samples, after about 3 million cycles of the dynamic tests, crystallized sodium chloride can be found in the area of the tightening screws of the modular prostheses (**Figure 8**). This means that there is an electrolyte pumping effect in the assembly space of the two parts, and therefore crevice corrosion is quite possible to occur. For series 2 samples, this process can be noticed earlier, starting from about 2.5 million cycles. In the case of electrochemical static measurements, no phenomena of electrolyte pumping were observed. The quantities of electrical charges consumed in the corrosion process (**Tables 4** and **5**) are greater in series 1 than in series 2 (**Figure 7**).

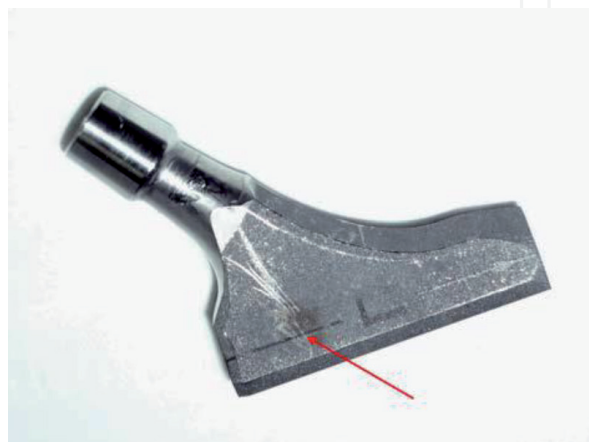
Two components of modular orthopedic prostheses—proximal module (**Figure 13**)—were explanted after 7 years. The proximal parts are made of Ti6Al7Nb (Lot 02-PL-06, Plus 662, PI 793—Gr. BS, art. 11,940, 1 series, lot 02.1424) and Ti6Al4V (Lot 03-PL-06, Plus 662, Gr. BL, art. 11,973—2 series, lot 03.463).

**Figure 13.**  
*Proximal module explanted.*

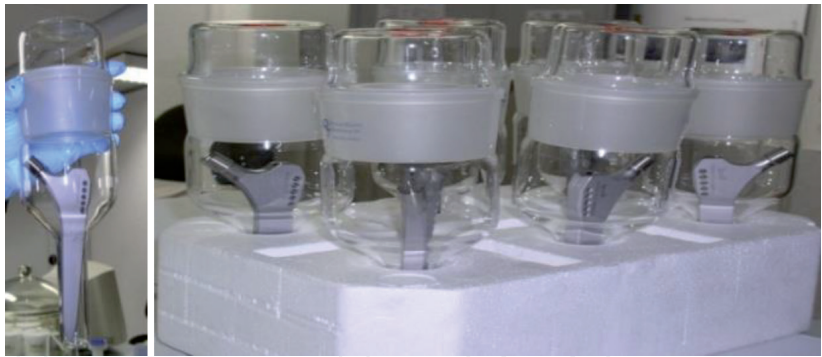
To minimize the volume/surface ratio, Pyrex glass reactors have been developed and adapted to the prosthesis shape (**Figure 17**). The orthopedic implant has a total area of 115.9 cm<sup>2</sup>. An electrolyte solution of HCl 0.07 N (300 ml) prepared from Titrisol<sup>®</sup> 1.0 N (Merck) was used. For extraction tests the release solution volume (ml)/total sample surface (cm<sup>2</sup>) ratio was equal to 3. The choice of electrolyte extraction was based on thermodynamic considerations [40] (solubility). Standards (EN-71-3) concerning bioavailability [41] and constraints of the analysis technique (simple matrix causes no perturbations) were considered.

**Figure 17.**  
*Glass reactors for cation extraction tests.*
