# Blast Effects on Structural Elements

*María Chiquito, Anastasio P. Santos, Lina M. López  
and Ricardo Castedo*

**Keywords:** blast load, full scale, numerical modelling, damage assessment, structural elements

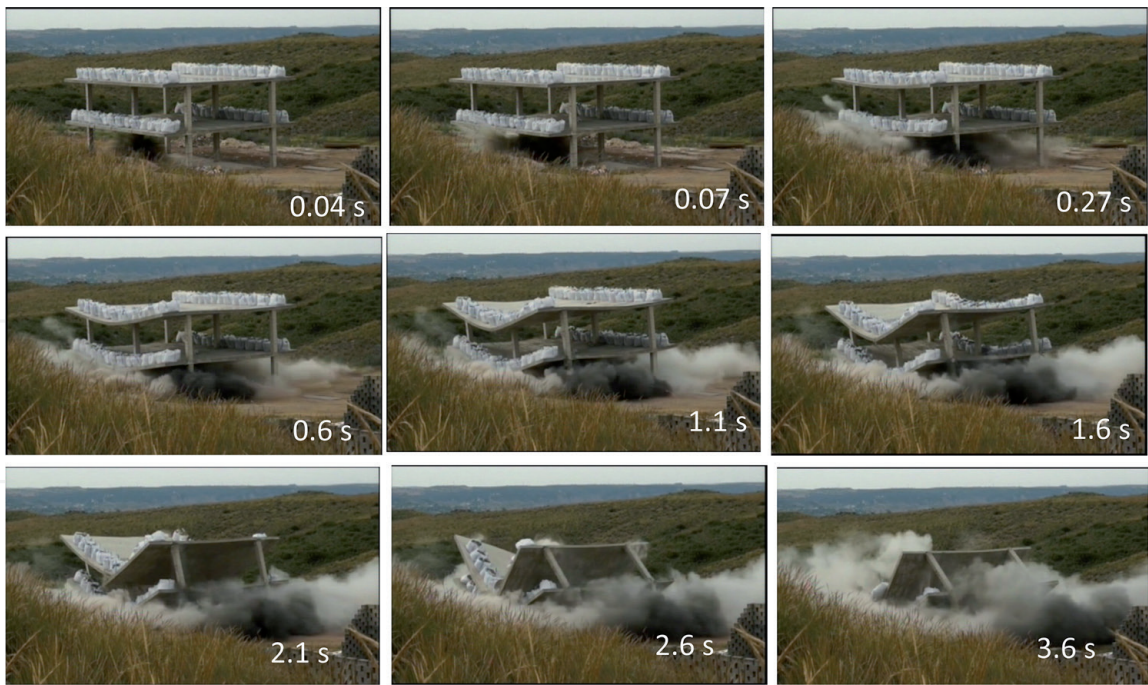
**Figure 13.**  
*Sequence of the test recorded with a conventional camera.*

The test was also recorded with two conventional cameras. **Figure 13** shows the sequence of the test with one of the cameras and the moment at which structure collapsed.
