# Translational Rock-Block Slides in a Tertiary Flyschoid Complexes of Southern Piedmont Region (North-West Italy)

*Fabio Luino and Laura Turconi*

## Abstract

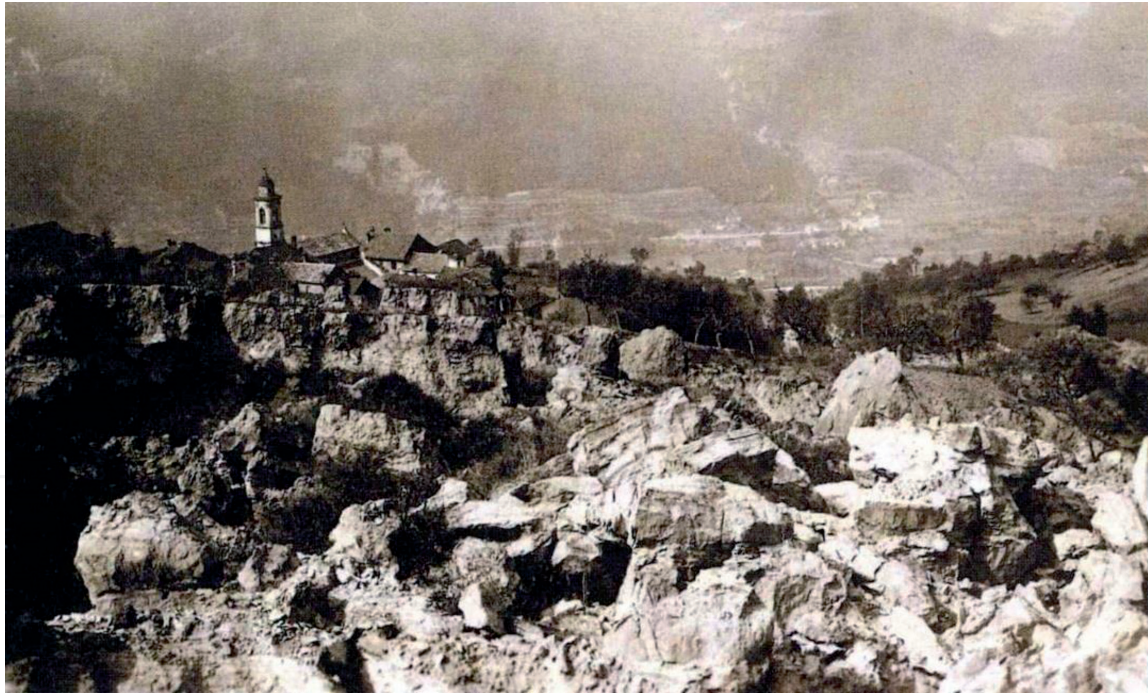
**Figure 2.**  
*May 16, 1926: Levice rock-block slides, top view. The large disjointed clods are evident.*

During an intense rainfall period on May 16, 1926, a translational landslide occurred near the village of Levice [15], involving a surface area of 3 ha (**Figure 2**). According to eyewitness accounts, long cracks appeared less than an hour before large fractures 20–25 m in depth opened in the slope. There were no victims, and no buildings were destroyed, but meadows and vineyards were damaged.

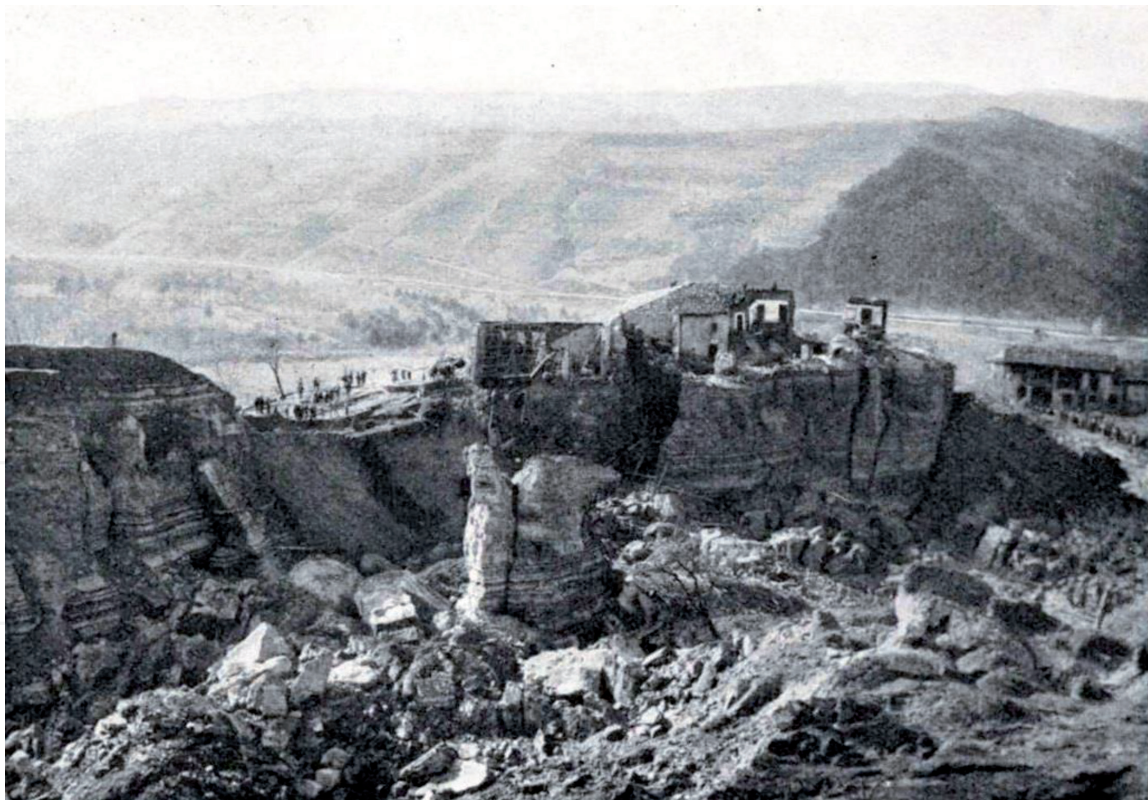
**Figure 3.**  
*Cissona, Cascina Bric farmhouse. The large rock-block slide that caused three casualties on April 7, 1941.*

On April 7, 1941, following a rainy period after an especially snowy winter, a sudden translational landslide destroyed the Cascina Bric farmhouse, near the village of Cissone: the mass movement killed three people and destroyed several buildings. The width of the main scarp was about 300 m, and the rock blocks were about 30 m deep (**Figure 3**). The phenomenon was carefully studied by Boni [17], with a good report accompanied by excellent photographs. The author highlighted the conditioning role, for the purposes of stability, of the geological-structural structure of the region and of the lithological characteristics of the rocks involved;

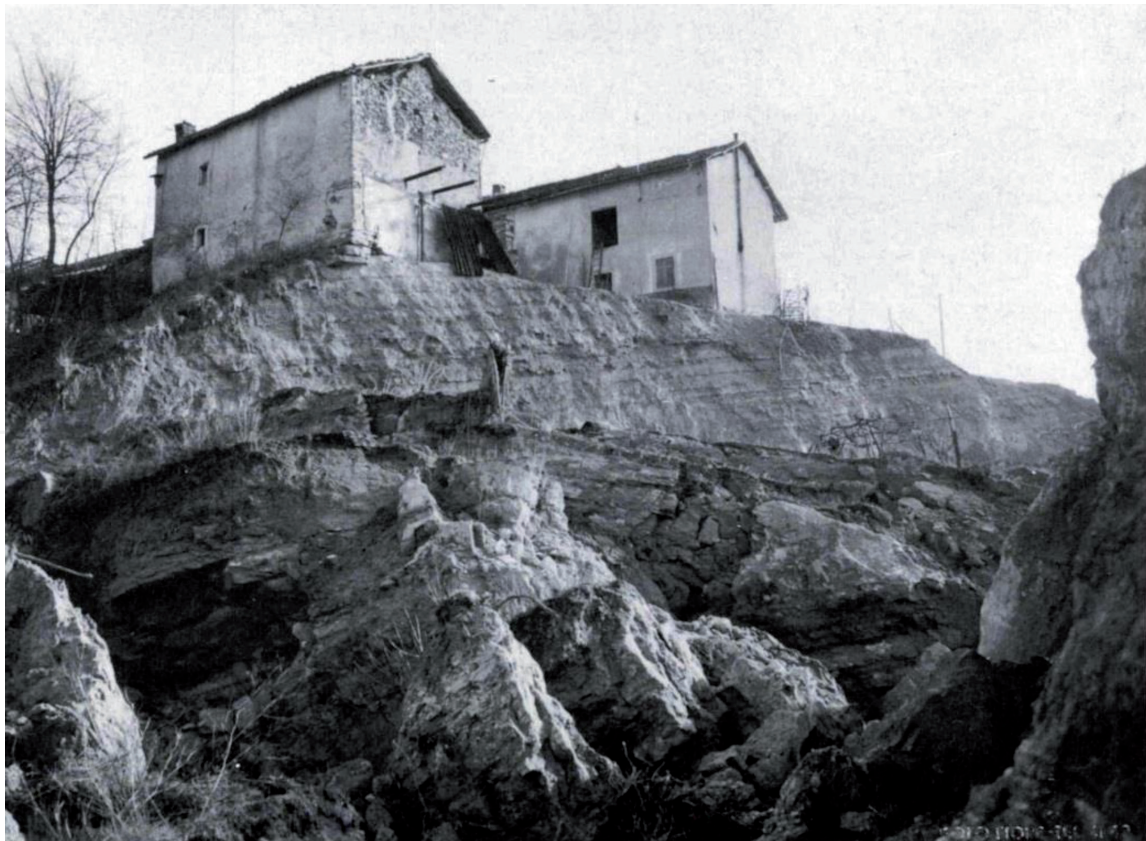
**Figure 4.**  
*Detail of the landslide phenomenon of January 1963 in the crown area, in a photograph of the time. There are clearly visible bedrock structure dip slope of tertiary-age sedimentary rocks (on the left) and part of a slipped clod (on the right).*

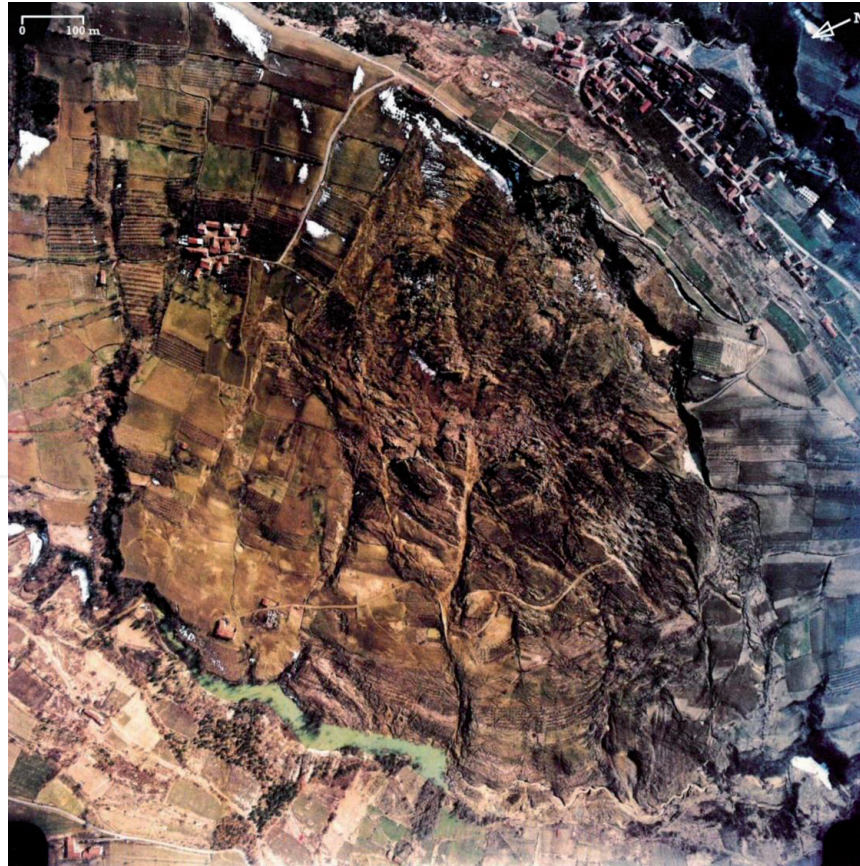
**Figure 5.**

*Aerial photograph of the huge translational rock-block slide at Somano (February 1974). The movement stopped at the opposite slope causing a dam and consequent small lake of the Gamba stream.*

In February and March 1972 and February 1974, several translational landslides occurred in the Langhe hills [8, 22]. Some of the movements affected entire slopes and caused severe damage to rural buildings, main highways, secondary roads, and agricultural activities (in particular vineyards and wineries). Two of these landslides, the Somano and Arnulfi rock-block slides, were extensively studied. The Somano landslide occurred on March 13, 1972 and was reactivated on February 18, 1974. With an area of almost 1 km<sup>2</sup> and a volume of about 10 million m<sup>3</sup>, it was the largest rock-block slide to occur in the Langhe in the twentieth century (**Figure 5**).

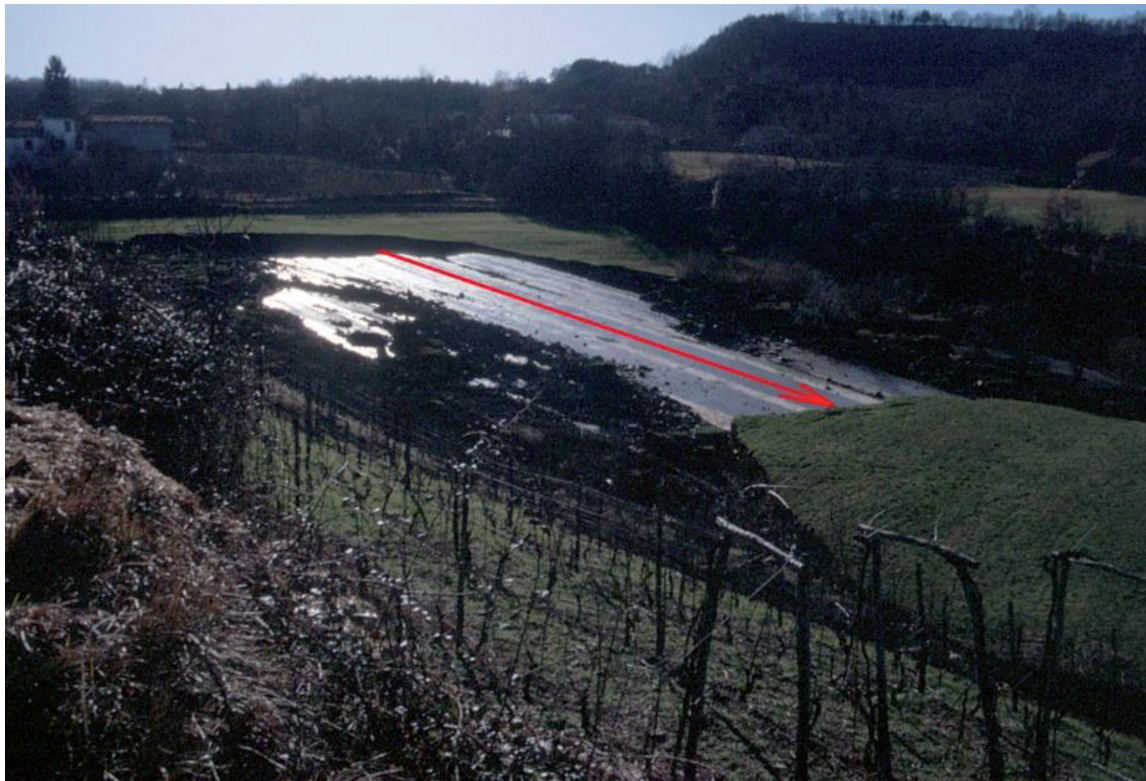
**Figure 7.**  
*Sliding surface of the Monastero Bormida landslide (February 6, 1994): The following days, the glossy surface was extremely slippery. It created great difficulties for geologists during the survey.*

TRBSs develop along bedding planes on slopes with gradients that vary from 8 to 15°, with 11° as the most common angle (**Figure 7**). They usually correspond to joints that form the interface between sandy-arenaceous and marly silty levels. The dominant direction of translation is nearly always parallel with the dip of the strata, even when the dip direction of the slope face is different. In the latter case, landslides develop at right angles to the slope. At the end of the movement, the sliding surfaces appear as a smooth, inclined plane that sometimes shows the shallow tracks left by the sliding rock block (**Figure 8**).

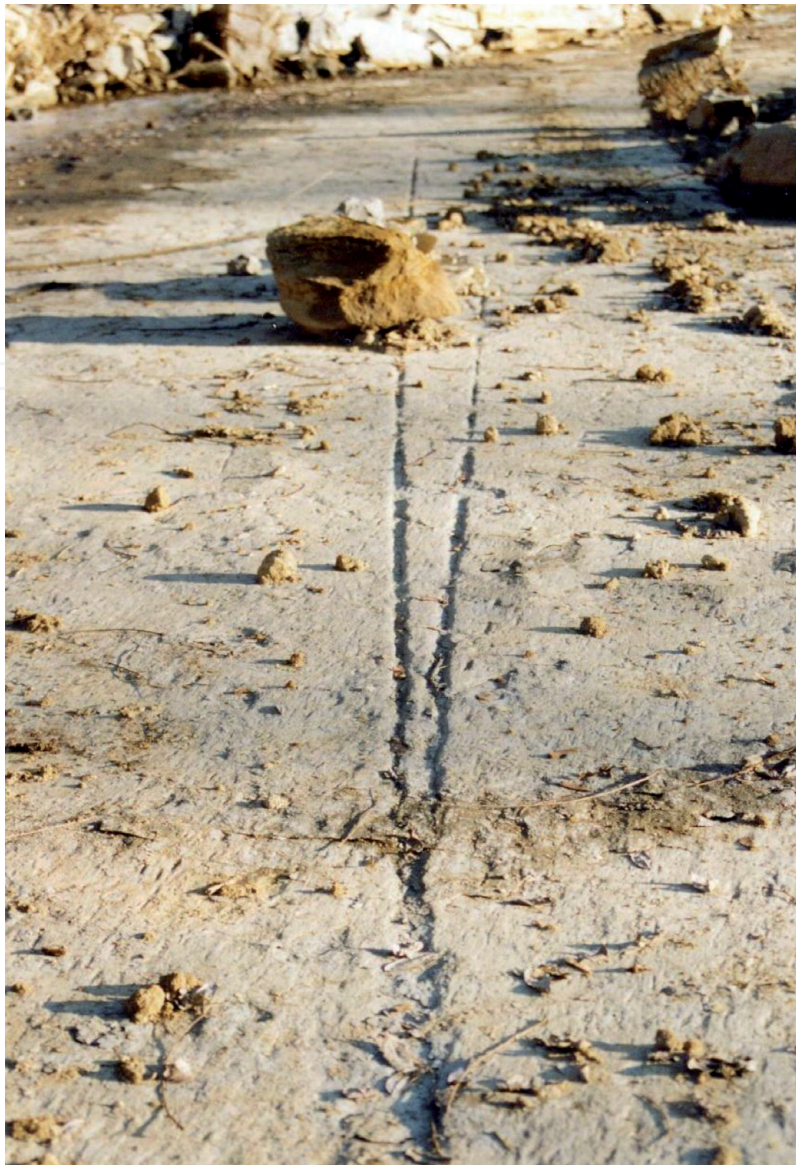
**Figure 8.**  
*Sliding surface of the Murazzano landslide taken from uphill: The shallow tracks left by the sliding rock blocks are evident.*

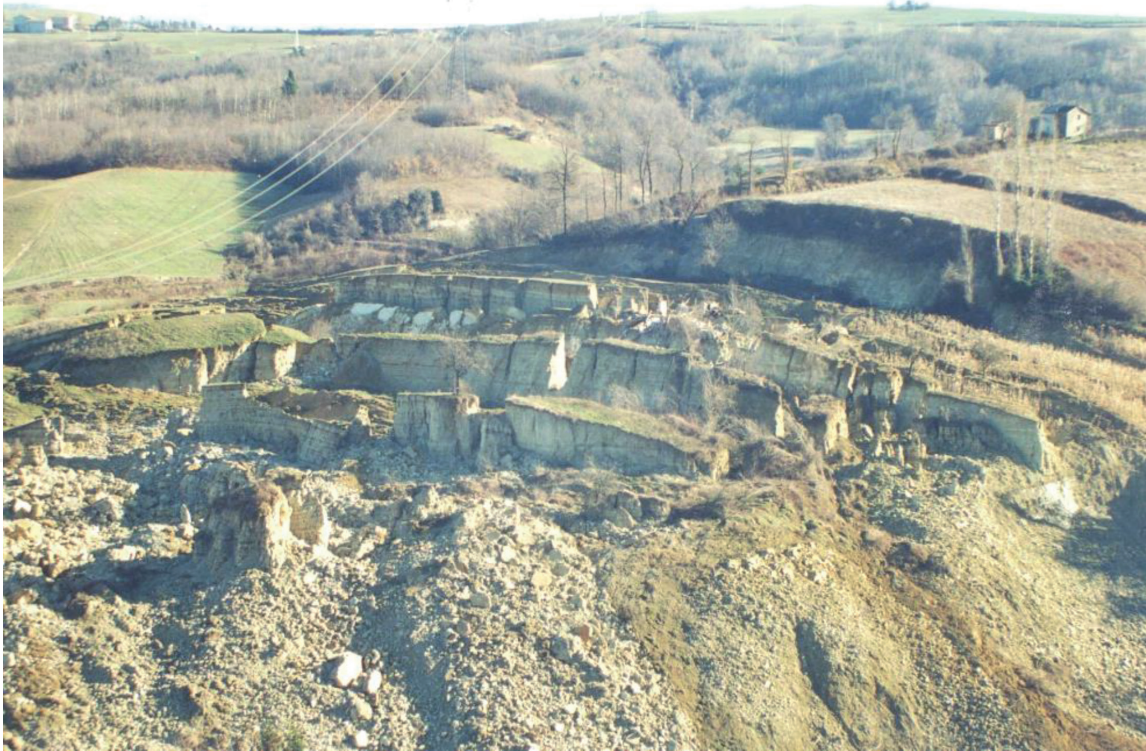
**Figure 9.**  
*Murazzano Cascina Fascinea farmhouse, one of the most evident landslides of the 1994 event with an area of about 7.4 ha. The clods detached and moved for over 80 m had a height of 8–10 m.*

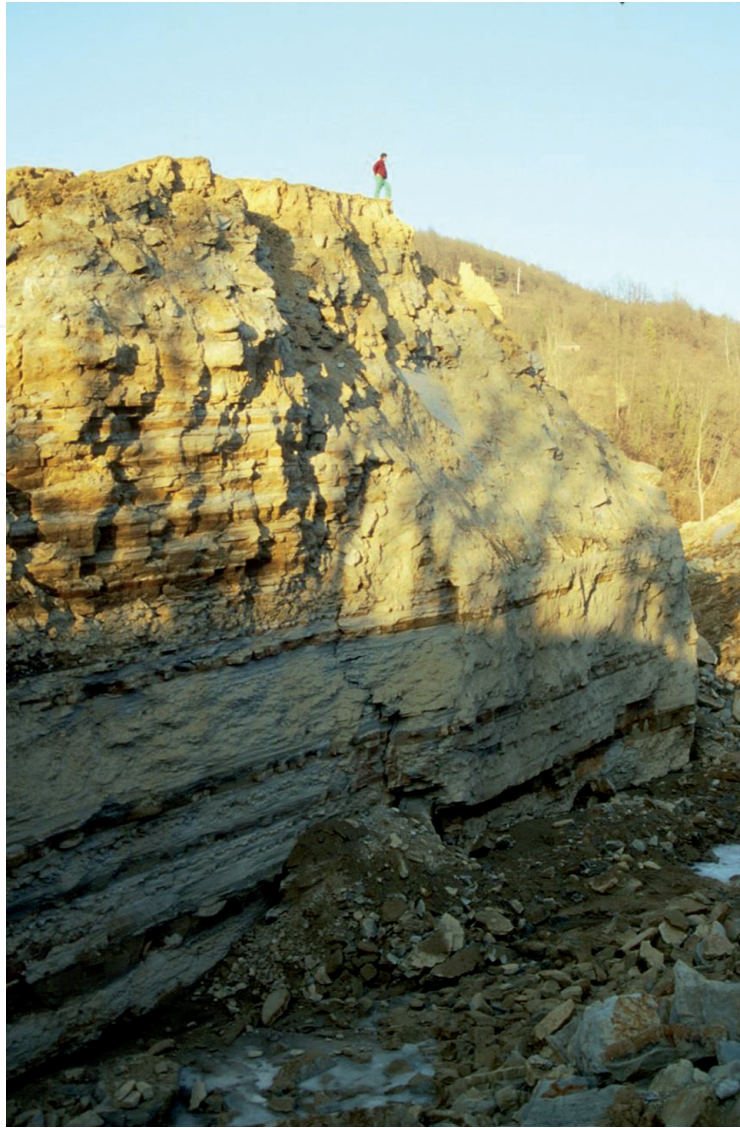
**Figure 10.**

*San Benedetto Belbo rock-block slide. This landslide is the one with the maximum known thickness: The clods in some points were 22–23 m high, a value that can be deduced from the presence of the geologist on the top. During the late evening of November 5, 1994, eyewitnesses interviewed in the following days said that on the slope of the landslide, they saw many flashes originating from the rubbing of the rock on the sliding surface.*

and further decreases for landslides with thicknesses greater than 15 m (1.5%) [10]. In this last category, we can count the landslide of San Benedetto Belbo (**Figure 10**), which was the maximum known depth of any instability that occurred in November 1994 event.

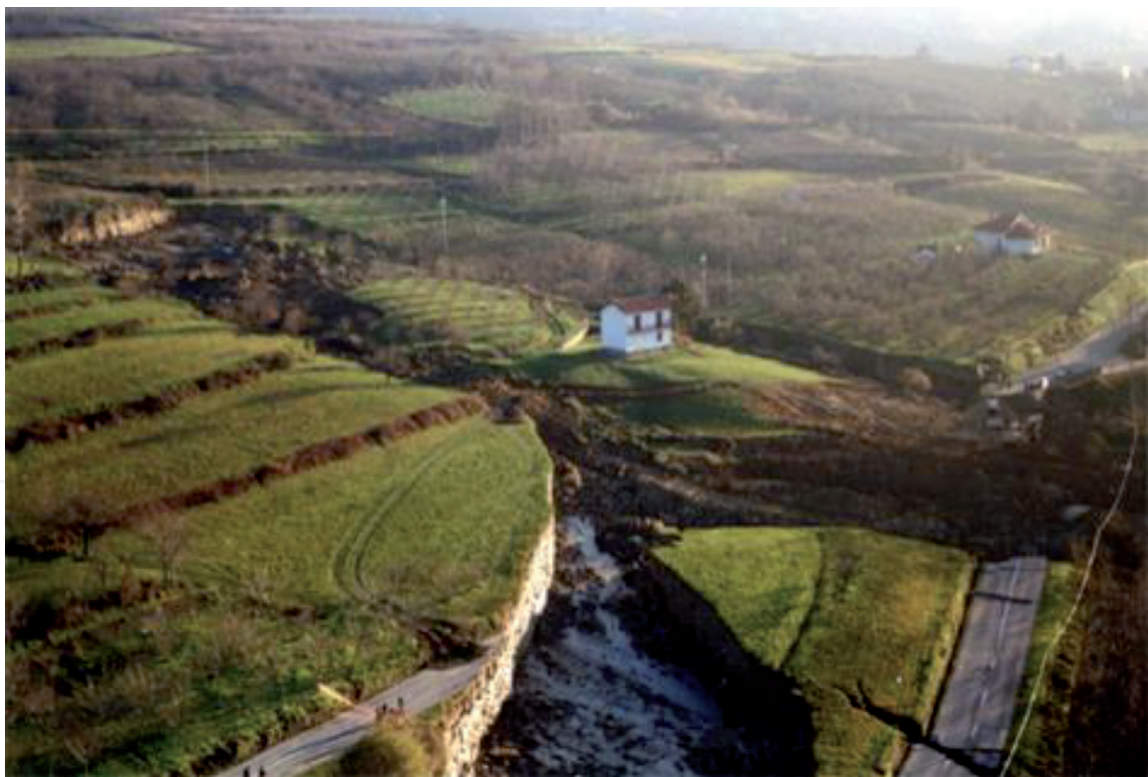
**Figure 11.**  
*Rock-block slide near Feisoglio town: The mass movement slid about 50–60 m from their original position, destroying a road. The estimated area was about 4.63 ha, while the volume was about 385,000 m³. The gray layer surface is evident. The small white house moved together with the rock block nearly undamaged.*

In the wide range of cases recorded over the years, there have been landslides that have been translated by a few meters, but most of them by several tens of meters (**Figure 11**). The systematic analysis of the summary sheets and the results

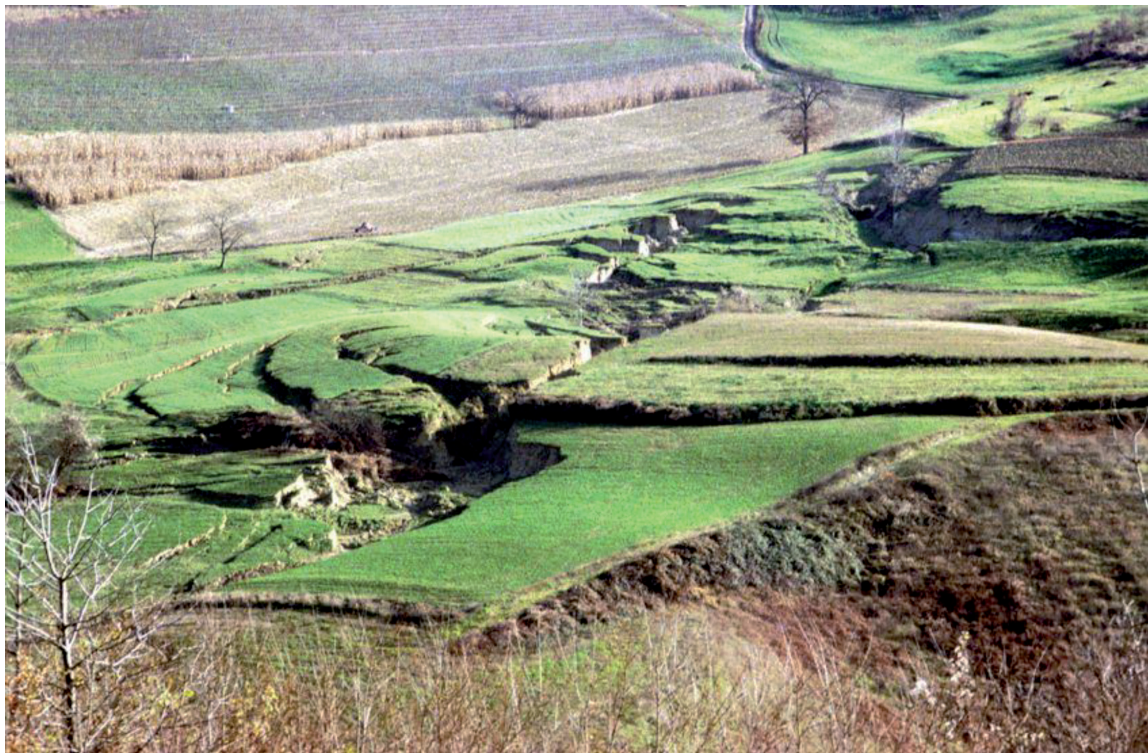
**Figure 13.**

*Spectacular example of rock-block slide in a second stage characterized by a period of quiescence that can last for several years. During this time, the density of fracture systems increases greatly, leading to vertical displacements and the formation of morphological steps. Cracks can be some hundreds of meters long, often coinciding with the perimetrical fractures of older translational block slides.*

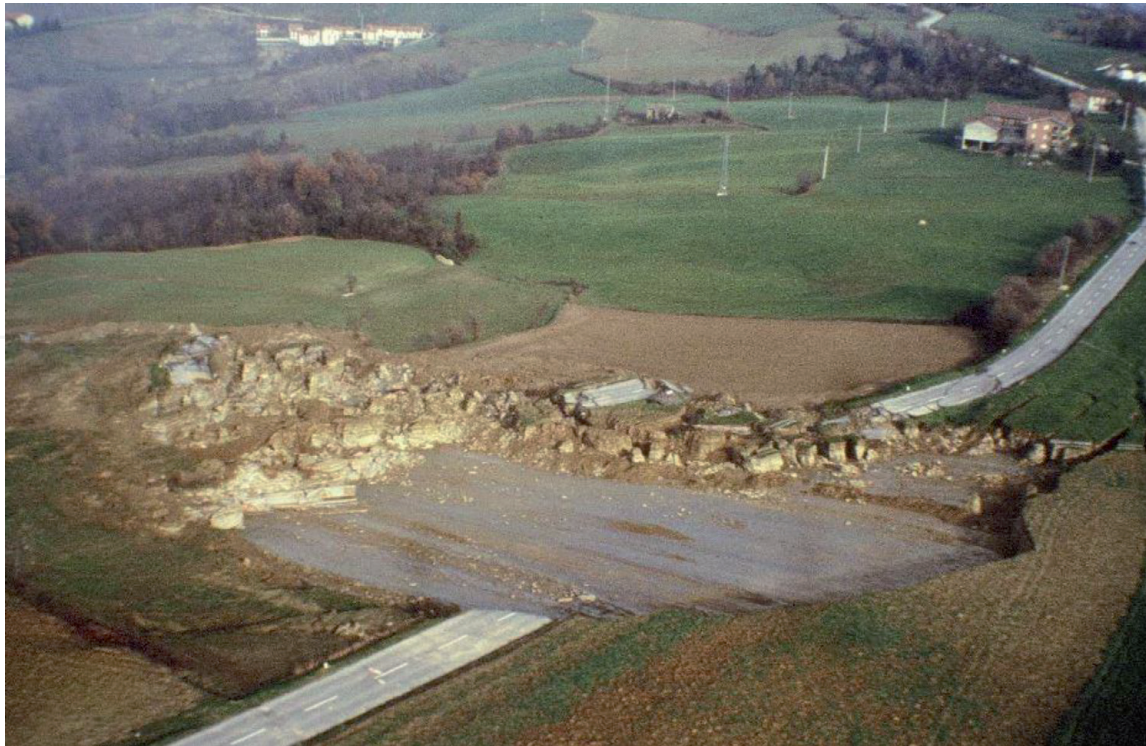
**Figure 17.**

*Murazzano rock-block slide, one of the most showy TRBSs triggered in November 1994, here shot a week later when a temporary road had already been restored. The clods moved along a surface with a gradient of  $9.8^\circ$  for a distance of about 80–100 m. The crown was located about 20–25 m upstream of the provincial road.*

It has been repeatedly observed that the slope cuts for the opening of service roads, exposing the cracked substrate and thus facilitating the infiltration of water into the subsoil are preferential places for the development of the first movement of land, with extensive opening of the cracks and subsequent propagation of the instability in the closest zones (**Figure 17**).
