# Anchorage Pile Strengthening of Shale Slopes and Cementing Falling Stone Blocks by Mixture of Melted Waste Plastics/Asphalt and Fly Ash for Slope Stability in Asphaltite Open Pit Mining Site in Avgamasya, Şırnak

*Yıldırım İsmail Tosun*

## Abstract

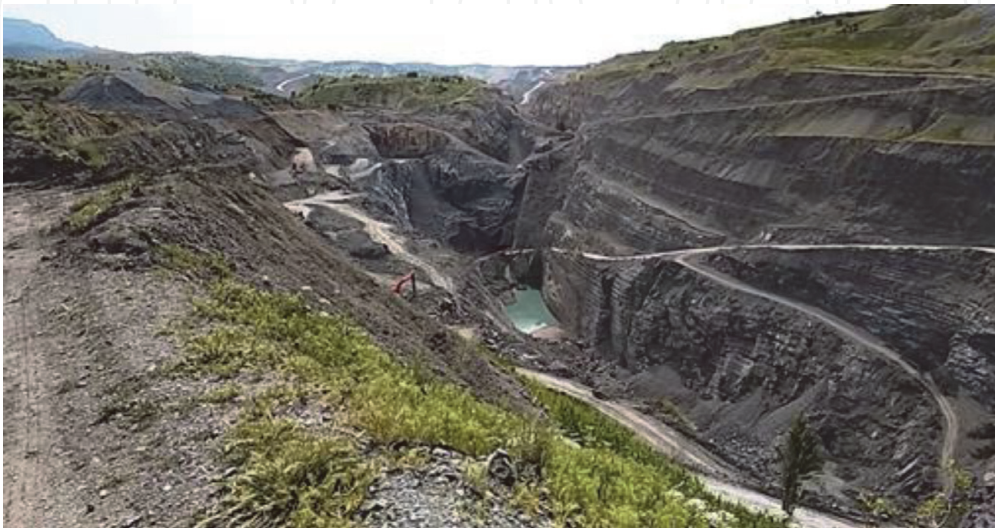
**Figure 2.**  
*Avgamasya No. 1 pit Şırnak asphaltite coal mine site and survey area.*

In recent years, both the opening of our university in our city and the migration movement from rural to provinces have also affected the coal economy in Şırnak. Open pit mining excavation and asphaltite production increased in different excavated pits in the area. A total of 500,000 asphaltite excavation by Asphaltite open pit mining with 20 separate pits continued to increase rapidly in Şırnak. Equipment and safety demands have also increased due to excessive extraction. This increase in demand caused people who are not competent in excavating in open pit mining production to enter the hauling, the control mechanism of dumping ability, modeling slopes to control the intensive stability, and areas that are not included in the development plan that are rapidly foreseen to mining development and safety. A vast majority of the excavations in the Avgamasya open pit No. 1, 2, 3, 4 were excavated without adequate ground research. In the asphaltite mining of Şırnak, there were generally adjacent open pits in Silopi, Uludere. It is believed that such new open pits in Şırnak have been developed due to the neighboring hard condition of rock cracks, rock fallings, landslides, and sometimes the existing collapsed pits (or structural damage caused by the rotation of the equipment) or hydrological ground problems. Finally, Şırnak Avgamasya No. 2 landslide caused 8 workers' death, closing the excavation work. For these reasons, the investigation of the new buildings to be built in our province and the ground conditions on the basis of regional and parcels of new areas to be developed has become essential [18, 19]. The unconditional expectations related to this study were also defined for this region such as the influence of the ground water, rock cracks and slope design, and explosion exchange dynamics leading to landslide. GEO5 software and manual stability analysis showed high risk area for plotting (**Figure 2**).

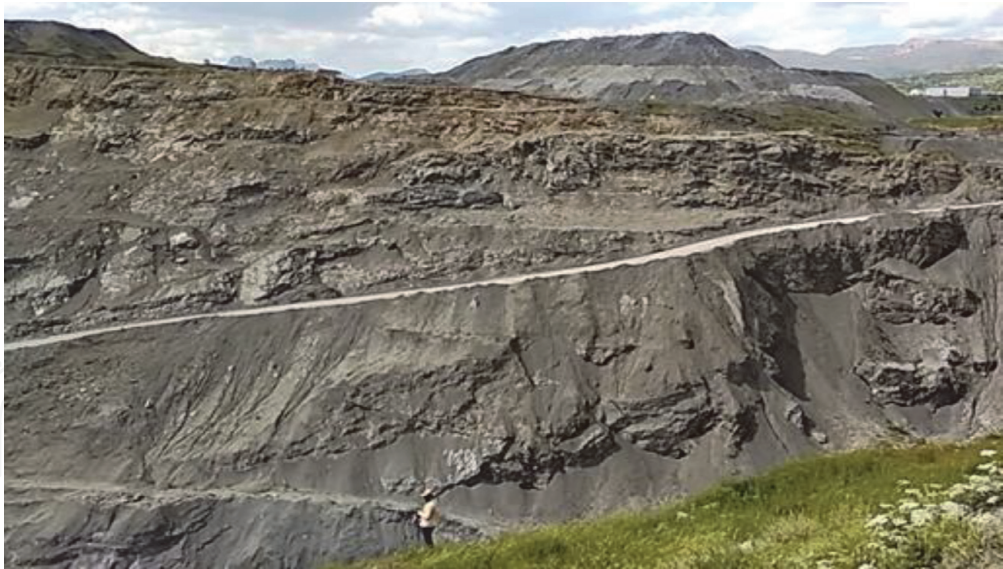
**Figure 3.**  
*North face of Avgamasya No. 1 pit Şırnak asphaltite coal mine site and survey area.*

The surface of new alluvial deposits starting from city center to the south of Avgamasya open pit 1 (**Figure 3**) in the study area is gray marl shale. This part is generally covered with silty soil, and some parts of it consist of sandy and clayey zones. It has been determined that the new alluvium continues in the drilling up to 35 m by the Special Provincial Administration [32]. Slope Rubble is located south of the Stream in the study area.
