Techniques to Evaluate and Remediate the Slope Stability in Overconsolidated Clay

Herman Peiffer

In this chapter, the origin and remediation of an important sliding in the overconsolidated Boom Clay in Kruibeke (Belgium) is discussed. Local and environmental factors caused an unstable slope about 30 m deep. A larger sensitivity to erosion resulted finally in the instability of the slope. Because of the formation of fine cracks in the soil there was a possibility for the water to penetrate in the clay close to the surface, resulting in the presence of higher water pressures. Also, the presence of the excavator on top of the slope during exploitation had an important impact on the stress state of the soil. Both an analytical and numerical approach were used to estimate the factor of safety. Because of the change of the soil characteristics, the factor of safety decreases, which can be estimated through a numerical analysis (using the Strength Reduction Method). This chapter also discussed the applied techniques for the remediation using numerical analysis. Also, the importance of the field test is discussed. An integrated approach, using numerical analysis and field tests in combin

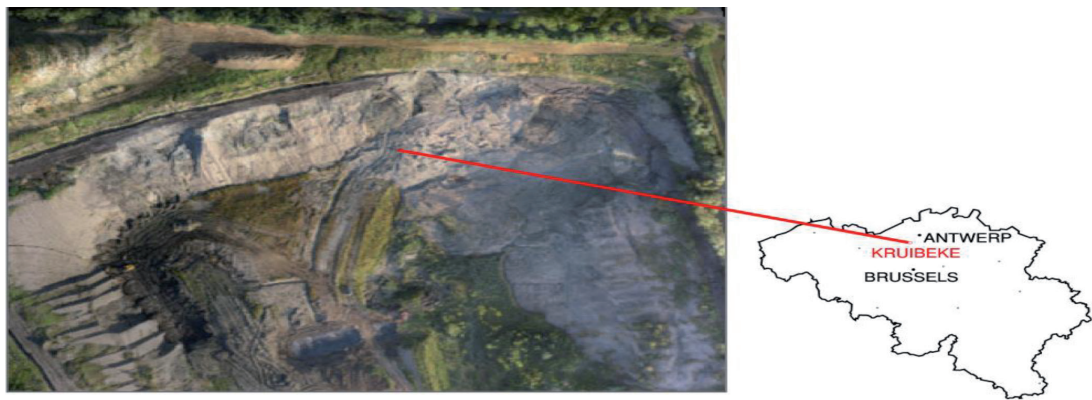
Figure 1.
Layout of the slide (2014) (as adapted from Peiffer (2016) [5]).

The research was conducted in Kruibeke (Belgium) (**Figure 1.**). This research site has overconsolidated Boom clay. In the period of 1963–2010, 30 meters deep pit was excavated in the Boom Clay. The clay was used for the fabrication of expanded clay granulates.

Figures 1 and **7** present a general view of the slides and the soil movement in 2014. As shown in these figures, a block of 100 m by 50 m in size started to move downward, resulting in a movement of about 9 m down at the corner of the pit.

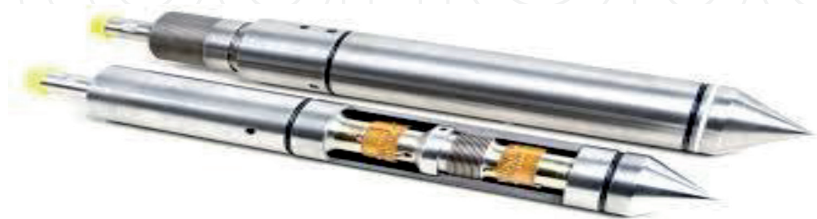
Figure 3.
The CPT-cone.

The test method consists of pushing an instrumented cone, with the tip facing down, into the ground at a controlled rate of 2 cm/s. The typical cone tip has a cross-sectional area of 10 cm², corresponding to a diameter of 36 mm (**Figure 3**).

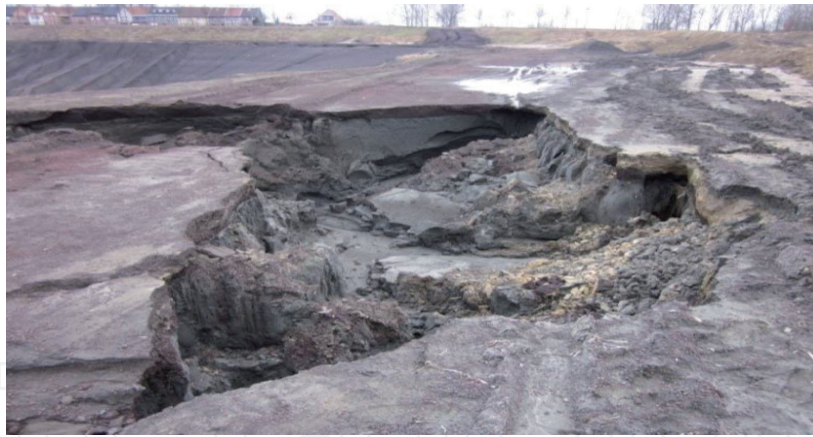
Figure 7.
Detailed impression of the instable slope (as adapted from Peiffer (2016) [5]).

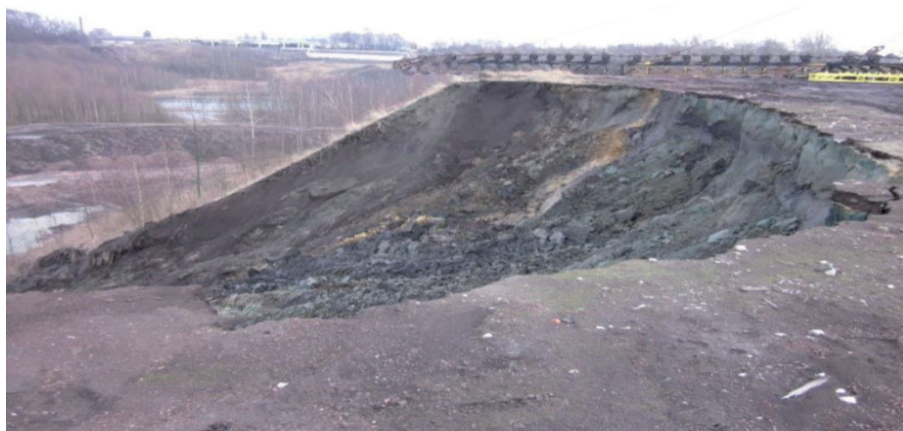
Figure 8.
Photo of the unstable zone after the instability of the slope (as adapted from Peiffer (2016) [5]).

The first slide occurred in 2011. The size of the slide was limited. In the second half of 2013, one more slide occurred in the neighborhood at point 5 shown in **Figure 2a.**, A photo of the slide is presented in **Figure 8**.

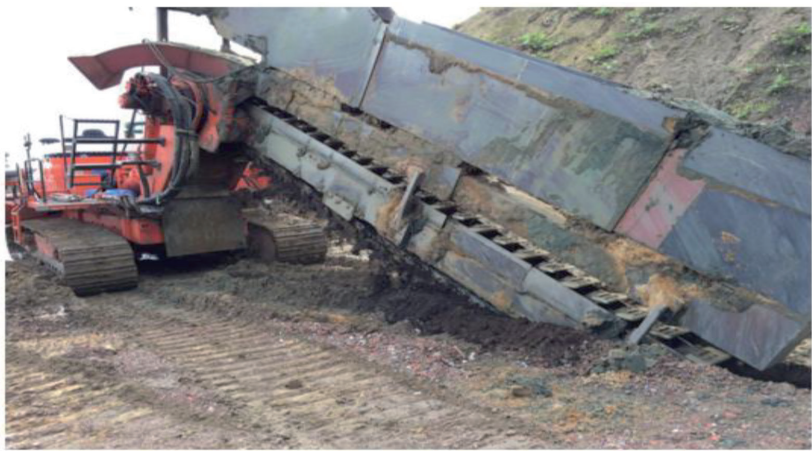
Figure 16.
Installation of the deep drainage.

The PLAXIS-analysis resulted in a design where a deep drain has to be installed at a depth of 5 m., as shown in **Figures 16** and **17**. This drain was installed at the beginning of November 2015. The red line in **Figure 15** is the position of the drain in the plan view.

After the installation of this drain, there was an immediate effect on the depth of the groundwater. The original depth of 1.5 m increased to a depth of about 4.5 m. The safety factor of the slope stability increased from 0.9 to 1.31.

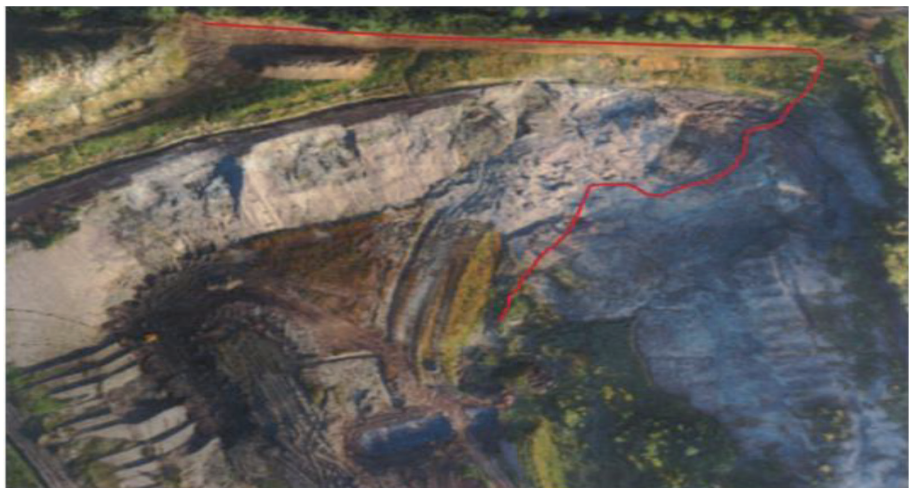
Figure 17.
Position of the drain in plan view (red line).

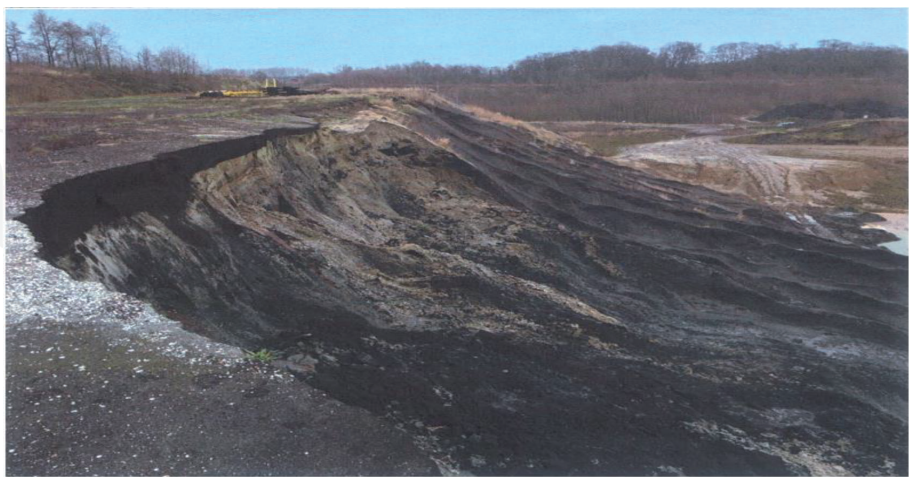
Figure 18.
Smoothing of the slope.

The original angle of the slope (before sliding) was 27°. After the sliding, the clay was remolded.

Before the rehabilitation works of the slope, an angle of the slope of 18° was realized. These works were realized in order to reduce the risk of additional slidings. The result of this work is presented in **Figure 18**.
