Behavior and Design of Transfer Slabs Subjected to Shear Wall Loads

*Alonso Gómez-Bernal, Eduardo Arellano Méndez,
Luis Ángel Quiroz-Guzmán, Hugón Juárez-García
and Oscar González Cuevas*

Abstract

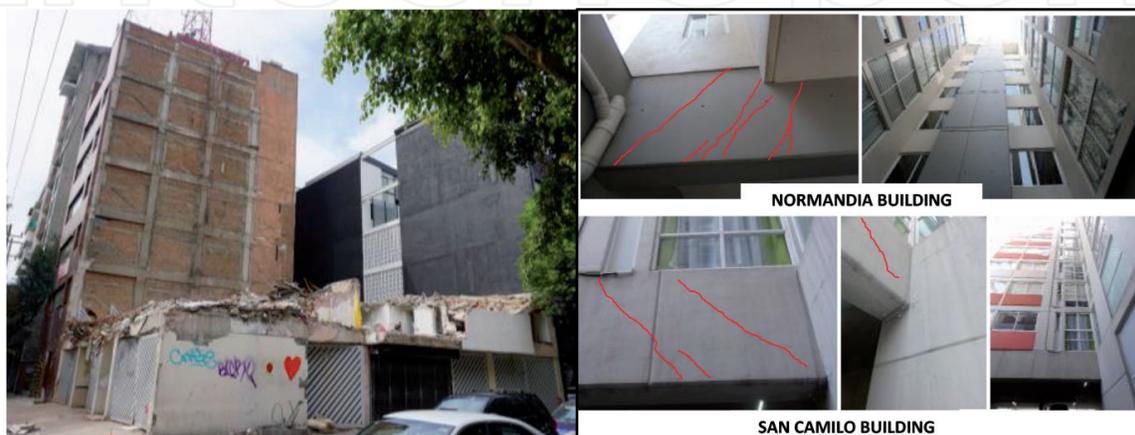
Figure 1. (a) left: Collapse of a building with discontinuities in elevation; (b) right: Diagonal cracks in the girders of the transfer floor in two buildings supporting six and seven stories, respectively.

During the September 19, 2017 earthquake ($M = 7.1$) an extensive damage was observed in Mexico City, some buildings structured with transfer slab system suffered important damage [3]. For example, **Figure 1a** show the total collapse of a building located in the Lake bed zone which had eight stories, the structure was located at the corner of a block, only the ground story consisted of reinforced concrete frames, while the upper stories were structured only with masonry walls conforming a structure with high discontinuity in elevation; this building collapsed due a high irregularity killing 5 residents. **Figure 1b** shows other two cases that correspond to two modern buildings structured with this transfer floor system, when these structures were reviewed, minor diagonal cracks were detected at the ends of the girders of the floor transfer (**Figure 1b**), in one of these buildings residents were evicted.

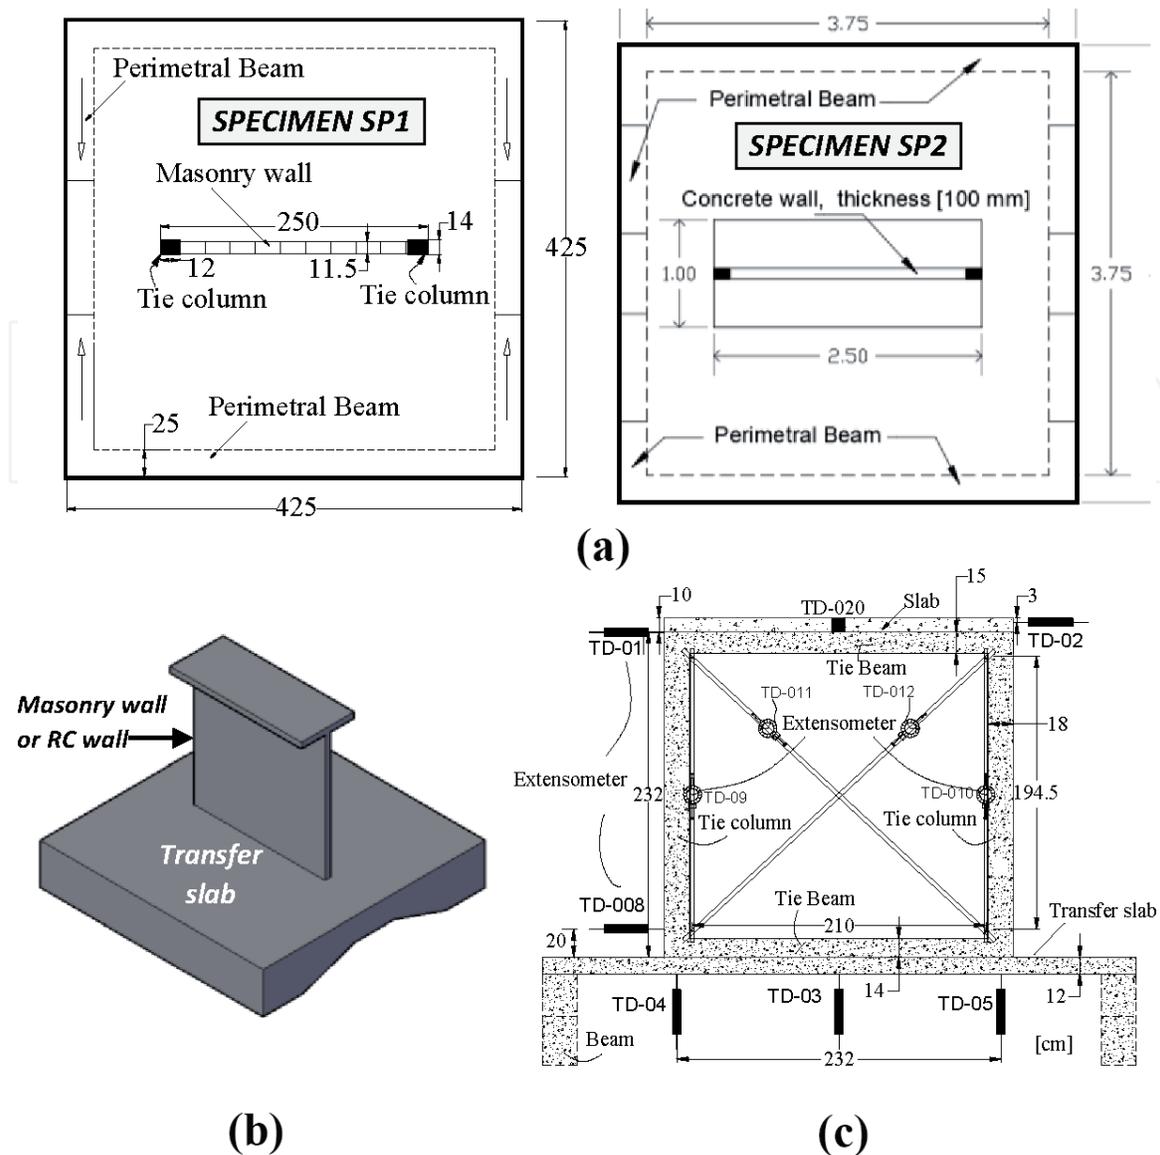
Figure 2. Geometry and details of slab-wall specimens SP1 and SP2: (a) plan view of specimens; (b) transfer slab 3D model; (c) location of exterior instrumentation.

Specimens SP1 and SP2 consist of four reinforced concrete perimetral girders with a solid two-way slab which together conform a monolithic structure. These girders have a transversal section of 25×70 cm, and the slab is square of 425×425 cm and 12 cm thick, the slab plane is located at 77 cm over the laboratory floor (see **Figure 2**). The concrete strength was $f'_c = 250$ kg/cm². The two beams aligned transversals to the wall are haunched girders, while the two girder parallels to it have a rectangular section. The haunched girders were used to adjust the specimen to the conditions of the laboratory's reaction floor, and the position of the laboratory's horizontal load reaction system. The design and steel reinforcement in the slab were determined using typical procedures, such as the ones used in real buildings in Mexico. On the outer strips, the spacing of the bottom re-bars was set to 40 cm. On the central strip, the spacing was set to 20 cm in both directions. In the top of the slab, the reinforcement spacing was also set to 20 cm. **Figure 3** shows details of the reinforcement used in the slab specimens.

The second specimen, SP2 (**Figure 2**), consists of a slab with a Reinforced Concrete (RC) wall, reinforced with electrowelded wire mesh, besides at the ends were placed tie columns. The wall was placed on top of a squared two-way slab, with the same characteristics of SP1 specimen. The RC wall is 2.50 m wide by 2.40 m high, and with a thickness of 10 cm (top-right of **Figure 3**).

Figure 2c shows the TDs on the lower face of the slab. The TD that provides the most relevant information is TD03 because it is in the center of the slab, exactly below the center of the wall (masonry in SP1, or concrete in SP2). The TD03 transducer is used as a control node to determine vertical displacements.

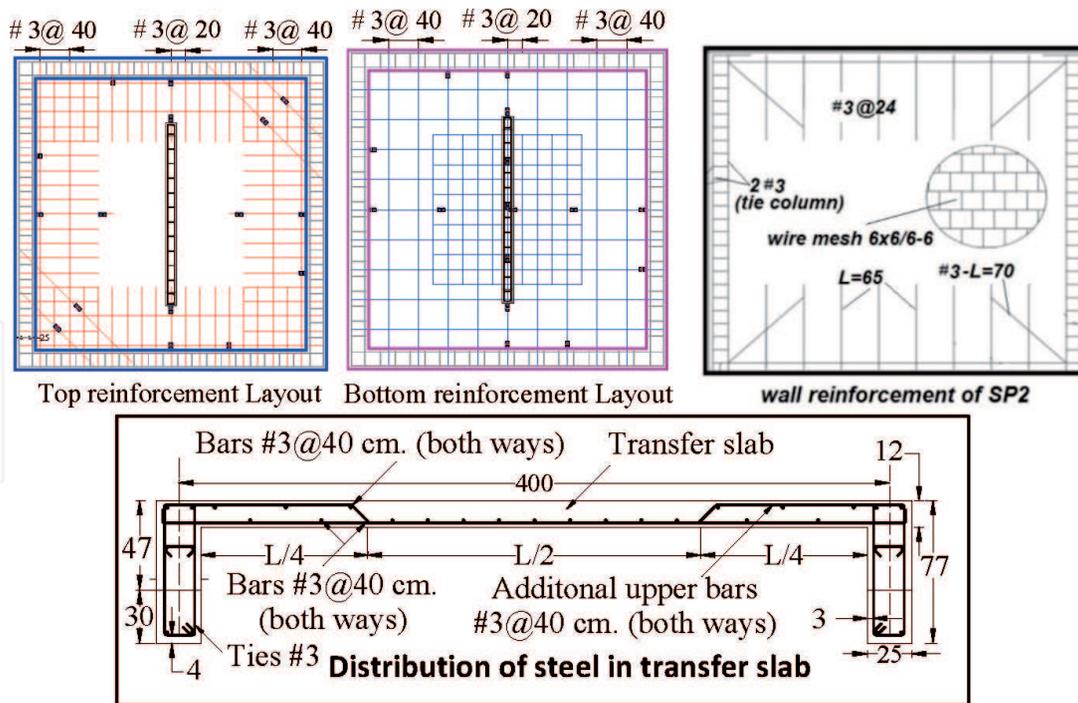
Figure 3. (Top) Reinforcement details in transfer slab and reinforced concrete wall of SP2; (Bottom) assembly of strain-gages in bars is included.

The interior instrumentation consists of a set of strain gages (SGs) that were installed in the reinforcement bars of the concrete elements. In specimen SP1, 16 SGs were fixed in the bars of the bottom of slab and 16 SGs in the top (**Figure 3**). The tie-columns of the masonry wall had 20 SGs in the longitudinal re-bars. Additionally, 10 SGs were embedded in the concrete slab and the tie-columns. In specimen SP2,

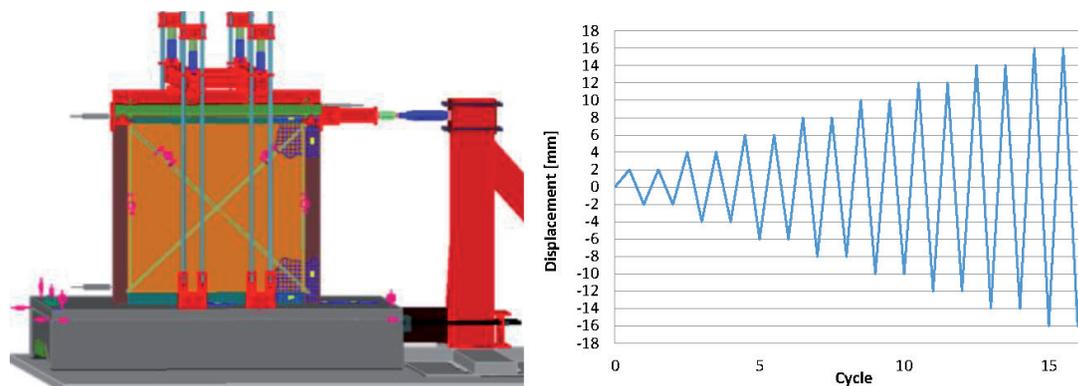
Figure 4. Test set-up and typical displacement time history (horizontal loading).

Three mechanical steel devices were designed and built to develop the experimental program: the first for attachment purposes, the second one for simulate the gravitational loading, and the third one for the lateral cyclic loading. The attachment device prevented the slab-wall specimen from moving in a vertical or lateral way during the test whenever the loads were applied to the wall. The vertical load device was fabricated by a system of steel girders, eight tensors and their anchorages (see **Figure 4**). At the top of the girders there are four vertical actuators (each with a 25 Ton capacity), supported on a base plate, which keeps them in an upright position and prevents them from slippage. The third device was designed for the incremental cyclic horizontal loading. We used a double-action hydraulic actuator with a 25 Ton push capacity, and a 13 Ton pull capacity. A more detailed description can be found in [13].

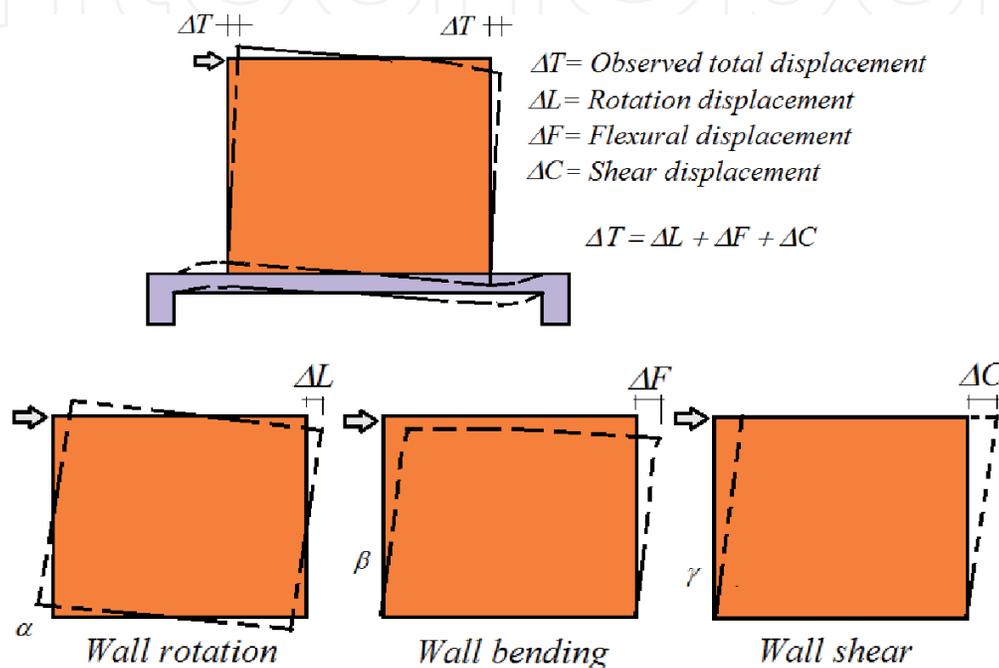
Figure 5.
 Total deformation (above) and principal deformation modes.

In order to define force-deformation behavior and the different damage states of the two tested specimens, it is necessary to establish the deformation modes or configurations for each of the three load protocols studied (**Figure 5**). Therefore, the failure in the walls of the specimens, SP1 and SP2, will depend on the bending (ΔF) and shear (ΔC) deformations induced by horizontal loading. However, in this case, since each wall is supported by a slab, the lateral displacement due to the wall rotation (ΔL), induced by the slab deformation, must be considered. Total displacement, ΔT , at the top of the wall is then generated and presented in **Figure 5**.

where R = effective drift of the wall, ΔE = effective lateral displacement at top of the wall, ΔL , ΔF , and ΔC are defined in **Figure 5**, ΔI , ΔD are vertical displacements at ends in wall-slab joint, H = distance between TD-01 y TD-08 (**Figure 2**), L = distance between TD-04 y TD-05 (**Figure 2**).

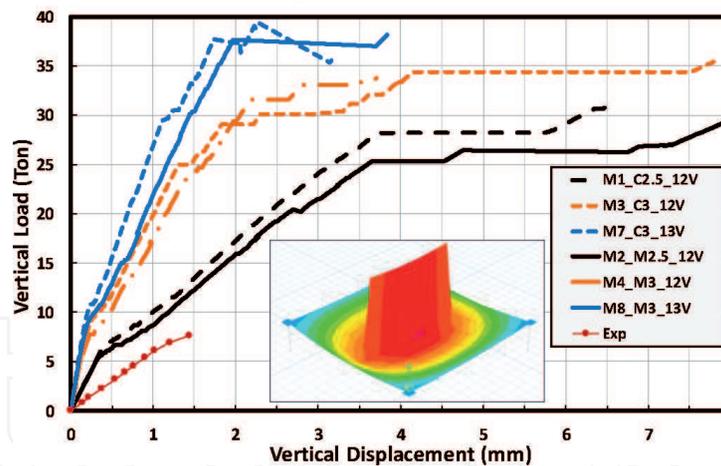
Figure 6.
Capacity curves obtained from numerical and experimental models, subjected to vertical loading.

The experimental (Exp) capacity curve of SP1 is compared with the numerical model curve (M2_M2.5_12V). It can be observed that in the experimental case a minor stiffness value is obtained, as is observed in the curve. This situation can be explained due to the perfect fixed ends along the slab perimeter in the numerical model. But in both capacity curves, the first slab cracking occurred at the same time. This occurs when the load reached a value of 5.5 Ton (**Figure 6**). Numerical model, M2_M2.5_12V, was conducted until the failure condition, the first slab cracking take place at 5.5 Ton; the whole structure exhibited linear behavior until the ultimate load of 25 Ton. At this point an almost perfect elastoplastic “nonlinear” performance was detected (**Figure 6**).

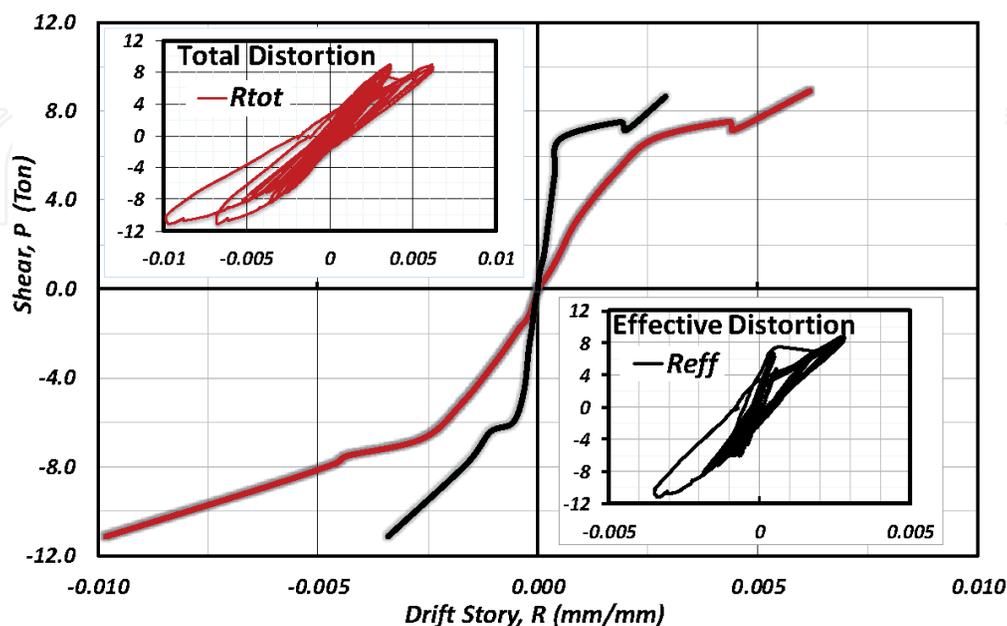
Figure 7. Global (R_{tot}) and effective (R_{eff}) distortions of specimen 1 (with masonry wall) during the combined load, as well as their respective envelopes.

The total distortions, R_{tot} , and the relative drift, R_{eff} , of specimen SP1, measured in the combined loading are illustrated in **Figure 7**. The envelopes of the hysteretic cycles are also shown, which are estimated with the bilinear behavior of the curves. The rigidity of SP1 was defined from the slopes of the curves; the stiffness of the complete system was determined to be equal to 11.3 Ton/cm, while the rigidity of the isolated wall was assessed to be equal to 40 Ton/cm (the effect of the rotation as a rigid body was removed). This stiffness is 3.5 times greater than that due to the wall resting on a flexible base (wall placed on the centerline of a two-way slab).

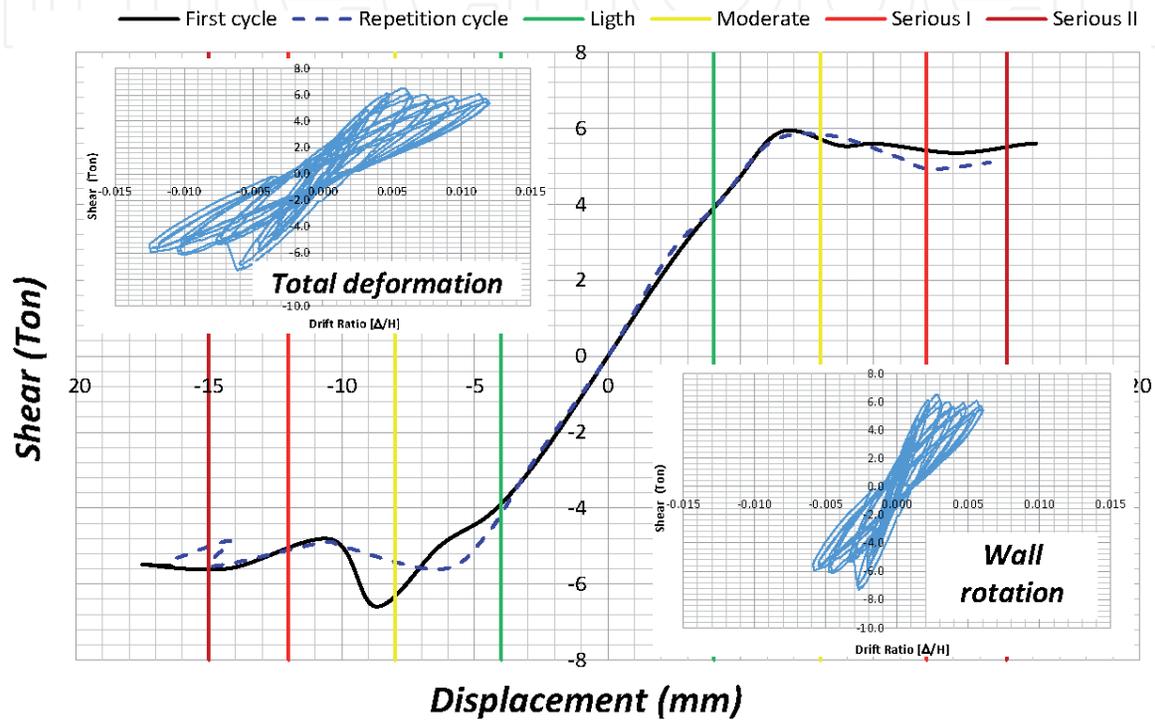
Figure 8. Distortions of specimen SP2 (RC wall) due to the combined load, as well as their respective envelopes.

For second specimen, SP2, it can be observed that the slab rotation is practically equal to the wall bending (**Figure 8**). It can be concluded that the wall did not have any shear deformation.

In **Figure 8**, four limits are proposed to define the behavior of the specimen SP2. A behavior without damage (green color), a behavior with moderate damage (yellow color), a behavior with serious damage that can be repaired (orange color) and a behavior with serious damage that cannot be repaired (red color).

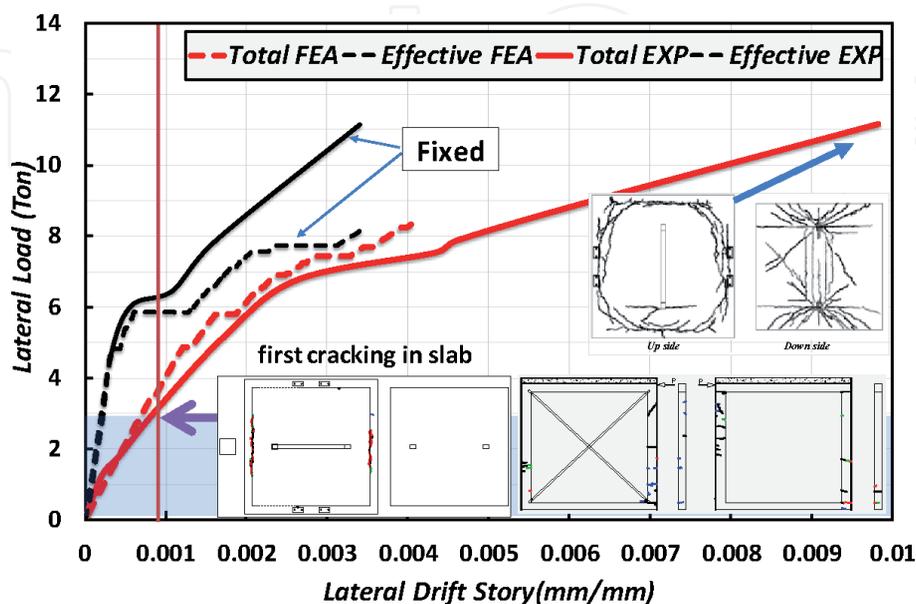
Figure 9. Comparison between numerical and experimental model SP1. Experimental flexible base (total) and rigid base (effective) versus numerical behavior.

In **Figure 9** are made two comparisons: first, the numerical capacity curve “Effective FEA” (or MBR_M2.5 masonry wall on rigid base) is compared with experimental curve SP1 “Effective EXP”; and second, the numerical capacity curve “Total FEA” (or M10_M2.5_12VL masonry wall on flexible base) with experimental curve SP1 “Total EXP”. The comparison between pairs of curves indicates that these are similar at low levels of load, but when comparison is made between rigid and

flexible base, we observed significant differences between the slopes of the curves. Then, stiffness results indicated that for a wall on a flexible base a value of 14 Ton/cm was reached, while the one on rigid base was computed as 40 Ton/cm, this represent a ratio of 3 times between both cases. In conclusion, when experimental SP1 curve and the numerical curve were compared for the same support conditions the slopes were similar.

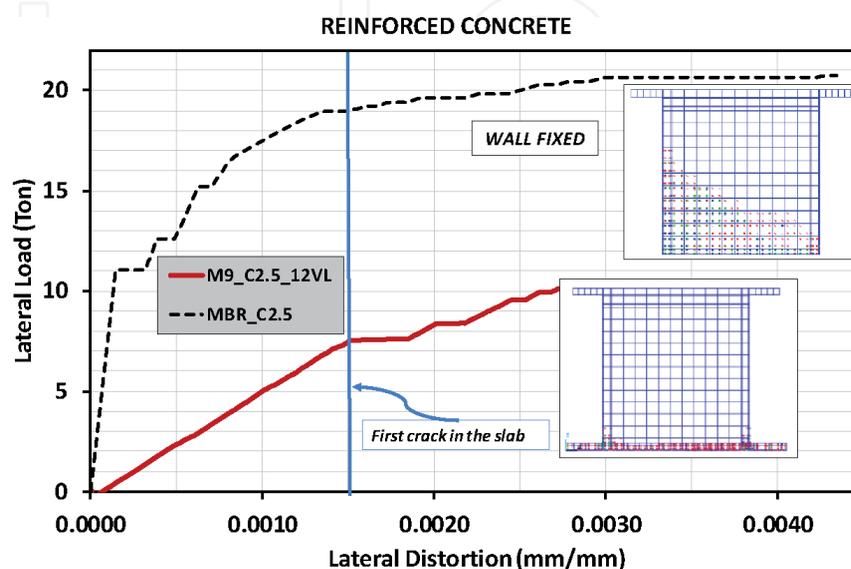
Figure 10. Load-distortion curves for M9_C2.5_12VL and MBR_C2.5 (fixed) models of RC wall, including crack patterns.

When the capacity curves from RC walls numerical models (**Figure 10**) are analyzed, we observed a great difference in the behavior respect to the one observed in the masonry wall models. The curves of RC walls numerical models M9_C2.5_12VL (flexible base) and MBR_C2.5 (fixed base), show a wide difference in the linear slopes for as many as 15 times; we calculated 14.1 and 210 Ton/cm. Nevertheless, the rigidity values for the flexible models M10_M2.5_12VL (masonry) and M9_C2.5_12VL (RC) are close: 14.1 vs. 11.3 Ton/cm [2, 13]. The high flexibility of the slab does not allow the RC wall to develop its full strength and rigidity. This is an outstanding result that we would like to underline.

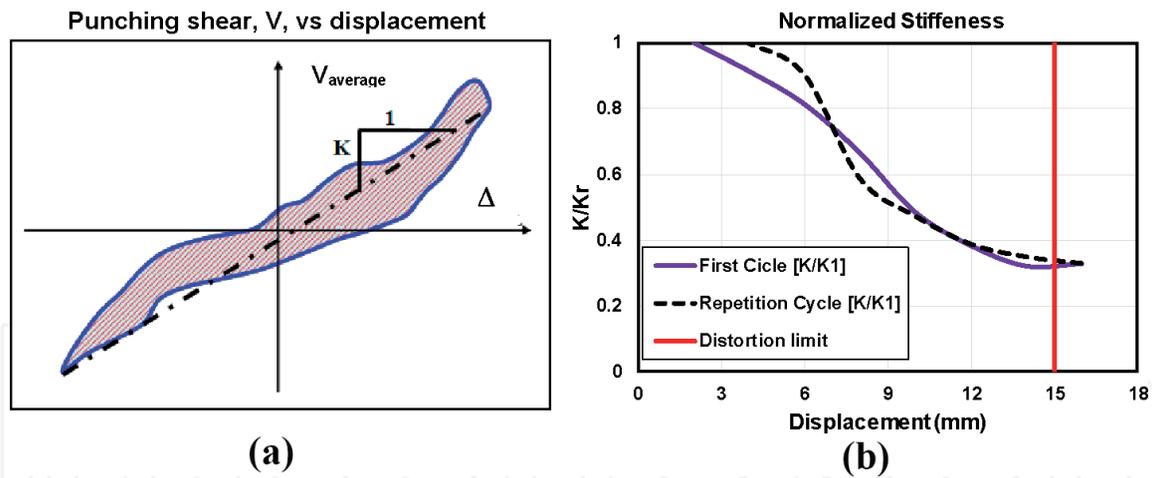
Figure 11. (a) Peak-to-peak stiffness according to Chopra [15]. (b) Normalized stiffness load-distortion curves for M9_C2.5_12VL and MBR_C2.5 (fixed) models of the concrete wall, including crack patterns.

Figure 11a shows peak-to-peak stiffness, which is the slope of the average lateral force vs. total displacement diagram [15]. K stiffness is achieved by joining the maximum displacement points in a cycle along a straight line; the slope of the line is the cycle stiffness, and, is calculated as the difference of the shear forces, divided by the difference of displacements. **Figure 11b** shows the normalized stiffness, calculated as the peak-to-peak stiffness between the first cycle stiffness for each data series, that is, the data series stiffness for the first cycle and for the repetition cycle.

In **Figure 11b** is included the drift story limit, $\gamma = 0.006$, (indicating that nonstructural elements can be damaged). For this distortion limit value, the normalized average stiffness is approximately 35% of the initial moment of inertia, this loss of stiffness is only due to the transfer slab, because the reinforced concrete wall showed no damage. This important result should be considered in the modeling of buildings with transfer slab, so that lateral displacements can be properly calculated.

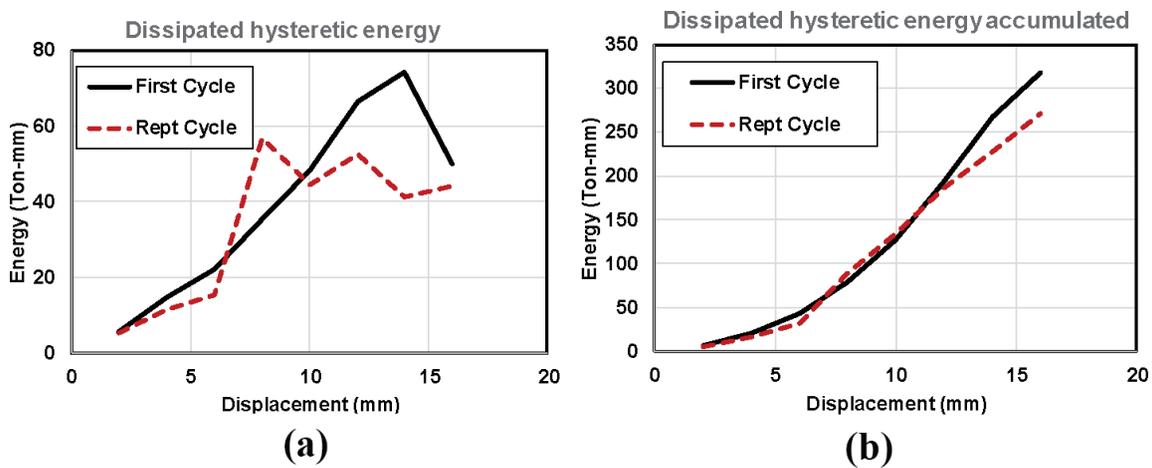
Figure 12. (a) Hysteretic energy dissipated by cycle and (b) accumulated dissipated hysteretic energy.

Figure 12a shows the hysteretic energy dissipated by cycle, for each data series (first cycle and repetition cycle). This energy was calculated for each cycle as the curve enclosed area "Average shear force" vs. "Total displacement" (shaded area in **Figure 11a**). It can be observed that the energy is increased with the lateral displacement. There is a change in the energy slope when the displacement is 14 mm, the energy decreases, probably due to the accumulated damage in the transfer slab. **Figure 12b** shows the accumulated dissipated hysteretic energy for each data series (first cycle and repetition cycle). It can be observed that the curve slope of the first cycle decreases, for the reasons mentioned above.

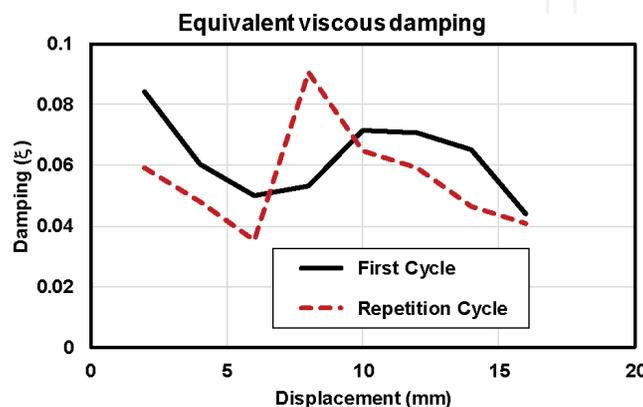
Figure 13.
 Equivalent viscous damping in specimen SP2.

The amount of equivalent viscous damping [15] corresponding to the energy dissipated by the structure through its nonlinear response at every cycle can be determined using the response of Specimen SP2. The equivalent viscous damping can be calculated in experimental curves, with Eq. (5). This parameter represents the internal frictions in the material [15] that, in the case of the studied specimen

Equivalent viscous damping is also used as an index that measures the damage accumulated in the member; as the crack increases, so does the damping. Mexican Building Code assumes an equivalent viscous damping equal of 5 percent of the critical, to use in seismic design. **Figure 13** shows that the average damping in the connection is about 6%, which is a value similar that assumed in traditional design.

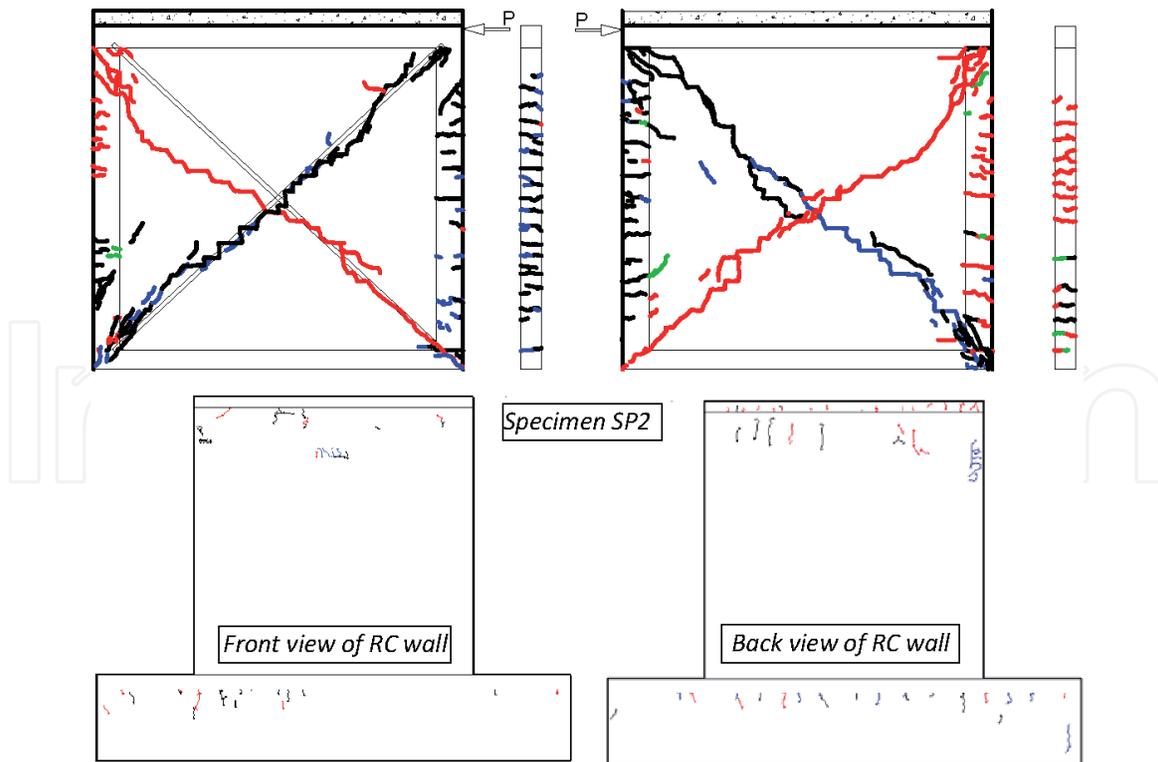
Figure 14. Cracking on the masonry wall (top) and on RC wall (bottom), after applying the complete load cycles. Cracking on the front side and back side of the wall is illustrated.

The crack pattern of masonry wall of SP1 is show in **Figure 14**, the cracks had an orientation similar with typical patterns of masonry walls subject to shear loads. This distribution of cracks is typical in confined masonry walls where the cracks are in wall diagonals, and regardless of how the wall is supported, flexible or fixed. Whereas, the crack pattern on the RC wall of specimen SP2 is illustrated in **Figure 14**, it can be observed only a few minor cracks located in the top of the wall, practically without cracks (**Figure 14**), this because the horizontal force is transmitted as a shear

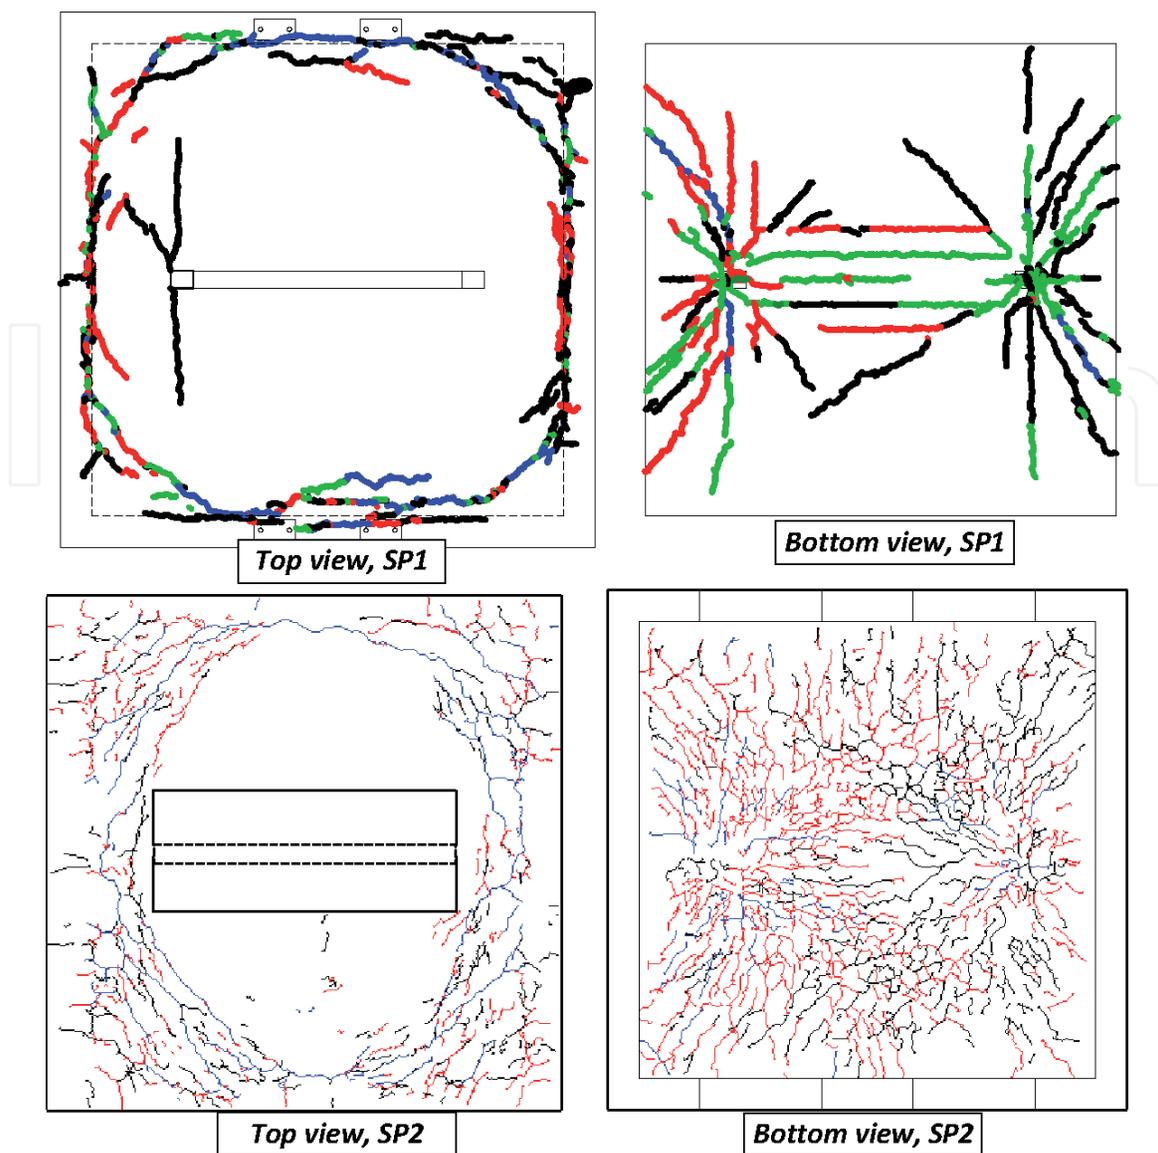
Figure 15. Cracking in the masonry wall-slab prototype SP1 (top) and cracking in the RC slab after applying the complete load cycles in the RC wall-slab prototype SP2 (bottom).

We also studied the pattern and distribution of cracking in the numerical models. Cracks in the masonry wall of experimental prototype SP1 are similar as the ones observed in the slab-wall numerical models. In the other hand, the behavior of the RC wall of specimen SP2 was according with the expected, it is to say, only minor cracks, the pattern is very similar with the numerical model of **Figure 10**; In the case of RC walls, the crack pattern was quite different when the base condition is analyzed; the wall on a flexible base (transfer slab) only showed a few cracks, while a wall resting on a fixed base, the crack pattern is concentrated in the tension zone of the wall (lower left corner). RC wall on a fixed support demanded its full shear capacity, while the wall on a transfer slab developed only some shear strains. This situation can be attached to the rotations of the slab, which caused a great decrease in the rigidity capacity of the entire system, **Figure 15**; a situation very delicate for the slab, particularly in the zones at the ends of the wall. The slab presented in this zone large cracks on its lower side and crushing of concrete on the upper side. This condition diminishes the slab capacity significantly (**Figure 15b**).

During the combined loading stage in prototype SP1, first cracks were detected at slab edges, close to the contiguous girders, and perpendicular to the wall. But, when the load was increased, cracks trajectories at both faces of the slab were detected (top of **Figure 15**). Cracks in the perimeter edges of upside slab were delineated, and other cracks were detected at the edges of masonry wall (**Figure 15**, top-left and bottom-left). Nevertheless, in the downside of slab, the cracks were defined as parallel lines to the walls and other lines with radial trajectories, most of these last cracks had a common origin located in the connections

between tie-columns and slab. In the specimen SP2 (bottom of **Figure 15**) was observed a significant damage, in both sides the path of cracking was similar of SP1, however the damaged was more extensive.

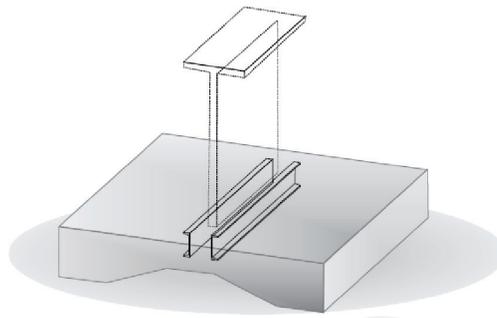
Figure 16.
Reinforcement system with two C-shaped steel channel.

Due to the reinforced concrete wall was not damaged, the decision was made to repair the tested Specimen SP2. The repair consisted in the incorporation of two C shaped steel channel (**Figure 16**). The reinforcement system was designed neglecting the load capacity of the slab. Considering a vertical load of 8 Tons applied to the wall and a lateral load applied to the upper end of the wall of 6.5 Tons. The beams were considered fixed at their ends.

slab was drilled so that the stud shear connectors could be placed (**Figure 16**), finally the grout was placed.

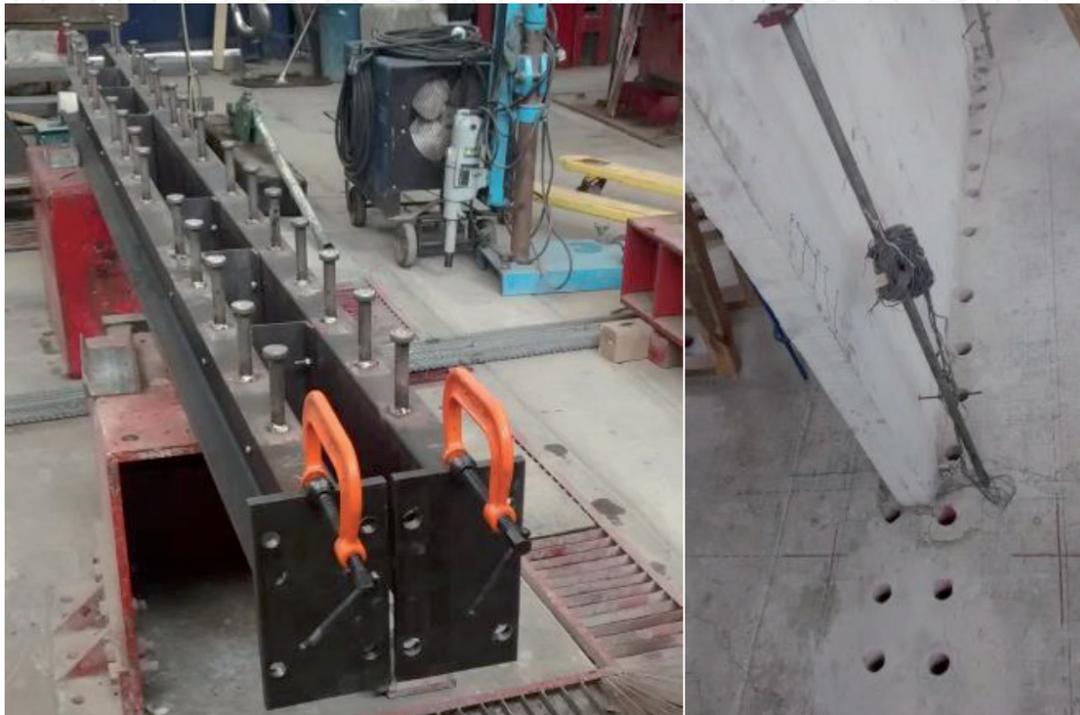
Figure 17.
C-shaped steel channel with stud shear connectors (left), drills in the concrete slab.

In the bending design of steel beams, we assumed a member with a simple section. Stud shear connectors were placed in the steel profiles to achieve a composite section (**Figure 17**). The steel profiles were fixed to the perimeter beams by steel plates that were fixed by fasteners. A space of 1 cm was left between the concrete slab and the steel profile to fill it with grout, thereby ensuring that the concrete slab is in contact with the profile along its entire length. The concrete

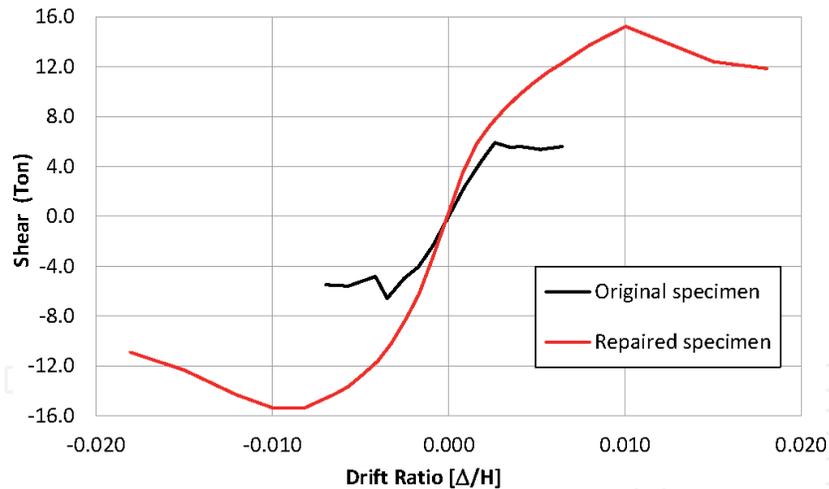
Figure 18.
 Comparison of hysteresis envelopes of the original and repaired specimen SP2.

When the second specimen, SP2, is repaired, it is possible to increase some of the most important mechanical properties, such as strength, rigidity, and deformability (**Figure 18**). The resistance of the original specimen is 6.59 Tons while the resistance of the repaired specimen is 15.4 Tons, that is, it increased 2.34 times. The initial rigidity of the original specimen is 2.64 Ton/m, while the rigidity of the repaired specimen is 4.32 Ton/m, that is, an increase of 64% was achieved. The maximum displacement in the first specimen was 16.1 mm, which corresponds to a 0.6% drift ratio, the maximum drift ratio in the repaired specimen was 45.15 mm, which corresponds to a drift of 1.8%, that is, the capacity of displacement was tripled.

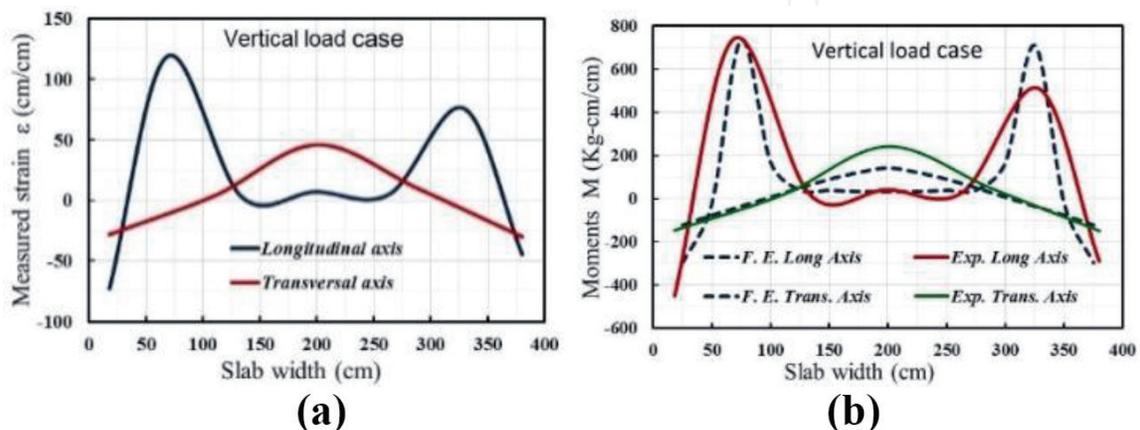
Figure 19.
 (a) Strain variations in central strip in longitudinal direction, vertical load case; (b) bending moment in central strip.

In Figure 19 are illustrated the strain variations measured from vertical load stage along the two principal central strips of SP1 slab model (longitudinal and normal wall directions). These strains were measured with the strain gages set installed in the slab (Figure 3). The first cracks in the slab (Figure 9) appeared when the vertical load reached a value of 4.8 Ton. Figure 19b also show the bending moment diagrams associated to the strains along central strips; additionally, the moment diagrams were compared with those computed using Finite Element Analysis. Maximum bending moments are in the joint of slab with tie column zone. In a lateral strip located at 75 cm from the centerline, the measured strains were approximately 60% of those of the central strip, consequently maximum negative moment also had this reduction.

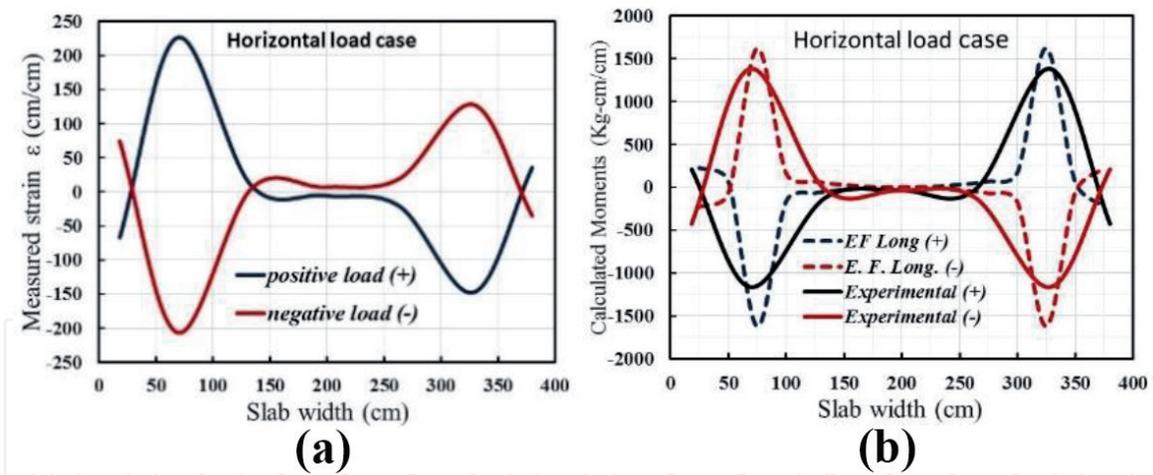
Figure 20.

(a) Strain variations in central strip from horizontal load case; (b) bending moments in central strip.

In the horizontal load case, strain variations and bending moment diagrams along the center strips of two directions of the slab are shown in Figure 20; these

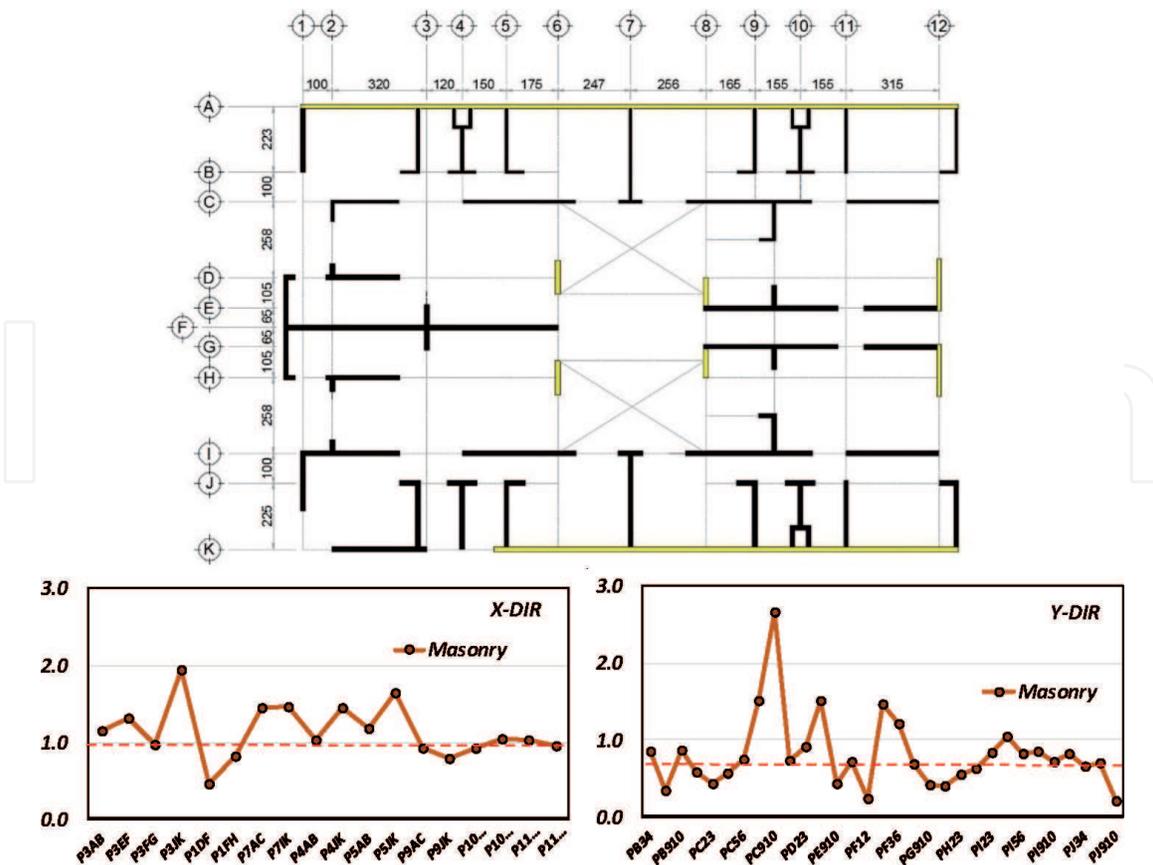
Figure 21. Transfer floor plan in building A, and shear ratio (V_u/V_D) in walls located on the transfer floor. In black line are indicated the interrupted walls in transfer slab.

Building A has six stories on the ground level and a basement walls as part of mat Foundation. The ground story (top of **Figure 21**) is intended for parking, and their structure is based on RC frames; the five remaining stories are structured with load-bearing walls some of red brick masonry and others of reinforced concrete. Floor slabs are of various types, so the Mat foundation plate is reinforced concrete with concrete walls, the first floor (transfer slab) also is reinforced concrete cast on site, but the remaining upper levels were constructed with prefabricated beam and block, lightened with polystyrene. The plan is shown in **Figure 21**, the area enclosed by the axes A–K and 8–12, is the part of the building which rests on the transfer floor system, which is formed by beams and a solid slab of 12 cm. Most of the interior walls are interrupted at that level and do not rest on any beam (*black line* in figure).
