Digital Technology to Preserve Heritage Structures

Steve Hold

Abstract

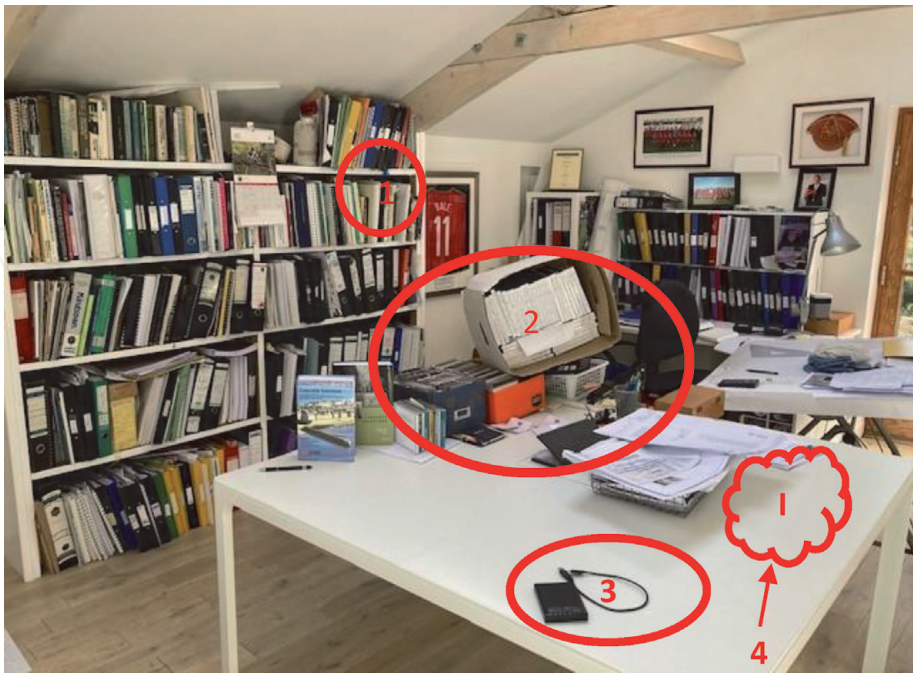
Figure 1.
1. Level – Normal hard copy files of projects, investigations, and solutions. 2. Level – Information from files and VHS video takes. on to CDs. 3. Level – Information stored on files on hard drives. 4. Level – Information available from ‘cloud’.

Since the 1990s, major projects that I have been involved with as project manager or repair works engineering designer and specifier have been recorded by progress photographs and video notes. In this way a visual and 3D record of what was done and how it was achieved has been archived. This work has now accumulated a significant archive of different types of Heritage structures and how they were investigated, repaired, or strengthened for both teaching and sharing the more innovative ideas of such sensitive repairs. The objective is then to make this recorded visual detailed information available to the current, or present-day generation of engineers or conservationists who are interested in the preservation of these types of Heritage monuments. The method of doing this in the past has been by passing this knowledge on and includes ‘papers’ and ‘presentations’ at conferences for Civil Engineering, Forensic Engineering and Heritage bodies [1]. This after many years has built up a ‘legacy store’ of digital data used for such presentations. In recent years the progression of technology has meant transferring all of this type of standard information usually from VHS video for projects in the 1990s to CDs and then more recently having the CD information available on hard drives in the current era. This type of data storage not only condenses a large amount of practical knowledge down into a very small space for archiving but can transfer information through the internet as required to interested parties anywhere in the world. Currently even less space for storage will be needed when storing is transferred to the next stage of archiving development in the ‘Cloud’ and as a by-product of ‘file sharing’ and ‘transfer links’ data sent worldwide (Figure 1).

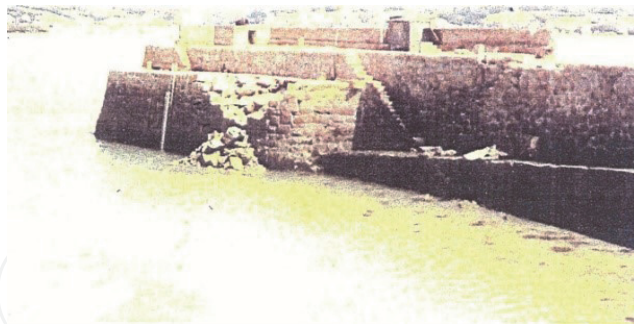
From the archives search the failure of the inner face of the breakwater wall (**Figure 2**), Ref. [3] was seen to be the result of wave impact on the outside face of the breakwater causing, through 'stress propagation', the wall on the inner face of the breakwater to be forced outwards resulting in a partial collapse. The inner wall had also settled because it was originally built on the beach sand using large, loose blocks of granite stones with no foundations in 1640 by a young king Charles II. The solution shown in the model, in **Figure 3** (Ref. [3] Vid [1]), was for 'mini-piles' and 'secret fix ties' across the two granite walls of the structure which are designed to arrest any further movement.

Figure 2.
St Aubin's fort breakwater failure 1972 (archives).

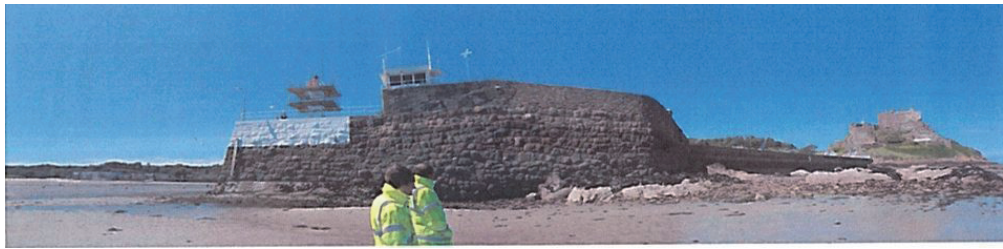
Photographic merges and videos of the pierhead at low tide (with Gorey Castle in the background) showed the size of the loose granite masonry structure and where ‘bulging’ of masonry and loss of concrete foundations were exposed (**Figure 7**). The pierhead itself shown in **Figure 8** had to be rebuilt in 1964 after a major storm failure shown from the archives in **Figure 6**. To understand the evolution of the structure from the original pre-1620 pier, a LiDAR survey accurately captured the geometry of the whole of the pier in 2009. There was another major storm event in 2011 and a second LiDAR survey was taken, and the Point Cloud data overlaid on the GPS referenced coordinates of the original 2009 survey. **Figure 7** shows graphically the super imposed LiDAR scans to show where there was a “bulge” outwards of the masonry and a loss of concrete at the base.

Figure 8.
Gorey Pierhead and breakwater at low tide. Gorey Castle in background (digital photo merge), Ref. [10].

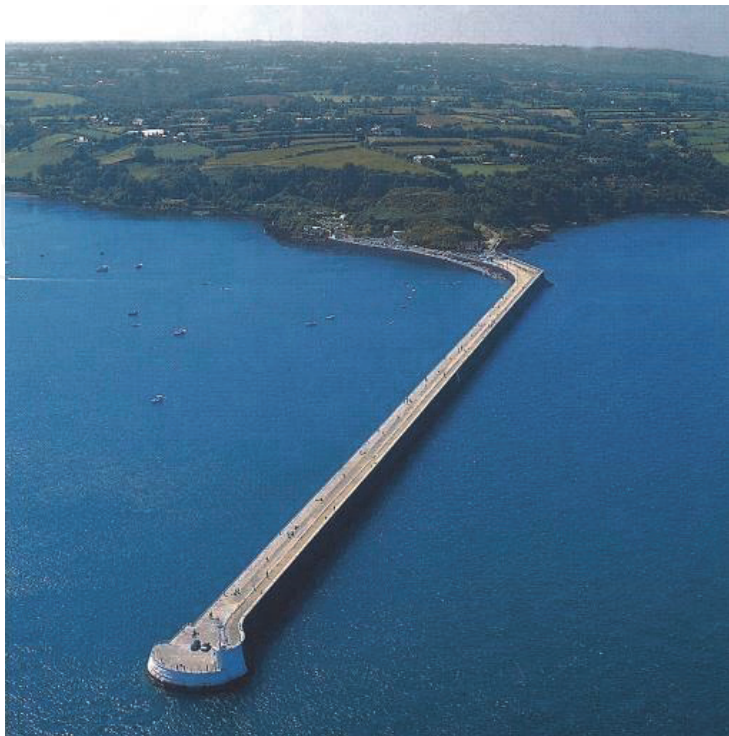
Figure 9.
St. Catherine’s breakwater and roundhead 600 m out to sea.

Another very large breakwater on the island of Jersey (Jersey projects are particularly challenging because of the 11 m tidal range and adverse sea state conditions) was St. Catherine’s Breakwater which stretches some 600 m out to sea (**Figure 9**, Ref. [11]). In a time of urgent crisis for the end of the structure in 2008, the breakwater roundhead was surveyed with GPR (ground penetrating radar) and found to have a very large hidden void under the concrete slab covering the roundhead at the end. If not repaired before the coming winter, then there was likely to be a failure and collapse. As soon as this occurred a section of the breakwater would have been likely

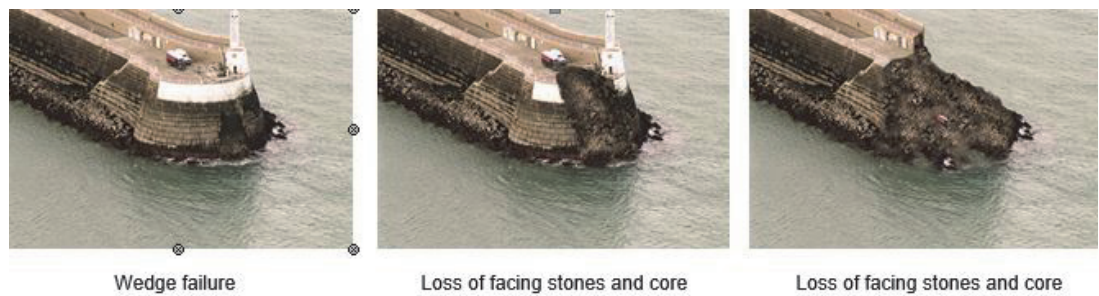
Figure 10.
Photographic manipulation used to obtain emergency repair and protection funding, Ref. [11].

to unravel during the type of fierce winter storms that occur around the coast of the Island. Digital models, drawing models using photoshopping images (**Figure 10**, Ref. [9]) of a likely collapse and unravelling mechanism helped to convince the governments treasury to release emergency funds. Drone surveys were then used to capture visual images of the whole structure that is particularly difficult and dangerous to survey conventionally and this also contributed to obtaining the urgent Government funding to repair and preserve this heritage marine monument as well as to be able to monitor it in the following years. (An early graphical model of the rock armour protection needed following the roundhead repairs is shown in **Figure 11**).

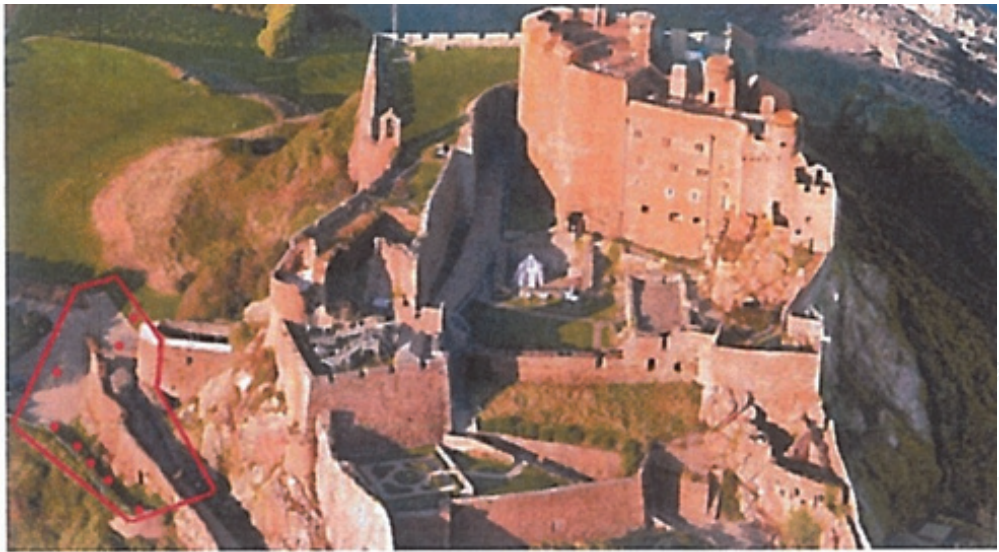
Castle, excavations were carried out to create more car parking space adjacent to the Castle entrance (**Figure 15**, Ref. [10], Vid Ref. [2]). However, the works were excavated too close to the East Gate of the Castle and undermined the wall close to, and beneath this gate. The resulting movement and cracking in the masonry was significant but was also difficult to assess and map conventionally but with the use of the LiDAR model the engineering team was able to design repairs (**Figure 16** Ref. [10], Vid Ref. [2]).

LiDAR was used to accurately record the surface of the structure's masonry shape and to map the cracks so as to identify what parts of the masonry had moved

Figure 15.
LiDAR area of high density focus for accuracy. Show red line cracks.

and by how much. This type of heritage masonry is very difficult to draw conventionally but the high intensity LiDAR scans produce accurate drawings that not only provide an archive but also very good visual records of this type of historic masonry structure and when and where it was repaired.

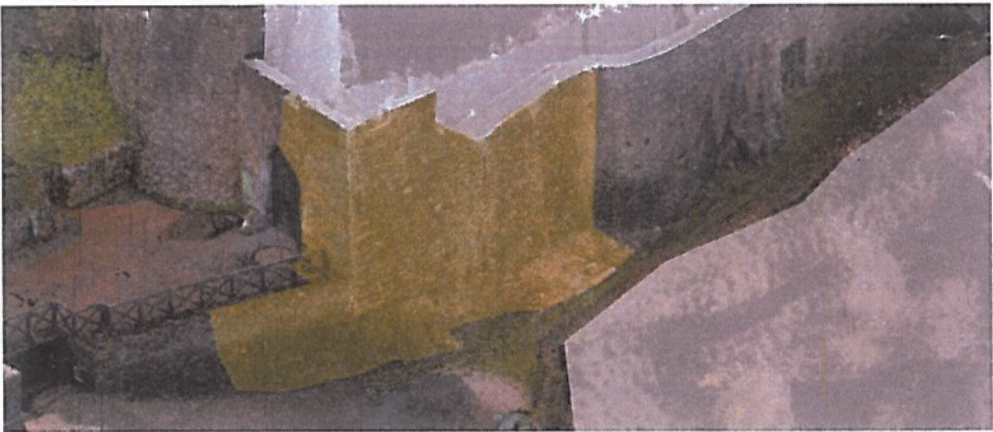
Figure 16.
Drone survey of castle. Target area for LiDAR. Screen shots and survey video of castle, Ref. [10], Vid Ref. [2].

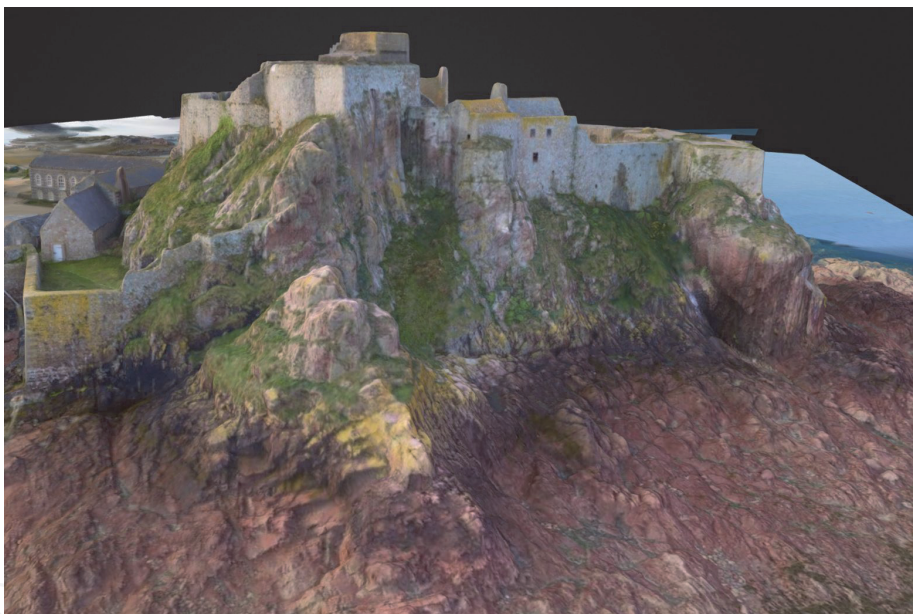
This type of technology, especially the use of drones to gather large numbers of images of a difficult to access part of a structure enables the production of ‘Point Cloud’ models with 3 mm accuracy. This methodology also means that the safety of personnel in gathering data such as at the Castle walls and the difficult and dangerous to access breakwater walls, has increased significantly. Also, distance in using this digital technology is not limited and Heritage conservation knowledge has, or should have, no international boundaries. By using LiDAR and drones to produce digital models, I have been able to work on the strengthening and preservation of several Heritage monuments in China. Examples are the Chongching Gate and the Yongying Bridge in Shanghai and the White Pagoda in Guang’an were able to be

Figure 22.
The drone survey model of the higher in accessible west facing castle walls.

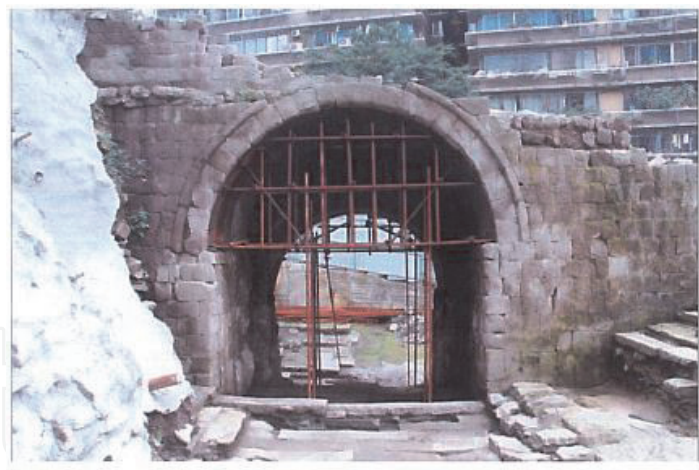
图八：北立面现场照片

Figure 23.
The threatened Chongqing gate to be preserved and strengthened.

assessed for strengthening and preservation using the ‘secret fix’ Cintec anchor method developed in the UK. Through digital communications and from exchanges of data I have been able to provide assistance in these Heritage preservation schemes. Along with the progress of Chinese modernisation and development in recent decades has come the recognition and appreciation by local Government Authorities, the community value of the Heritage monuments being preserved (Figures 23–28, Ref. [15]).

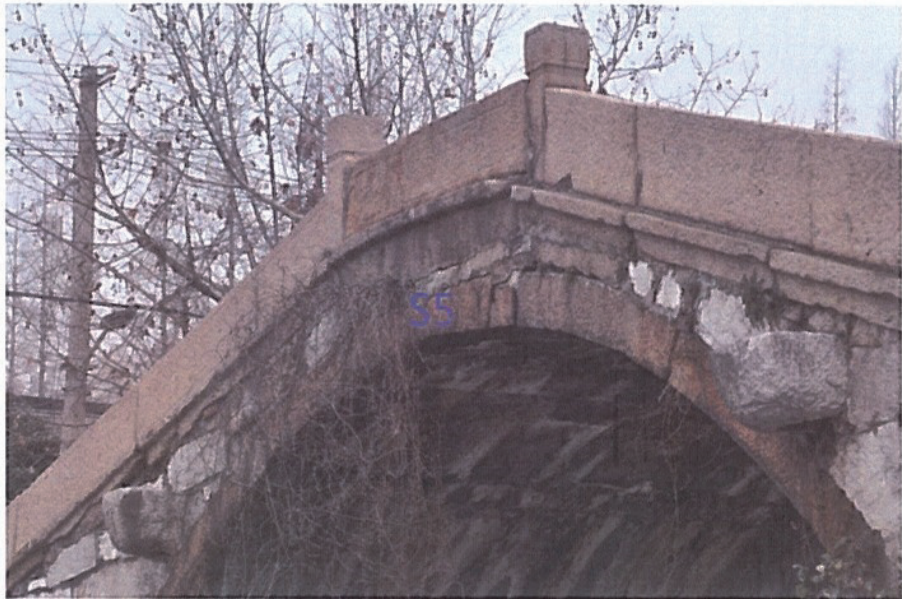
Figure 25.
The damage to the slender Yongying bridge.

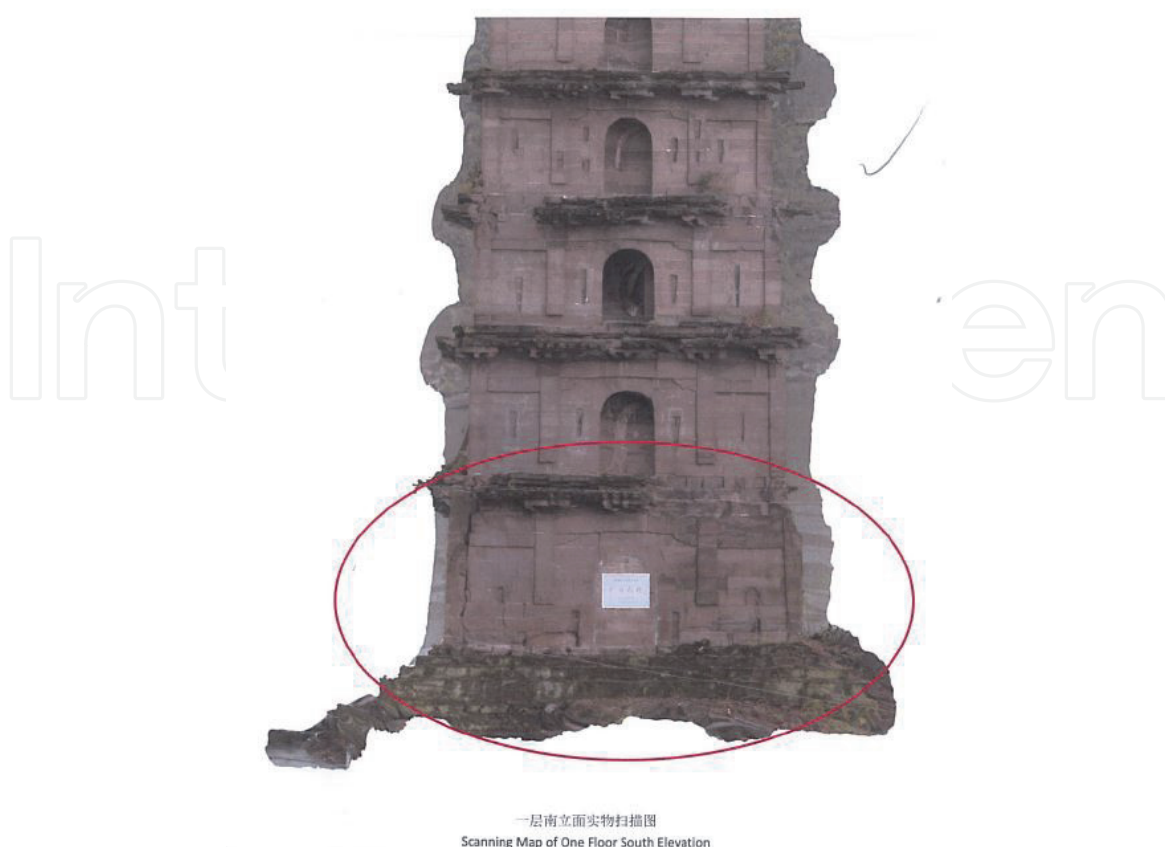
Figure 27.
LiDAR scan of the white pagoda surface erosion.

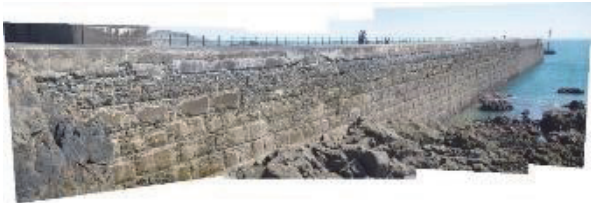
Engineer’s inspection of the Elizabeth Castle Breakwater in St. Helier, Jersey (Figure 29, also refer back to Figures 17 and 18, Ref. [9], Vid Ref. [4]).

Figure 29.
The damaged west side of Elizabeth Castle breakwater.

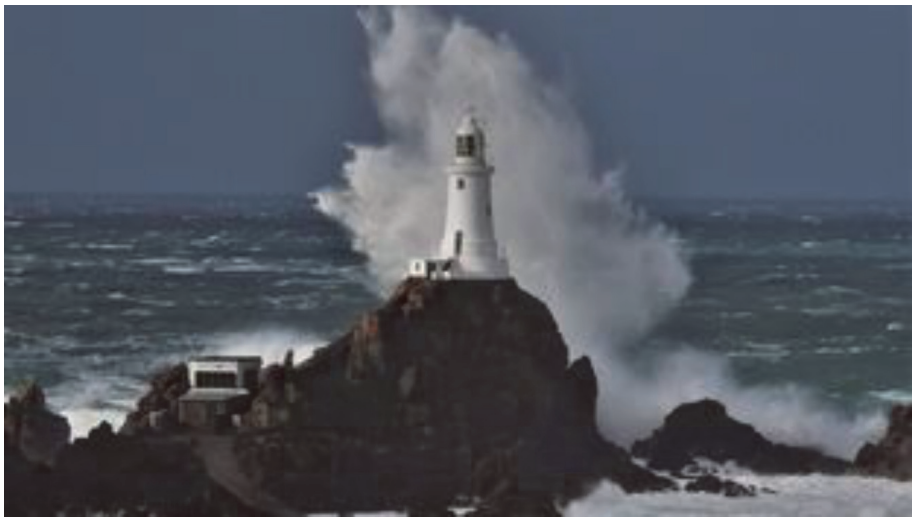
Figure 33.
Lighthouse with raging storm.

This structure was conceived and constructed in 1860s by the English Victorian era engineer Jonathan Coode (Figure 30). He developed in the course of designing the breakwater a new innovative method for constructing new concrete blocks instead of using large granite stone blocks to construct the Elizabeth Castle Breakwater (Figure 31). It was also discovered in other archive records on the Island that at about this same time, he was able to construct the first concrete lighthouse on the island of Jersey at Corbiere (Figures 32 and 33).

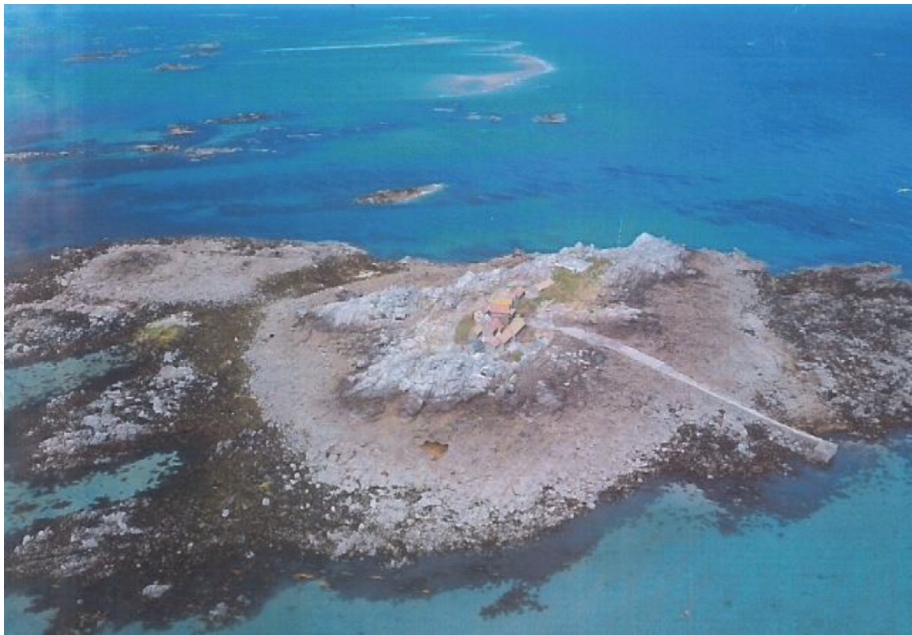
In terms of circumventing dangerous rocks and restoring Heritage value to a site, the recent work to assess and design the repairs to a sea wall at Les Minquiers, a rock archipelago 20 km south of Jersey, between the island of Jersey and mainland of France, has relied heavily upon a drone survey (**Figure 34**, Vid Ref. [6]). This particular dangerously rocky outcrop of islands forming an archipelago of unique flora and fauna is virtually inaccessible unless by light small boat (**Figure 35**). Previously there had been no surveys or any drawings done of the main island itself or the fisherman's shelter cottages that had historically been built on the island (**Figure 36**). The ability to replay and 'pause' the drone video enabled the difficult and remote access parts of the failed

Figure 34.
LiDAR model of structure and later a full access drone survey of outer surface, Ref. [6]. (Link to video materials is available at the end of the chapter).

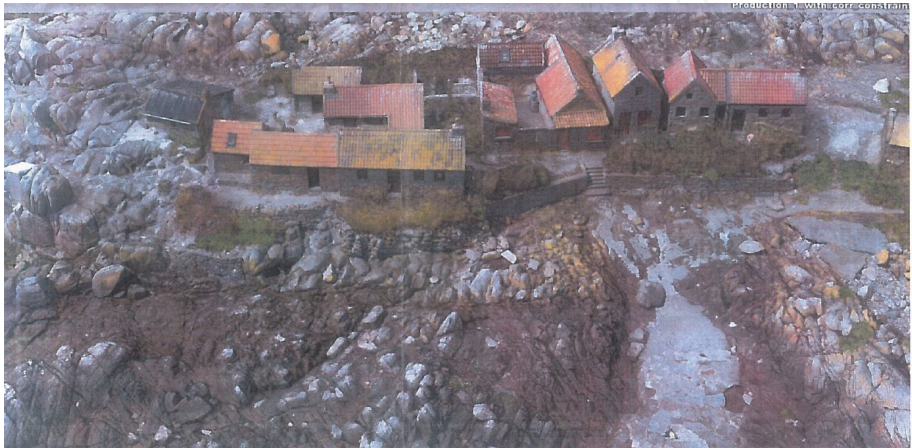
Figure 36.
Location of the damaged sea wall to be rebuilt.

office to be able to discuss the problems and the practical methods that can be used to strengthen and preserve the Heritage structures (**Figures 36** and **37** for the sea wall rebuild at Les Minquiers is another good example).
