Detection of Delamination in Wall Paintings by Ground Penetrating Radar

Wanfu Wang
Dunhuang Academy
People's Republic of China

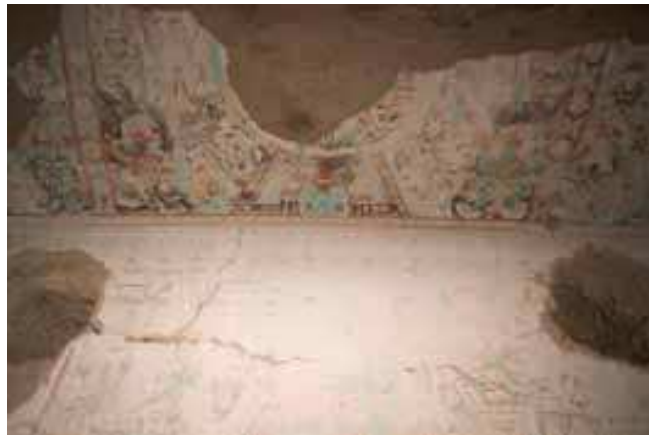
Fig. 1. Delaminated wall paintings in Cave 329 of Mogao Grottoes

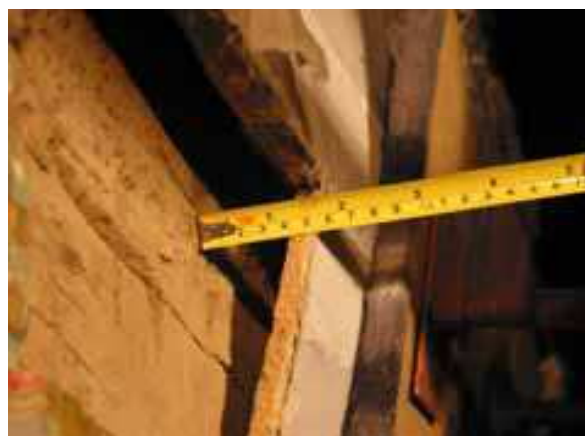
Fig. 2. Delaminated wall paintings in Eastern Audience Hall of Potala Palace

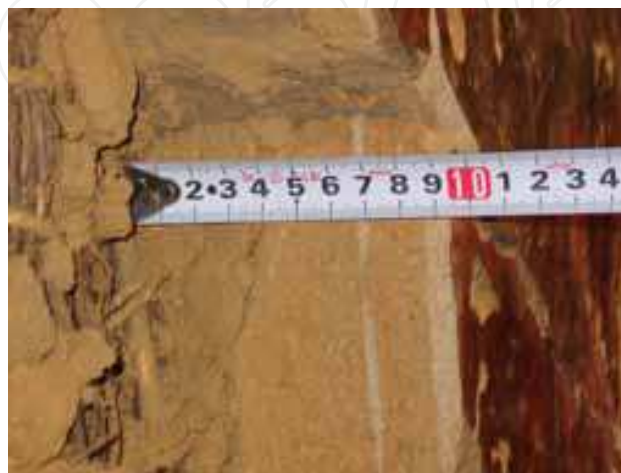
Fig. 3. Typical plaster section of wall paintings in Potala Palace

The depth of mural delamination is generally 2 ~ 5 cm, rarely more than 10 cm (Fig. 3). Therefore, ground penetrating radar can detect depth of 20 cm to meet the requirements. Based on physical modeling experiment in the laboratory, the author uses the RAMAC GPR made in Sweden to detect delamination of wall paintings in Tibetan lamaseries and Lashao temple. During the in-situ test, the ground penetrating radar is equipped with a shielded

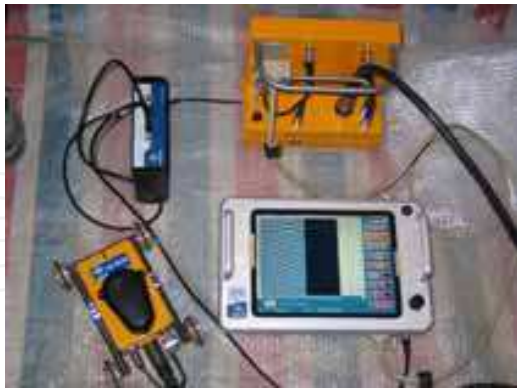
Fig. 4. RAMAC/GPR made by MALÅ GeoScience

RAMAC GPR, made by MALÅ GeoScience in Sweden, is used to carry out the physical modeling experiment. It is designed on the basis of general modular, and it consists of control unit, antenna and computer terminals (Fig. 4). When detecting the delamination of wall paintings in Tibet Potala Palace, the 1.6 GHz shielded antenna with the highest center frequency at that time was used. At present, the latest product, 2.3 GHz radar antenna, takes a higher central frequency. As for the impulse electromagnetic wave generated by the transmitting antenna, its time domain (Fig. 5) and frequency domain (Fig. 6) characteristics

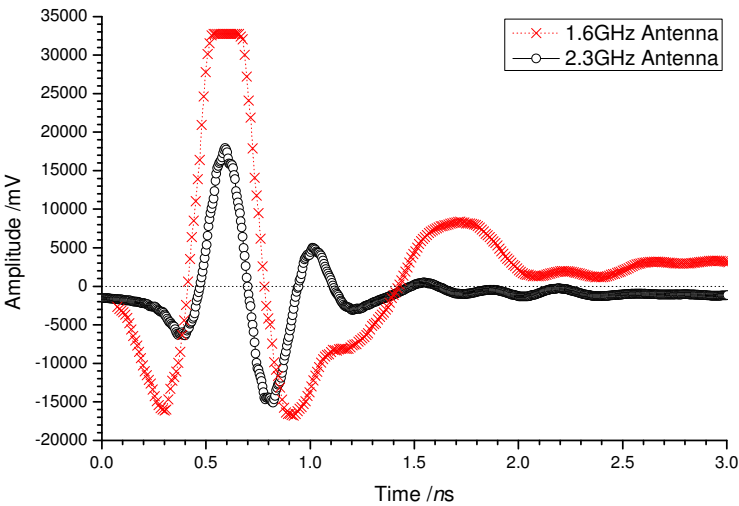
Fig. 5. Time domain waveform of carrier-free pulse emitted by GPR antenna

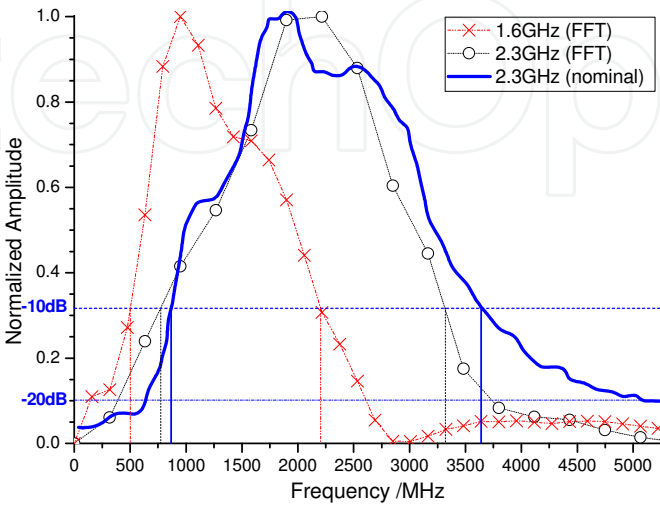
Fig. 6. Frequency domain spectrum of carrier-free pulse emitted by GPR antenna

When $\mathbf{P}_{dB}(f)$ is -10 dB, $A(f) = 10^{-1/2} \cdot A_{\max}(f) \approx 0.32 A_{\max}(f)$. As shown in Fig. 6, when the normalized amplitude is 0.32, its normalized power is equal to -10 dB.

In Fig. 6, the signals in time domain have been transformed into frequency domain by Fast Fourier Transform (FFT), the higher bound f_H and lower bound f_L of spectral band width of the electromagnetic wave transmitted by 1.6 GHz antenna is 502 MHz and 2,203 MHz respectively. As to 2.3 GHz antenna, the higher bound f_H and lower bound f_L is 772 MHz and 3,321 MHz respectively. The relative band width \mathbf{B} is defined by the following equation:

If the threshold of -20 dB spectral density, in equal to normalized amplitude of 0.1 in Fig. 6, is regarded as the recognition limit, the effective band width of 1.6 GHz antenna in frequency domain is 121~2,624 MHz. Therefore, the minimum wave length of the electromagnetic wave transmitting in the wall painting plaster is 6.62 cm. Then, the maximum theoretical vertical resolution of $\lambda/8$ is about 8 mm.

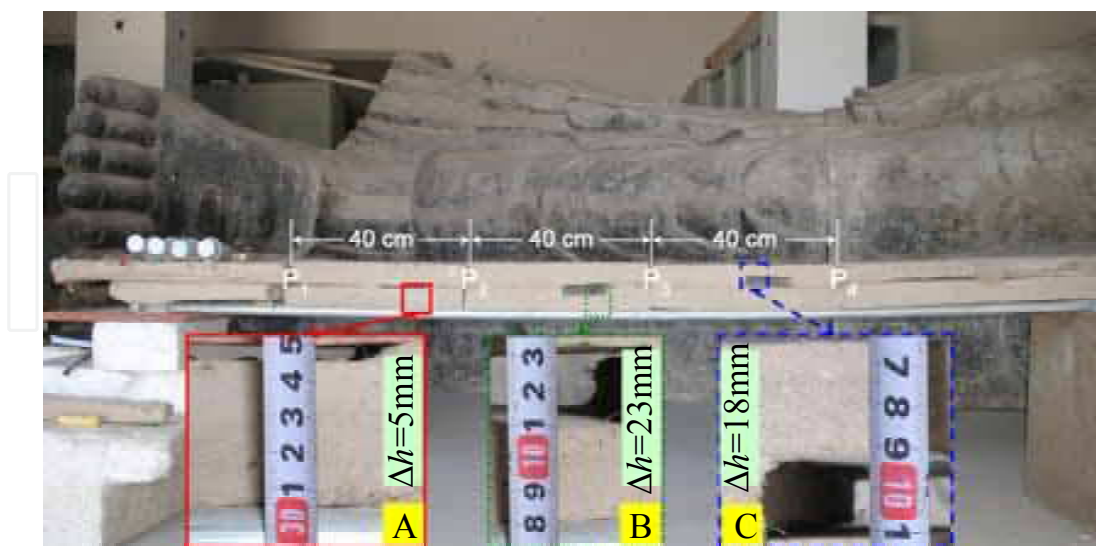
Fig. 7. Schematic layout of rectangular voids in plaster replica for detection by GPR

In Fig. 7, the length of the delamination parts A, B, and C is 100 mm. Their buried depth h and thickness Δh is 45 mm & 5 mm, 45 mm & 23 mm and 27 mm & mm respectively. The relative dielectical constant of the loam plaster is about 1.74, so that the propagation velocity

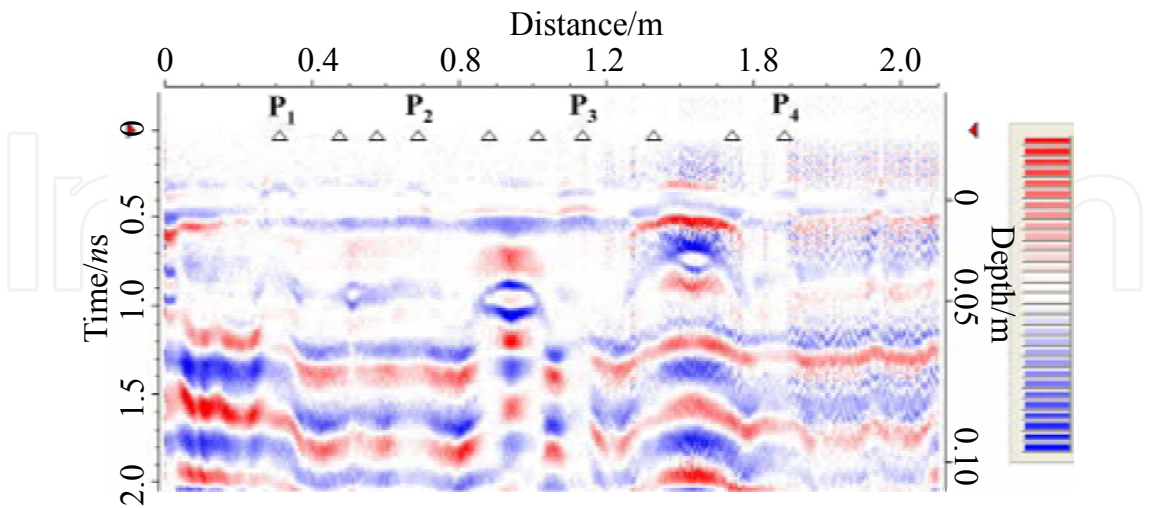
Fig. 8. Presentation of post-processed GPR profile in software of Ground Vision

In Fig. 8, the length of the radar profile is about 2.1 m, the interval of the triggering time is 0.1 s, the total time spent is 62.1 s, and 621 traces of data have been collected. The average speed of the antenna is about 3.38 cm/s. The time window t of the profile is 2.26 ns, the sampling frequency, f_s , is 141.82 GHz. The number of samples, N , collected in each trace is 320, which is figured out by the following equation:

What is shown in Fig. 8 is a radar profile, presented in the form of a matrix with 320 rows and 621 columns after loading the filter of finite impulse response (FIR). In the Ground Vision, which is a software affiliated to the ground penetrating radar equipment, through the processing of direct current (DC) removal, band pass filtering and subtract mean trace, the delamination in replica plaster can be distinguished clearly in the point mode of radar profile. Since the delamination A is not that thick, it is difficult to be located in Fig. 8. The delamination C is so shallow that the noise over the echo is strong. The delamination B is the most obvious and its thickness, Δh , can be calculated with the following equation:

In equation (5), t is 2.26×10^{-9} s. According to the characteristic waveform of delamination B in time domain, N_t and N_0 is 179 and 155 respectively, and N is 320. The thickness of the delamination is figured out as 0.0254 m, namely 25.4 mm. It is very close to the actual thickness in replica plaster. By the same rule, N_t and N_0 for delamination C is 141 and 123 respectively, and its thickness is calculated as 19.1 mm.

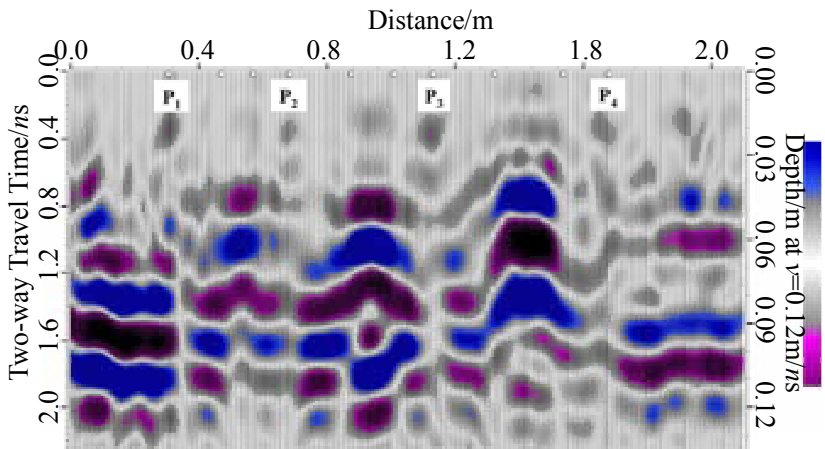
Fig. 9. Post-processed GPR profile in combination of wiggle mode and point mode

Fig. 9 is the interpretation result of the same radar profile in software of REFLEX after the processing of subtract DC shift, band pass butterworth, background removal and F-K migration. It is the combination of presentation in point mode and wiggle mode. The delamination parts of A, B and C are obvious. Compared with the background, their common characteristics are the sudden increase in negative amplitude and the phase inversion.

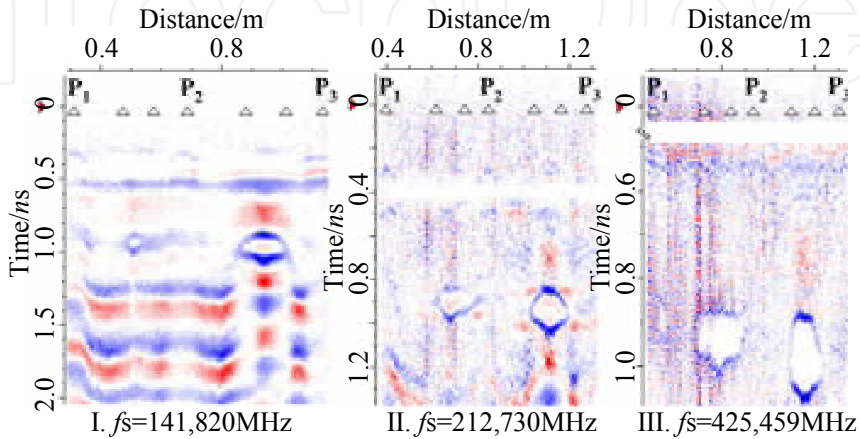
Fig. 10. FIR filtered GPR profiles at different sampling frequency

Fig. 10 is the interpretation result of delamination A and B at different sampling frequency. The higher the sampling frequency is, the more samples in illustration of delamination at the same time depth are. The bigger the difference of two way travel time between the upper and the lower surface of delamination is, the more serious the delamination is.

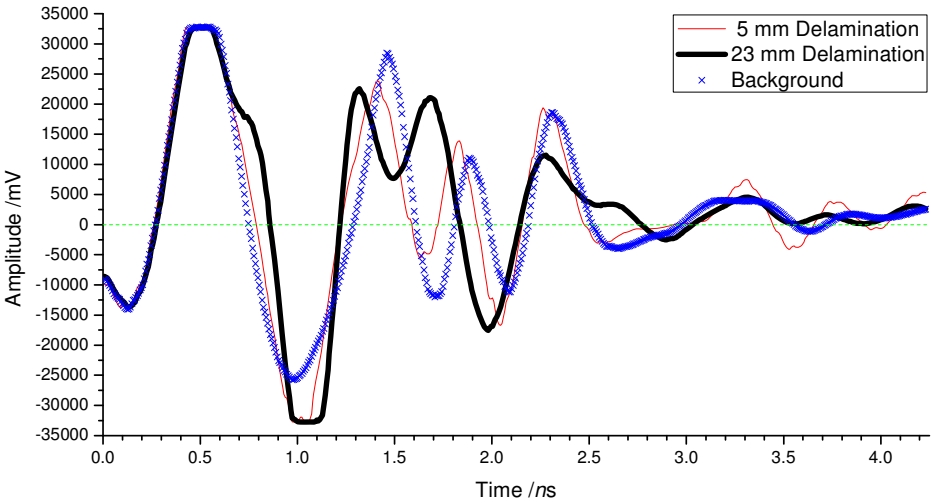
Fig. 11. Characteristic traces in time domain at sampling frequency of 142 GHz

The typical wave forms (Fig. 11, Fig. 12) of delamination A with the thickness of 5 mm, delamination B of 23 mm thick and background are extracted from the radar profile. The comparison and analysis of transformed wave forms in time domain are presented in Fig. 13 and Fig. 14.

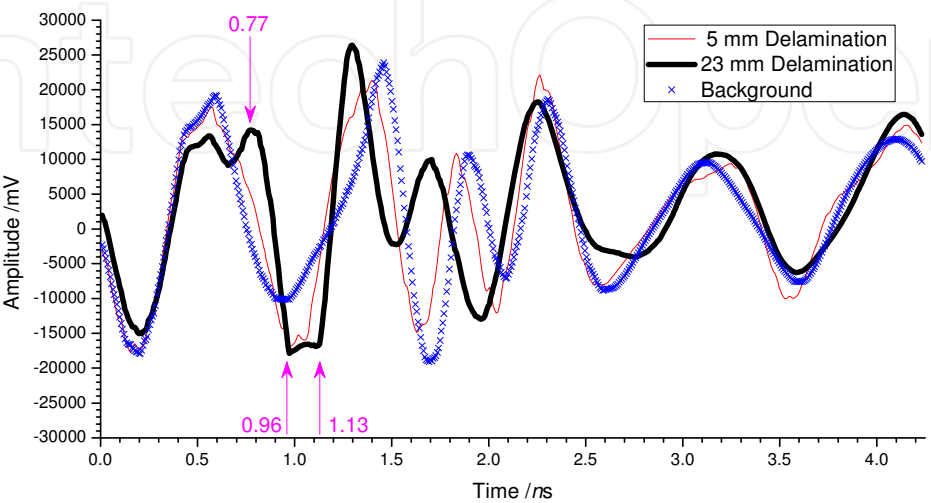
Fig. 12. Comparison of typical traces after high pass at 1.2 GHz in time domain

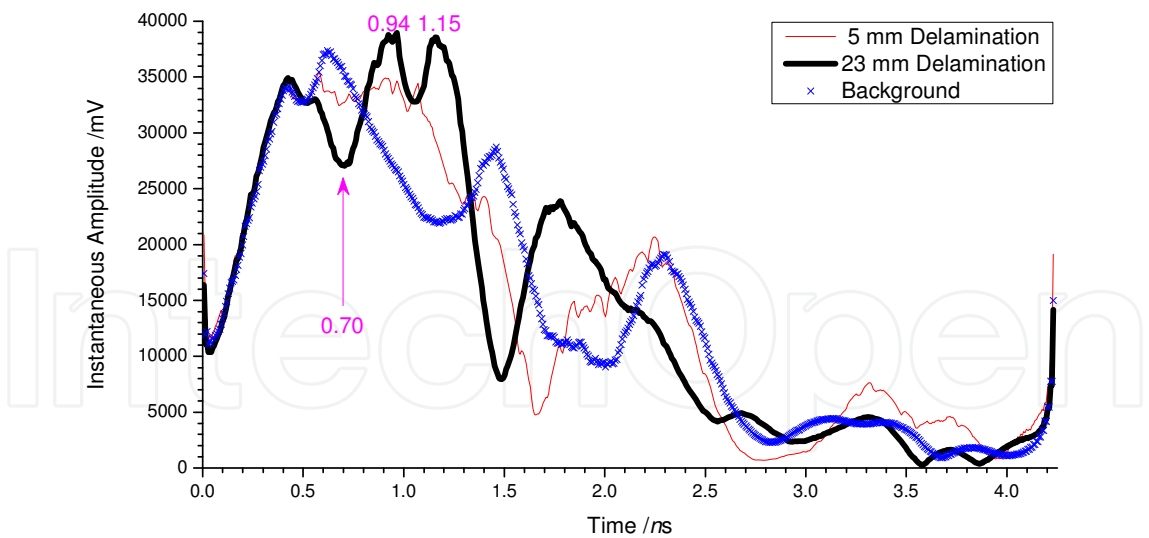
Fig. 13. Comparison of instantaneous amplitude after Hilbert transform

At the upper and lower interfaces of delamination, the instantaneous amplitude as well as the instantaneous phase of the delamination and the background in time domain go through alienation. The two way travel time is 0.7 ns and 0.9 ns respectively when the contrast is great, which is in consistent with the contrast of original waveforms in time domain.

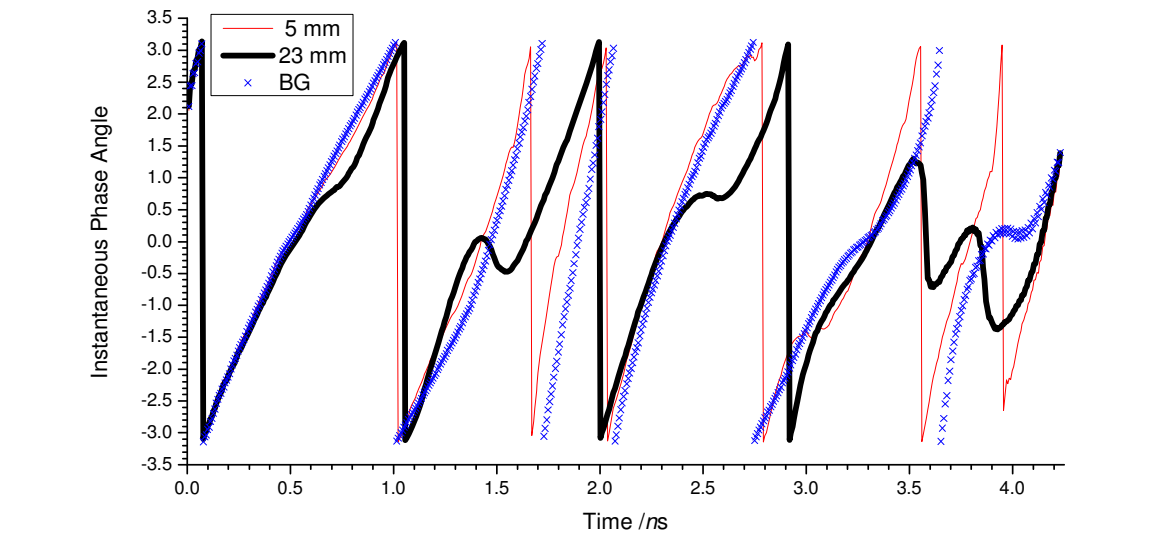
Fig. 14. Comparison of instantaneous phase after Hilbert transform

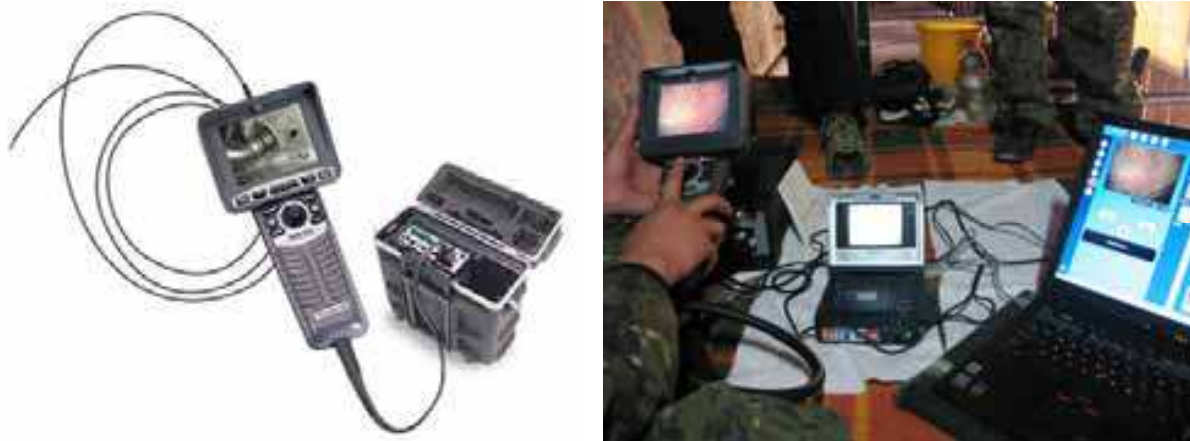
Fig. 15. XL PRO Video probe made by EverestVIT for remote visual test

Visual inspection by means of video probe (Fig. 15) shows that delamination in wall paintings in the Sagya Monastery is very serious. The delamination is mainly distributed at the top of walls, usually in the form of wall painting plaster delaminating from the rammed plaster (Fig. 16).

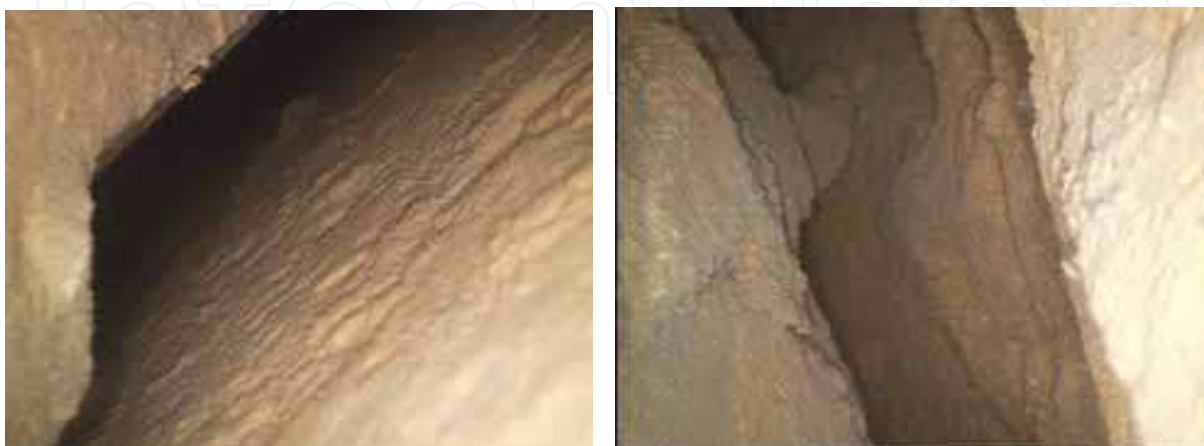
Fig. 16. Visualization of delamination in wall paintings by EverestVIT VideoProbe

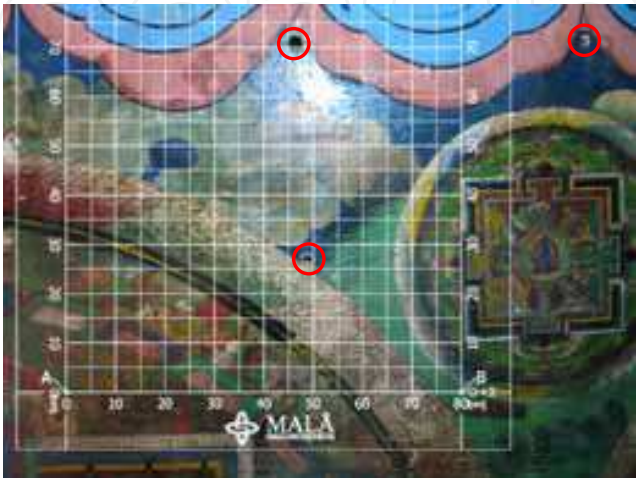
Fig. 17. Relative position of detection area to probing holes

It has been proven by video probe that the delamination in wall paintings around the probing holes is thick. The three holes (Fig. 17) are connected with each other in that when it is blown at one hole the dust come out from the other two holes. It is a pity that although the interior condition of the delamination can be visualized and imaged by probing test, the thickness of the delamination can not be determined without reference. Only the existence of the delamination can be ensured. The around area (Fig. 18) is selected as the site of field test for detection.

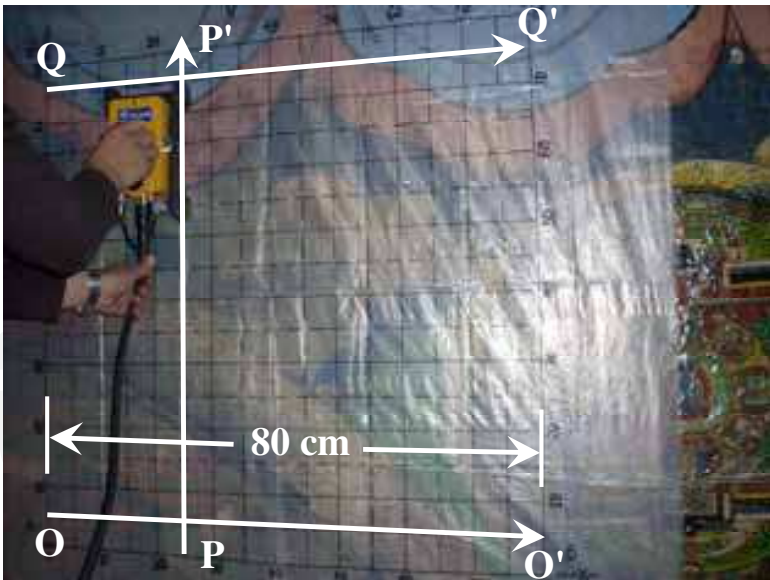
Fig. 18. In-situ detection of delamination in Mandala Hall of Sagya Monastery

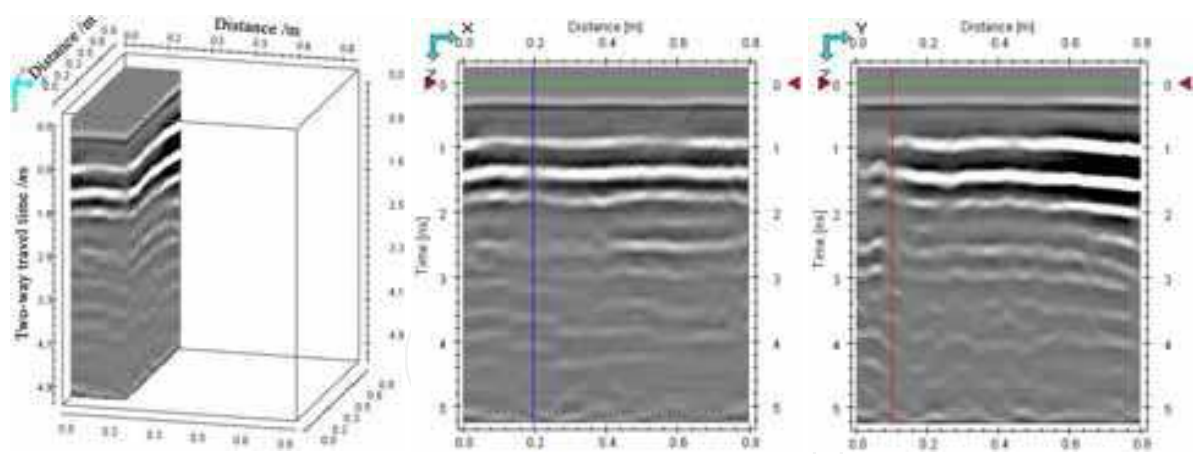
Fig. 19. Typical GPR profiles in illustration of delamination at Mandala Hall

The field test for detection of delamination in wall paintings was carried out on August 7, 2007. Test parameters were as follows: the sampling frequency is 60779.928037 MHz, interval of triggering distance is 0.002590 m and the depth of time window is 5.528141 ns. In the post-processing software of Easy 3D, as the radar profile is filtered by FIR, it is found that the delamination at the top is more serious than that at the bottom in the west wall (Fig. 19).

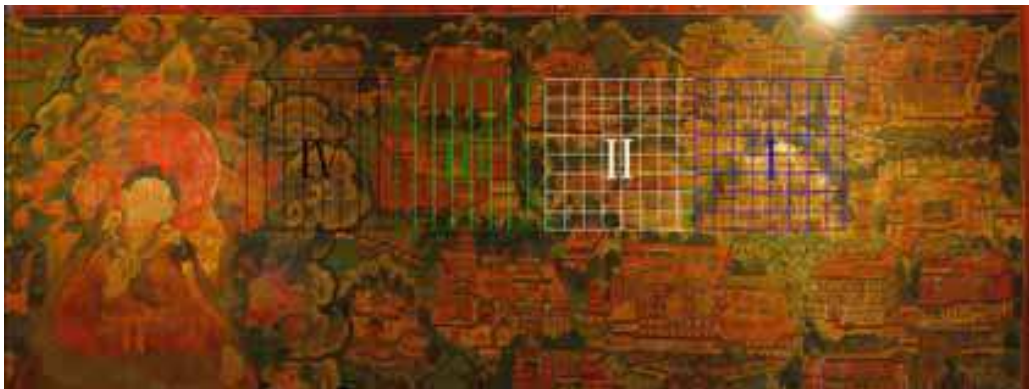
Fig. 20. Detection area in the Western Hall of Potala Palace

The south wall of Western Hall in Potala Palace is selected as the detection area (Fig. 20). From left to right, this area is divided into five square grids with a side length of 80 cm, so that each coverage is 0.64 m². The spacing distance of both transversal and vertical profiles in grid project is 10 cm (Fig. 21).

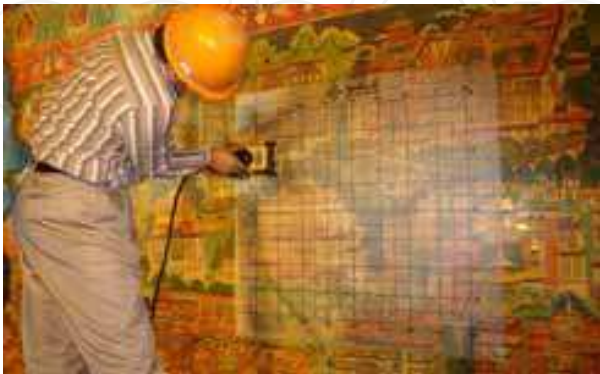
Fig. 21. In-situ orthogonal grid project

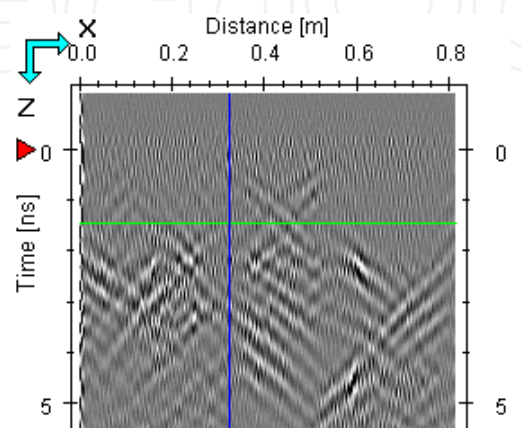
Fig. 22. Plaster-support interface illustrated in radar image

From Fig. 22, it can be seen that when the two-way travel time of electromagnetic wave is near 2 ns, the reflected signal is strong. Suppose that the electromagnetic wave travels at 0.1 m/ns in plaster, the thickness of the plaster layer is 10 cm. Besides, the signal of the wave appears unusual at the horizontal distance of 0.42 m, which may be the area of delamination.

Raw GPR profile data is digitally processed by the following filters in sequence: automatic gain control (scale: 500000, window: 21), direct current adjustment (start: 207, end: 311), delete mean trace (use entire date), finite impulse response (background: 15, lowpass: 5), and moving average (samples: 3). After the post processing as above, the wall made of stone adobe is distinctly illustrated in Fig. 22, since relatively more electromagnetic waves are reflected from the plaster-stone interface.

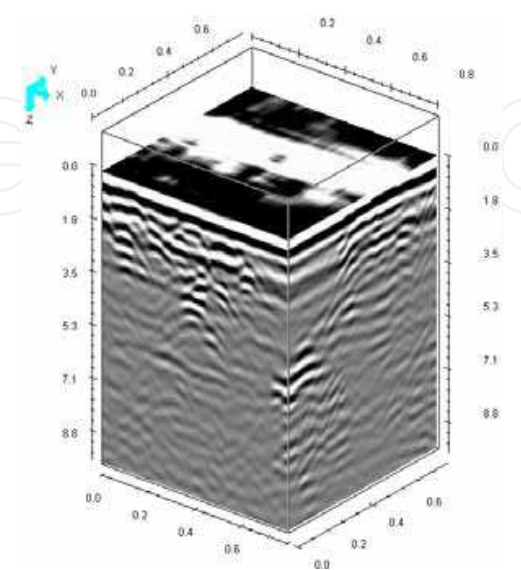
Fig. 23. 3D presentation of underneath beam

If the data in Fig. 22 is only filtered by finite impulse response in Easy 3D, the length of the wooden beam, read as 0.8 m, can be seen clearly in the radar profile (Fig. 23). Furthermore, its width is about 0.28 m in the side view (Fig. 24).

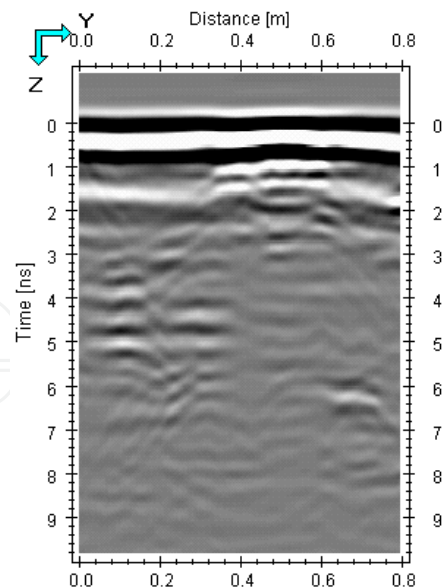
Fig. 24. Width of the wooden beam

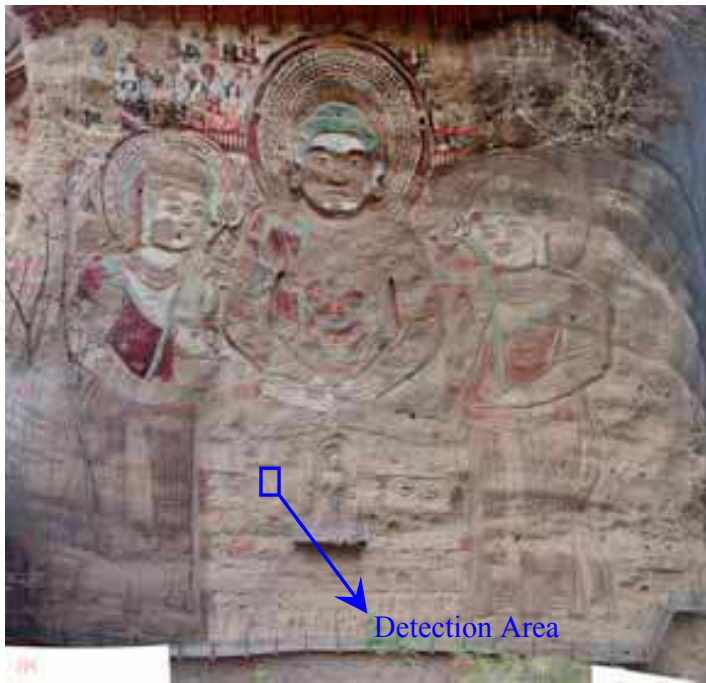
Fig. 25. Overall view of the field test in Lashao Temple

The detection area, 0.8 m long and 1.2 m high, in Lashao Temple of Wushan Shuilian Caves is relatively flat, on the north of the lion relief of the Buddha figure (Fig. 25). Altogether, 17 horizontal and 13 vertical profiles (Fig. 26) have been taken, and the distance between adjacent profiles is 0.1 m.

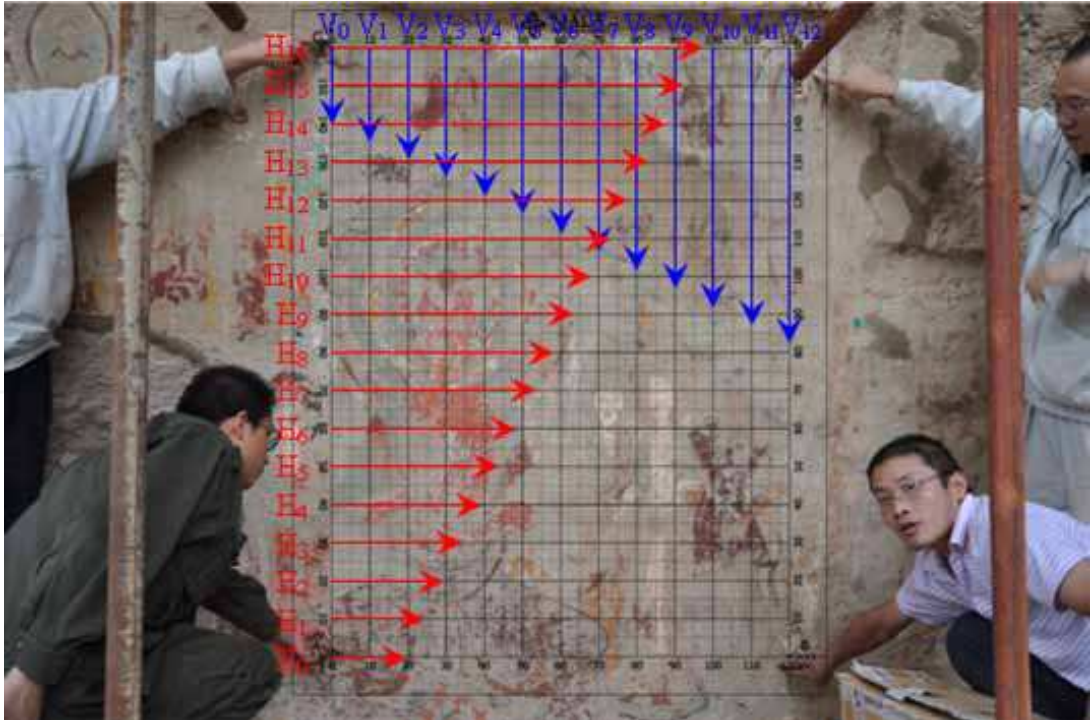
Fig. 26. In-situ detection of delamination in wall paintings in Lashao Temple

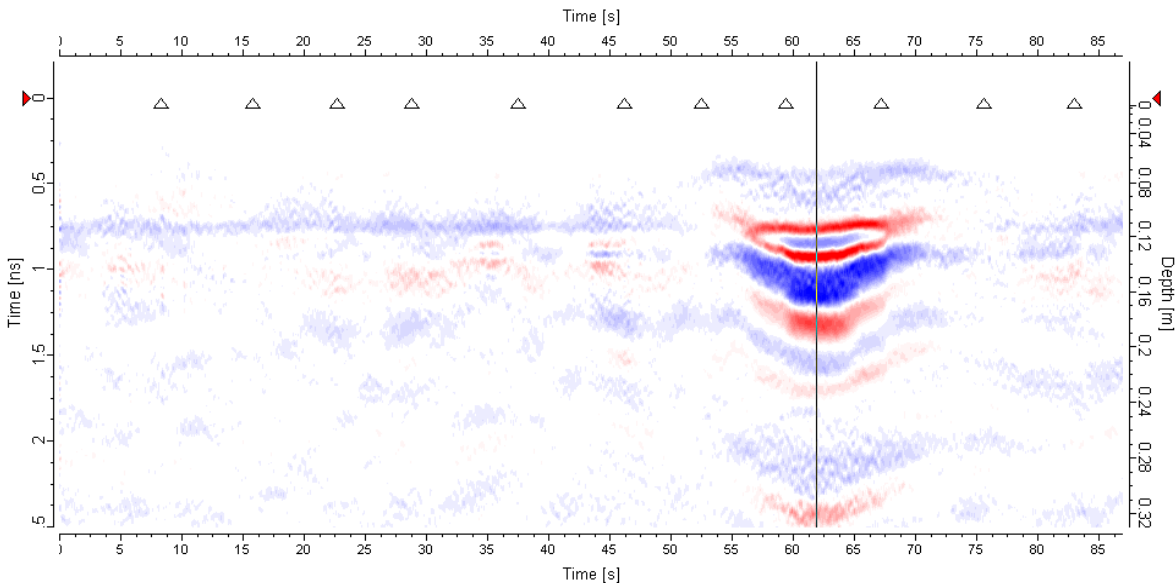
Fig. 27. Presentation of GPR profile H₃

It is shown in the interpretation results (Fig. 27, Fig. 28, Fig. 29) that the delamination in wall paintings in the detection region is mainly located at the lower left corner, which is in consistence of the area where the loss of mural plasters is serious. In addition, delamination is also serious in the lower right corner and the upper part of detection area. Taking into account that the vertical resolution of RAMAC ground penetrating radar is about 5 mm, delamination in detection area should be more serious (Fig. 30).

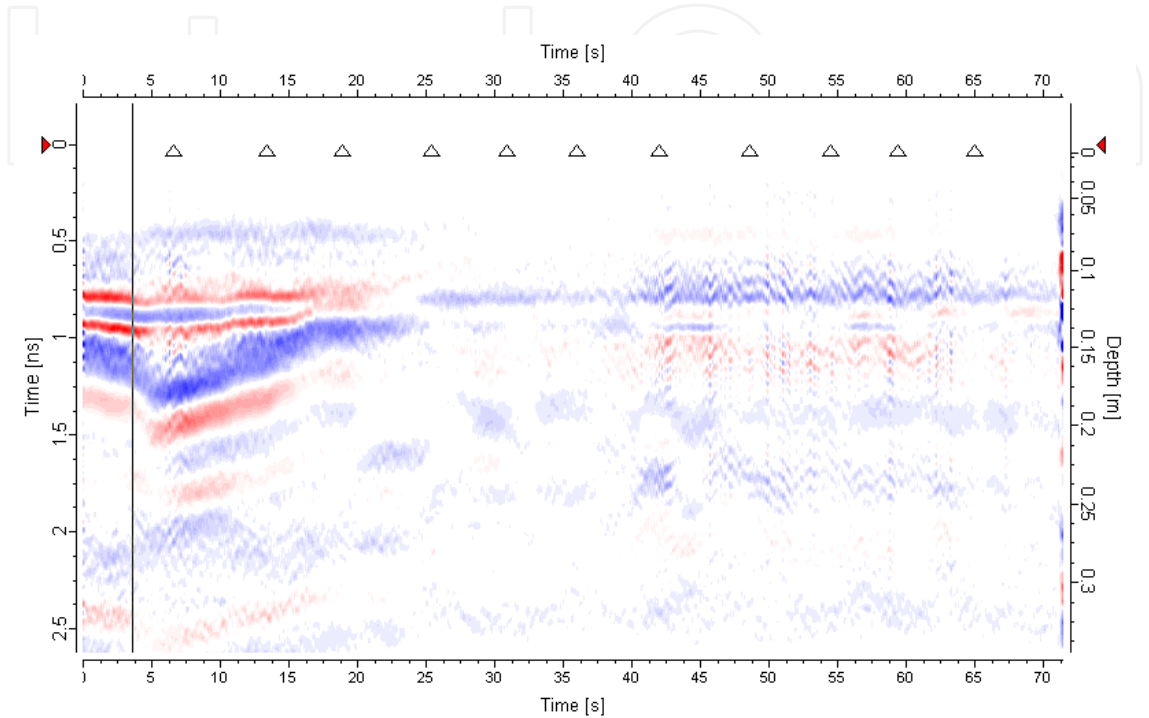
Fig. 28. Presentation of GPR profile H₅

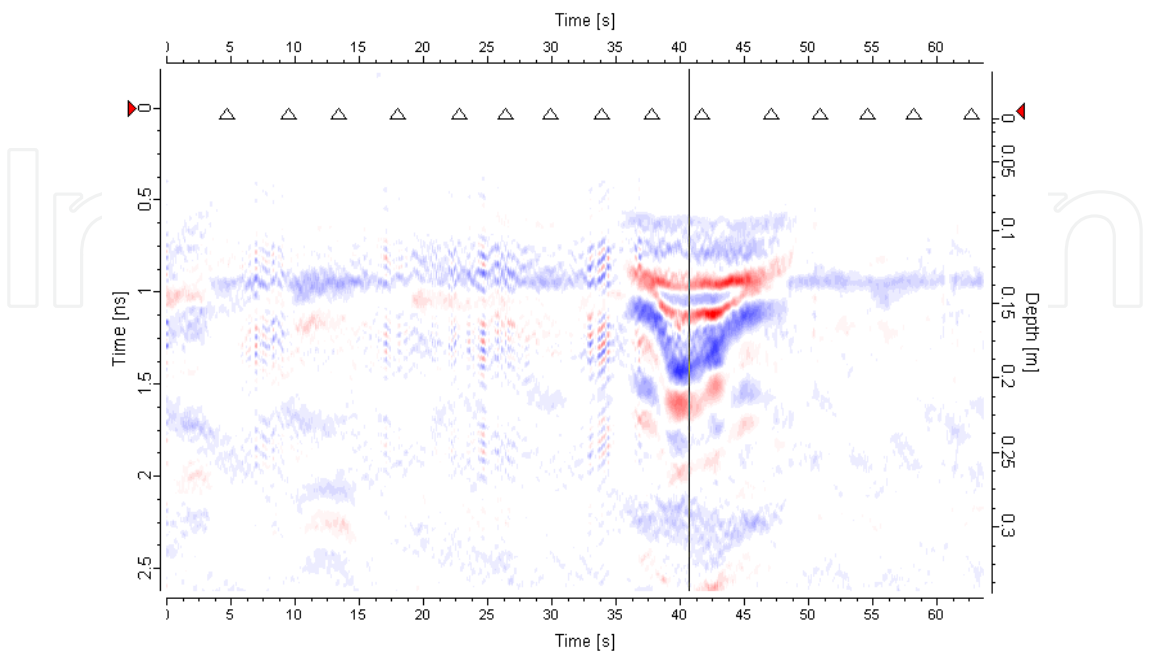
Fig. 29. Presentation of GPR profile V₁

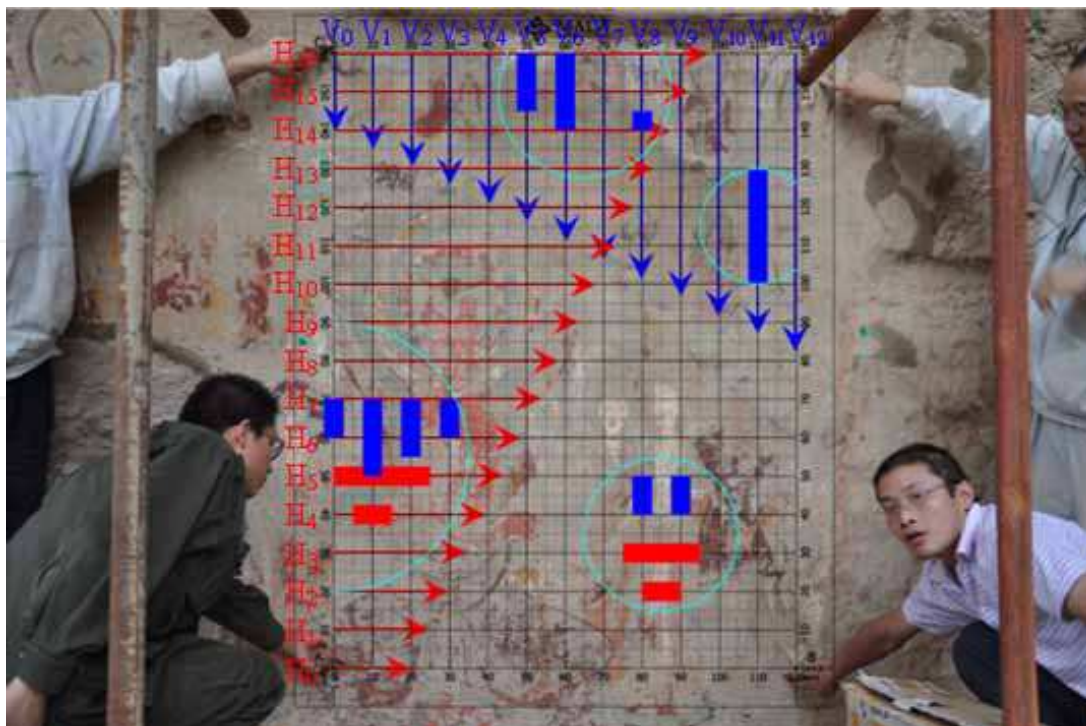
Fig. 30. Comprehensive interpretation of delamination in wall paintings, marked by arc
