Damageability of Gas Turbine Blades – Evaluation of Exhaust Gas Temperature in Front of the Turbine Using a Non-Linear Observer

Józef Błachnio and Wojciech Izydor Pawlak

*Air Force Institute of Technology (Instytut Techniczny Wojsk Lotniczych-ITWL),
Poland*

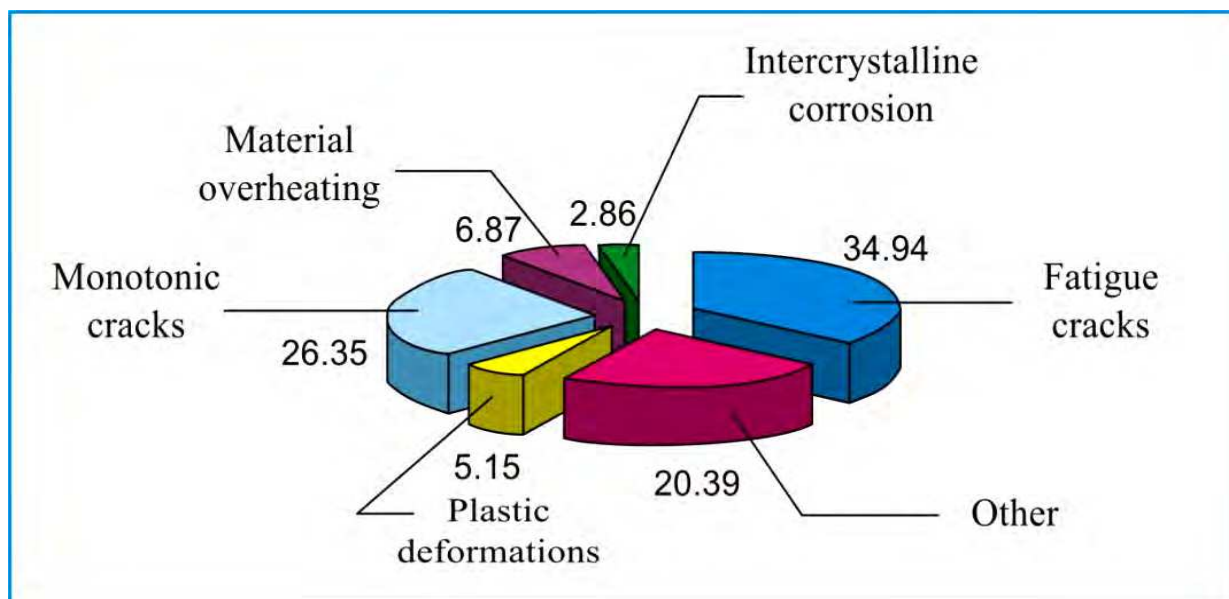
Fig. 1. Causes of failures to aircraft turbine engines during service (in percentage terms) (Błachnio, 2007)

and/or engineering process attributable defects; most damages/failures are service-attributable (Fig. 1).

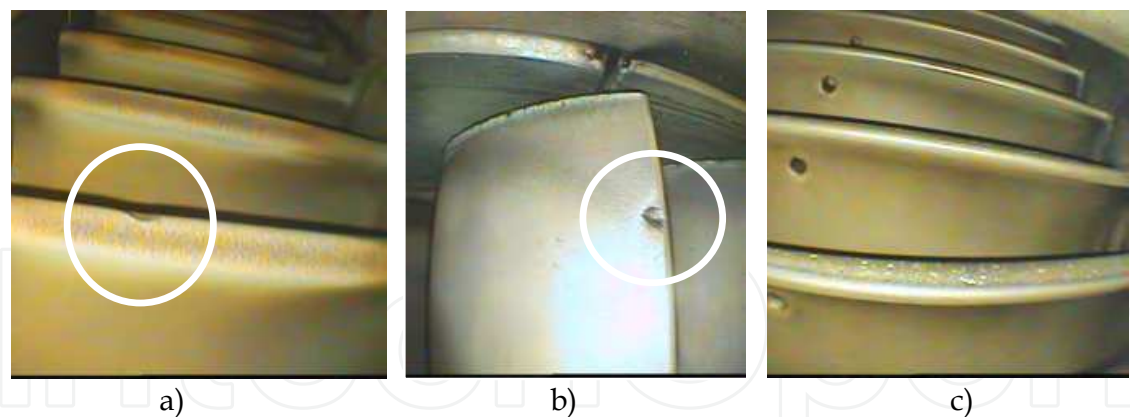
Fig. 2. Deformations of turbine blades in the form of dents caused by foreign matter (Reports, 2000-2010): a) – on the leading edge, b) – on the trailing edge, c) – on the on suction faces of blades

Blade deformations in the form of dents (Fig. 2) are caused by a foreign matter ingested by the turbojet engine compressor and by particles of metal and hard carbon deposits from the combustion chamber. Such dents result in stress concentrations in blade material and prove conducive to the initiation of fatigue processes. Scratches on blade surfaces (Fig. 3) due to the foreign matter impact are also reasons for local stress concentrations and, consequently, potential corrosion centers. What results is, again, material fatigue which, together with possible corrosion, prove conducive to fatigue fracture.

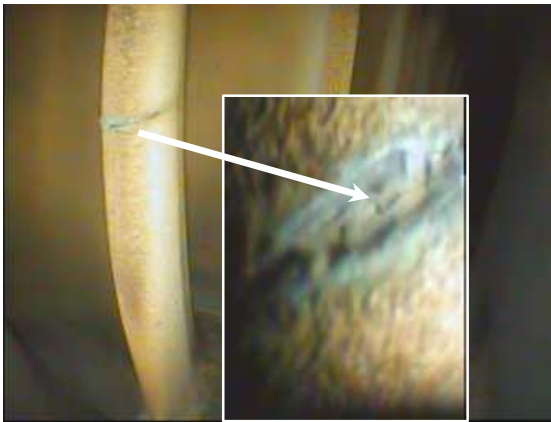
Fig. 3. Scratches on protective coating conducive to corrosion on the leading edge of a turbine blade (Reports, 2000-2010)

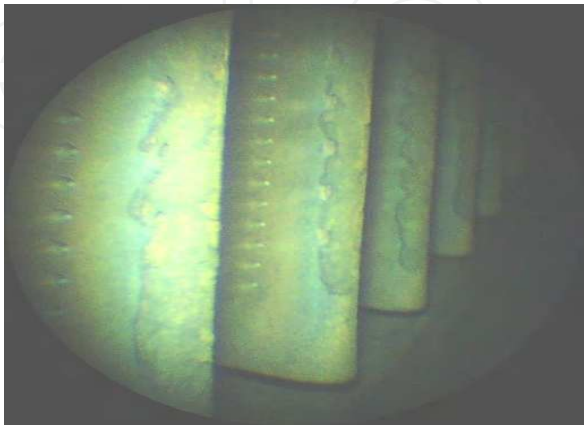
Fig. 4. Erosive wear of leading edges of rotor blades (Korczewski, 2008)

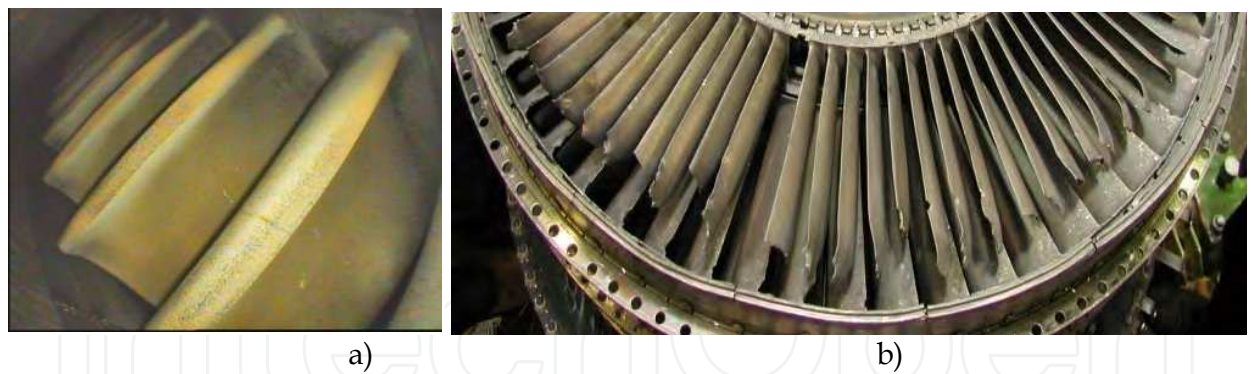
Fig. 5. Failures to gas turbine rotor blades caused by (Reports, 2000-2010):
a) – fatigue cracking of leading edge, b) – fatigue fracture located at the blade’s locking piece

Fatigue of material of turbine rotor blades is caused by a sum of loads due to: non-uniform circumferential distribution of the exhaust gas stream leaving the combustion chamber and its unsteadiness in time, non-uniformity of the exhaust gas stream leaving the nozzle, and excitations from the structure of, e.g. the turbojet engine. The dynamic frequency of free vibration attributable to the rotor blade of variable cross-section depends on the centrifugal force, therefore, it is a function of rotation speed. It also depends on temperature of the working agent affecting the longitudinal modulus of elasticity (Young's modulus) of the material. The most hazardous are instances of turbine blade operation at resonance of the 1st form of vibration (single-node form). Such circumstances usually lead to fatigue cracking and finally, the blade breakaway (Fig. 5).

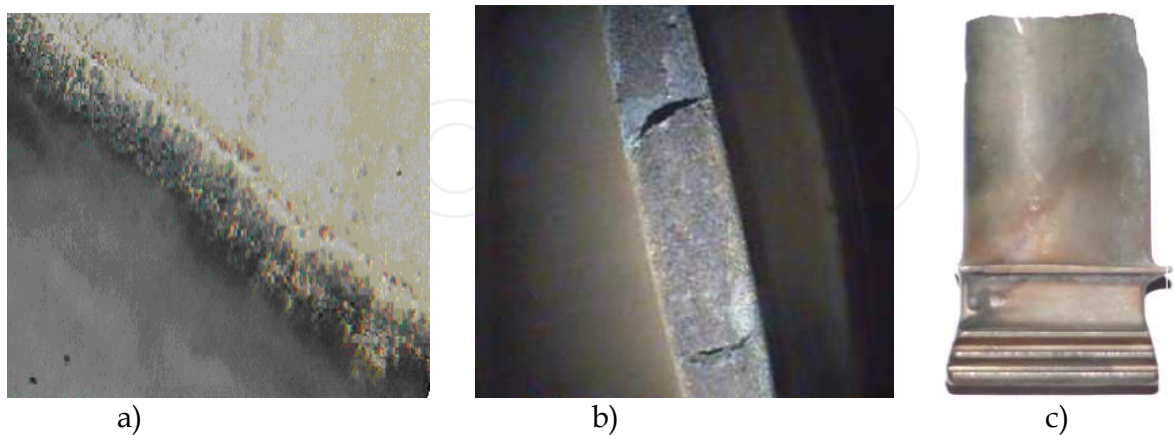
Fig. 7. Characteristic forms of failures caused by overheating of blade material (Reports, 2000-2010): a- partial melting of blade’s trailing edge, b) – cracks on blade’s leading edge, c) – breakaway of the blade (Błachnio, 2010)

Another very frequent cause of failures to vanes and blades is overheating of material combined with thermal fatigue caused by the excessive temperature and prolonged exposure time as well as by chemical activity of the exhaust gas (Fig. 7, Fig. 8). The high-temperature creep resistance of alloys for turbine vanes and blades is closely related with the strengthening γ' phase. The γ' phase is a component of the material's microstructure that has the strongest effect upon properties of superalloys. The shape, size and distribution of γ' phase particles are factors of crucial importance to mechanical properties of the material.

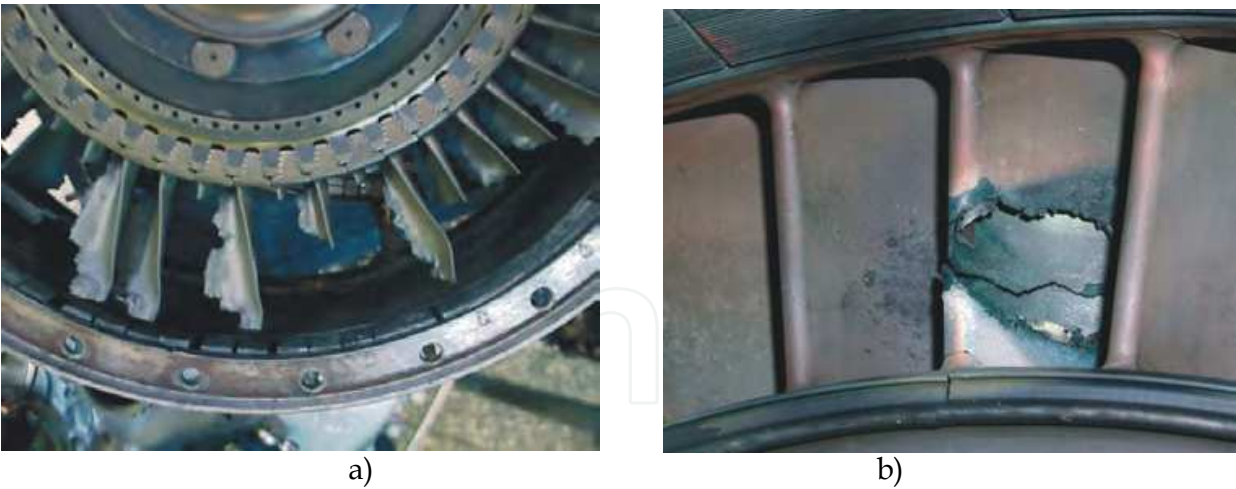
Fig. 8. Characteristic forms of failures to gas turbine caused by long-lasting excessive temperature of exhaust gases (Reports, 2000-2010) : a) – burn-through of turbine rotor blades, b) – melting of a nozzle vane

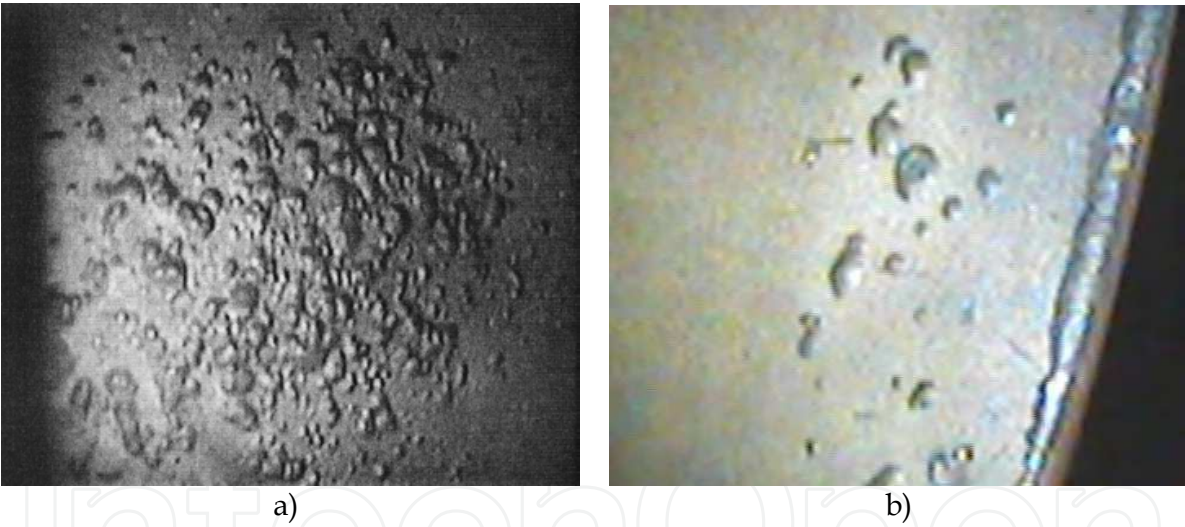
Fig. 9. Failures to turbine blades operated in the seashore environment, caused by chemical impact of exhaust gases (Reports, 2000-2010): a) – on blade surface, b) – on blade leading edge

Failures in the form of high-temperature corrosion of turbine vanes and blades are first and foremost caused by chemical compounds found in both the exhaust gas and the environment, e.g. moisture in seashore environment. Sulphur compounds in aircraft fuel, e.g. the Jet A-1 type (F-35) may contain not more than 0.3% of sulphur per a volume unit. This, in turn, may increase the content of SO_2 in the exhaust gas up to as much as approx. 0.014% (Nikitin, 1987; Paton, 1997; Swadźba, 2007). Hence the conclusion: the higher content of this element in aircraft fuel, the higher amount of SO_2 and SO_3 in the exhaust gas. It brings about the hazard of chemical corrosion on the surfaces of vanes and blades, which additionally may be caused by improper organization of the fuel combustion process. Chemical corrosion of turbine vanes and blades results in the formation of surface corrosion pits and, consequently, in the blade cracking and sometimes fracture.

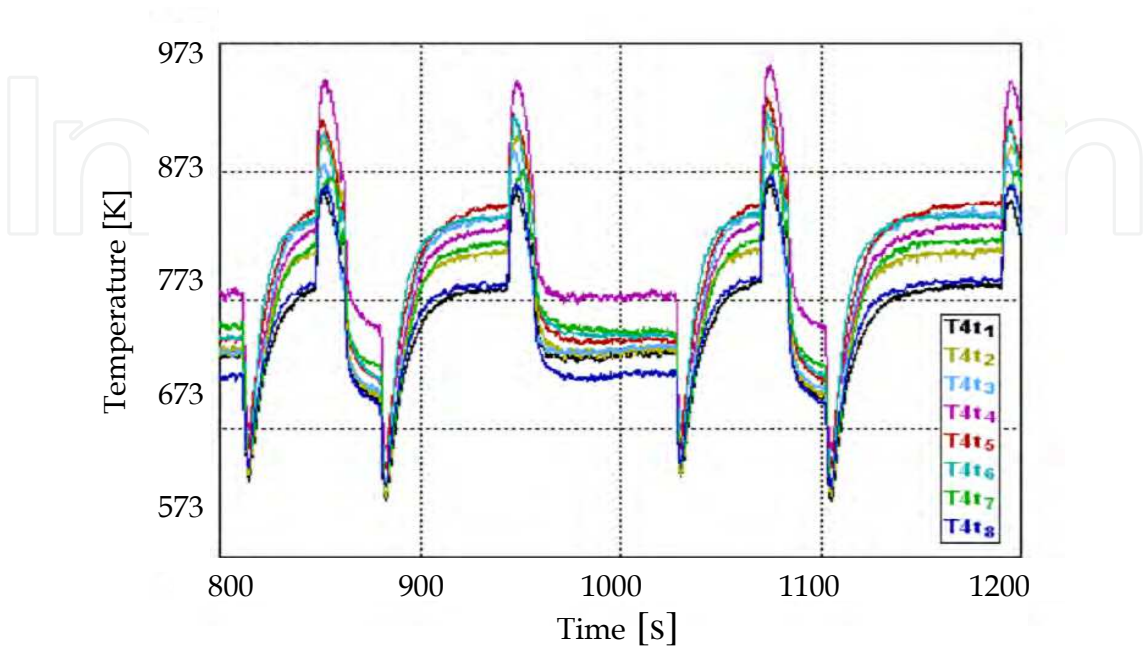
Fig. 11. Instantaneous circumferential non-uniform temperature T_4 distribution measured with 8 thermoelements (T_{4t_1} - T_{4t_8}) located behind the turbine; measurements taken at increasing/decreasing rotational speeds

uniform circumferential temperature distribution (Fig. 11). One of possible causes of non-uniform temperature distribution downstream the turbine lies in the improper fuel atomization due to excessive carbon deposit on fuel injectors (Fig. 12).

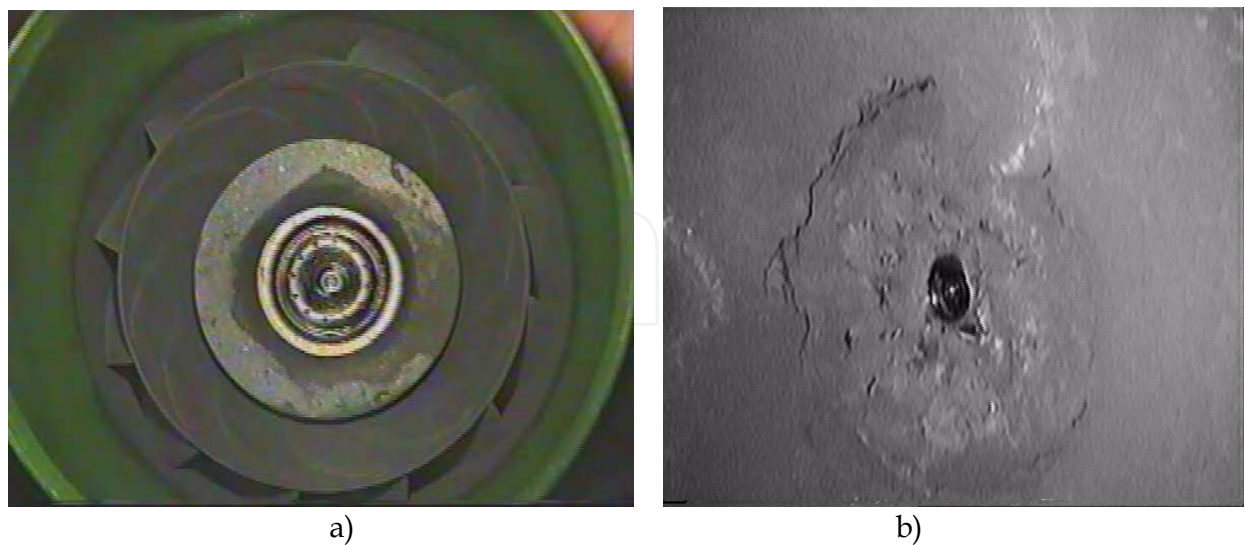
Fig. 12. Condition of combustion-chamber injectors: a) – clean, b) – polluted with carbon deposits from fuel

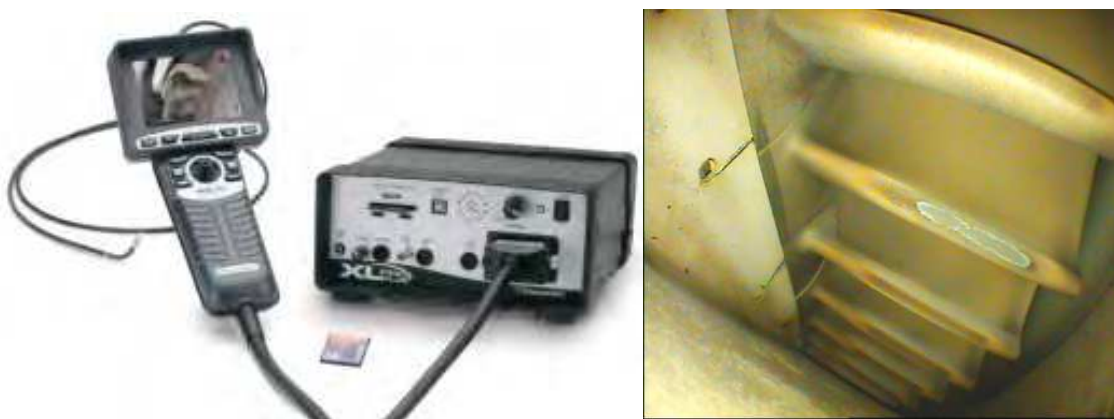
Fig. 13. An industrial videoscope and an image of gas turbine blades condition (Reports, 2000-2010)

Any decision on whether the engine needs repair is taken by a diagnostic engineer who performs visual inspection with, e.g. a videoscope (Fig. 13) and is able to inspect and diagnose condition of difficult of access turbine components. The condition assessment is performed using a recorded image of the inspected component's surface and comparing it with pattern images of surfaces of serviceable and unserviceable (fit/unfit for use) components, e.g. analogous vanes and blades of the turbine. An experienced diagnostic engineer is capable of assessing the risk that failures such as dents, melting of materials, fatigue cracks or corrosion may pose. However, the assessment of, e.g. overheated material is much more difficult as it has to be based on the colour of the blade surface (Fig. 14).

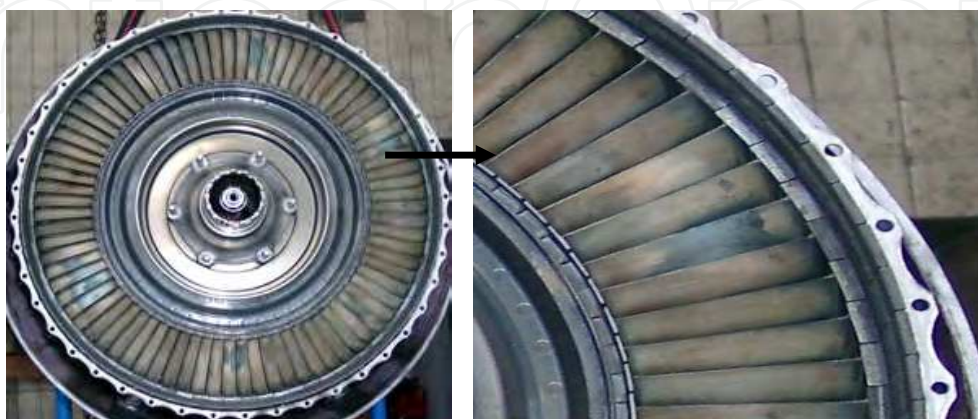
Fig. 14. A gas turbine with visible changes in colour on surfaces of vanes – the evidence of different degrees of vane overheating (Reports, 2000-2010)

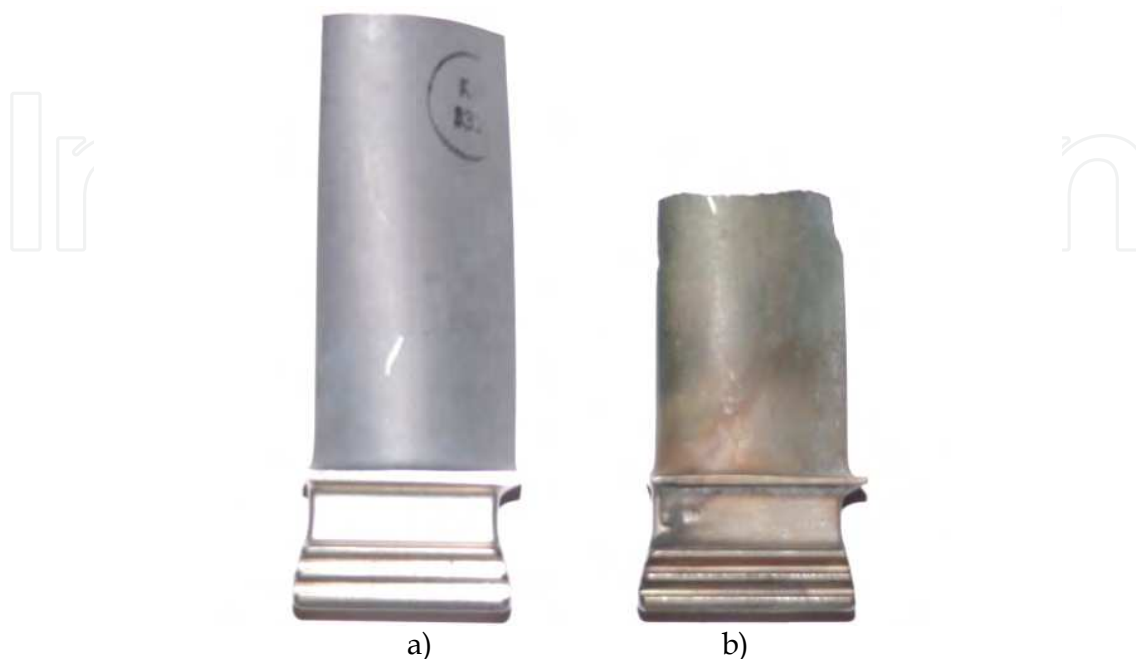
Fig. 15. Gas turbine blades : a) – the new one, b) – the in-service damaged one, magn. x0.75

Subject to examination were gas turbine blades with in-service damages (Fig. 15). Changes in the microstructure of a blade that has already been operated can be assessed on the basis of changes demonstrated by a new blade subjected to temperature within a specified range, and exposed to this temperature for sufficiently long time.

Metallographic examination of specimens taken from an overheated blade (Fig. 15b) made it possible to find out degradation of the blade microstructure. Numerous microcracks along grain boundaries and transcrystalline ones were detected nearby the blade fracture (Fig. 20a). According to the studies (Okrajni & Plaza, 1995; Sieniawski, 1995; Tomkins, 1981), such decohesion results from the creeping and fatigue processes. The metallographic microsection enabled detection of the γ' phase coagulation. The coagulation and the precipitates dissolving effects intensify nearby the blade surface. In addition, fine-dispersion secondary precipitates are observed; the presence thereof increases susceptibility of the alloy to brittle cracking (Fig. 20a). Extension of the γ' phase in the alloy results in the change of phase shapes from cuboidal (Fig. 16b) to lamellar ones (Fig. 20b) as well as substantial extension of the size of this phase as compared to a new blade.

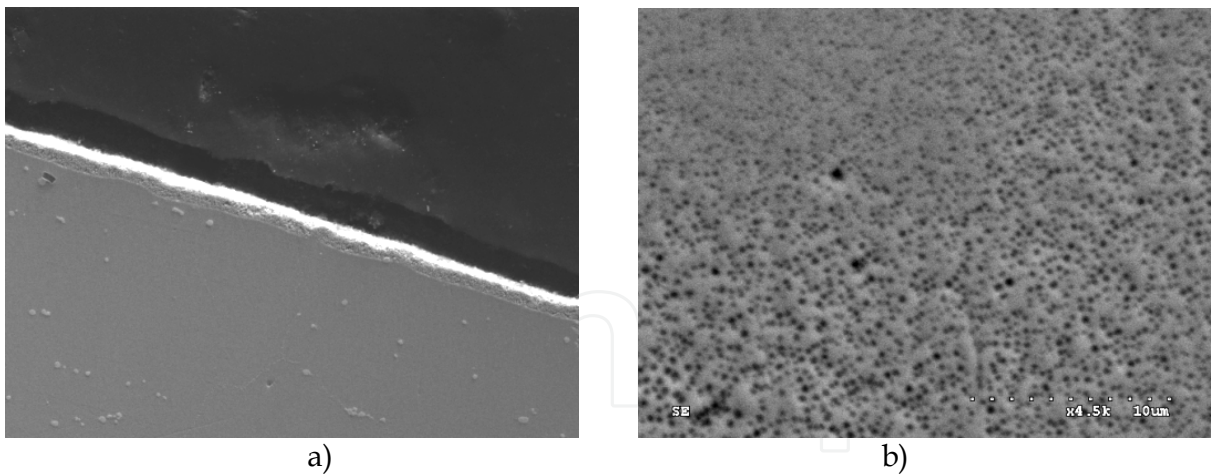
Fig. 16. SEM microstructure of a new blade: a) – aluminium coating, magn. x450, b) - EI 867-WD alloy, magn. x4500

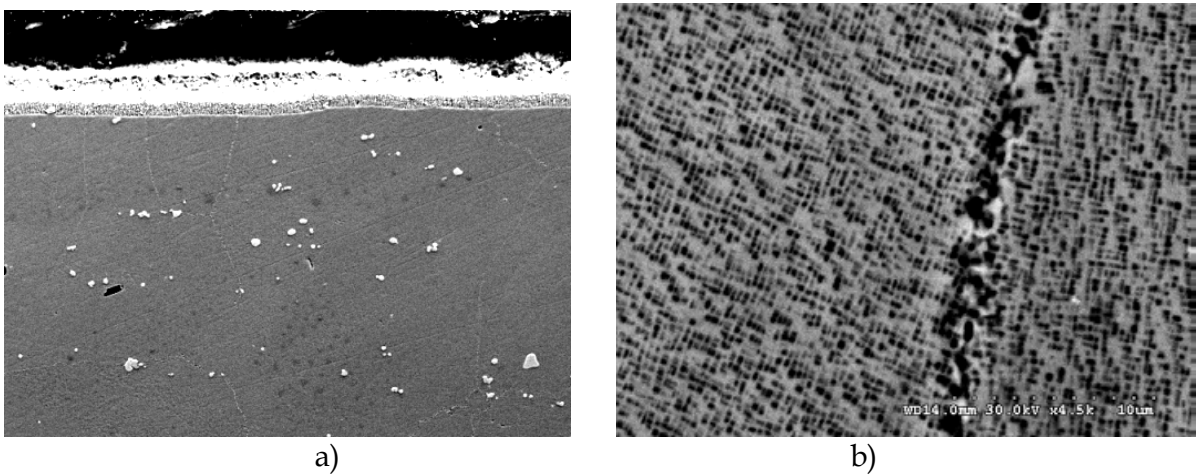
Fig. 17. SEM microstructure of blade material subjected to soaking in a furnace at 1223 K: a)– aluminium coating, magn. x450, b) - EI 867-WD alloy, magn. x4500

The soaking at 1223 K results in the initiation of changes in precipitates of the strengthening γ' phase: the particles start changing their shapes from cuboidal to lamellar (Fig. 17b). On the other hand, the soaking at 1323 K results in evident changes in shapes of precipitates of the strengthening γ' phase to lamellar (Fig. 18b). At the same time, the surface roughness and thickness of the aluminium coating increase at both temperatures. These properties get intensified as the temperature growth. One can see the non-linear extension of the coating in function of the soaking time and temperature, both in the surface-adjacent area and in deeper layers where diffusion of aluminium had already occurred. The extension results in lower density of the material due to excessive porosity, which proves conducive to the penetration by the exhaust gases particles and leads to more intense destructive effects of both the thermal and chemical treatment upon the coating and the parent EI 867-WD alloy.

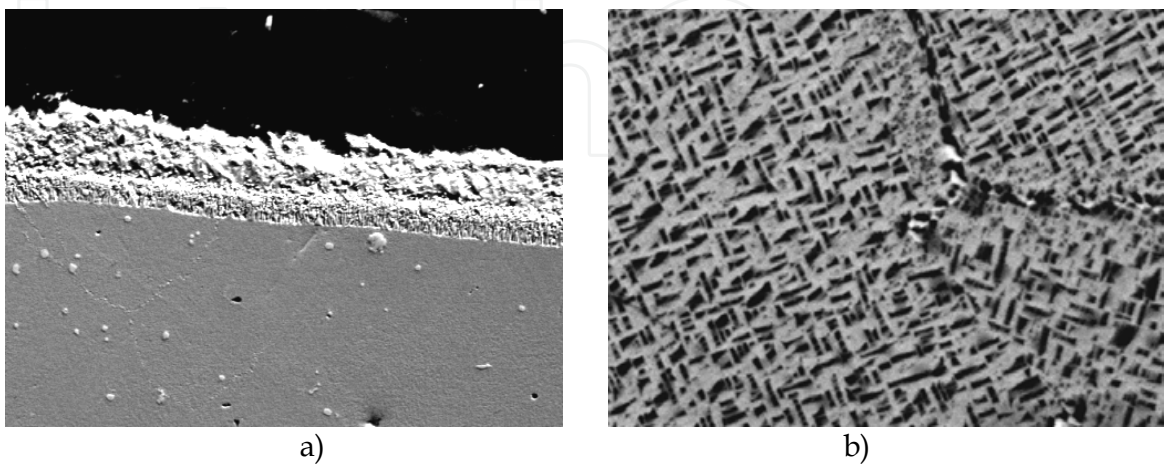
Fig. 18. SEM microstructure of material subjected to soaking in a furnace at 1323 K: a) - aluminium coating, magn. x450; b) - EI 867-WD alloy, magn. x4500

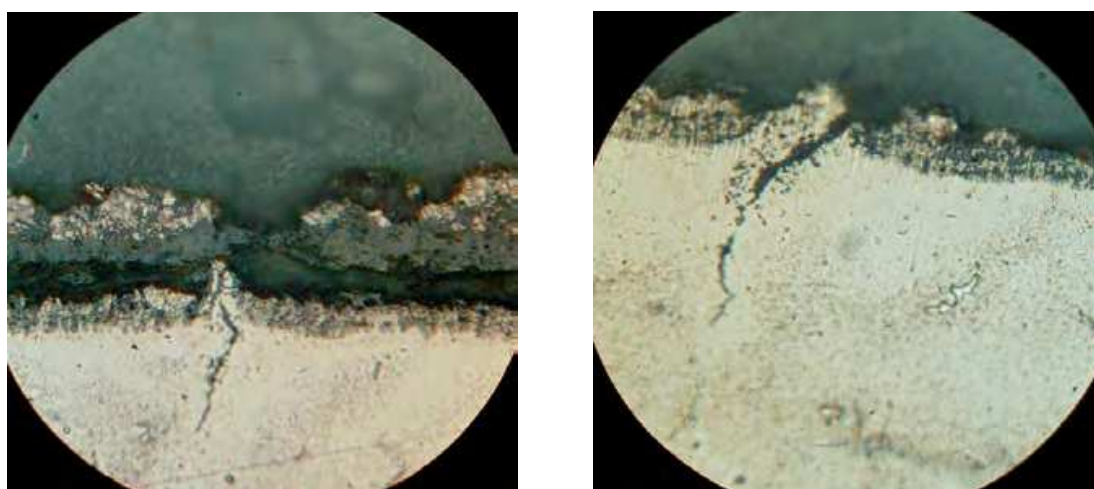
Fig. 19. Microstructures of exemplary in-service damages to gas turbine blades, magn. x500

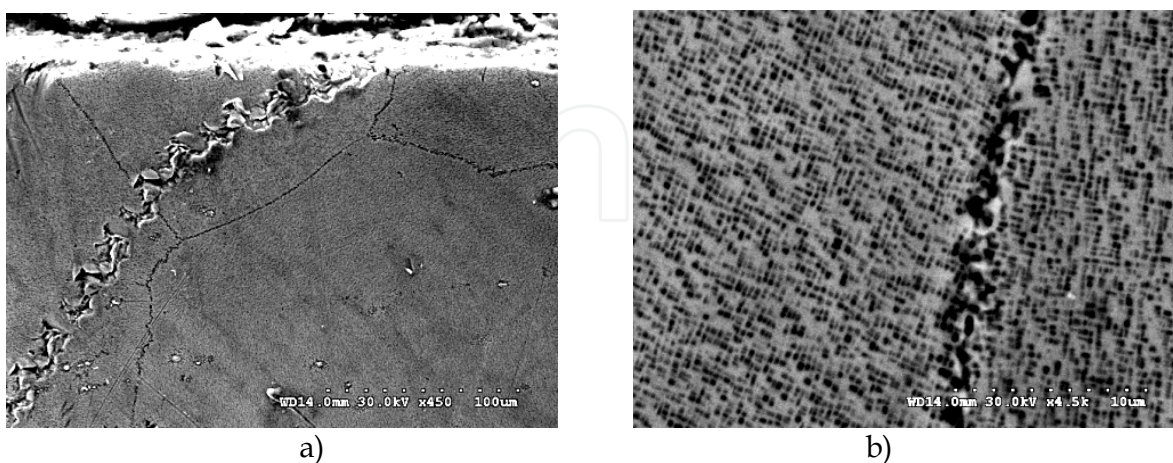
Fig. 20. Results of examination of a gas turbine blade damaged due to long-lasting operation: a) - SEM microstructure for the EI 867-WD alloy at fracture, one can see a crack of the transcrystalline (TC) nature, magn. x450, b) – SEM microstructure of the alloy with visible changes in size and shape of the γ' phase, magn. x4500

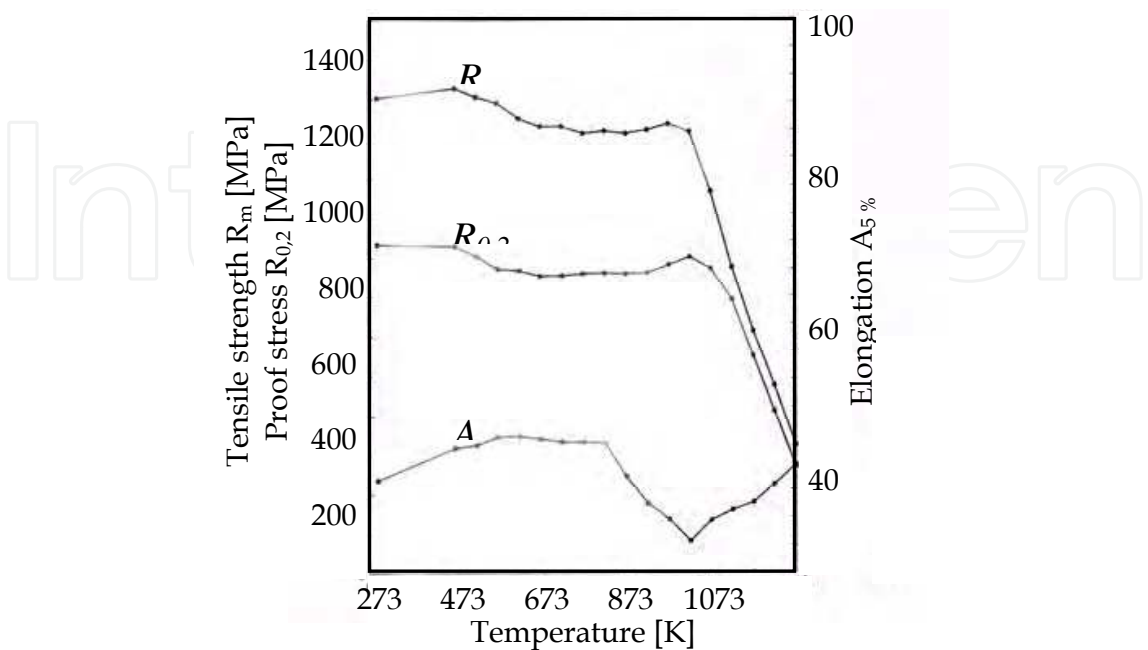
Fig. 21. Alterations in mechanical properties demonstrated by the EI-867 alloy vs. temperature (Poznańska, 1995)

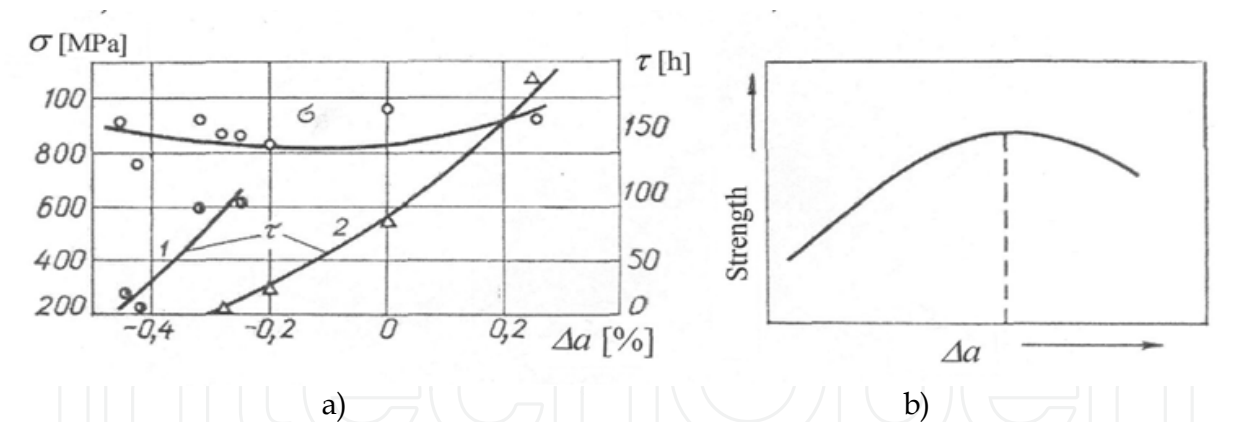
Fig. 22. Effect of misfit between parameters of the crystallographic lattice for γ and γ' phases of a nickel alloy onto (Paton, 1997): a) strength limit (at 293 K) and durability limit (at 1373 K and $\sigma = 80$ MPa), b) - strength of a two-phase system

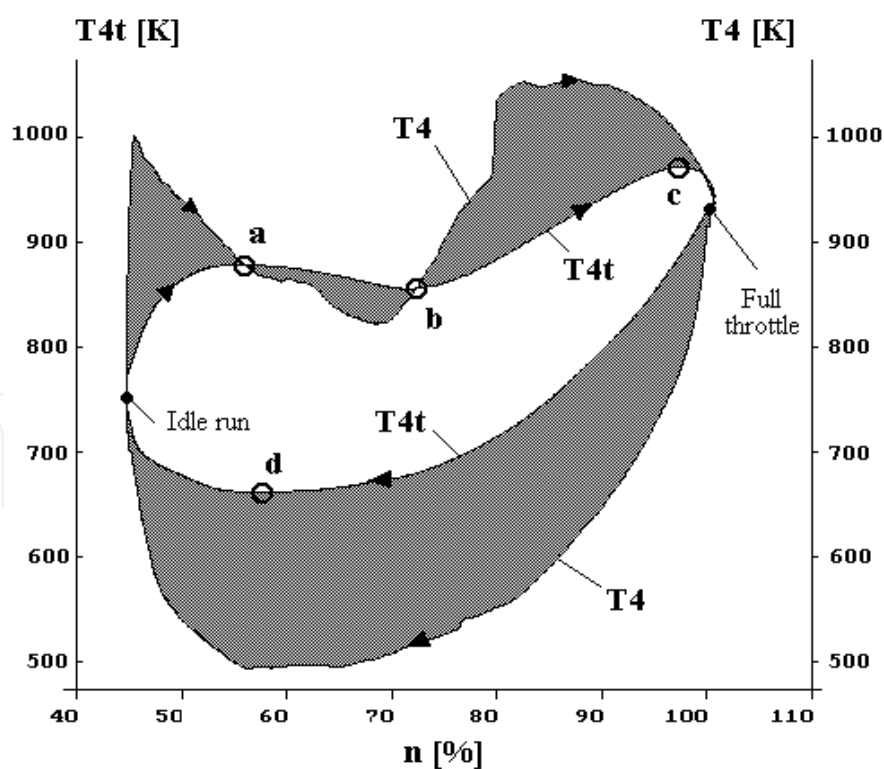
Fig. 25. Comparison between phase cycles of temperatures measured directly by means of a set of 8 thermoelements (T_{4t}) and measured indirectly (T_4) by a non-linear observer during full acceleration and deceleration of the engine under test at ground conditions

The analysis of cycles plotted in Fig. 25 serves as the proof that the method that has already been used for mathematical modeling of dynamic properties attributable to thermoelements (Michalski & Eckersdorf, 1986; Wiśniewski, 1983) is inadequate. The diagrams for T_{4t} and T_4 temperatures intersect one another only for the phase of full acceleration, i.e. at the ' a ' and ' b ' points, whereas a slight discrepancy is observed for the ' c ' point.

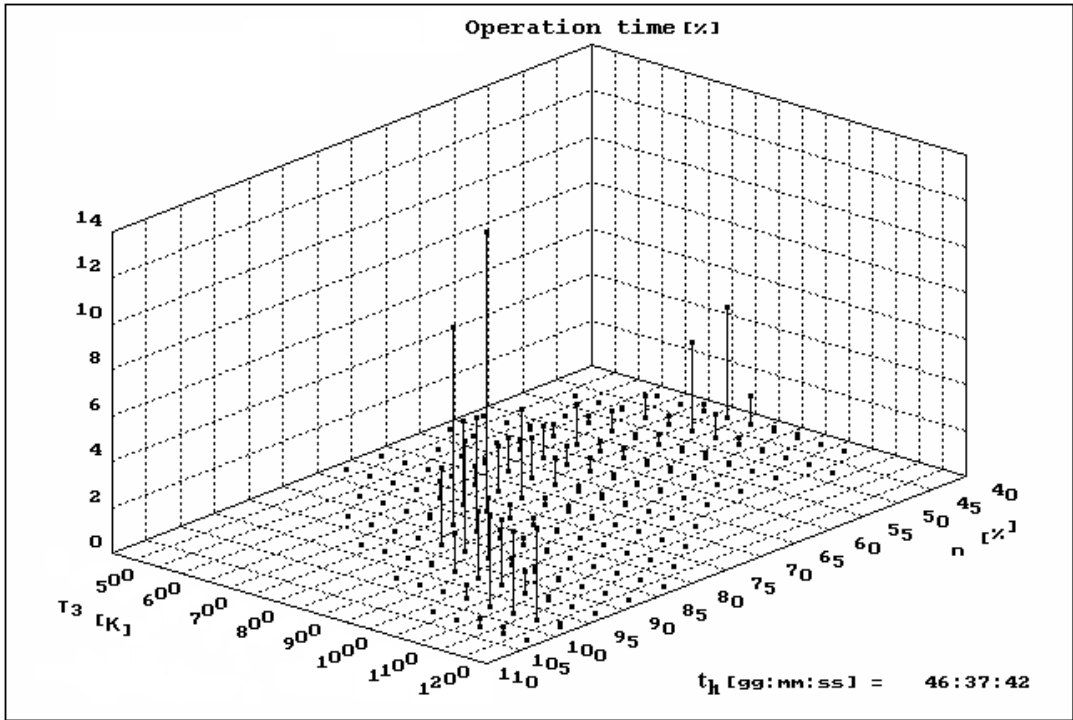
Fig. 28. Spectrum distribution for the average total temperature for the working medium at the outlet of the combustion chamber (calculated with use of the non-linear observer of the engine) and rotation speed

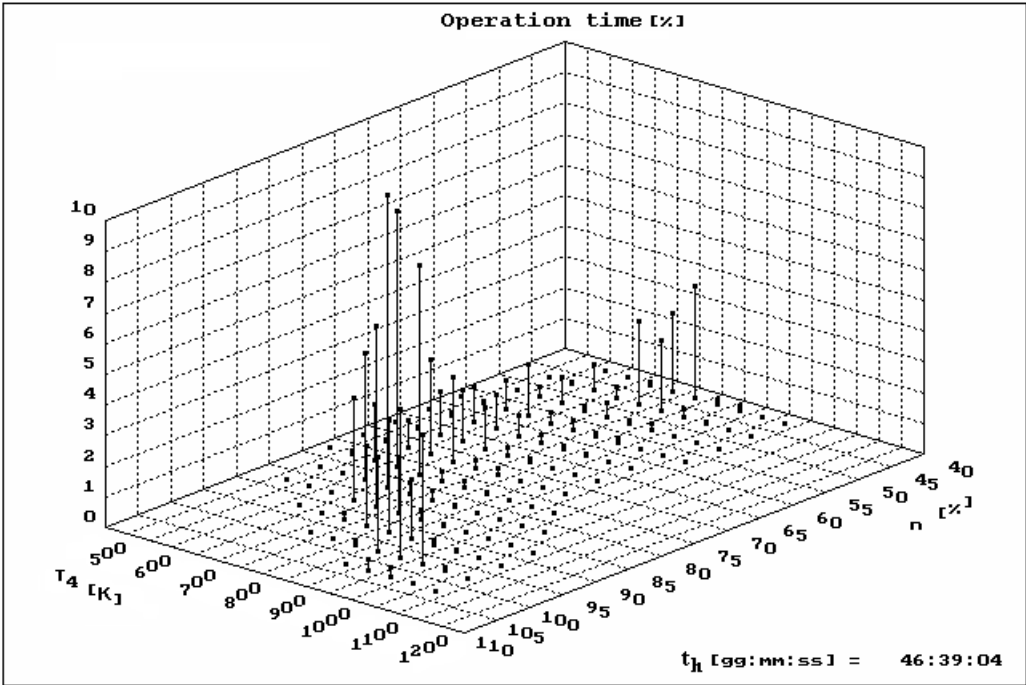
Fig. 29. Spectrum distribution for the average total temperature of the working medium inside the engine nozzle (calculated with use of the non-linear observer of the engine) and rotation speed

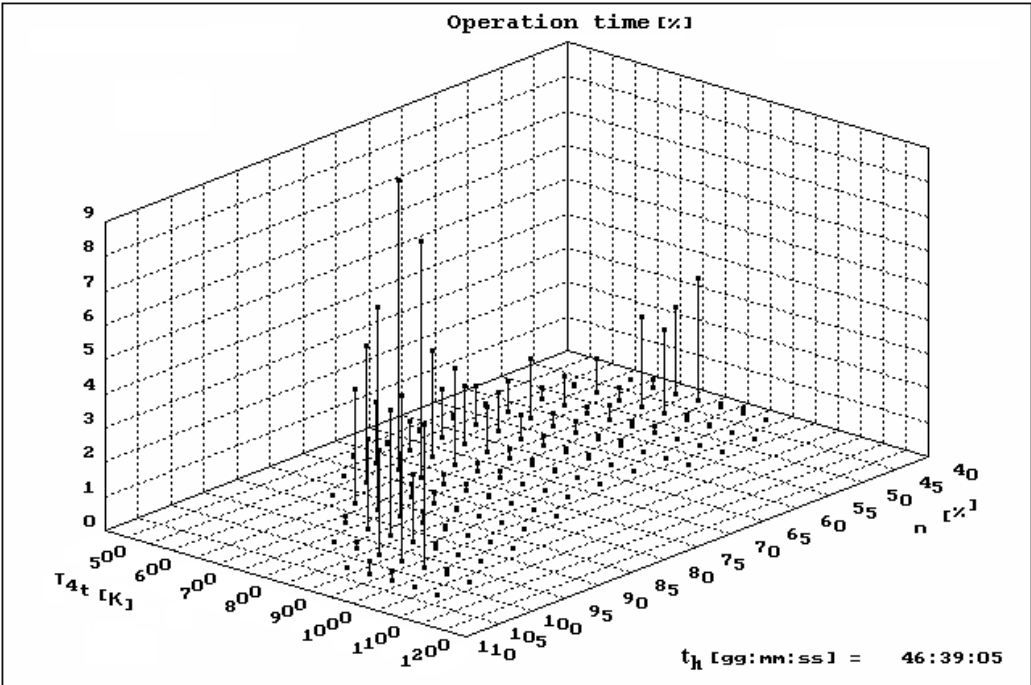
Fig. 30. Spectrum distribution for the average temperature of the working medium inside the engine nozzle (measured with use of set of thermoelements) and rotation speed

In addition, Fig. 30 shows the histogram for the rotation speed (n) and the gas temperature (T_{4t}) inside the engine jet and measured directly with use of a set of thermoelements.

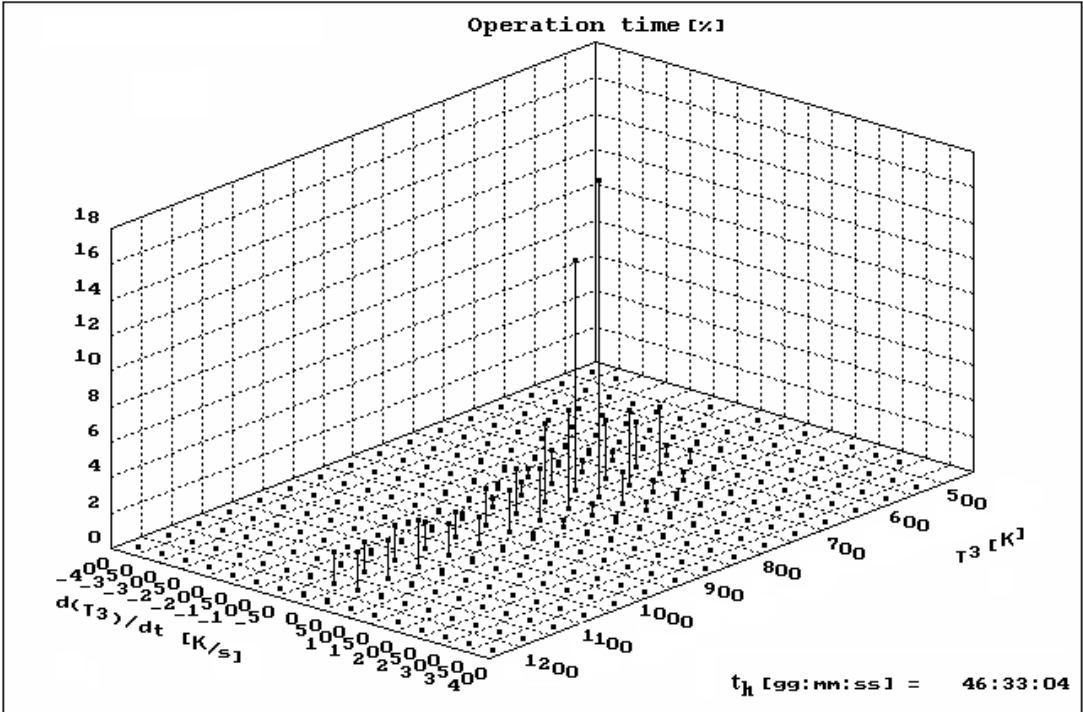
Fig. 31. Spectrum distribution for variations of the average total temperature of the exhaust gases at the outlet of the combustion chamber (calculated with use of the non-linear observer of the engine) and rotation speed

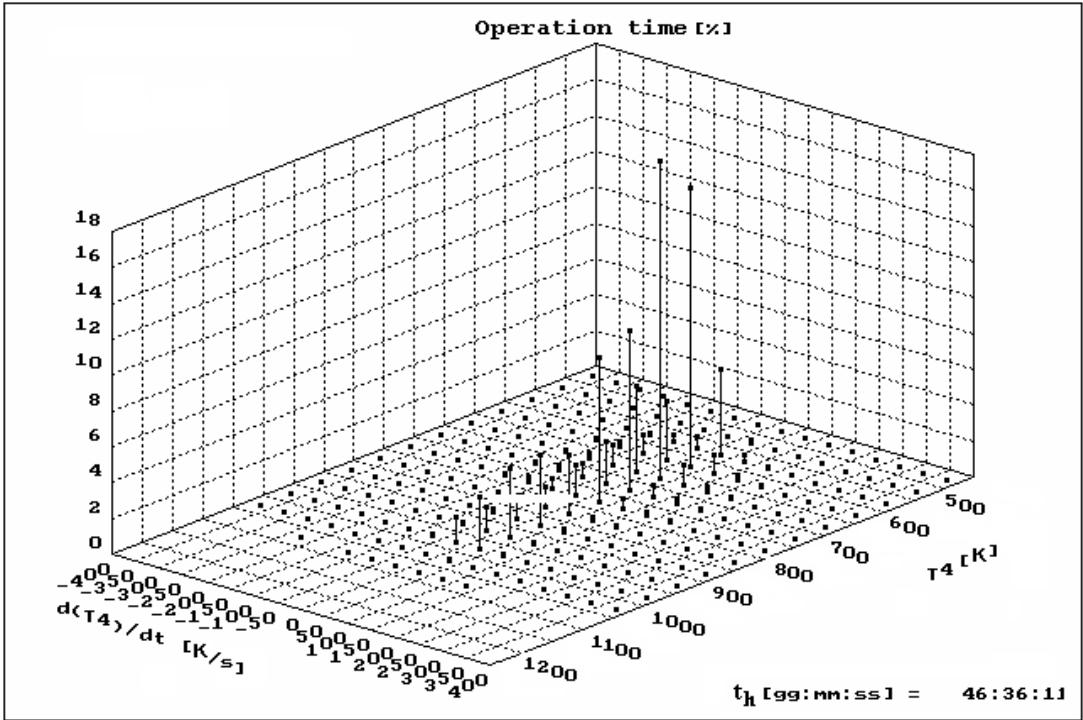
Fig. 32. Spectrum distribution for variations of the total temperature of the exhaust gases inside the engine nozzle (calculated with use of the non-linear observer of the engine) and rotation speed.
