Application of Remote Sensing for Tsunami Disaster

Anawat Suppasri¹, Shunichi Koshimura¹, Masashi Matsuoka²,
Hideomi Gokon¹ and Daroonwan Kamthonkiat³

¹*Tsunami Engineering Laboratory, Disaster Control Research Centre,
Graduate School of Engineering, Tohoku University*

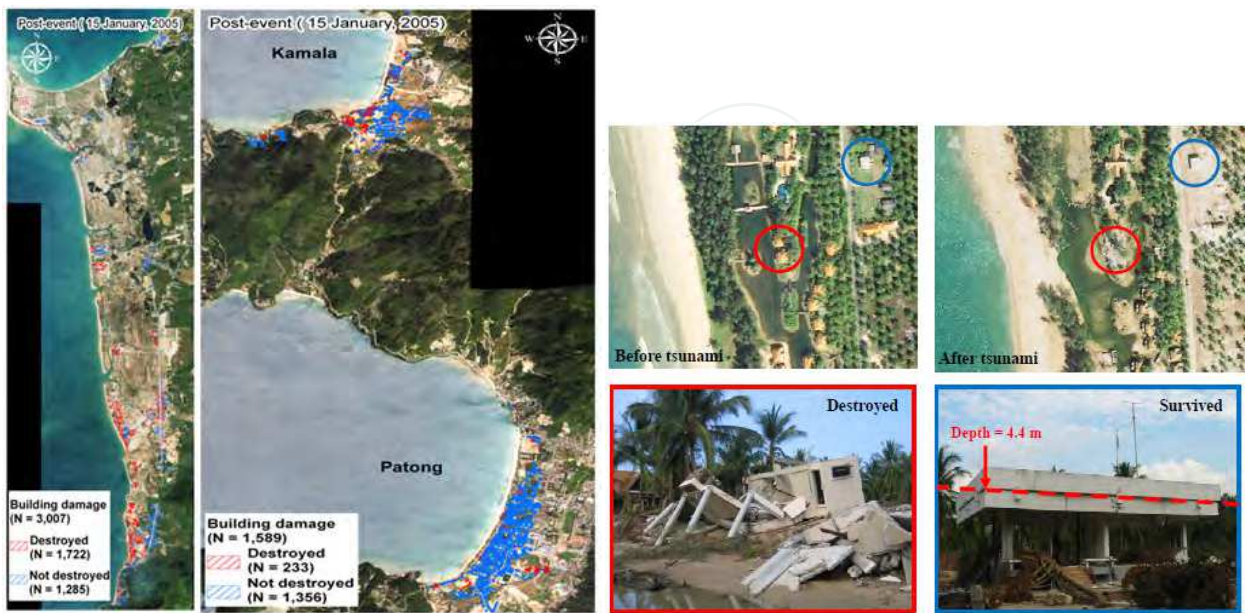
Fig. 10. Visual damage inspection results in Phang Nga and Phuket, Thailand

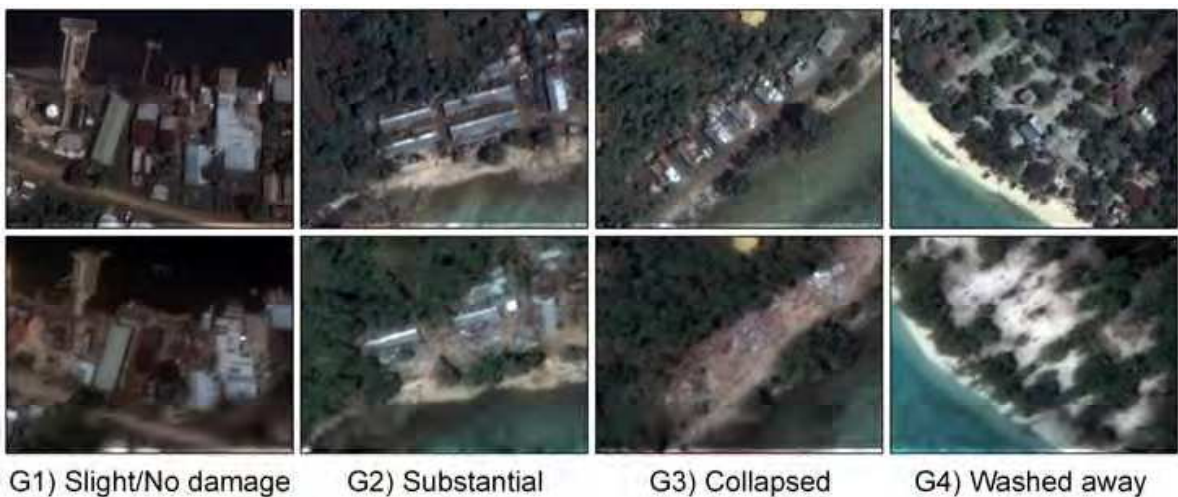
Fig. 11. The structural damage interpretation is divided into four classes: slight/ no damage, substantial damage, collapsed and washed away

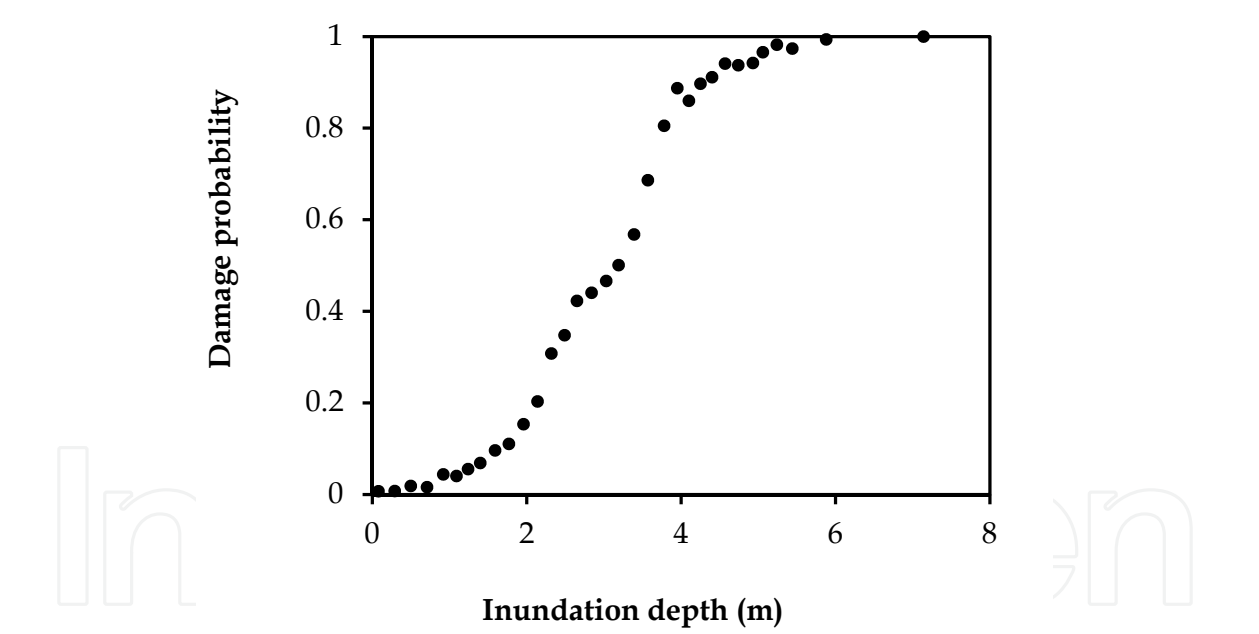
Fig. 19. The plot of damage probabilities and the median values of inundation depths that were compiled from sample data

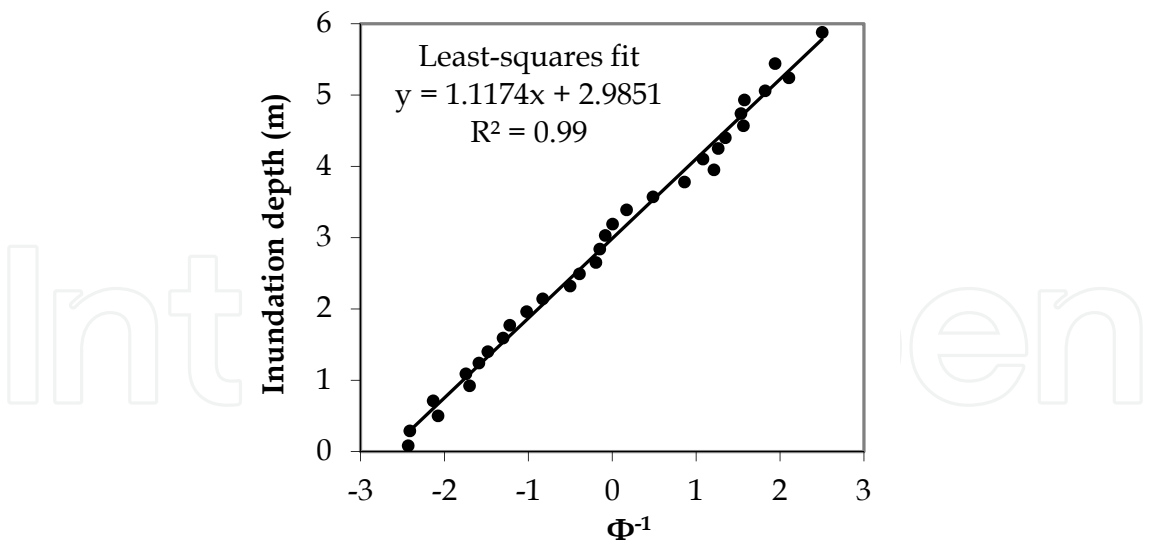
Fig. 20. An example of the plot on normal probability paper

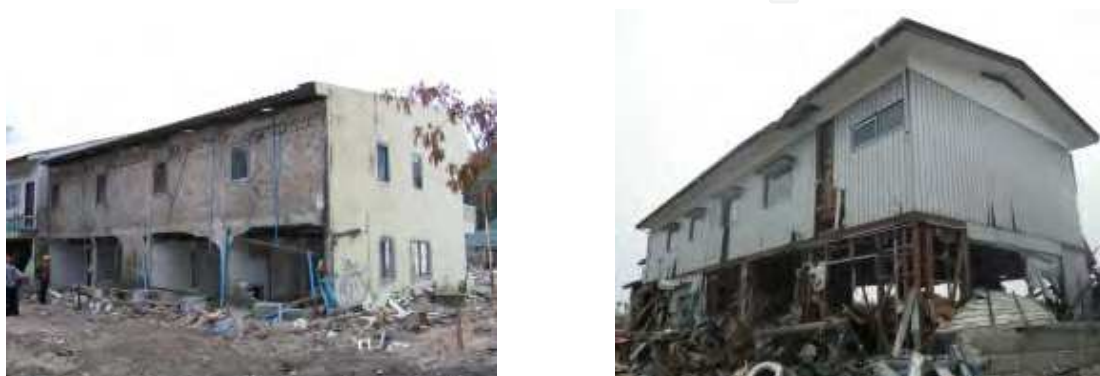
Fig. 25. Examples of building damage in the case of the 2004 Indian Ocean tsunami in Thailand and the 2011 Tohoku tsunami in Japan
