Recent Landslide Damming Events and Their Hazard Mitigation Strategies

Ahsan Sattar and Kazuo Konagai

Advances in Geotechnical Earthquake Engineering - Soil Liquefaction and Seismic Safety of Dams and Monuments

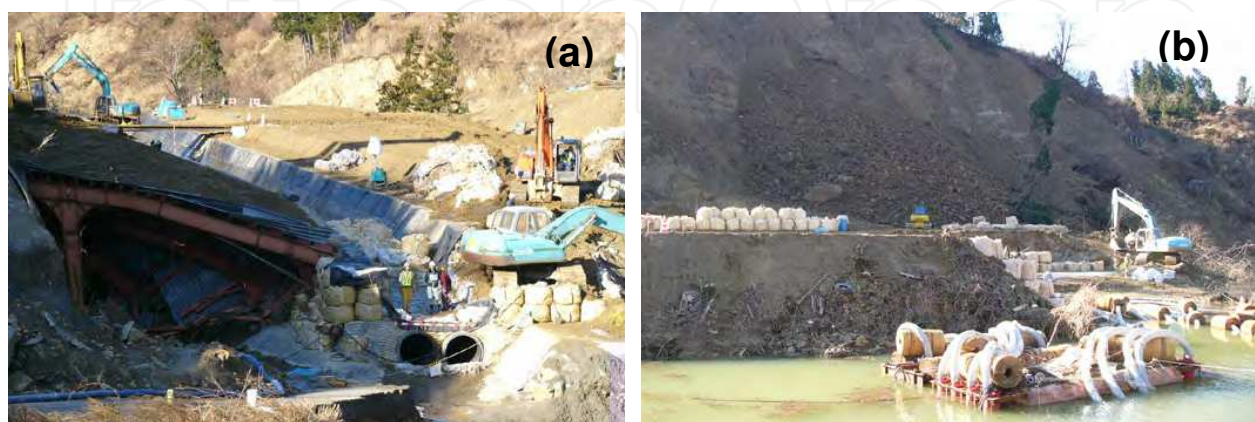
Fig. 4. Emergency works at Higashi Takezawa landslide dam. Photo taken on 20.12.2004 by Takeji & Tadashi, 2005

The following steps have been taken for stabilizing the landslide mass: twelve pumps were installed first to lower and keep the lake water level 11.5 m below the overflow point. In addition, the outflow level was raised by 3 m with sand bags at the outlet. Keeping in view the pumping power for this temporary system, diversion pipes were installed in case water overtopped the landslide mass (Fig. 4). Finally, a 280m long concrete-faced spillway was constructed with its cross-section large enough for snow melts.

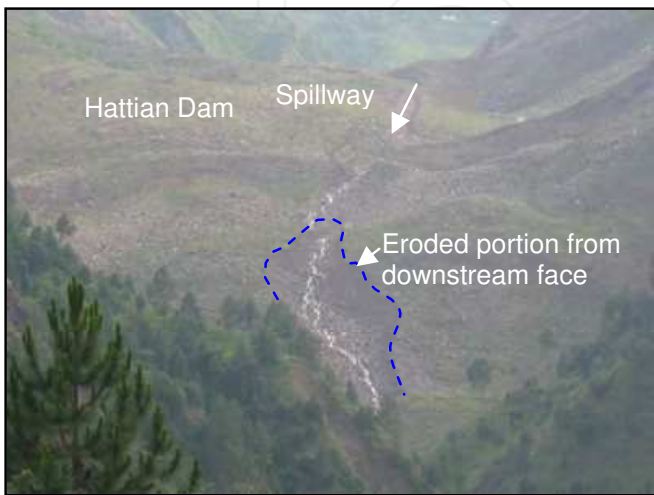
Fig. 7. Front view of the Hattian landslide mass, showing the downstream face erosion.

Gradual toe erosion was initially observed, which was then followed by a rapid head cutting erosion of the downstream face of the dam (Fig. 7). On 9th February 2010, the water of Karli Lake breached the debris dam after five days of incessant rain, and the breaching drained about 36 million m^3 of water from the lake. According to the back analysis conducted by Konagai, et al., (2011) the peak outflow was about 5500 m^3/s . A moderate 32 mm/day rainfall was estimated on the day prior to the day of breaching. About 7.78 million m^3 of soil was estimated to have been eroded during the breaching event. The flushed debris mass was deposited along the Karli River. Fig. 9 shows the satellite image and profile of the Karli River before and after the breaching. A major portion of the eroded material is deposited over the approximately 2km downstream stretch from the dam along Karli River and less significantly beyond the stretch. The flow along the Karli River reached the depth up to 20 m. The debris deposit was about 40 m thick near the toe of the dam.

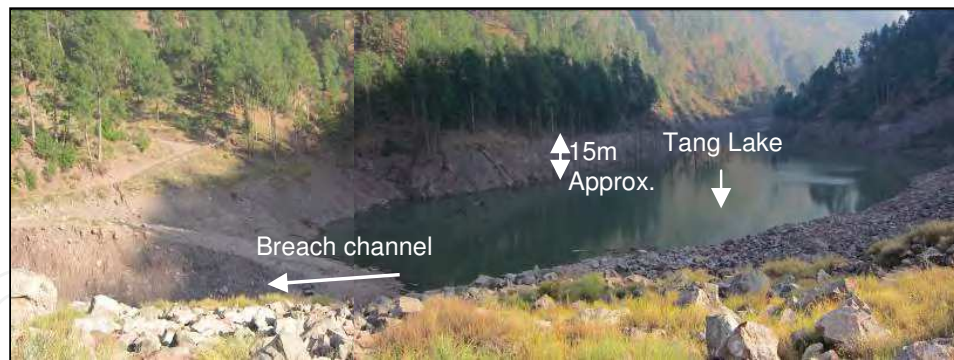
Fig. 12. Tang Lake after breaching (Photo taken on 6th Dec-2010). From Konagai et al., 2011

The Tang Lake breached during the monsoon rains (July-August) of 2010. In the breaching process, the water from Tang Lake eroded the north-eastern end of the landslide lobe, which had been covered with boulders segregated up at the time of deposit, and approximately 15 m depth of the lake water was drained leaving 1.9 million m³ water in the lake (Fig. 12).
