# Resolving the Difficulties Encountered by JPL Interplanetary Robotic Spacecraft in Flight

Paula S. Morgan

*Jet Propulsion Laboratory, California Institute of Technology,  
USA*

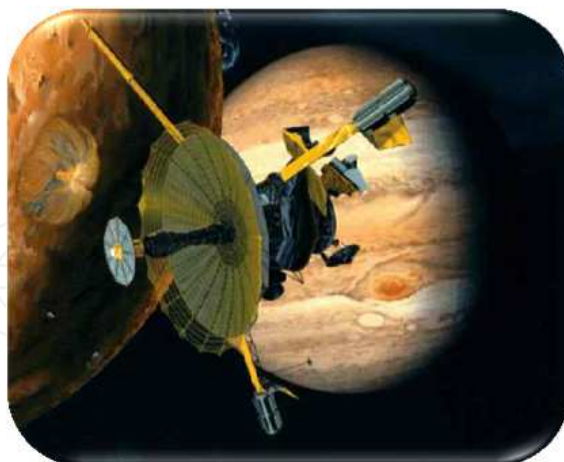
Fig. 1. JPL's Galileo Spacecraft: Mission to Jupiter.

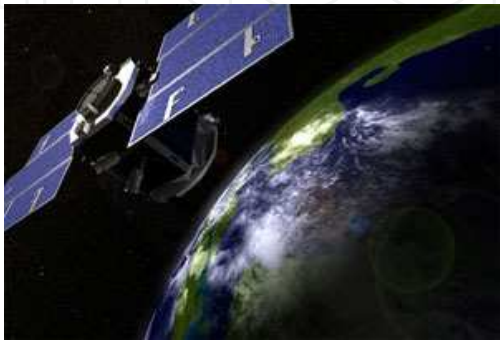
**CloudSat:** Earth Orbiting Satellite  
**Standard FP:** 3 Safe-Mode Responses  
5 Under-voltage Responses  
Memory Scrubber & Bus FP  
**Unique FP:** Significant computer & thermal FP

Fig. (4a). CloudSat Spacecraft FP Allocation.    Fig. (4b). Stardust Spacecraft FP Allocation.

Figures (4a) through (4d) depict four JPL spacecraft designs with quite different mission objectives, which employ typical and mission unique FP (Ball Corp., 2001; JPL, 1997, 2005).

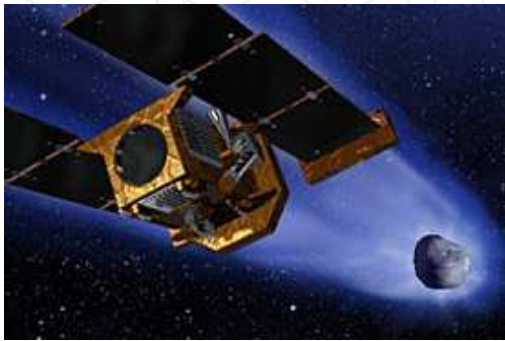
**Stardust Spacecraft:** Inner Solar System; Comet Explorer  
**Standard FP:** 1 Safe-Mode Response  
1 Under-voltage Response  
1 Command Loss Response  
Memory Scrubber & Bus FP  
**Unique FP:** Some computer & thermal FP

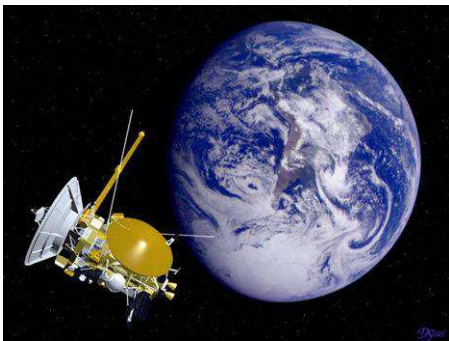
<b>Cassini Spacecraft:</b> Outer Solar System Explorer	<b>Voyager Spacecraft:</b> <i>Interstellar Explorer</i>
<b>Standard FP:</b> 1 Safe-Mode Response	<b>Standard FP:</b> 1 Under-voltage Response
1 Post-Safe Mode Response	1 Command Loss Response
1 Under-voltage Response	<b>Unique FP:</b> Computer FP, attitude articulation and control computer FP, and radio unit FP
1 Command Loss Response	
Memory Scrubber & Bus FP	
<b>Unique FP:</b> Significant command & data processing computer FP, radio unit FP, thermal FP, fuel tank pressure FP, attitude articulation and control computer FP

Fig. (4c). Cassini Spacecraft FP Allocation.

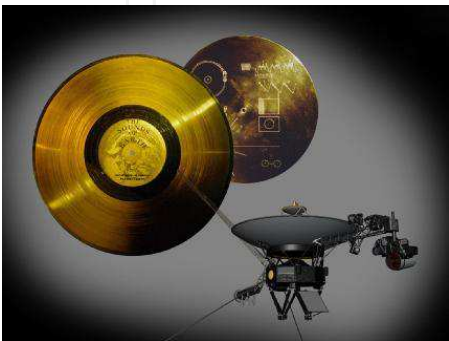
Fig. (4d). Voyager Spacecraft FP Allocation.

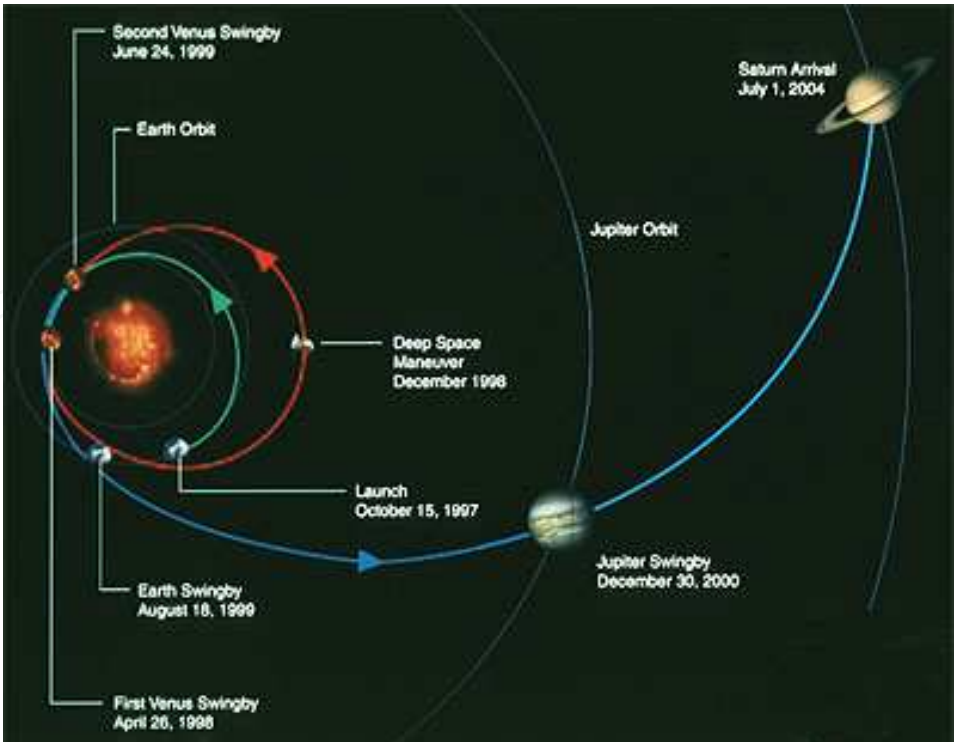
Fig. 5. Cassini’s Inner Planet Flyby Schedule.

During the 6.7 year cruise phase, several Trajectory Control Maneuvers (TCM) were performed using Cassini’s Main Engine (ME) and Reaction Control System (RCS) jets to guide the Spacecraft to its intended destination. Once near the Saturnian system, the “Saturn Orbit Insertion (SOI)” burn maneuver was implemented to slow the craft down so that it could be captured into Saturn’s orbit. This marked the beginning of its four-year Orbital Tour phase around Saturn’s complex system of moons which is shown in Figure 6. The probe was separated on Christmas Eve 2004, landing on the Titan moon in January 2005. The current end-of-mission plan is for a controlled 2017 Saturn impact (Smith & TPS, 2009).

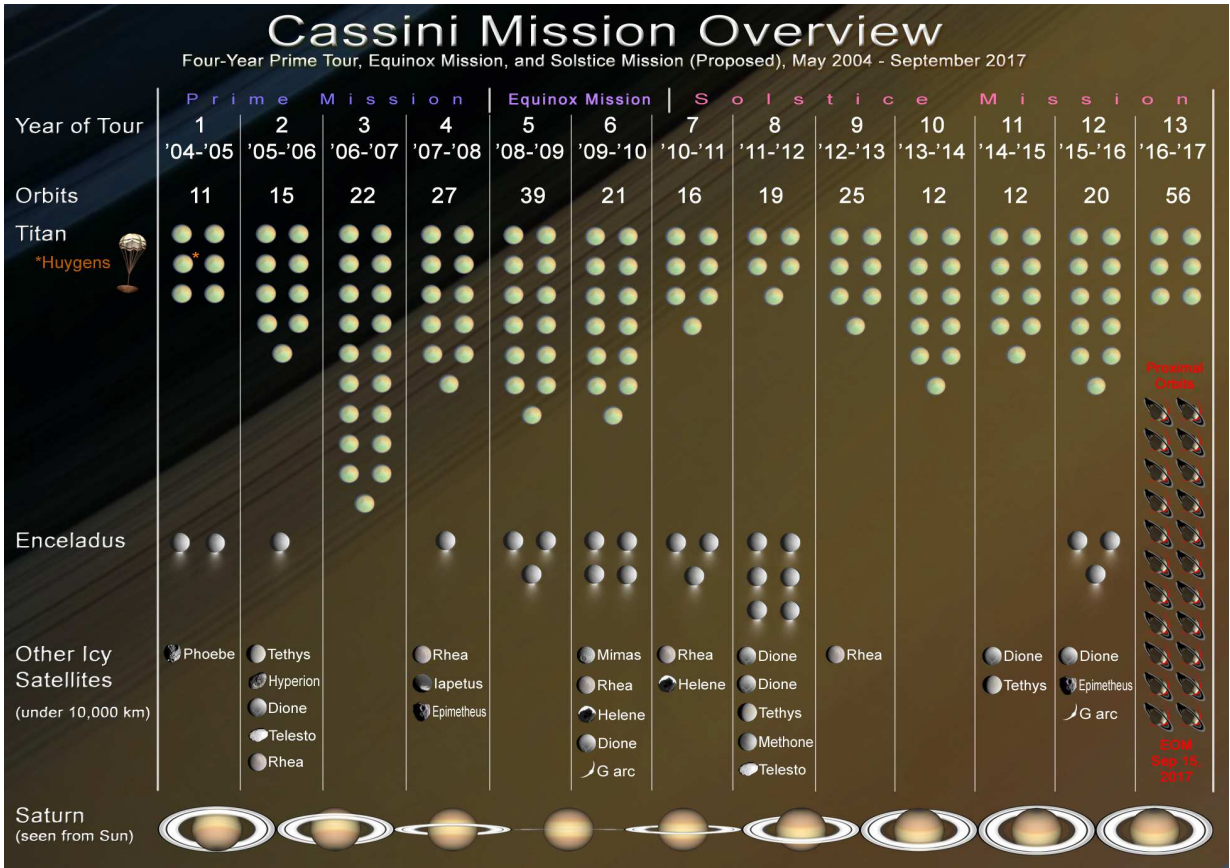
Fig. 6. Cassini’s Prime Mission, Extended Mission (XM), and Extended-Extended (XXM) Mission.

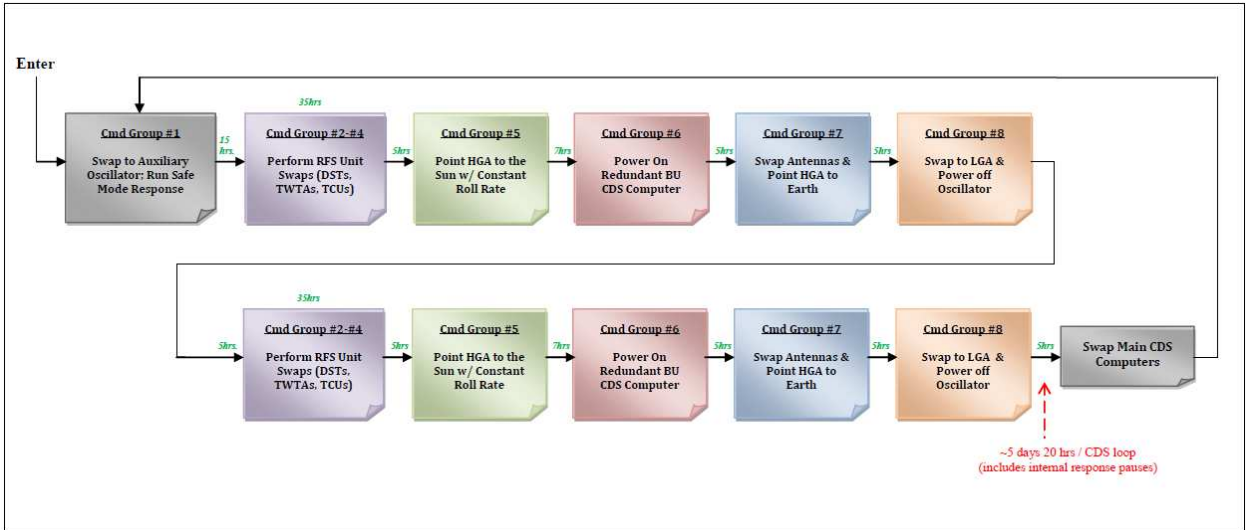
Fig. 7. Cassini’s Command Loss Response Chain for One CDS Cycle (Endless Loop Response).

Figure 7 illustrates how the Cassini Spacecraft’s Command Loss FP Algorithm addresses faults that can cause ground-spacecraft communications loss; this condition is referred to as “loss of spacecraft commandability.” A special “countdown timer” has been implemented into the onboard CDS FSW to keep track of the last time an uplink command was received from the ground operators. This timer decrements continuously (at one second intervals) and is reset back to its “default value” (several days for Cassini) each time an uplink command is received by the spacecraft. The extended absence of uplink commands will eventually lead to the monitor’s request for the response, since the timer will eventually decrement to “0”. Under these conditions, the assumption is that the spacecraft has experienced a failure where it can no longer receive commands.

Cassini contains redundant units for the Command & Data Computer (CDS), Radio Frequency (RFS) devices, (Deep Space Transponders, TWTAs, Telemetry Control Units (TCU)), as well as three antennas (one High Gain Antenna (HGA) and two Low Gain Antennas (LGA)). The Command Loss Response is divided up into “Command Groups” with “Command Pauses” installed after each group of commands has been executed. These pauses allow several hours (the equivalent of at least two RTLT periods) for the SOFS team to attempt re-acquisition of the spacecraft using the newly response-commanded spacecraft configuration. As shown in the figure, the first Command Group will select the auxiliary oscillator and execute the Safe-Mode response which turns off non-essential loads, commands the spacecraft’s High Gain Antenna to the Sun, and places the spacecraft in a known uplink & downlink state. A 15 hour wait period has been installed after this first Command Group to allow sufficient time for the SOFS team to re-establish the uplink, if possible, before hardware swaps begin. If this attempt is unsuccessful, the response will proceed with the next course of actions in Command Group #2 which is to start the series of RFS hardware unit swaps. Five to seven hour wait periods are installed between each subsequent Command Group to allow the SOFS team adequate time to send commands to the spacecraft to re-establish the uplink on the new commanded configuration. At the end of the response chain (approx. 5 days 20 hrs), a swap to the redundant CDS is initiated and the

response will activate on the other computer’s FSW (the response runs endlessly until an uplink command is received by the ground). The goal of Command Loss FP is to perform hardware swaps and/or re-command the S/C attitude until the ground acquisition is restored. Once the spacecraft successfully receives a command from the ground and the uplink has been re-established, the response will terminate and reset its countdown timer, thus leaving the spacecraft on the last successfully commanded configuration.

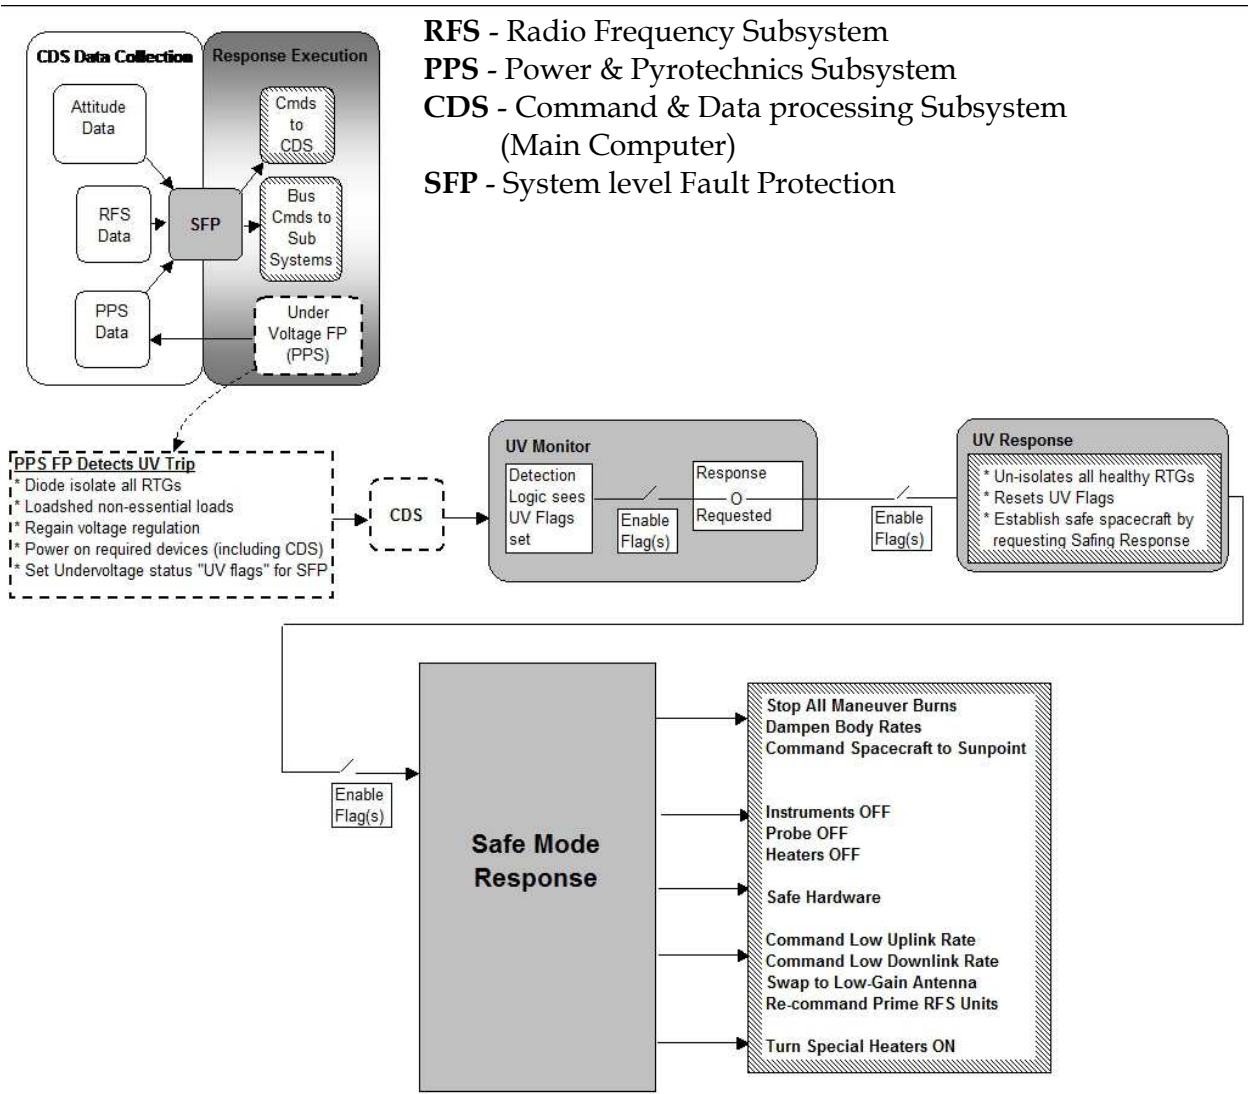
Fig. 8. Cassini’s Under Voltage Fault Protection Actions for a Shorted RTG.

Cassini’s “Under-voltage Trip” monitor and response are shown in Figure 8, “Cassini Spacecraft’s Under Voltage FP Actions for Shorted RTG” in which a RTG power unit (one of three on this spacecraft), has shorted. In this example, the Power Subsystem FP senses a power drop below the predefined threshold for the duration of the persistence filter. The

first action taken by the Power Subsystem FP is to diode-isolate all three RTGs, turn off (loadshed) all spacecraft non-essential loads, regain the voltage regulation to 30 watts, and then turn on all essential hardware. It also sets three "UV Status Flags" (one for each RTG) to notify System-level FP (SFP) that an Under-Voltage trip event has occurred. Once the CDS becomes operational, it will deliver these UV Status Flags to SFP. SFP's Under Voltage monitor will examine the state of each RTG and if enabled, will request the Under Voltage response. The SFP response un-isolates any correctly operating RTG, unsets its corresponding UV Status Flag, and establishes a predictable, safe spacecraft state by executing the Safe-Mode response.

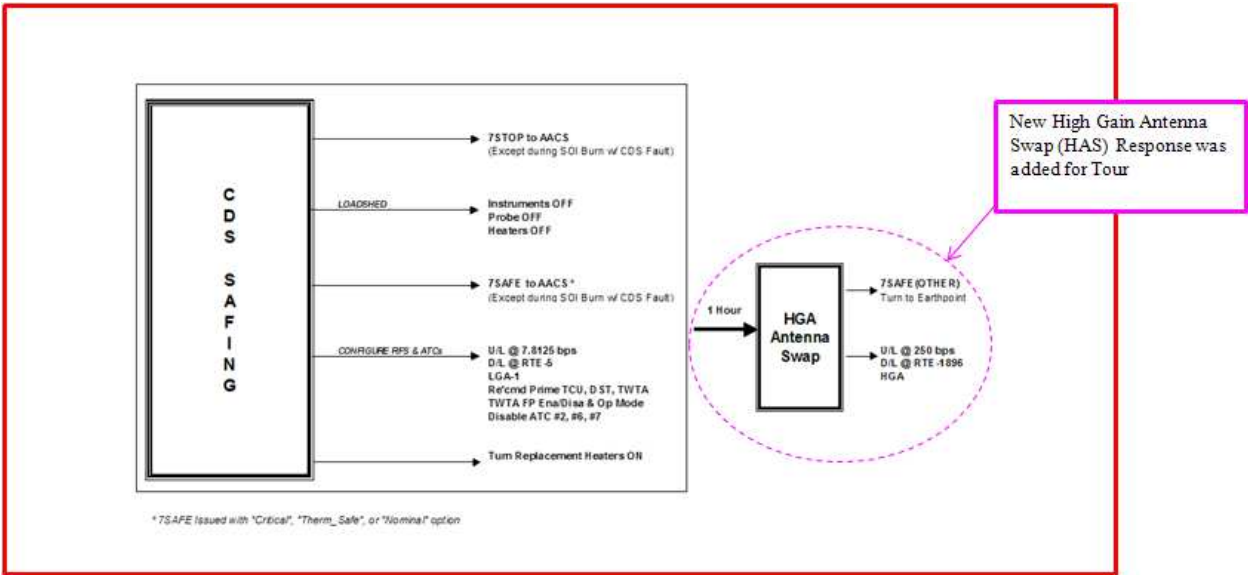
Fig. 9. New HGA Response was added in 2003; Configured to Run 1 hr. after Safing Response Executes.

As stated previously, the Safing Response (and internal FP routines) provide a safe spacecraft state with low uplink & downlink rates for the SOFS team to diagnose the fault condition, recover the spacecraft systems, and reactive the onboard sequence. Two weeks was originally allocated for this recovery period. But once the Cassini spacecraft reached the Saturnian system and began its mission Tour phase in 2004, three Orbital Trim Maneuvers (OTMs) were now required for each loop around Saturn-Titan, making the two-week-turnaround period infeasible since a lengthy spacecraft recovery period could cause Cassini to fall off the Tour trajectory. A High Gain Antenna Swap (HAS) Response was therefore designed into the FSW to help the SOFS team improve recovery time. This HAS response executes one hour after the Safing Response activation to increase the downlink rate from 5bps (bits per second) => 1896bps, and the uplink rate from 7.8125bps => 250bps. Figure 9 shows the HAS Response following the Safing Response activation.

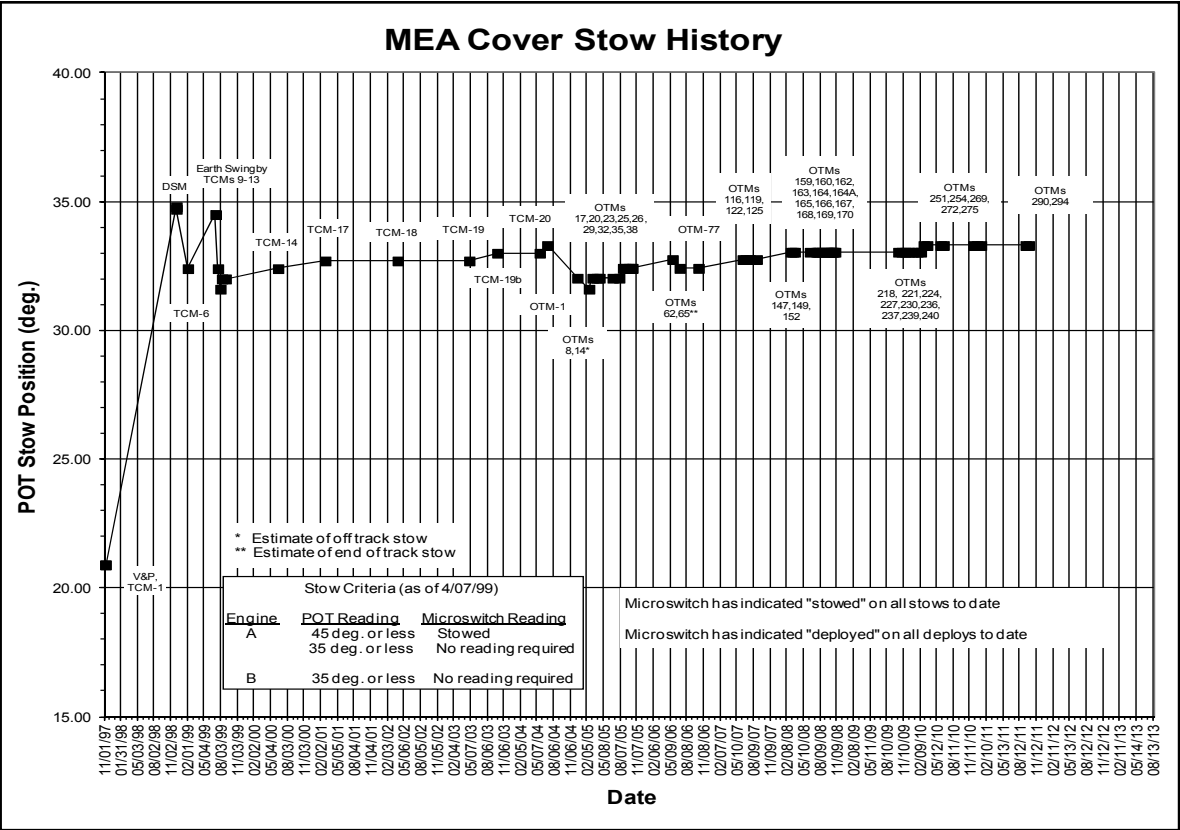
Fig. 10. Main Engine Assembly (MEA) Cover Stow (Open) History ~ Position vs. Mission Time.

Cassini’s ME assembly requires a cover which must be deployed (closed) when the engines require protection from micrometeoroid and on-orbit dust impacts which often surrounds Saturn and its moons. Shortly before the Deep Space Maneuver (DSM) burn when the MEA cover was stowed (opened), the cover assembly did not open as far as was observed in ground tests. The cover opened 14 degrees less than expected, but the SOFS team demonstrated that this opening angle was adequate to allow for successful main engine burns to commence (on either nozzle). The cause of this degradation in performance of the MEA cover was attributed to the increased stiffness in the cover material (kapton & beta cloth) due to exposure to the space environment which was experienced during flight within the inner solar system, although a period of disuse also contributed to this increased stiffness. These environmental effects cannot be adequately modeled in ground tests. The SOFS team’s ongoing response to this unexpected behavior of the cover actuation was to monitor its behavior closely (along with device experts) with results to date demonstrating that the opening angle has remained acceptable through several dozen cycles, with no further signs of degradation observed as depicted above (Figure 10). As of the date of this writing, 66 in-flight cycles have now been performed (Millard & Somawardhana, 2009).

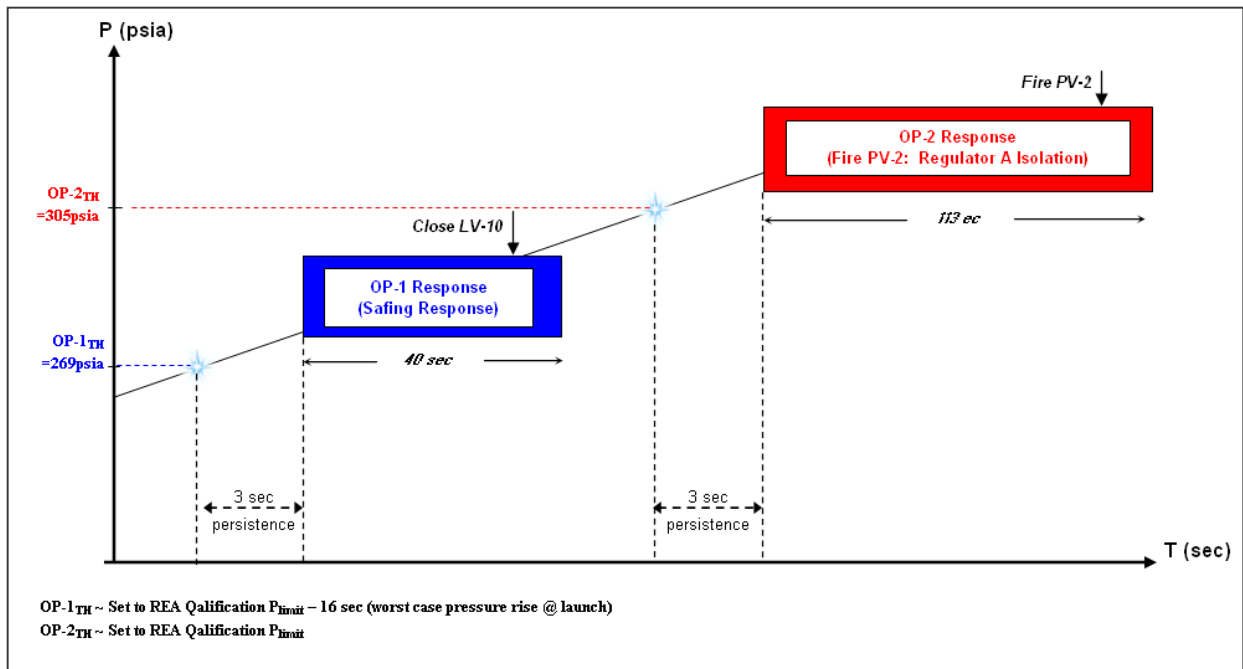
Fig. 12. OP-1 & OP-2 Monitor and Response Configuration.

Enhancements were incorporated into Cassini’s PMS design due to this increased risk in leak rate. A redundant, backup regulator was installed, as well as two new ‘Over Pressure’ (OP) FP algorithms, which were designed to detect any tank over-pressurization within the fuel and oxidizer tanks, which was to be use for all non-critical ME burns (non-critical mission phases; i.e. not used during the critical SOI Burn event). The pre-launch mission design called for the PMS system to be characterized 30 days prior to the SOI Burn maneuver, so that the OP FP could be disabled. Leak mitigation measures were also added to the PMS plumbing: Two high-pressure helium latch valves (LV10 & LV11), a pyro-isolation ladder upstream of the regulators (PV10-PV15), plus several filters as depicted in Figure 11 (Barber, 2002; Leeds et al., 1996):

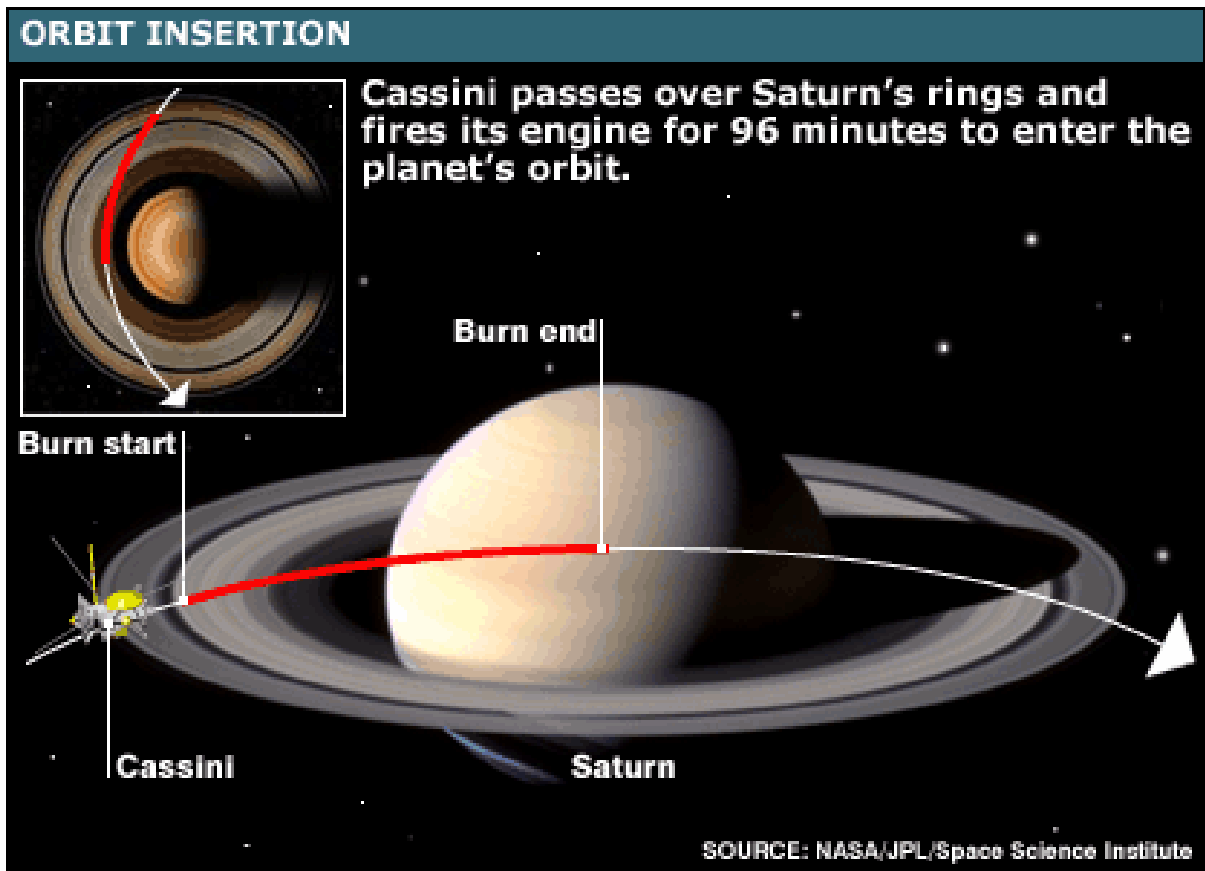
Fig. 13. Insertion of the Cassini Spacecraft into the Saturnian System.

Since the PMS system could no longer be characterized and pressurized 30 days prior to the SOI Burn, the solution was to open LV-10 70sec before SOI Burn would commence, and close LV-10 when the desired tank pressure levels were reached. Identification of new failure modes associated with these changes in SOI Burn strategy were also necessary (e.g. helium LV-10 could become stuck closed, thus requiring an automated swap to the redundant helium LV-11 via FP; the Prime Regulator could fail wide-open or completely closed, thus requiring a swap to the redundant Backup Regulator), and these studies were conducted during the cruise phase of the mission before reaching Saturn.

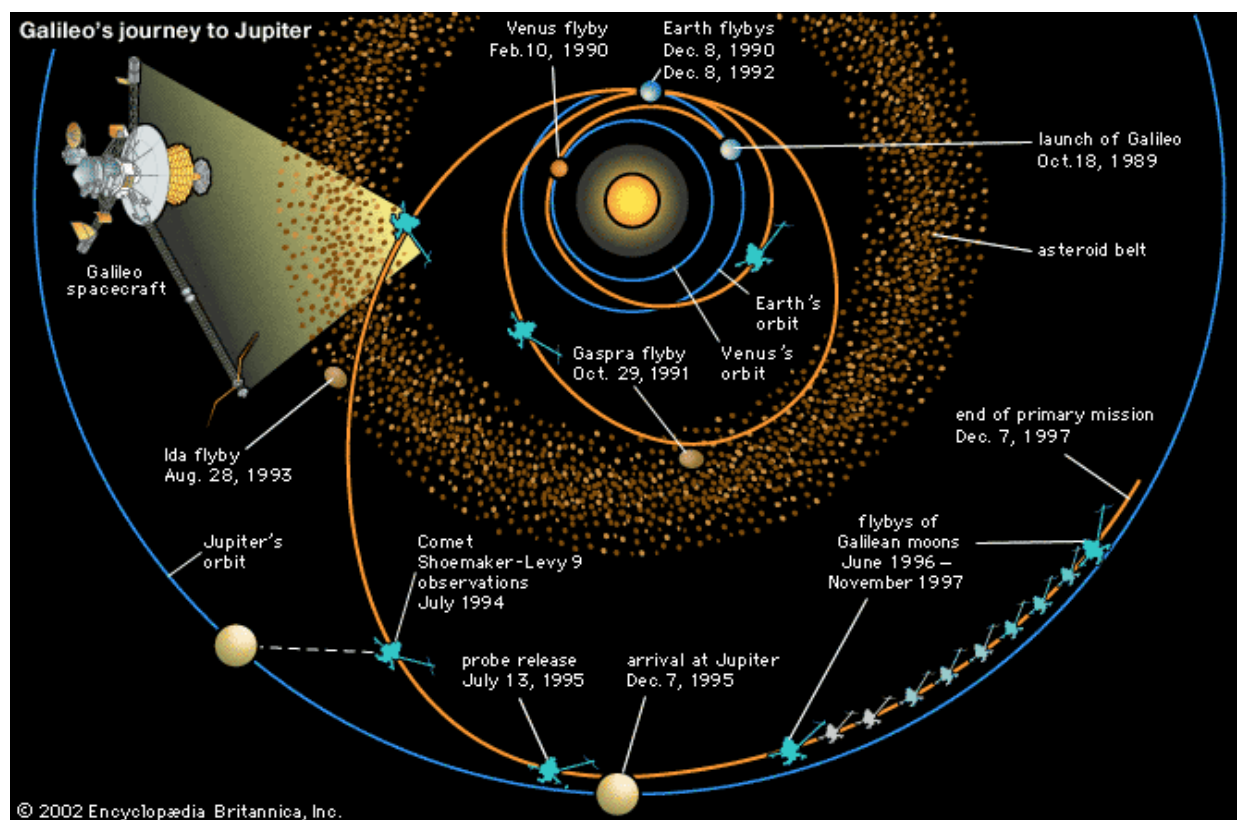
Fig. 15. Galileo's Mission Trajectory.

booster option presented a crisis in that the energy required to achieve a direct trajectory to Jupiter would no longer be possible. The mission was re-profiled to use several gravitational slingshot maneuvers of the spacecraft by the solar system's inner planets, so that a Venus-Earth-Earth Gravity Assist (VEEGA) strategy was designed and implemented in order to provide the additional velocity required to reach its destination. Galileo flew by Venus on February 10, 1990 gaining 8,030 km/hr; flew by Earth twice, the first time on December 8, 1990, then a second flyby of Earth on December 8, 1992, adding 3.7 km/sec to its cumulative speed. In 1994, Galileo was perfectly positioned to observe the fragments of Comet Shoemaker-Levy 9 crash into Jupiter. Galileo released its probe on July 13, 1995, and became the first man-made satellite on December 8, 1995 to enter Jupiter in a 198-day parking orbit.

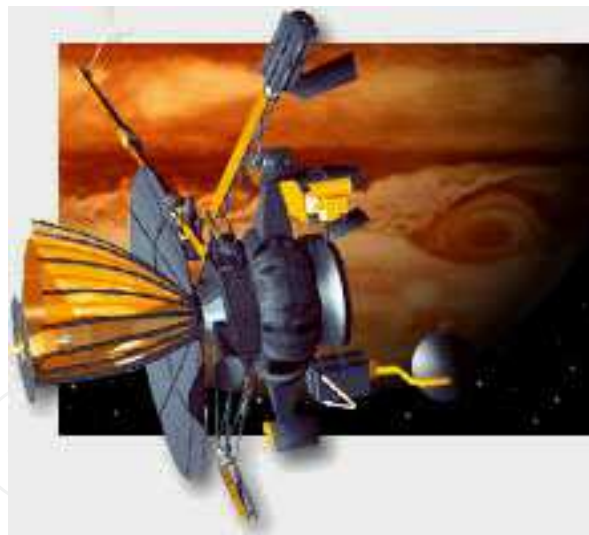
Fig. 16. Galileo's Undeployed HGA.

away (after the first Earth flyby). The SOFS Team communicated with Galileo through its two Low Gain Antennas (LGA). When commanded to deploy on April 11, 1991, the HGA only partially deployed, leaving the HGA mission in jeopardy. An investigation team was organized to rectify the problem where numerous attempts were made to fully deploy the antenna over the next two years, while investigating the alternative of using the LGA to support the Jovian operations segment of the mission. All attempts to fully deploy the HGA were unsuccessful, leaving the HGA antenna nearly useless.

In order to redesign the Galileo mission for LGA use only, the telecommunications link architecture was redesigned. The current architecture only supported 10 bps at Jupiter which was less than  $1/10,000^{\text{th}}$  of the 134 kilobits per second (Kbps) required. Since modifications to the spacecraft's hardware to boost the transmit power was not possible, receiving capability of Earth's ground stations and developing a more efficient data and telecommunications architecture was the primary focus of the needed upgrades. Arraying the DSN antennas increased the rate by a factor of 2.5, and modifications to the receivers and telecommunications link parameters, improving encoding and onboard data compression further increased the downlink from 10 bps to 4.5Kbps. Since these improvements were insufficient to bring down all science data objectives, the SOFS team negotiated with the science team to prioritize science goals, develop new science plans, and periodically update spacecraft FSW to increase data efficiency. Also, as a backup to the downlinked data, the onboard Data Memory Subsystem (DMS) tape recorder was utilized during selected high activity periods (Nilsen & Jansma, 2011).

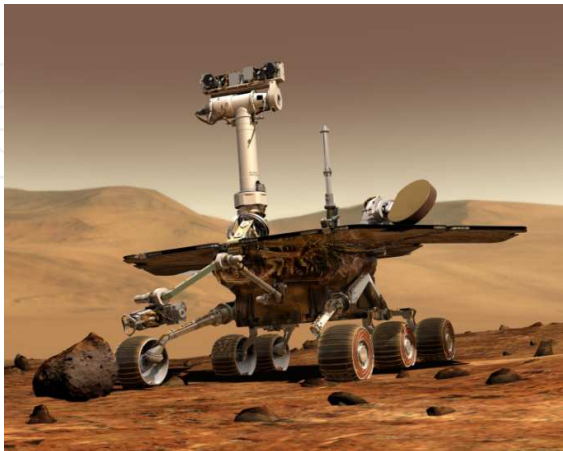
Fig. 17. Mars Exploration Rover.

The Mars Exploration Rover (MER) mission is an ongoing, scientific undertaking involving two golf cart-sized robotic rovers. This mission is part of NASA's Mars Exploration Program, which includes two previous Viking program landers (1976) and the Mars Pathfinder probe (1997). The six-wheeled MER robotic vehicles, Spirit and Opportunity,

landed in 2004 to explore the Martian surface and its geology. The mission’s primary objective is to search for and characterize a wide range of rocks and soils that hold clues to past water activity on Mars. Originally a three-month mission, the MER mission was extended to present day. To date, much evidence has been collected to indicate that Mars was once a wetter and warmer place than has previously been determined.

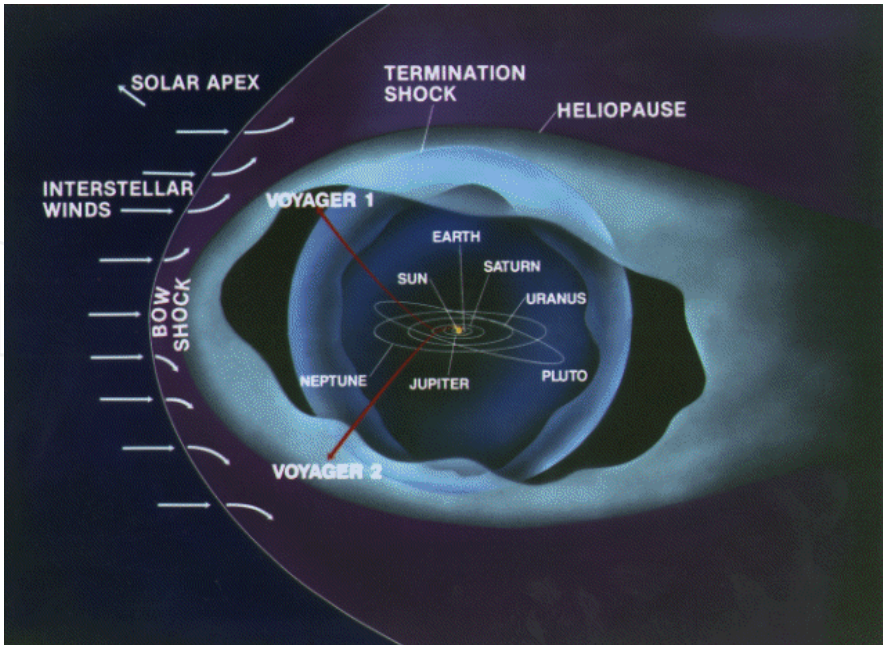
Fig. 20. Current Voyager Spacecraft Position.

The number of real-time commands must be kept to a minimum for spacecraft missions that must endure long RTLTs. For the Voyager spacecraft, the SOFS team performs commanding primarily by uplinked sequences containing several instructions. Since scheduled DSN antenna time coverage (~9hrs) is too short to wait for real-time verification of these commands, the team utilizes an alternative method to verify command success: the command sequence is transmitted by the DSN antenna (ground station) to that point in space where the spacecraft *will be* a OWLT (One Way Light Time) hence. For the Voyager 1 in July 2011, this OWLT was approximately 16.2hrs, respectively; downlink telemetry is then transmitted from the spacecraft and received by the DSN antenna from the point in space where the spacecraft *was* OWLT ago (Medina, Sedlacko, & Angrum, 2010).

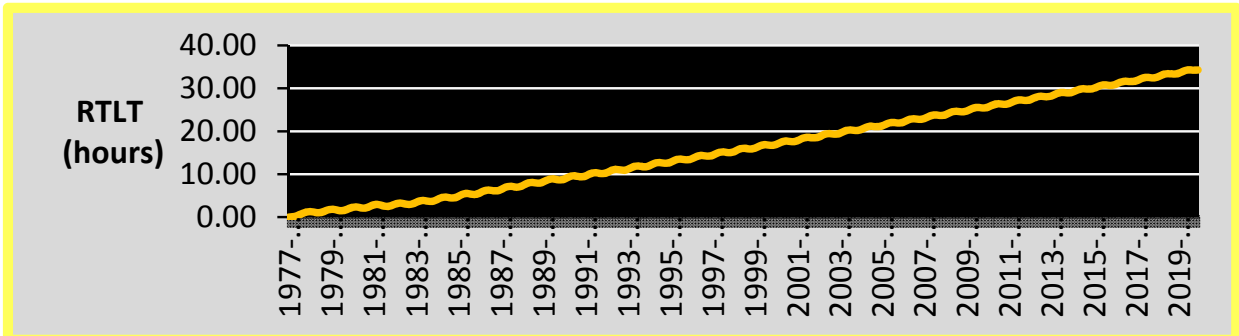
Fig. 21. Voyager 1 RTLT vs. Time.

A total time allotment of 32hrs, 23min, and 55sec plus sequence execution time, FSW processing time, and command execution time is required in order to verify each command sequence (i.e. more than one DSN antenna pass coverage is required to uplink and verify every command/command sequence; see Figure 23).

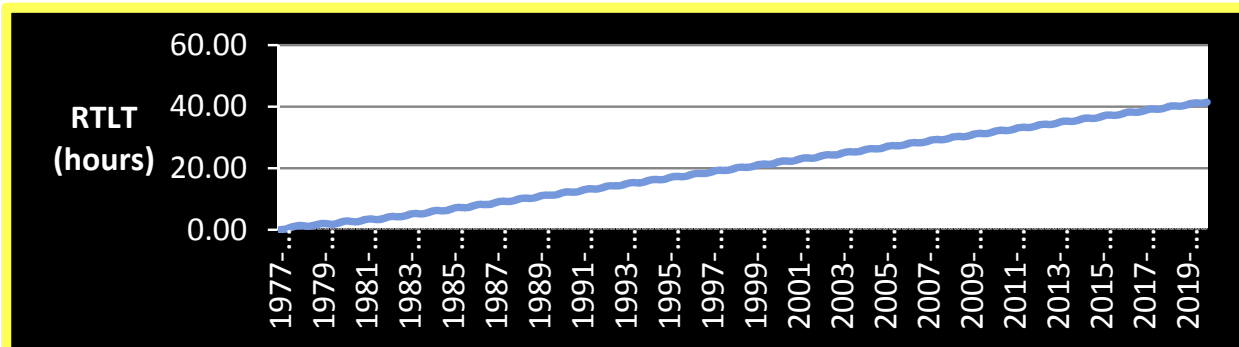
Fig. 22. Voyager 2 RTLT vs. Time.
