# **Soil Erosion After Wildfires in Portugal: What Happens When Heavy Rainfall Events Occur?**

L. Lourenço, A. N. Nunes, A. Bento-Gonçalves and A. Vieira

<http://dx.doi.org/10.5772/50447>

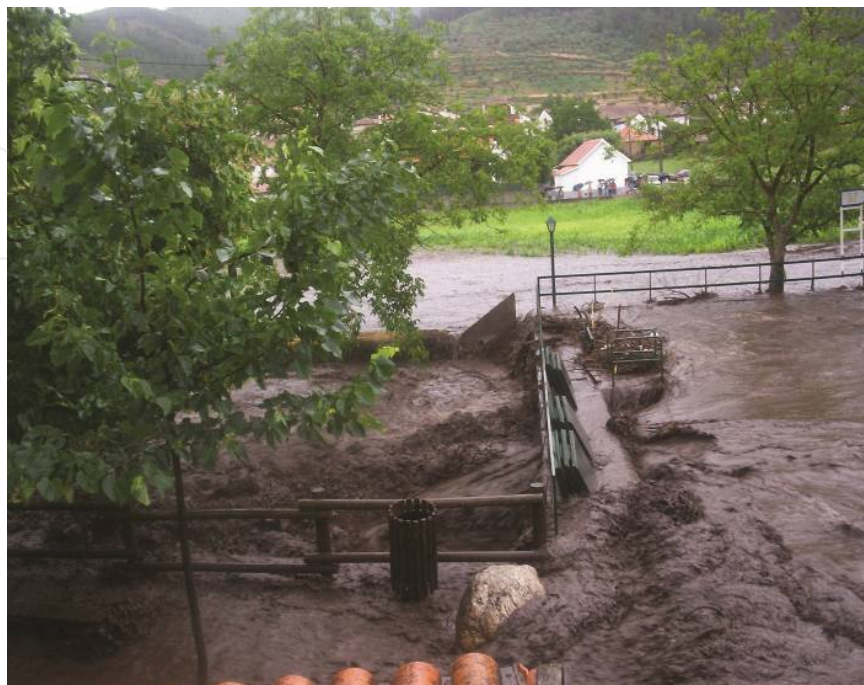
**Figure 4.** The super-elevation of the flow at Pomares Bridge and the flooding of the right bank of the river.

The figures 4 and 5 confirm the super-elevation of the flow at the Pomares Bridge (in the Pomares river basin) as well as the flooding of the right bank of the river. In fact, the stream flow created a 2.5 meter waterfront, although the floodgates were open. The impossibility of draining off the volume of water that had accumulated during the intense rainfall, as well as the power of the runoff and stream flow to transport materials obstructed the flow of the water and enlarged the flood area. Figure 5 simulates the peak discharge level and shows

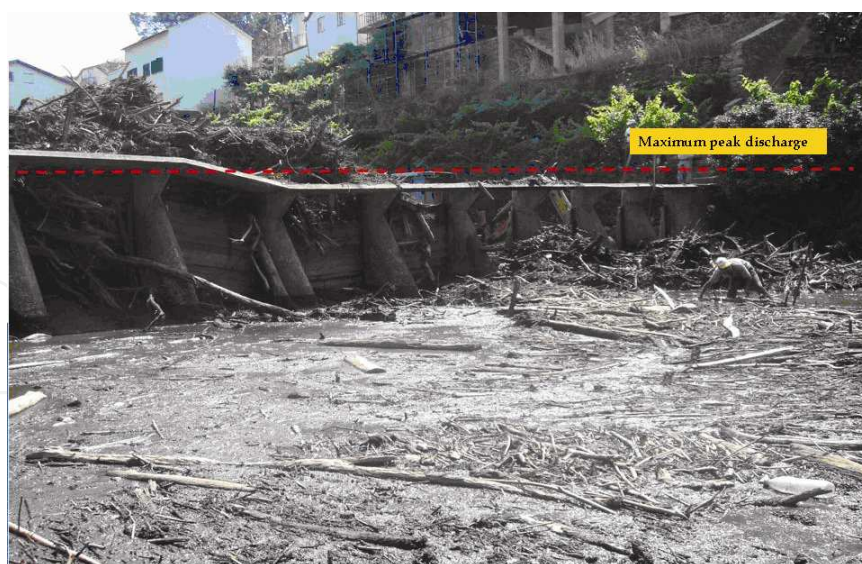
**Figure 5.** Simulation of maximum peak discharge and the blocked organic and sediment debris (Pomares Bridge).

the tonnes of material, mainly branches of trees and shrubs, carried downstream, which created a blockage at the bridge.

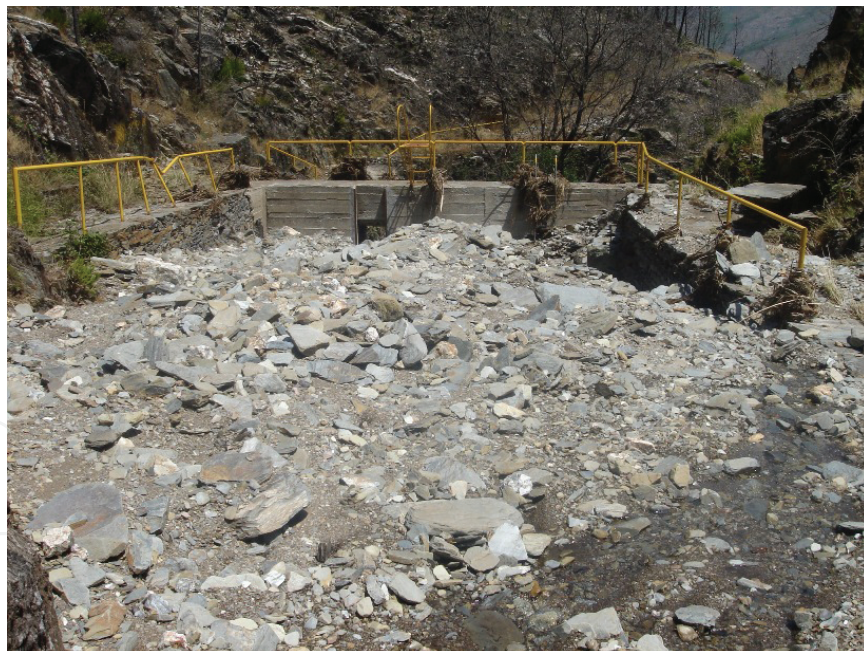
**Figure 7.** Deposition of sediment at Soito da Ruiva, in the Pomares basin.

Figures 7 and 8 show a plan of the debris flow deposition area caused by the inability of the drainage ditches to cope with the increased run-off generated in the upstream areas and the soil erosion, which led to flooding and the accumulation of large boulders and woody debris.

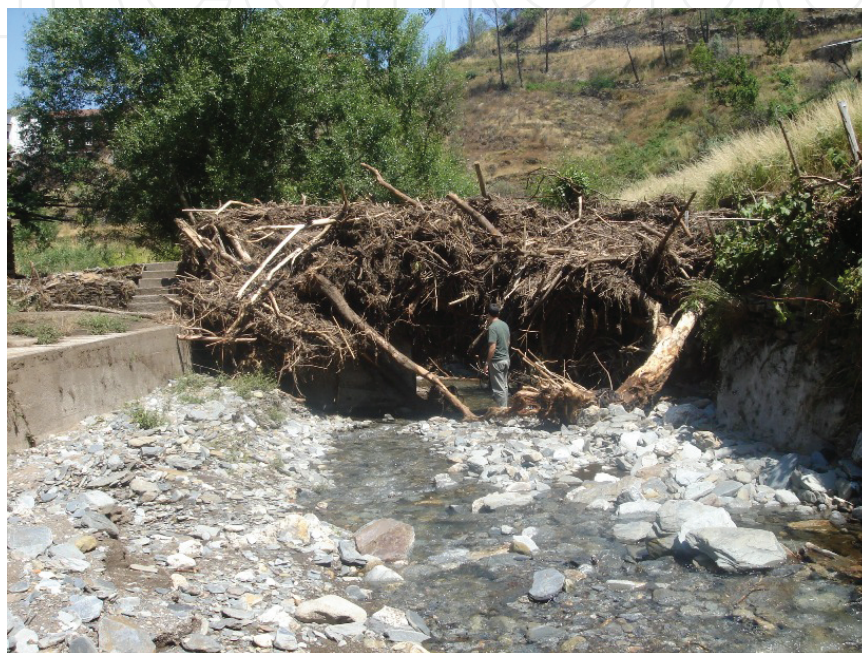
**Figure 8.** Wood accumulation following the wildfire at Sobral Magro, in the Pomares basin.

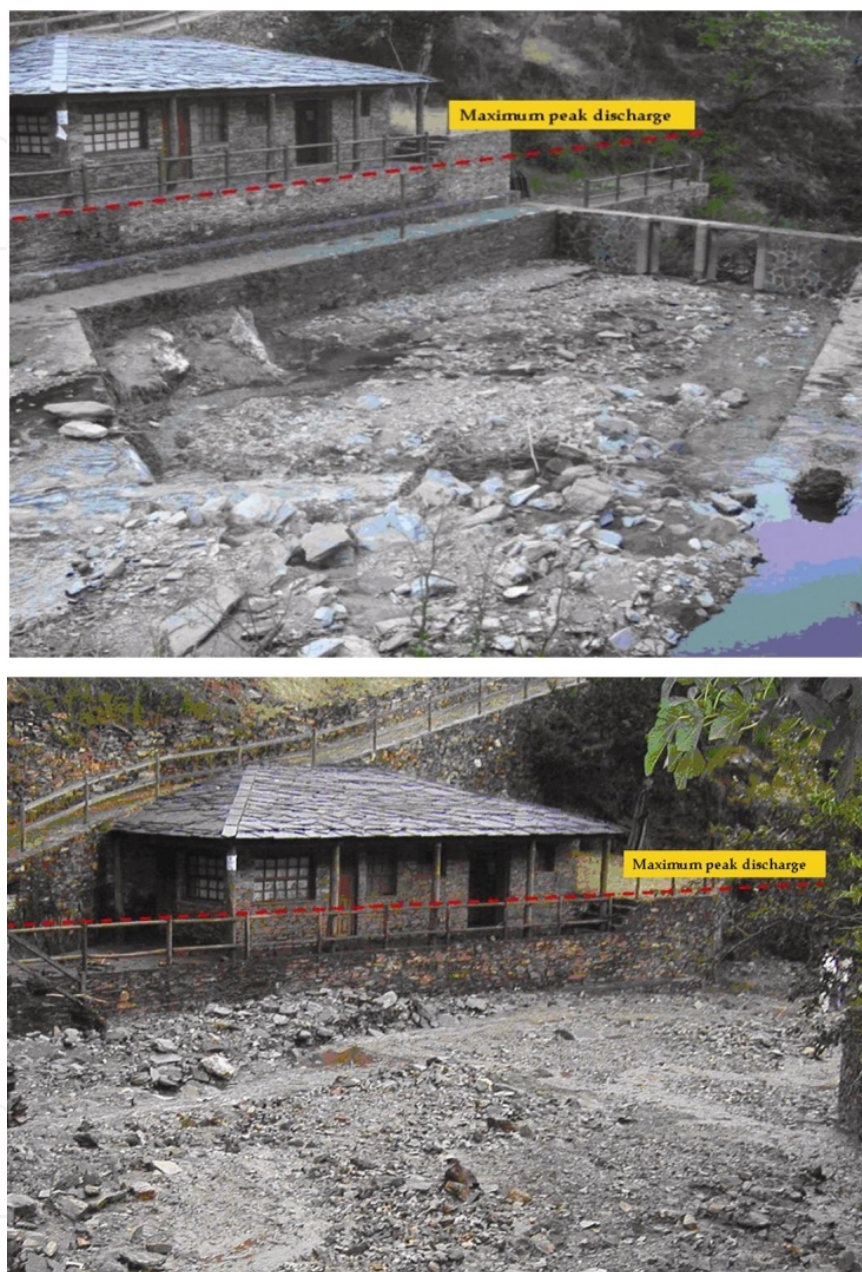
**Figure 10.** Simulation of the maximum peak discharge in the 16<sup>th</sup> June (above) and in the 14<sup>th</sup> July (below). Comparative analysis.

Figure 10, provided by a local resident and showing the volume of accumulated water, demonstrate that the peak discharge was higher during this event than the previous one. The flood marks on the house used to estimate the peak discharge level show that the ground floor was not flooded in the 16<sup>th</sup> June event, whereas during this flash flood the building was flooded to a depth of 1 metre.

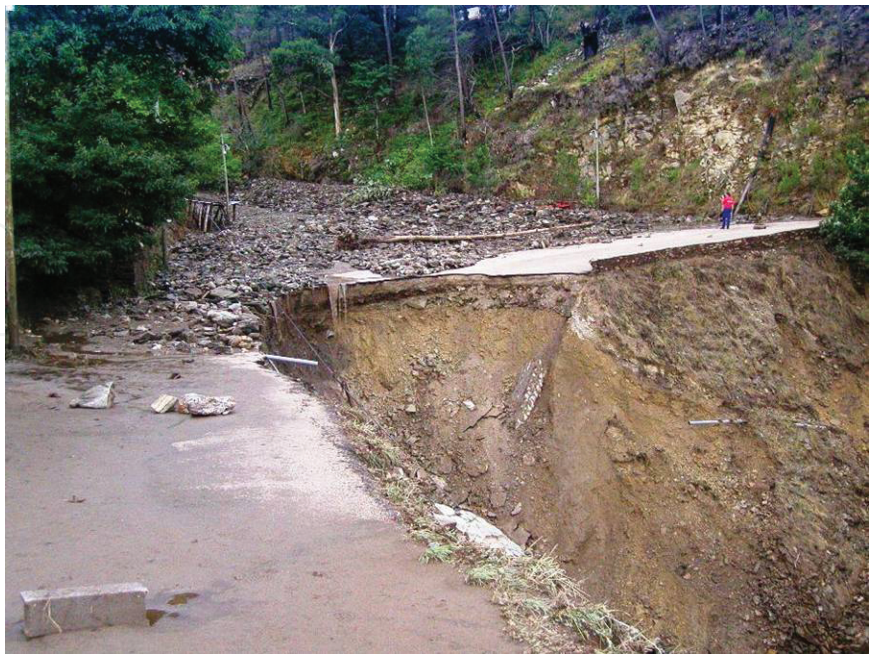
**Figure 12.** A car park partially destroyed by the water, causing a landslide.

the flooded area, with profound geomorphologic consequences. The force of the water demolished a bridge which a tourist was crossing at the time, leading to his death. A car park was partially destroyed by the water, causing a landslide, as can be seen in figure 12.

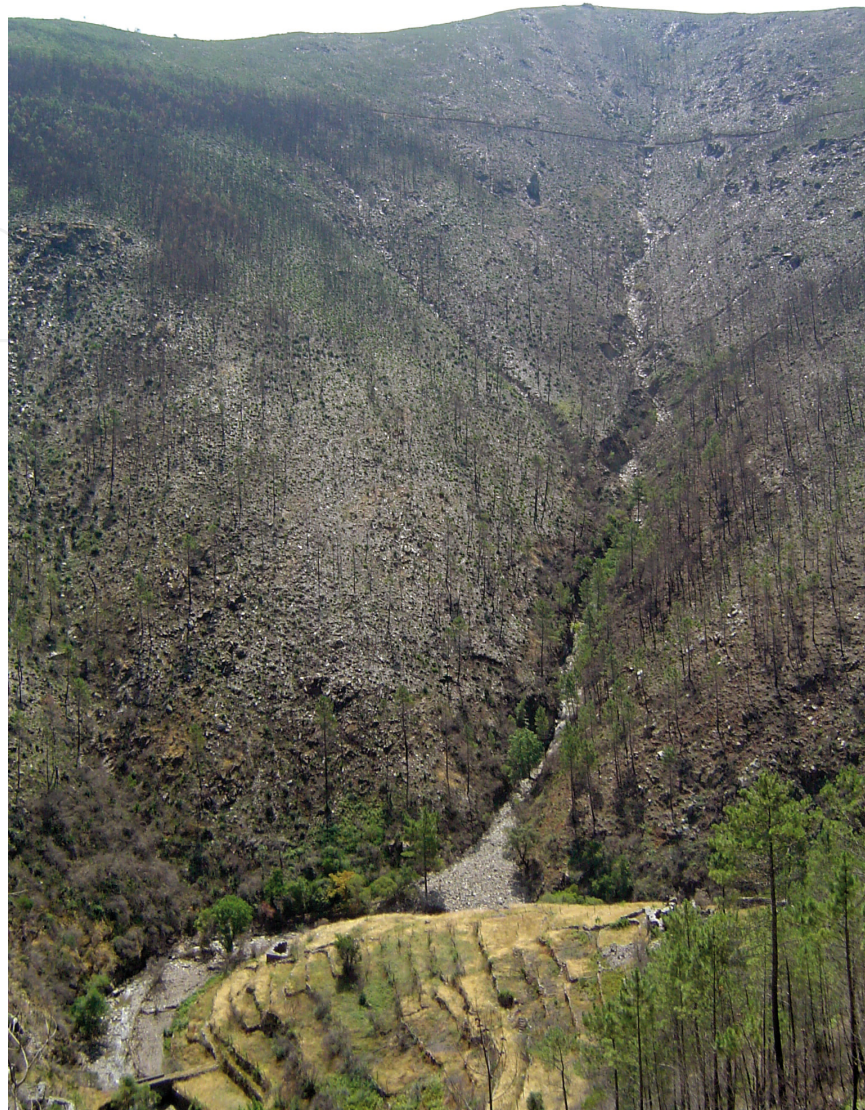
**Figure 13.** Rills and gullies erosion as a consequence of the intense rainfall.

In fact, intense rainfall increases the erosive power of overland flow, resulting in deeply incised channels, such as rills and gullies (figure 13), and accelerates the removal of material from hill slopes. Increased runoff can also erode significant volumes of material from channels. The net result of rainfall on burned basins is the transport and deposition of large volumes of sediment, both within and downstream of the burned areas. The following

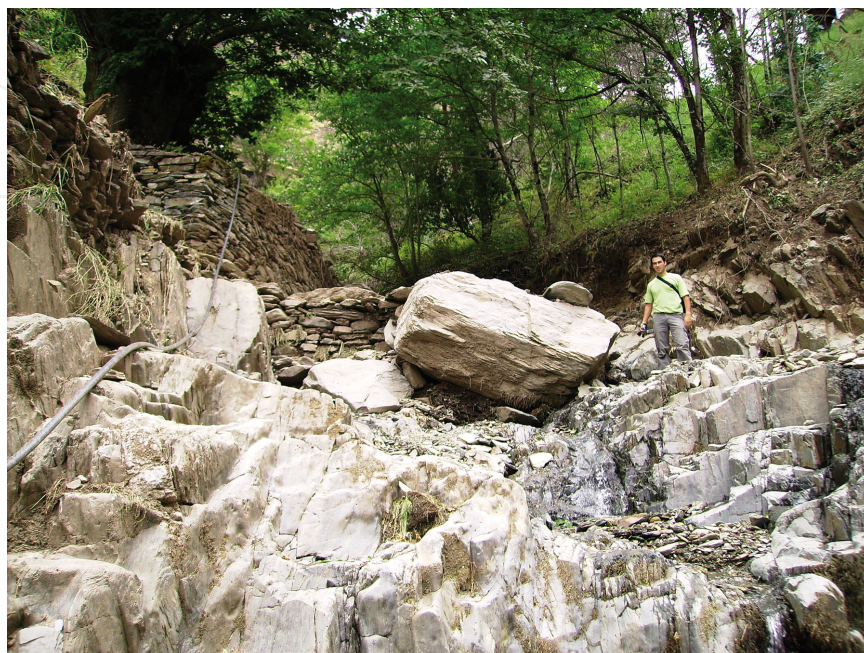
**Figure 14.** The powerful capacity to transport materials along the main channel during the event of 14<sup>th</sup> July.

photographs illustrate its powerful capacity to transport materials along the main channel and its highly destructive force (Figures 14 and 15). In figure 14 a large block can be observed abandoned in the river bed. In figure 15 a trout pond is crammed with material transported by the flood. The power of the stream affected sediment transport processes during the flood, also influencing the morphology of the river.

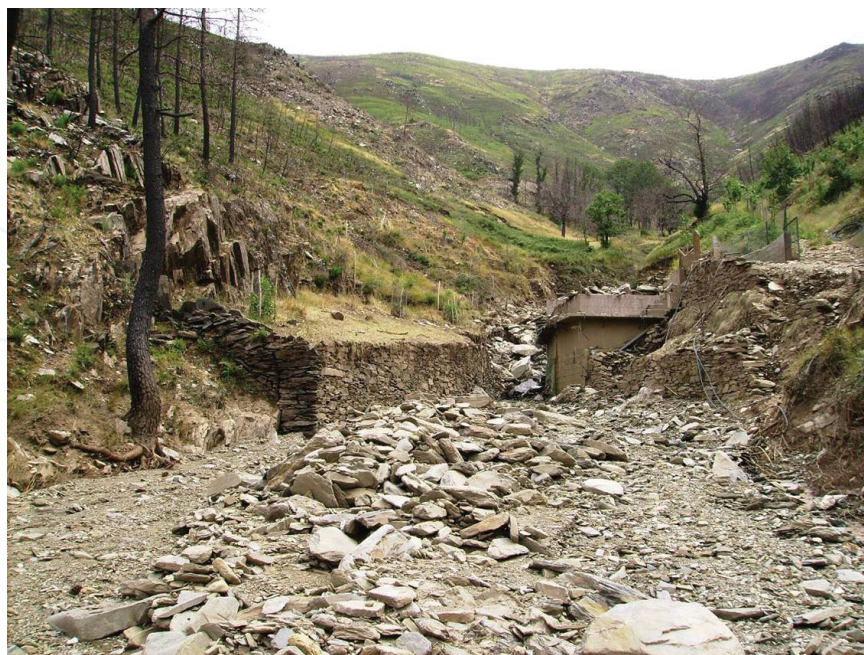
**Figure 15.** A trout pond is crammed with material transported by the flood.
