Applying Post-Tensioning Technique to Improve the Performance of FRP Post-Strengthening

Mônica Regina Garcez,
Leila Cristina Meneghetti and
Luiz Carlos Pinto da Silva Filho

<http://dx.doi.org/10.5772/51523>

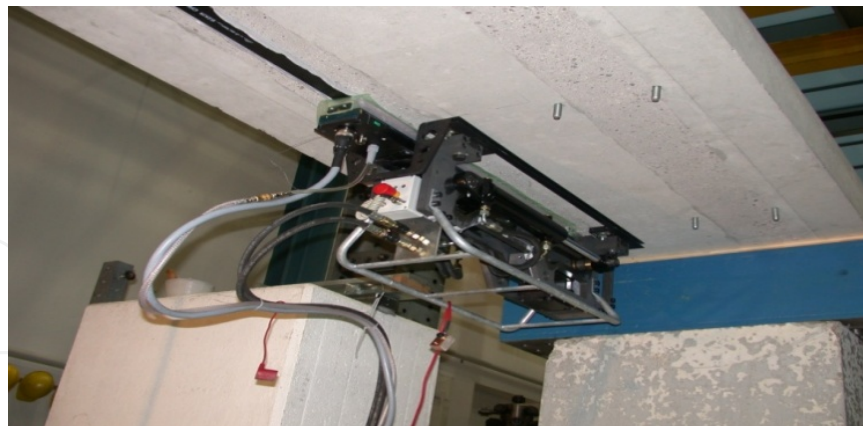
In a new version of the prestressing device developed by Stoecklin & Meier [17], two separate prestressing units at each end of the strip are directly mounted to the structure, what means that the FRP strip is prestressed against the structure, as shown in Figure 6.

Figure 6. New version of the prestressing device developed by Stoecklin & Meier (Meier [10]).

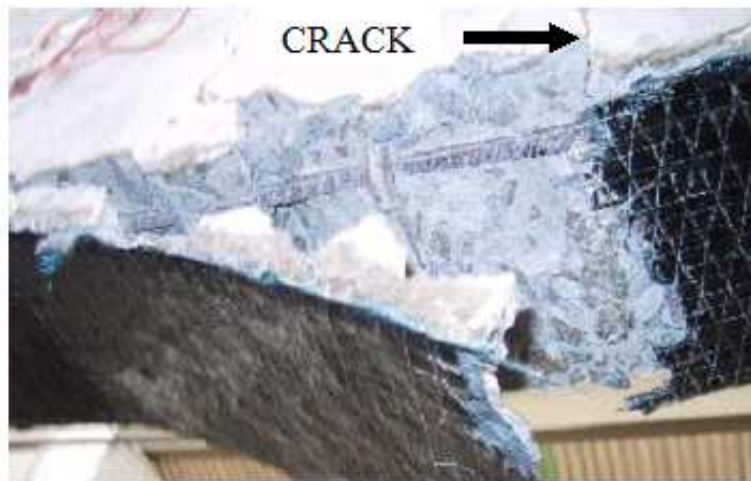
- High interfacial stresses near to the ends of the bonded FRP, also called peeling-off.
- Flexural or flexural-shear crack away from the ends, as shown in Figure 8.

Figure 8. Rupture of FRP close to a flexural crack tip.

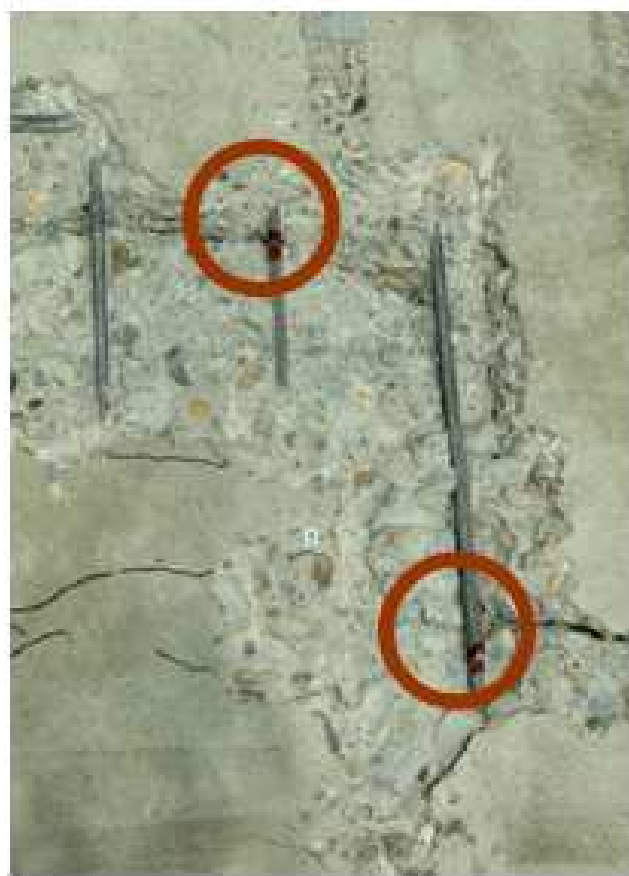
Meier U. [22] highlights that the steel rebars fail before the FRP post-strengthening, as can be seen in Figure 9 that shows the steel rebars of a post-strengthened concrete beam after a fatigue failure. However, cyclic loads can also damage the adhesive and affect the interface concrete-adhesive and adhesive-FRP, leading to premature failures.

Figure 9. Failure of concrete beam after fatigue loading test.

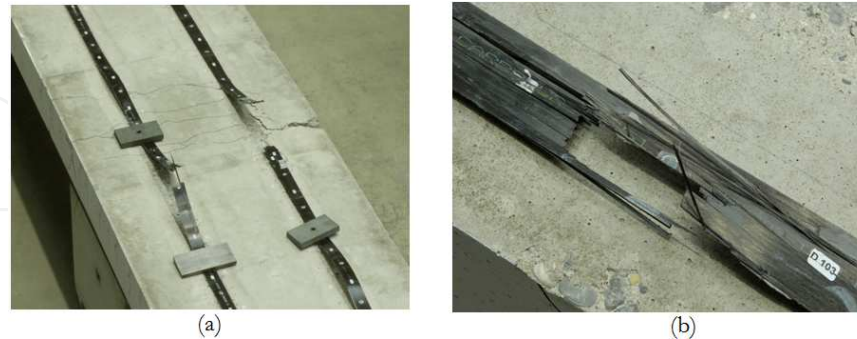
Figure 15. Failure of post-strengthening strips: (a) Next to a flexural crack; (b) Distant from flexural cracks.

Figure 15 shows one of the CFRP strips after the failure of the post-strengthened beam. Flexural crack showed in Figure 14 induced the identification of a steel rebar broken due to fatigue. After the test, the concrete was removed from the bottom of the beam and all steel rebars were inspected. Figure 16 confirms the existence of more steel rebars broken also due to fatigue.
