Finite Element Analysis Applications in Failure Analysis: Case Studies

Ahmad Ivan Karayan, Deni Ferdian, Sri Harjanto,
Dwi Marta Nurjaya, Ahmad Ashari and Homero Castaneda

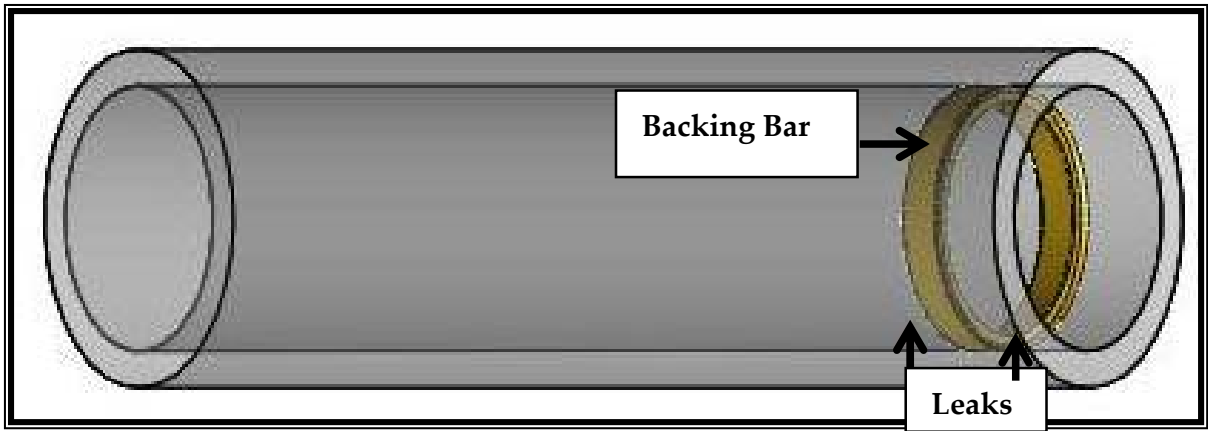
Karayan *et al.* [18] studied the failure of a seawater inlet pipe. The failure was first characterized by a small leak at approximately the 4-8 o'clock position. A schematic drawing of the inlet pipe showing the backing bar near the leak location is shown in Figure 1. This backing bar was installed on the welded surface. The visual examination of this failed pipe is shown in Figure 2. In order to find out the root cause of failure, a number of laboratory tests were performed. The results showed that the failure was caused by cavitation, as evident by the presence of a crater-like surface near the backing bar (Fig. 3). These localized craters seemed unusual since they were only noticed near the backing bar. An additional tool such as finite element analysis was used to determine why this was the case. A finite

Figure 1. Big and small leak near the backing bar at about 6 o'clock position viewed from the inner side of seawater inlet pipe.

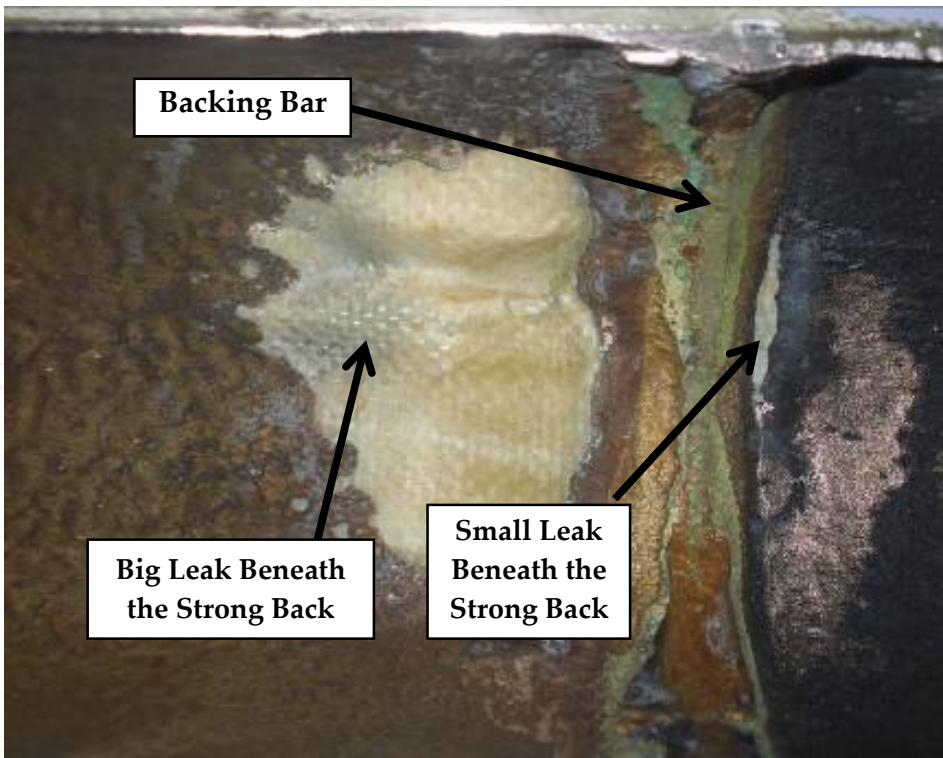
Figure 2. Big and small leak near the backing bar at about 6 o'clock position viewed from the inner side of seawater inlet pipe.

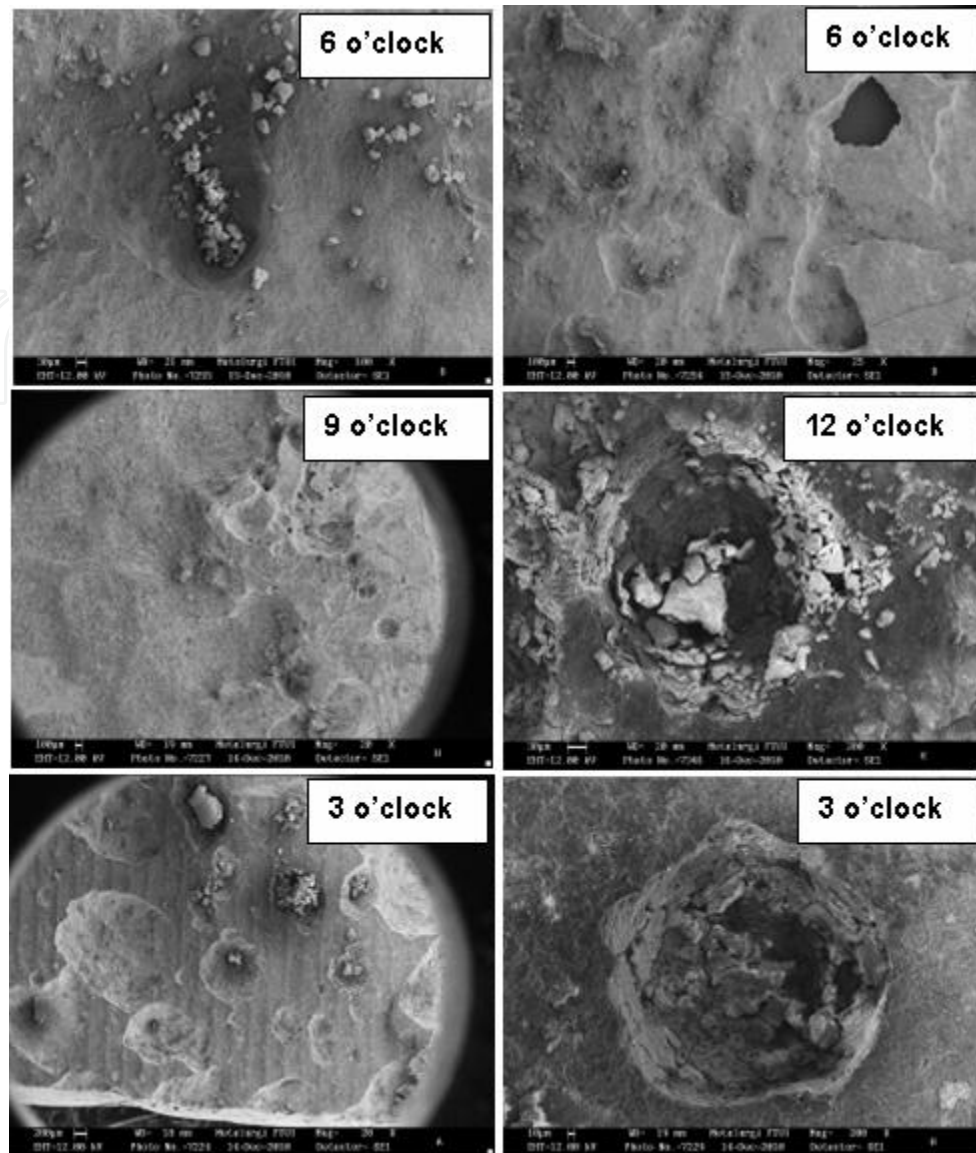
Figure 3. Surface morphologies of brown crater – like surface taken from 6 – 3 o'clock position.

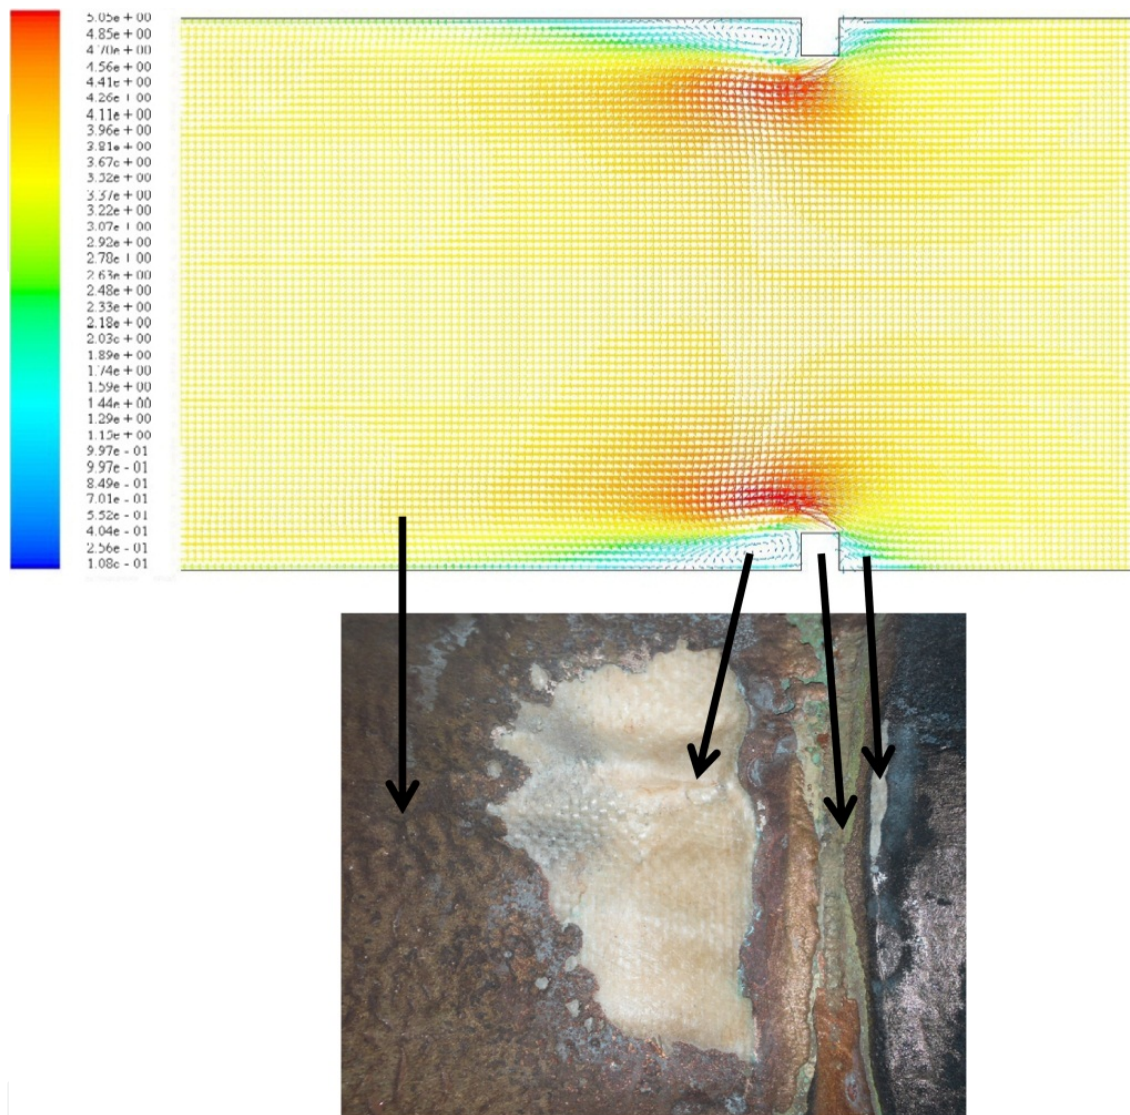
element analysis was executed based on the pipe dimension and actual fluid conditions such as velocity, pressure, temperature, and implicit parameters. Because there were no data for the initial height of the unwanted backing bar, the authors assumed that the initial height was the highest backing bar found on the specimen. Interestingly, the failure location predicted by the finite element analysis matched up with the actual evidence (Fig. 4). It precisely showed that the failure could be located around the backing bar where the eddy zone was formed in this area. This suggests that sometimes the results obtained from laboratory tests cannot explain why a failure occurs, although evidence indicates the existence of a certain problem. In this case, a finite element analysis is the only tool that can help a failure analyst find the root cause of failure. As can be seen from Figure 4, the leaks and crater-like surfaces found in the area near the backing bar were attributed to the formation of eddy zones in this area. The length of the eddy zone predicted that the area that might suffer from a flow-induced attack.

Figure 4. Finite element analysis of the inner pipe showing the orifice effect and the eddy zone near the backing bar correlated with the actual leaks on the inlet pipe.

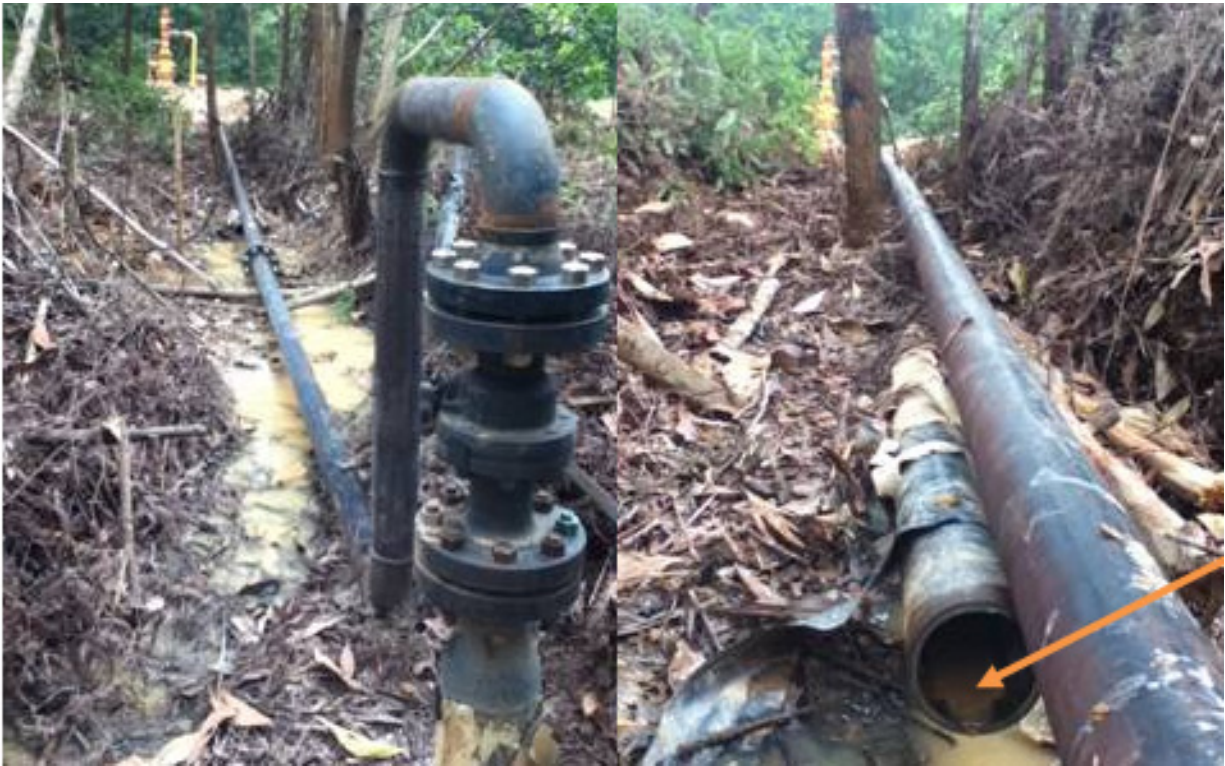
Figure 5. The specimen sent to the laboratory for analysis is indicated by arrow

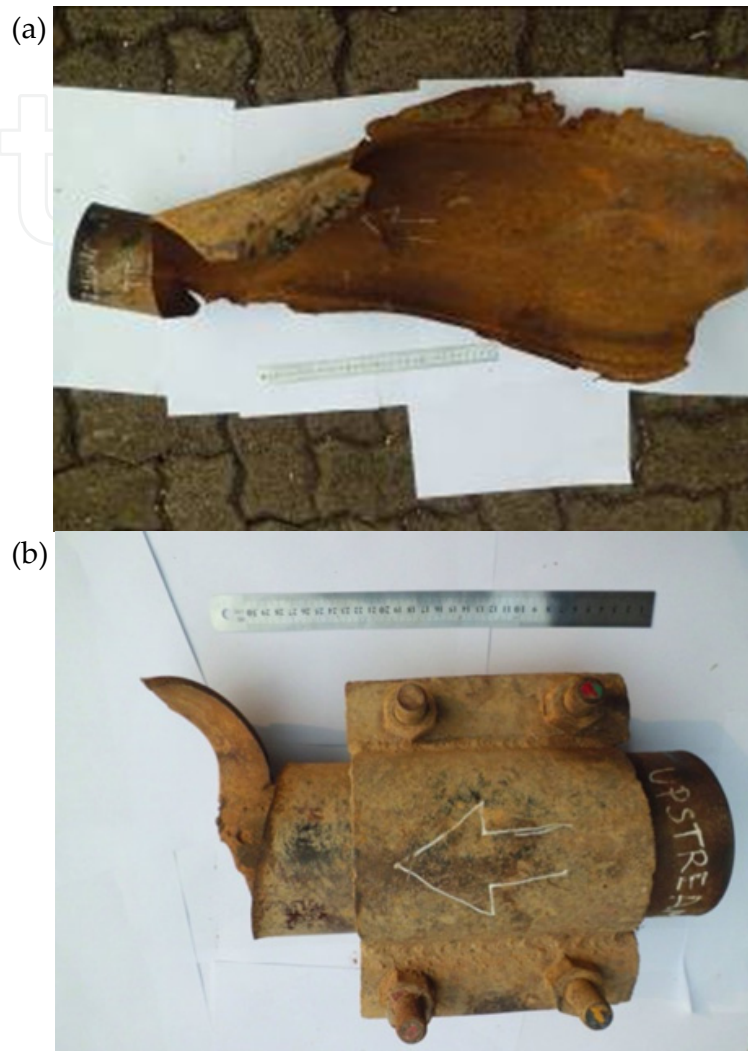
A visual examination showed that the burst area was located at the 6 o'clock position of the (a) downstream part and the (b) upstream part (Fig. 6). Some points on the inner surface of the downstream part at the 5-7 o'clock position showed surface degradation with wall thinning and pits (Fig. 7). Some points on the inner surface of the upstream part at the 5-7 o'clock position also showed surface degradation with wall thinning and pits (Fig. 8). A uniform attack at the burst area from the 5-7 o'clock position is shown in Figure 9.

Figure 6. (a) Downstream part and (b) upstream part showing the burst located at 6 o'clock position.

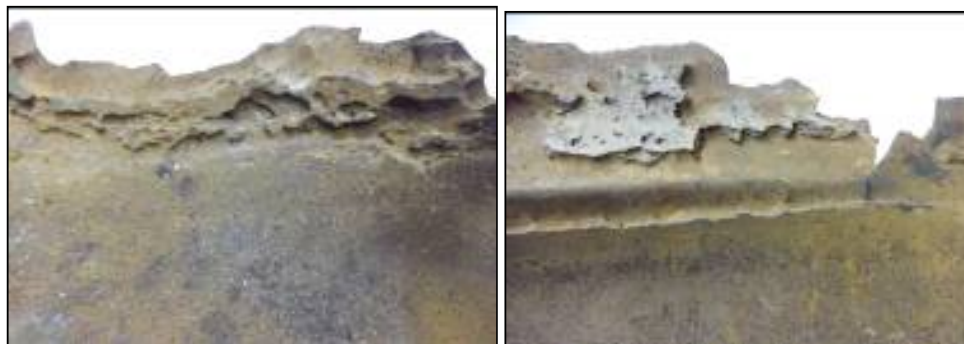
Figure 7. Wall thinning and pits at 5 – 7 o'clock position of downstream part.

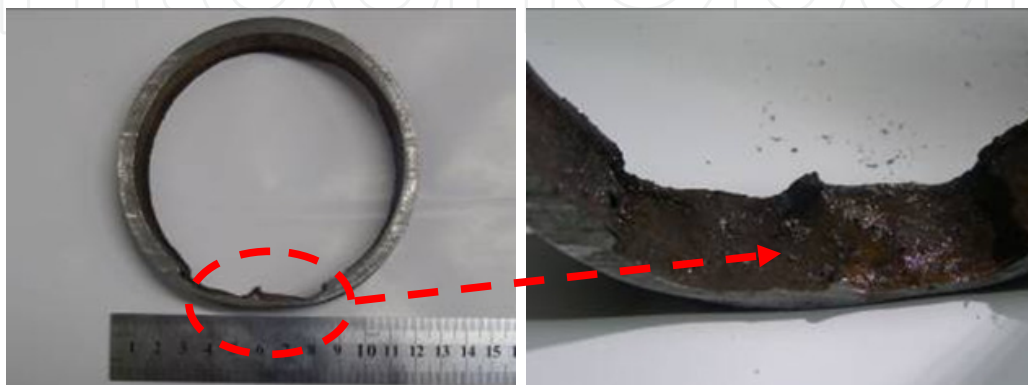
Figure 9. Uniform attack at the burst area from 5-7 o'clock position.

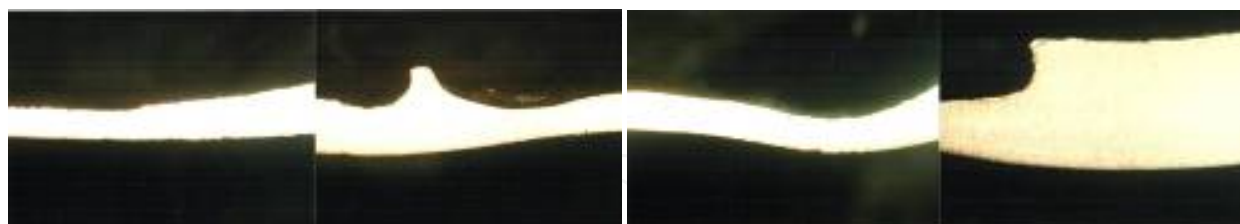
The metallographic preparation and macroetching were performed on the perimeter of the trunkline, and the results showed that the trunkline was made of seamless pipe (Figs. 10 and 11). The thinning area shown in Figure 9 was an ERW (electric resistance welding)-free area (Fig. 10). This information indicates that the failure could not be attributed to the ERW pipe issue.

Figure 11. Macrograph of 5-7 o'clock position showing the absence of ERW.

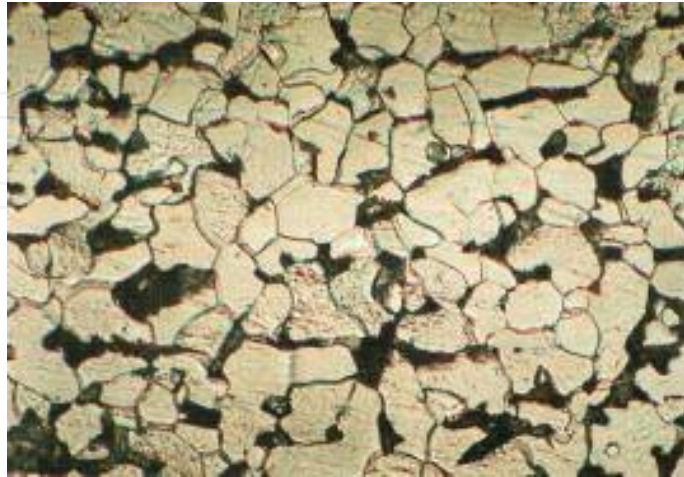
The microstructure of the trunkline was taken from the cross-section, and the results are displayed in Figure 12. As can be seen, the trunkline is composed of ferrite (light phase) and pearlite (dark phase) with equiaxed grains, which is typical of seamless pipe. The chemical composition of the trunkline was tested using an optical emission spectrometer and the results (Table 3) show that this trunkline is composed of an API 5L X60 steel [20]. Due to the insufficient geometry of the trunkline, the mechanical property of the trunkline was only examined by hardness testing. In order to verify that the specification of this material was API 5L, the resultant hardness values were converted to tensile strength (Table 4).

Figure 12. Microstructure of trunkline showing a typical seamless microstructure with equiaxed grains. The dark phase is pearlite and the light one is ferrite.

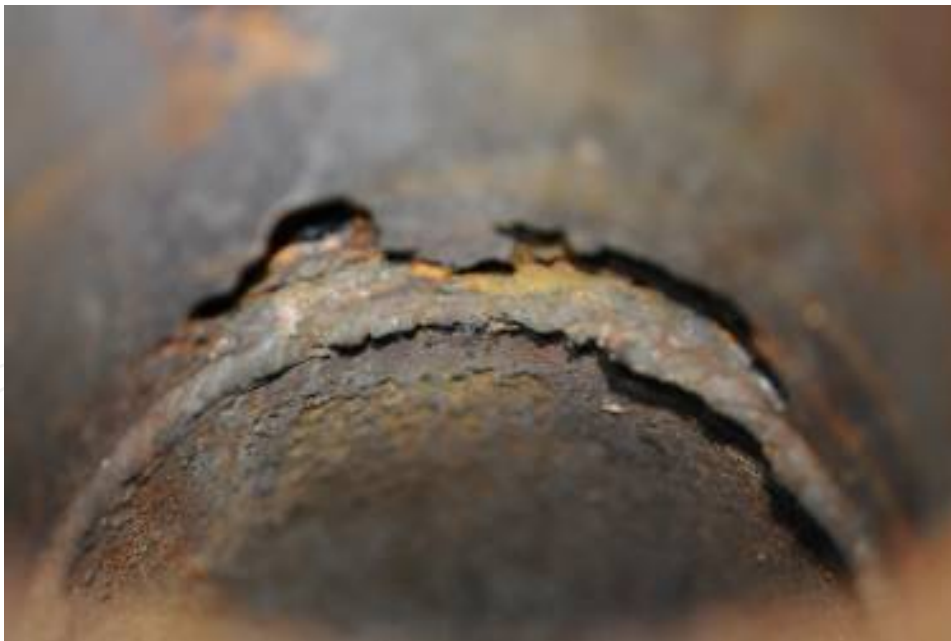
The finite element analysis was executed around the overfill, and the results (Fig. 13) showed that the area at which the pipe burst had a dead or eddy zone due to the excessive overfill (Figs. 14 and 15). Because there was no information about the initial overfill height, we assumed an overfill height of 1 cm for the finite element simulation. This selection was based on the fact that there was one point at the remaining overfill that had a height of 1 cm. The other areas were mostly degraded, with heights of less than 0.5 cm. Severe corrosion was noticed on every peak of overfill.

Figure 15. An excessive overfill and severe surface degradation beside overfill at 6 o'clock position.
