Glenoid Loosening in Total Shoulder Arthroplasty

Nahum Rosenberg, Maruan Haddad and
Doron Norman

<http://dx.doi.org/10.5772/53438>

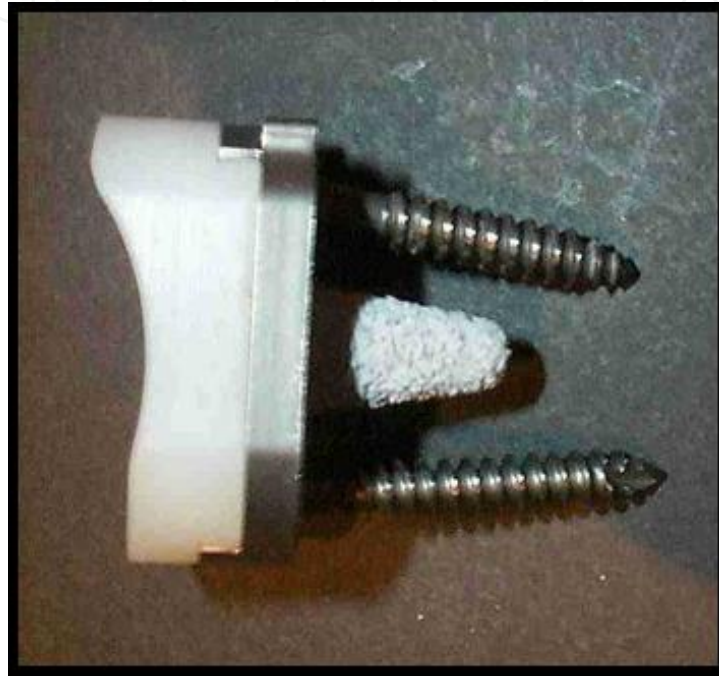
Figure 2. An example of glenoid component for cementless implantation: a polyethylene insert mounted on a metal back-plate with tapered peg covered by hydroxyapatite. The initial press fit fixation is enhanced by two screws. This design showed improved survivorship rates.

1. The fixation area of the glenoid component is limited, either for cemented or cementless fixation. In order to increase fixation interface the glenoid components bear keels (central or in offset position), pegs (straight or tapered) and/or curved backsurface of the insert. It is not clear what type of fixation design is optimal for the cemented fixation [11]. There is some clinical evidence that a central tapered peg on a metal back-plate, covered by hydroxyapatite for enhanced osseointegration, and initially fixed by two screws, might reduce loosening rate of glenoid component in cementless press fit fixation [15] (Figure 2).

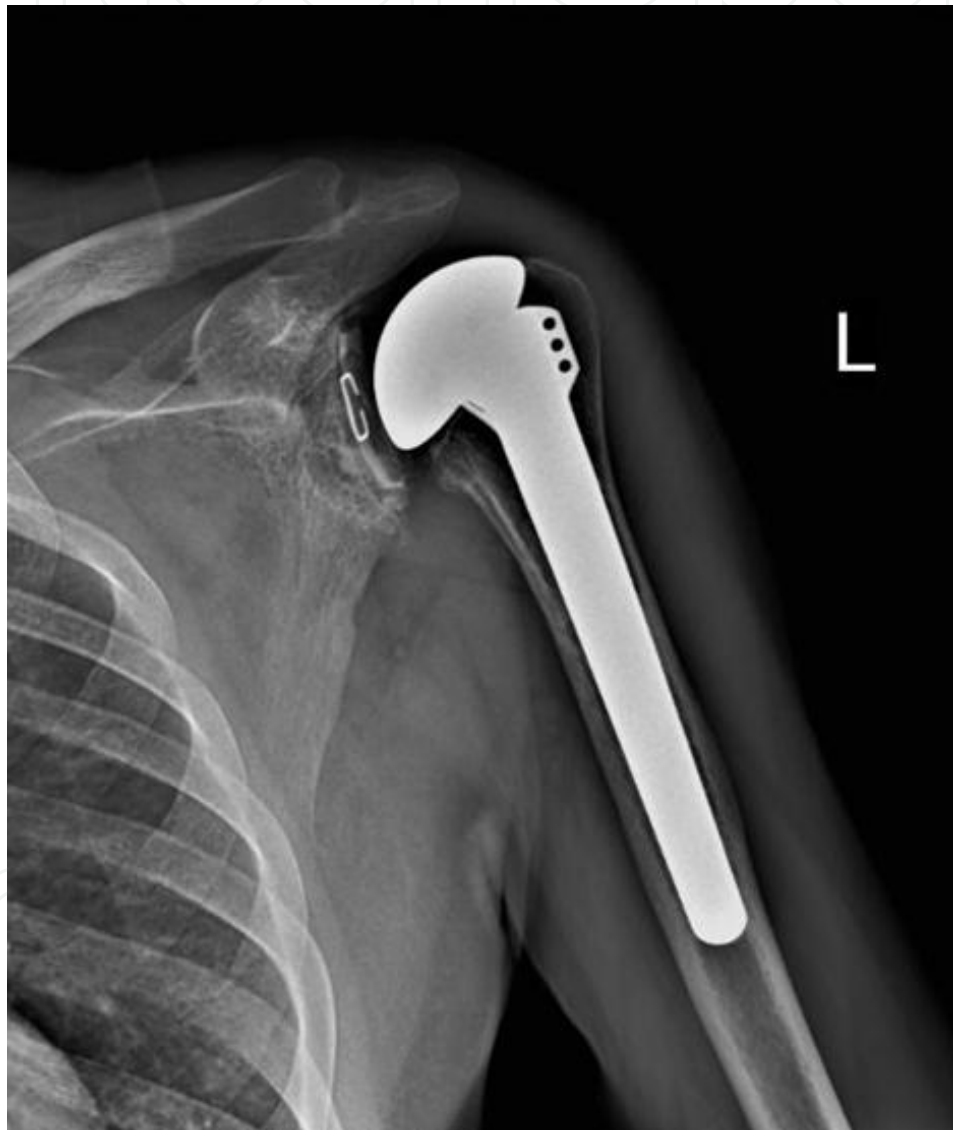
Figure 3. A shoulder radiograph (anterior-posterior view) of 60 years old male patient, three years after cemented TSA. Lucency is evident in the direct proximity to the glenoid component, but the patient is pain free and has good range of movements of the operated shoulder, without any laboratory evidence of infection and is satisfied from the function of the operated shoulder.

The clinical signs of the TSA prosthesis failure include an increased level of pain during follow-up, that appeared to be related to the implant, with restriction of external rotation to under 20° and abduction to under 60° and/or newly developed radiolucency at the glenoid component interface with the underlying bone, more than 2mm in width [17]. The recognition of coexistence of both physical and radiographic signs is essential, since the isolated finding of periprosthetic radiolucency, without pain or significant restriction of movements of the shoulder, might not be of a high clinical importance (Figure 3). This consideration
