# **Dikes Stability Monitoring Versus Sinkholes and Subsidence, Dead Sea Region, Jordan**

Damien Closson and Najib Abou Karaki

<http://dx.doi.org/10.5772/57277>

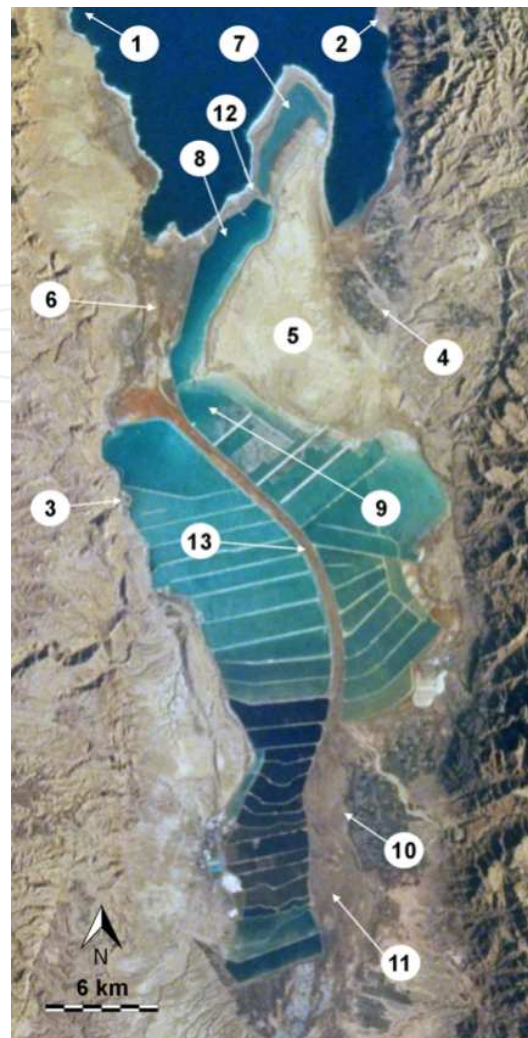
**Figure 1.** Dead Sea southern basin covered by salt evaporation ponds of the Arab Potash Company (East, Jordan) and Dead Sea Works (West, Israel). 1) Ein Gedi; 2) Wadi Shuqeiq delta; 3) Ein Boqeq; 4) Al Mazra'a; 5) Lisan Peninsula; 6) Lynch Strait (dried up); 7) \$38 M SP-0B; 8) \$32 M SP-0A; 9) SP-01; 10) southernmost sinkhole site; 11) Wadi Araba (braided river) flowing toward the northern Dead Sea basin; 12) Arab Potash Company brine intake station; 13) Truce line flood channel (borderline). Background: picture STS099-751-26 (Feb. 2000), Image Science and Analysis Laboratory, NASA-Johnson Space Center. "The Gateway to Astronaut Photography of Earth."

Retrospectively, the oldest and most damaged places are located inside an area about 15 by 25 km, bounded by the resorts of Ein Gedi, Ein Boqeq, Al Mazra'a and the Wadi Shuqeiq delta [5] (Fig. 1, 1-4). At regional scale, from a tectonic point of view, this zone is characterized by a coalescence of faults [6], and is centered over the Lisan diapir, which is the largest salt dome

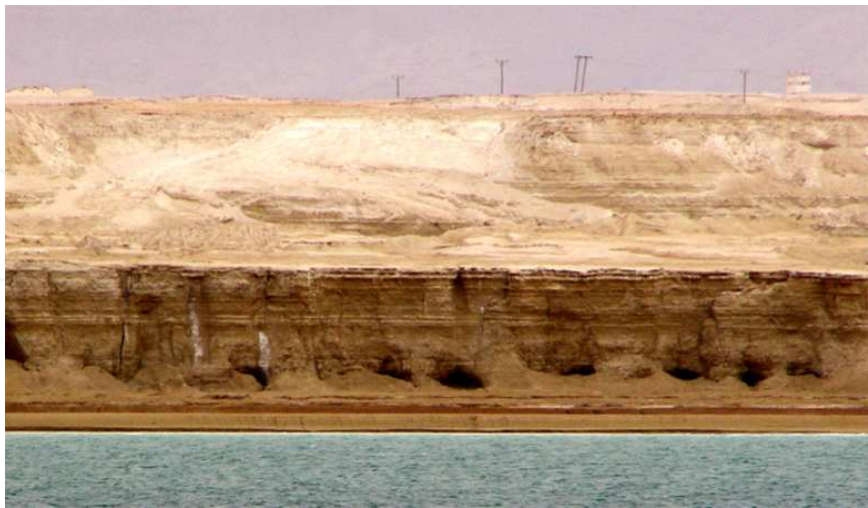
**Figure 3.** Picture taken from dike 18 (SP-0A) toward the east (Lisan Peninsula) and showing SP-0A filled (May 10<sup>th</sup> 2007) and cave entrances at the place where the level of the Dead Sea was in the 1960s (around-390 m). In the back-ground are the sub-horizontal salty marls of the Lisan Formation uplifted by a massive salt diapir more than 120 m below the surface (Fig. 2; grey colors).

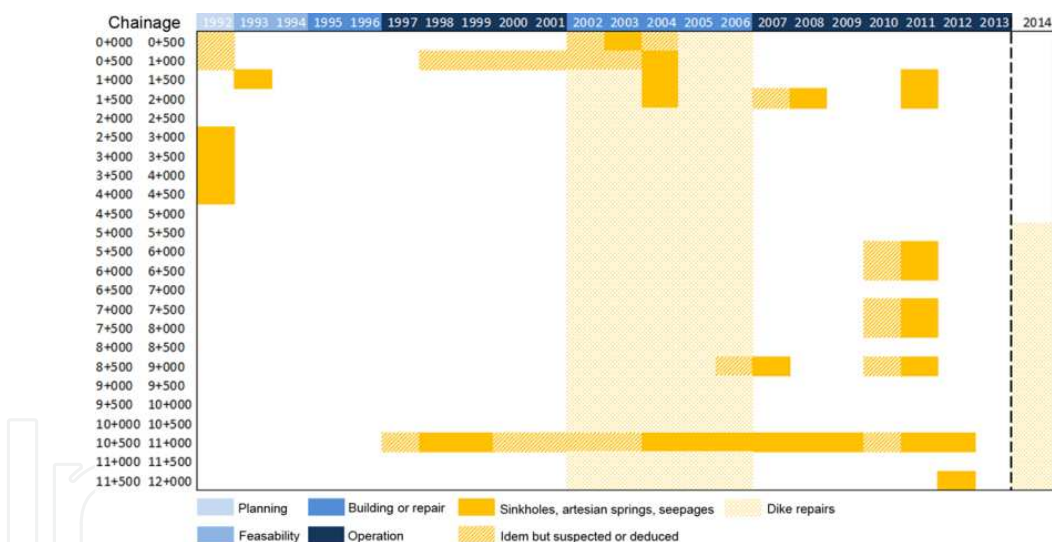
**Figure 5.** Hazards affecting SP-0A from planning to operation phase, distributed along dike 18 from chainage 0+000 to 12+000.

Figure 5 summarized the record of hazardous events for the different living stages of SP-OA and dike 18. Elements cited below come from direct observations, satellite images analysis,

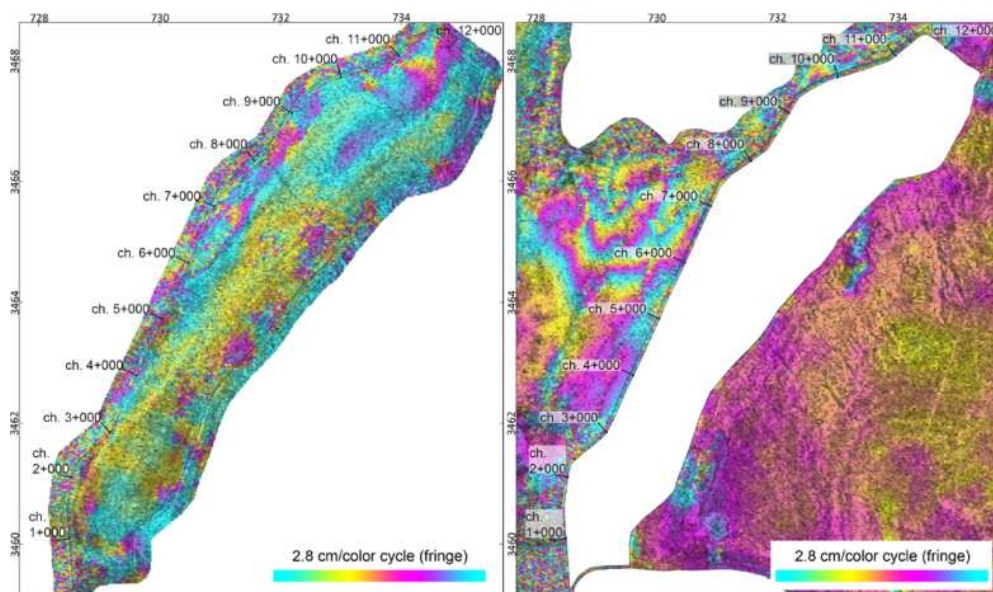
**Figure 8.** Left, filtered interferogram showing ground deformations recorded from 1995-12-17 to 1997-10-12 (665 days). The very short baseline of only 6 m allowed a clear delineation of the deformations where interferometric coherence was preserved. Obviously, during building stage, human activities modify the original distribution of the scatters on the ground. On the right, once filled, the deformations affecting the bottom become inaccessible. The pair 1997-12-21 to 1999-03-21 (455 days) provided the deformation fields with a great precision and accuracy owing to the 18 m perpendicular baseline.

Once in operation (Fig. 8, right side), no information can be retrieved from the bottom anymore (white patch). The deformation fields around saltpan are the only available information to deduce the phenomena occurring below the pond and the dike. Interferogram corresponding to the period 1997-12-21 to 1999-03-21 indicates a strong subsidence in the Lynch Strait. Three fringes representing  $3 \times 0.028$  m of displacement along the line of sight can be easily delineated. This subsidence is caused by the continuous supply of sediments. Decorrelation occurs over the delta because the rate of subsidence is too important to be detected in C-band while it can be done in L-band (see Fig. 10). This external deformation field affect dike 18 from chainage 6+000 to 7+500.

Complex fringes are also visible between 9+500 and 11+500. They are localized in one of the most active zone detected in 1992-1993 (Fig. 6). They attest that underground water circulation is still active in that zone. This element is in agreement with the setting up of a jetty at 10+600 to seal sinkholes at the bottom of SP-0A.

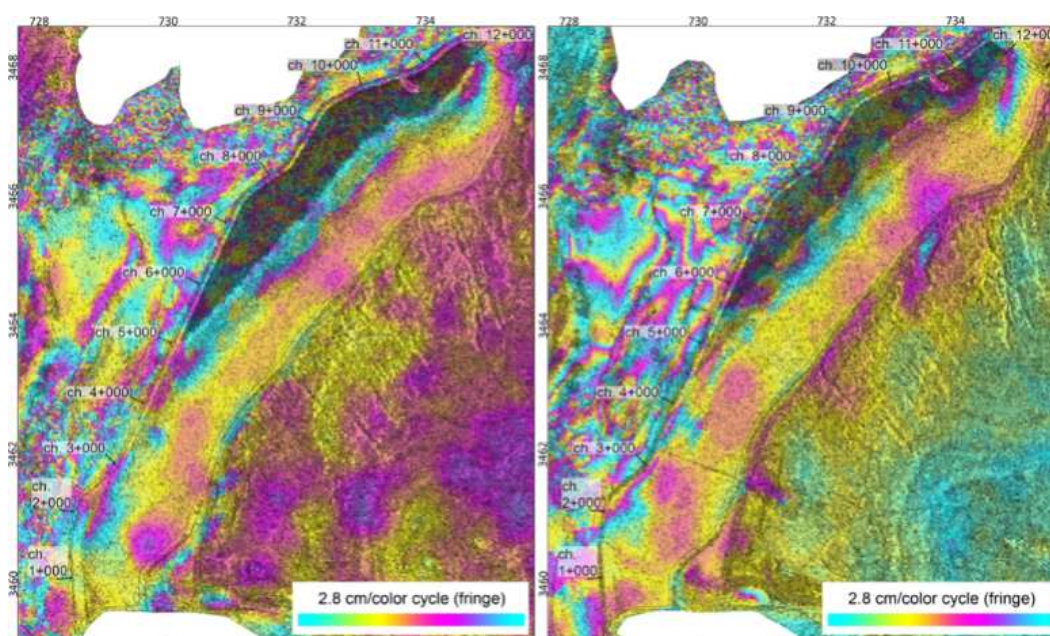
**Figure 9.** Left, filtered interferogram showing the deformation fields from 2004-06-27 to 2004-11-14 (140 days) with a perpendicular baseline of 37 m leading to an altitude of ambiguity of 249 m. On the right, ground movements recorded between 2005-08-21 and 2006-03-19 (210 days) with a perpendicular baseline of 16 m and an altitude of ambiguity of 571 m. Deformations inside SP-0A are quite similar and in agreement with the deformations recorded more than 10 years before.

In the southern part, from chainage 0+000 to 2+000, the deformations of the bottom in relation with seepage coming from SP-01 are always present. Subsidence and uplifted zones are in geographical agreement with the sinkholes and artesian springs observed over contemporary visible images.

In terms of displacement fringes, a clear contrast exists between the Lisan foreshore (now the bottom of SP-0A) and the Lynch Strait. This can be the result of water circulation below the platform caused by Wadi Araba supply. These complex deformation fields are affecting dike 18 over most of its length. Lynch Strait is a no-man's land between Israel and Jordan. There is no vegetation or activity and the area is flat. Therefore, the interferograms are showing with lots of details the ground movements. The recorded losses of coherence correspond to the presence of surface water (Wadi Araba, artesian water basins), or to areas where the speed of subsidence is too high to maintain coherence in C band. For example, this is the case of the Wadi Araba delta.

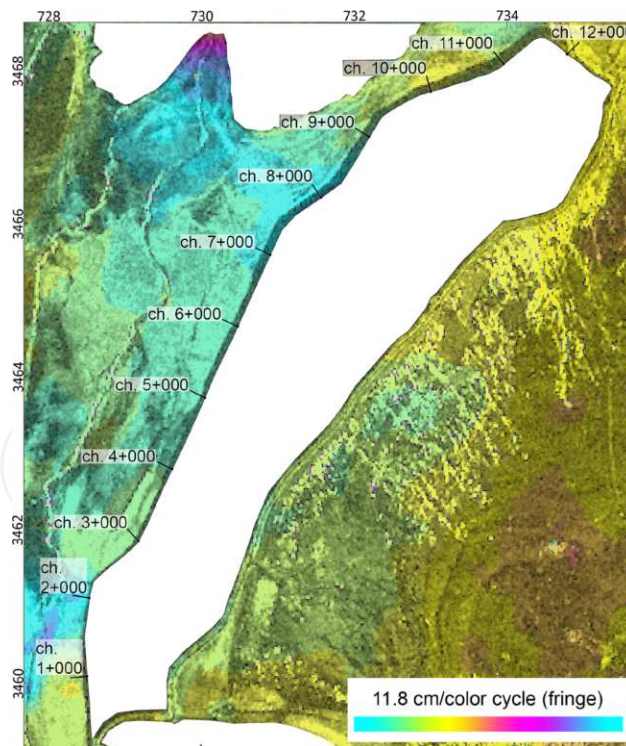
**Figure 10.** ALOS palsar filtered interferogram showing ground deformations recorded from 2008-04-01 to 2008-05-17 (46 days). The short baseline of 41 m leads to an altitude of ambiguity of 1551 m. The image image is therefore a "true" differential interferogram. Because of L-band, some deformation fields appear clearer than with C-band in the most active zones such as the delta of wadi Araba.

At a closer inspection, all along dike 18, some tiny deformation fields are visible. Their geographical extensions fit with ground motions previously recorded with ERS and Envisat. From Fig. 10, dike 18 can be divided into different zones based on the relative displacement between each sections: 0+000 to 1+000 : uplift; 1+000 to 2+200 : important subsidence caused by the underground water flux coming from SP-01; 2+200 to 4+000 : uplift; 4+000 to 6+600 : subsidence; 6+600 to 8+500 : strong subsidence; 8+500 to 9500 : subsidence; 9+500 to 11+00 : important uplift; 11+000 to 11+700 : subsidence.

The color cycle represents 11.8 cm of displacement along the line of sight recorded in 46 days. Two places have recorded a full cycle: UTM coord. 730-3468 and 728-3460. The zone located at 728-3460, outside SP-0A, is in the extension of the sinkholes lineament that appeared in 1992. Its zigzagging shape displays directions similar the the ones of the sinkholes lineament too. One as to note that in these two places, the mean velocity is about 90 cm per year. About 15 years before, the rates ranged from 10 to 15 cm per year. The difference in intensity could be explained by the always increasing head difference between the Dead Sea level and the surrounding water tables leading to a growth in the underground water discharge.

Regarding ground displacements, SP-0A can be divided, from chainage 6+000, into a northern and southern compartment. The northern part is affected by strong subsidence from chainage 6+500 to 9+000. The maximum is reached at 8+500 (white pixels or no data). Another maximum is found at 10+600. The two maxima are identified in C-band from the absence of detection (white pixels) taking into account the context: no vegetation, no human activities, rapid subsidence detected in L-band (Fig. 10).

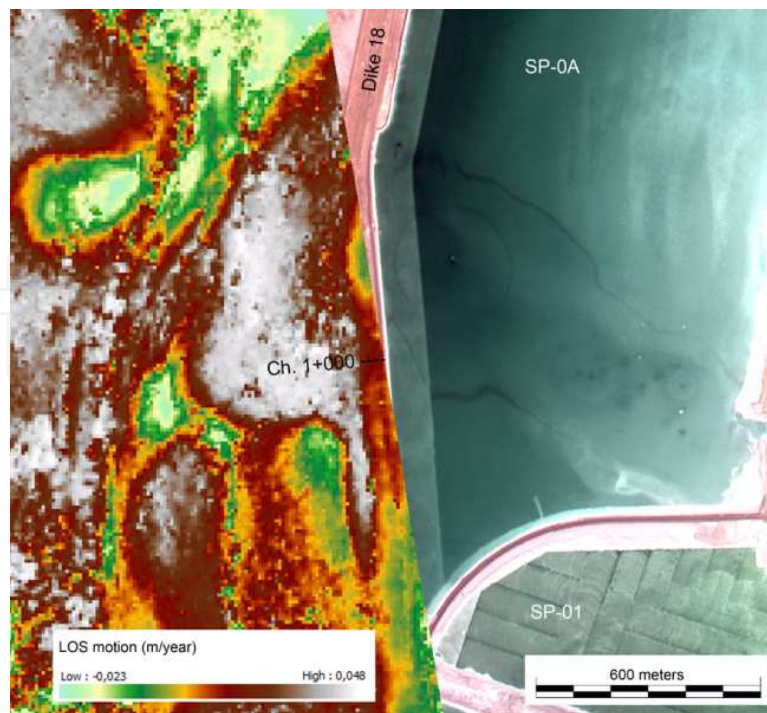
**Figure 11.** On the left, motion data computed from a pair of Cosmo-SkyMed images spanning from 2011-12-14 to 2012-05-06 (141 days). The deformations affecting dike 18 are related to the ongoing groundwater circulation below SP-0A. Sinkholes distribution affecting the bottom of SP-0A (right side) indicate the position of the underground stream. Worldview 2 image acquired the April 2<sup>nd</sup> 2011. Both data sets are in high resolution (about 2 m).

As an illustration, Fig. 11 shows the situation prevailing in the southern part of the SP-0A basin during the first half of 2012. On the right side, owing to its “coastal” (400-450 nm) spectral band, very high resolution Worldview-2 image enable the visualization of the Lisan foreshore through some meters of brine. Color changes correspond to subtle variations in the bathymetry. “Topographic anomalies” such as dark circles can be detected. They are either sinkholes or artesian springs already detected at least five years earlier, when that part of SP-0A was dried up for dike repairs. In particular, a circle 300 m in diameter appears close to dike 18. Other circular structures occupy the bottom of an ESE-WNW oriented “valley”.

Beyond the dike, Worldview 2 image does not provide any relevant indications at the exception of the sinkholes and of the most apparent cracks. These elements, although important in hazard mapping, provide a rough idea of the deformation fields threatening the integrity of dike 18.

The unwrapped phase computed from a pair of Cosmo-SkyMed images reveals the staggering blow generated by the groundwater entering the Lynch Strait by passing under dike 18. The deformation field is made of ripples (anticlinal and synclinal) centered on the main impact zone (chainage 1+200). The affected dike section is more than one kilometer long. The threat is extremely diffuse so that the established security measures oriented towards stabilization of cracks and sinkholes (“point-like” events) can not be efficient in this case. Fig. 11 provides an overall picture of the situation and this one could not be described as accurately with traditional techniques even with a dam over-equipped with sensors.

The circular features located between 1+000 and 2+000 are in relation with subsidence phenomena. They were identified in the early 2000s owing to SPOT images and VHR acquisitions. They probably result from water ingress along a former flood channel (Fig. 11).

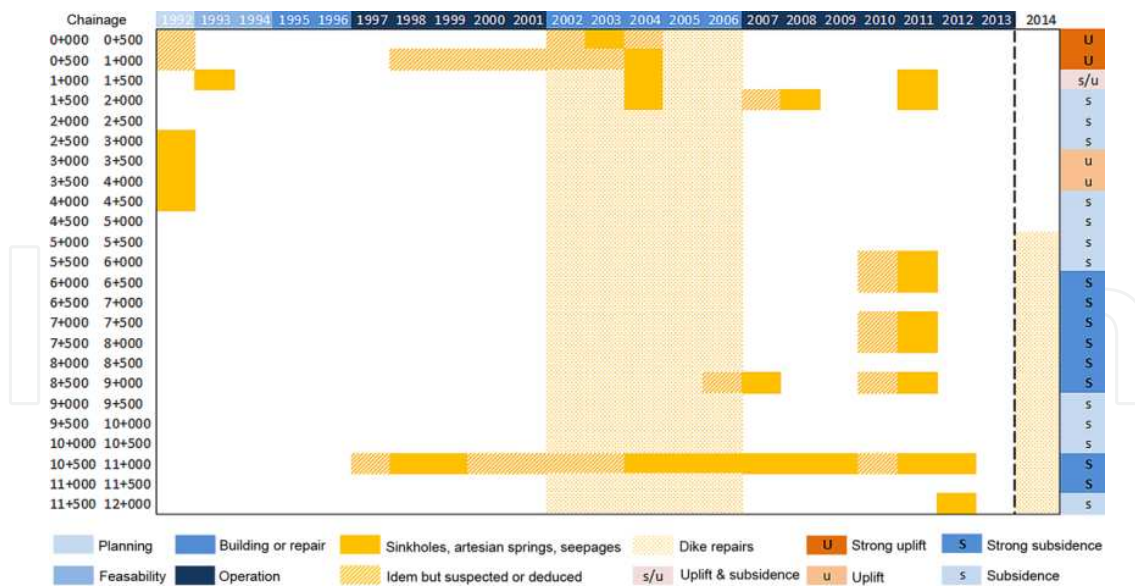
**Figure 13.** Comparison between sequences of hazard events along dike 18 and a qualitative assessment of the ground deformations computed from 1992 to 2010 with SBAS technique [36-38] ("SBAS" module of Sarscape software).

SBAS data operate a large number of interferograms. This technique allows a comparison between them and delivers a time series of ground motions that can be used to represent the dynamics of potential or actual hazards for dike 18. As an illustration, SBAS results allow a comparison with the hazards recorded during the two previous decades. Figure 13, right side column, summarizes the SBAS information in a qualitative way.

Those recorded from 5+500 to 12+000 are also in connection with subsidence. The dike segments located on the limits between uplift and subsidence are exposed to fractures where sinkholes can eventually appear. Such fractures are common in the remaining dikes 19 and 20 of SP-0B.
