# **Investigation of Ground Remote Sensing Techniques for Supporting an Early Warning Water-Leakage System**

Athos Agapiou, Dimitrios D. Alexakis,  
Kyriacos Themistocleous, Apostolos Sarris,  
Skevi Perdikou, Chris Clayton and  
Diofantos G. Hadjimitsis

<http://dx.doi.org/10.5772/59531>

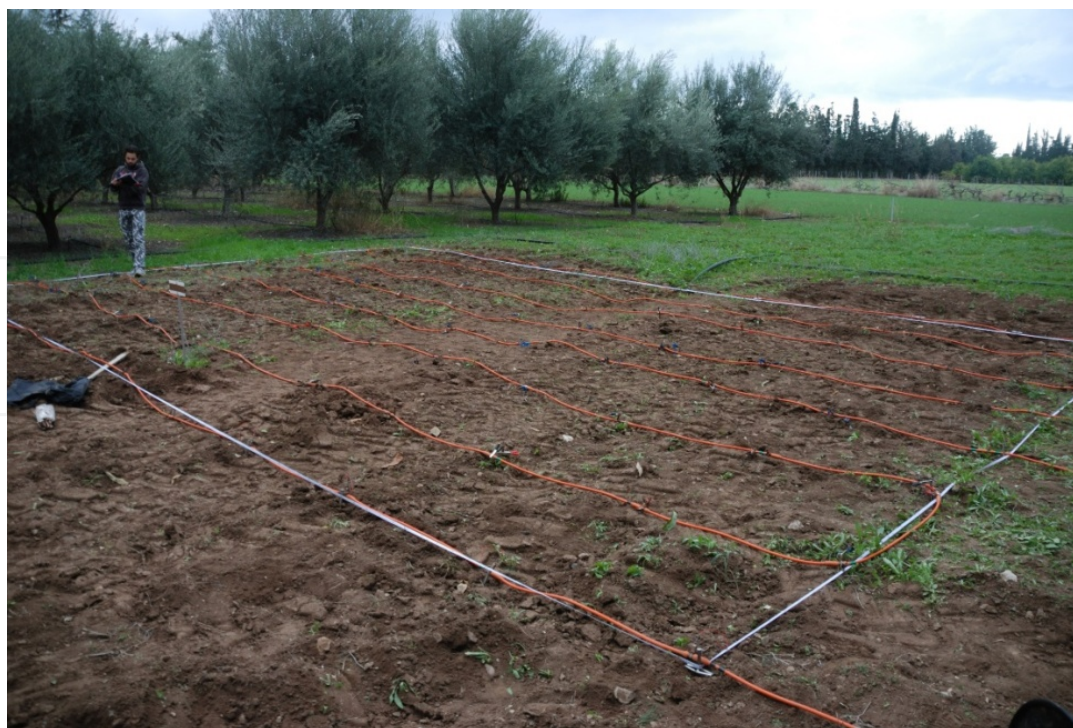
**Figure 1.** Area of interest. A pipeline was buried at a depth of approximately 1 meter.

In this area, a pipeline was buried 1 meter below surface. Cracks were produced in the pipeline in order to create an artificial leakage event. The end of the pipeline was connected to a valve. Figure 2 shows the area of interest approximately one hour after the artificial leakage event.

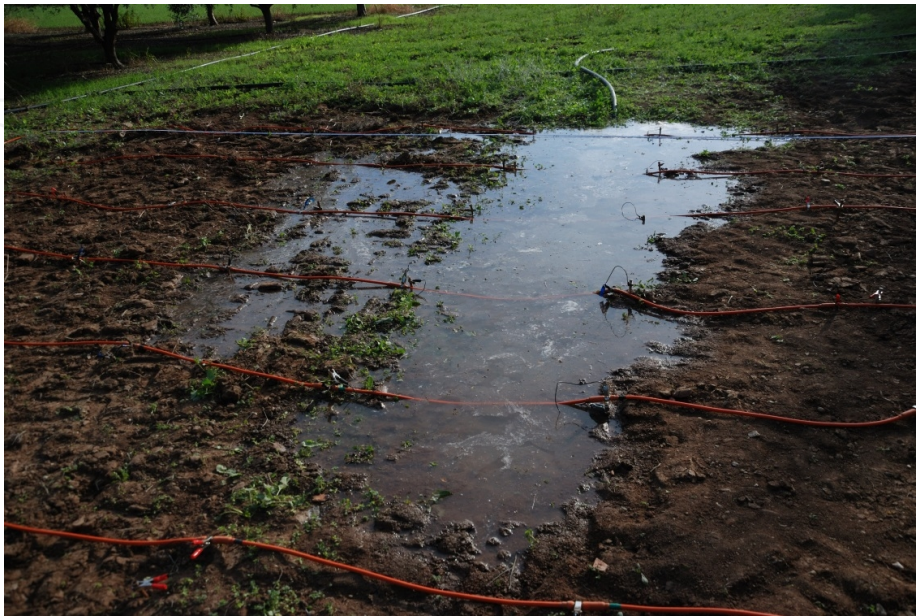
**Figure 2.** Leakage as observed from the surface

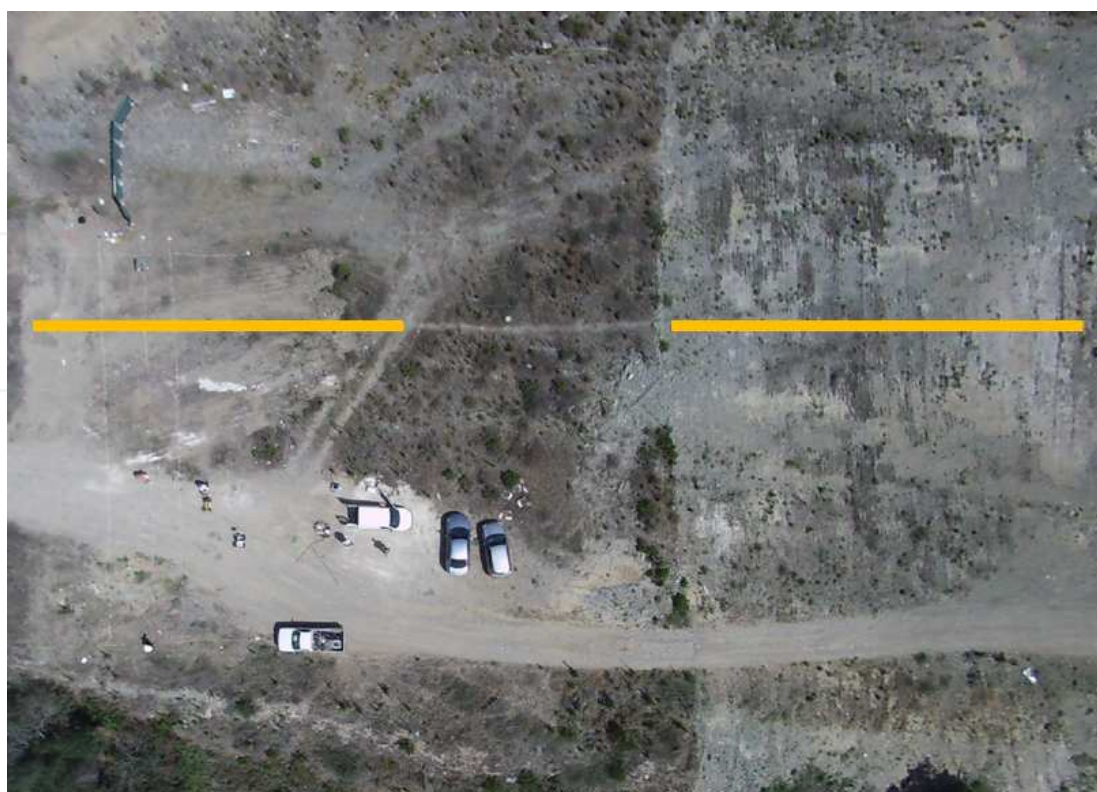
**Figure 5.** Lakatameia underground pipeline as observed from UAV

It was found that, in some cases, the UAV can identify water leakages and water pipelines in different ways such as increased vegetation along the pipeline where the water leakage occurs, change of soil characteristics along the pipeline route (Figure 5), as well as changes in the reflectance value of soils in the water leakage area. UAVs can also be used with thermal and infrared cameras to identify changes in temperature due to water leakage. An additional benefit of UAV platforms is that they can be used to survey large areas to provide overall coverage of the area or it can be used for areas that are inaccessible. The integration of UAV with other techniques is a useful method to cross-validate the leakage event.

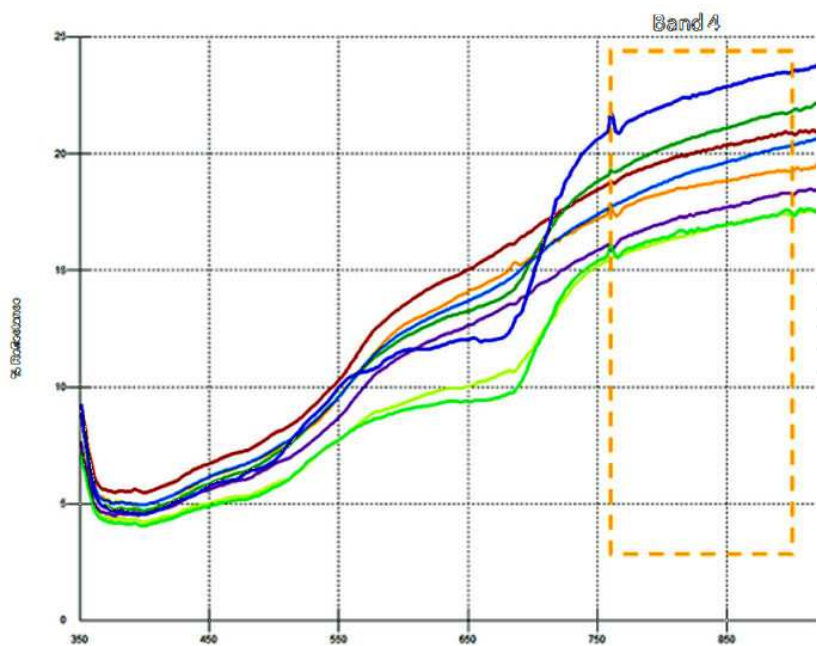
**Figure 10.** Spectral signatures profiles before and after the leakage event. The differences are maximized in the near infrared part of the spectrum (Band 4)

Figure 10 features the spectral signatures profiles from some regions of the study area before and after the leakage event. Using this figure, some preliminary conclusions can be drawn in relation with the reflectivity values of the same regions prior and after the leakage. The near infrared part of the spectrum (Band 4) tends to give the highest deviations. The reflectance values after the leakage is lower than prior to the event. Regarding the measurements over the pipeline there is a difference in the reflectance values before and after the leakage (spectral signature red and yellow).

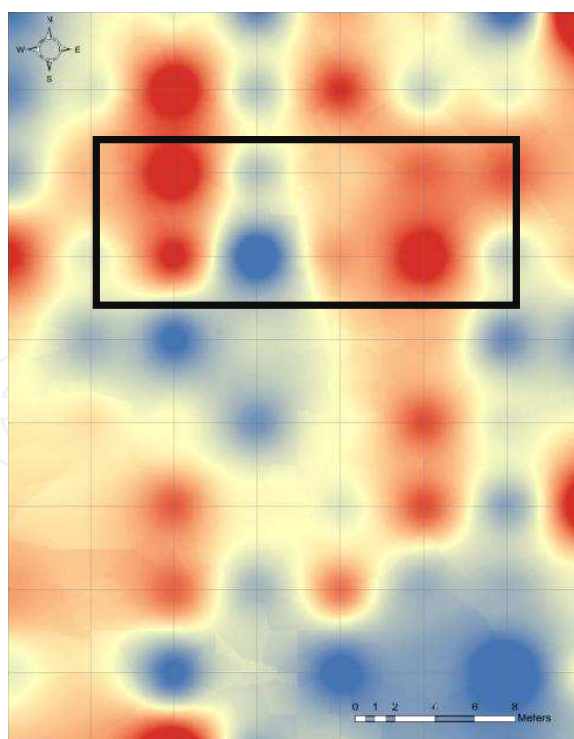
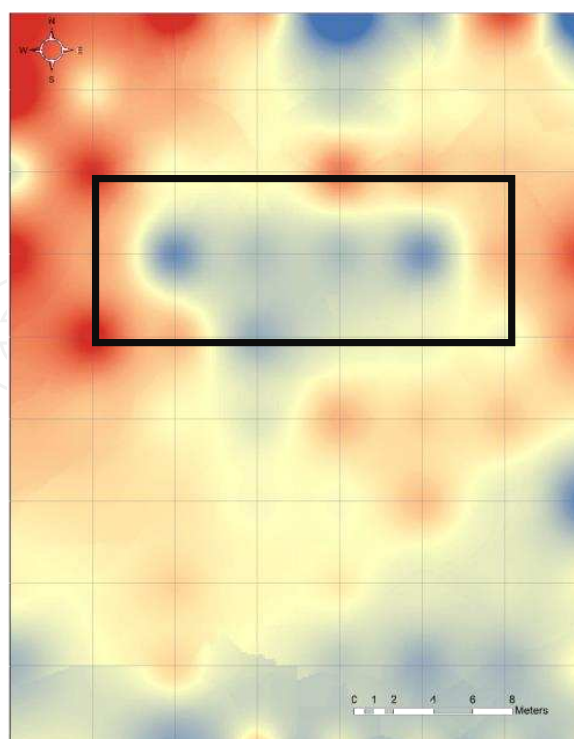
**Figure 13.** Difference values as calculated for SRxNDVI index

Figure 14. Difference values as calculated for SR index

Figure 15. Difference values as calculated for SARVI index

**Figure 16.** Difference values as calculated for RVI index

**Figure 17.** Difference values as calculated for OSAVI index

Figure 18. Difference values as calculated for NDVI index

Figure 19. Difference values as calculated for MSR index

**Figure 20.** Difference values as calculated for MSAVI index

**Figure 21.** Difference values as calculated for IRG index

Figure 22. Difference values as calculated for GNDVI index

Figure 23. Difference values as calculated for GEMI index

**Figure 24.** Difference values as calculated for DVI index

**Figure 25.** Difference values as calculated for ARVI index

Several vegetation indices presented in Figures 13-25 were able to highlight the leakage as well as the area around the buried pipeline before and after the leakage (table 2). The buried pipeline is indicted by the black triangle in each figure. However, in addition to the leakage event, there were other parameters that played a significant role for the detection of the problem. As the results indicate, vegetation indices, including the NDVI index, were able to identify the leakage, yet there were some problems related to the atmospheric conditions. In contrast, the ARVI index was able to map the leakage with no difficulties since it is an atmospheric resistance index. EVI was another index with can be applied for this purposes as well.

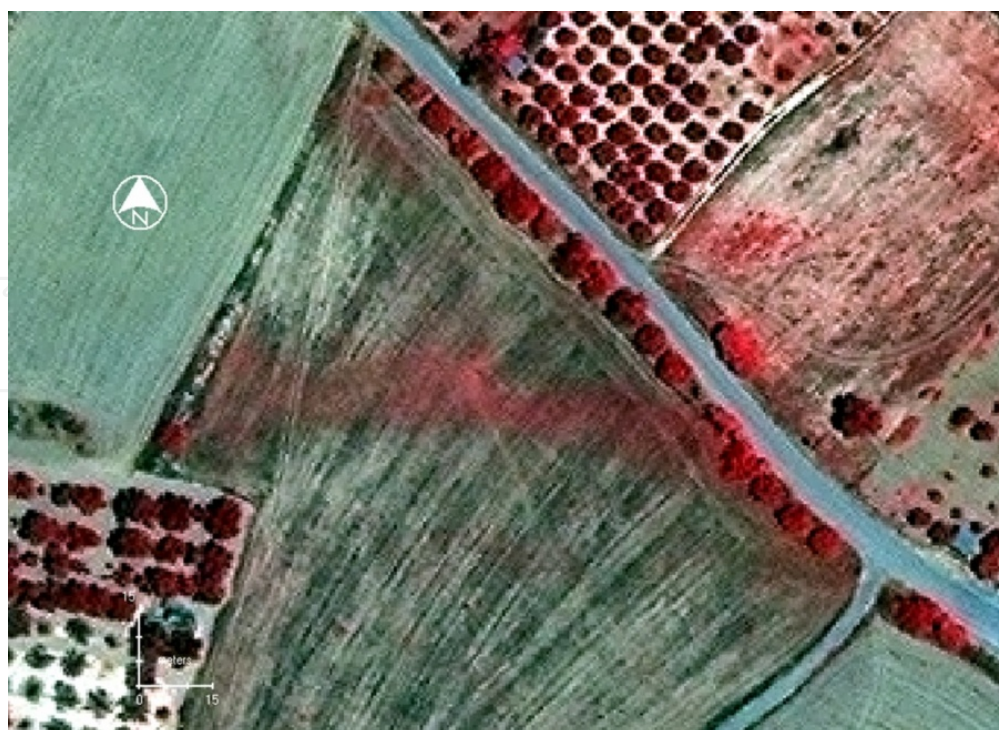
**Figure 27.** Detection of leakage problem using high resolution satellite data (Agapiou et al. 2014)

The modeler was built into the ArcGIS environment and successfully applied using several satellite data. Previous studies of the authors (Agapiou et al. 2014) the detection of leakage events was possible (see Figure 27).
