Electrochemical Characterization of an Optical Fiber Laser-Treated Biomaterial

Eurico Felix Pieretti, Olandir Vercíno Corrêa, Marina Fuser Pillis and Maurício David Martins das Neves

http://dx.doi.org/10.5772/intechopen.72653

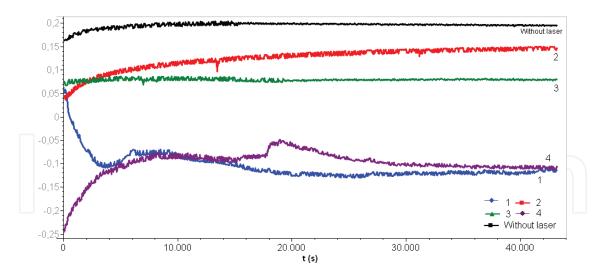
The corrosion resistance of the ISO 5832-1 stainless steel, greatly used for biomedical applications, was measured by electrochemical methods. **Figure 1** shows the variation of the open circuit potential as a function of immersion time for the four different types of laser marked surfaces and the blank (without laser), at 37°C, during a period of 12 h, which was reasonable time for the stabilization of corrosion potential. The tests were carried out for 10 specimens of ISO 5832-1 austenitic stainless steel, for each of the following conditions: unmarked and laser marking, changing the pulse frequencies in four levels. The analysis of **Figure 1** allows the understanding of some phenomena that have been repeated for several specimens depending on the type of surface evaluated.

Figure 1. Open circuit potential variation with time of immersion for unmarked and Yb-optical fiber laser marked surface, in different frequencies, during 12 h of immersion in phosphate buffer solution (PBS).

The curve presented in black color, referring to the steel without markings, is representative of the amount of 10 tests performed and presents a more constant open circuit potential for the period evaluated, which suggests the existence of a more stable passive film on the steel. From the first 4000 s of immersion, there is an increase in potential, which with the passage of time, exhibits more uniform behavior until reaching a value of the order of 0.18 V (SCE) in 12 h of test.

Most of the specimens marked by laser beam with parameters 2 and 4 showed a trend of increasing in potential for nobler and more stable values. Specimen 1 showed a drop in open

circuit potential for the first immersion times, around 4000 s. This potential drop can be associated with the attack of more active regions of the surface due to the formation of microplates related to defects generated by the laser marking process. The attack of the more active regions can be considered as a partial "cleaning" of the surface by corrosive attack that is followed by a more homogeneous surface responsible for the recovery of potential in the final moments of the immersion. Specimen 3 presented values of more uniform potentials throughout the open circuit immersion period.

For longer immersion times in this solution, around 25,000 s, all specimens with and without laser markings, exposed in **Figure 1**, show uniform behavior of the corrosion potential, indicating the formation of a stable passive film.

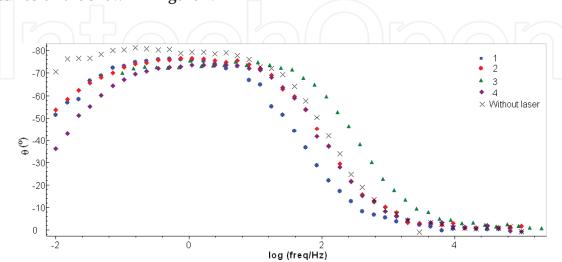
Figure 2. Bode diagram (phase angle) obtained after OCP for austenitic stainless steel ISO 5832-1 in PBS at 37°C.

Figure 2 presents the Bode (phase angle) diagram for the laser marked specimens and without marks, with phase angle values between −35° and −80°, in the low-frequency region, which corresponds to that of passive metals [18, 29–32], and the samples without laser treatment had the lowest values and the highest values were obtained for the samples marked in condition 4.

The electrochemical impedance spectroscopy (EIS) diagrams for the biomaterials under the conditions studied, obtained at 37°C in PBS solution, immediately after the potential monitoring corrosion are shown in **Figure 2**.

The diagram shows two constants. One is in the region of high frequencies, identified with a slope between 0.01 and 0.1 Hz. The other in the region of low frequencies, characterized by a slope between 1 and 10 Hz for the surface corresponding to specimen 1 and between 10 and 100 Hz for the other conditions of marked surfaces (specimens 2, 3 and 4) and without laser. This behavior was observed for stainless steels and associated with the constant at high frequencies at the external-medium oxide interface and the constant at mean frequencies at the internal metal-oxide interface [29–31].

In **Figure 2**, the Bode diagrams show a narrow plateau for the laser-labeled specimens under all conditions evaluated with phase angle values around -70° , in the medium frequency range, and a wide plateau with phase angle values close to -80° over a wide frequency range, from averages to low, for specimens without laser treatment, typical of passive materials [18, 29, 30].

Higher phase angles at low frequencies for unlabeled specimens suggest passive and more protective films. The drop in the phase angles at the lowest frequencies for the labeled specimens is an indicative of the deterioration of the passive film properties. In the laser-etched samples, the peak phase angle occurs at lower frequencies compared to the untreated specimens, suggesting that the outermost layer of the oxide is less protective than the others [18, 24].

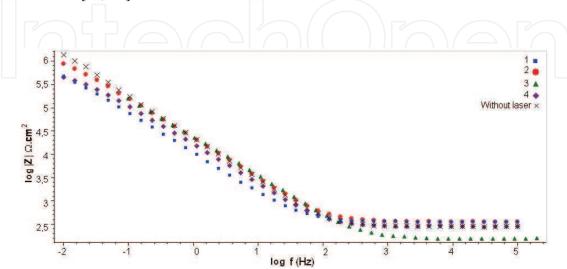
The Bode diagrams, shown in **Figure 3**, represent the reproducibility obtained in 10 tests for each condition and suggest that the change in the laser beam parameters used for the markings has a small influence on the impedance in the low-frequency region, the lowest values obtained for the specimens marked in conditions 1 and 4, and the highest for the material without laser treatment, in this frequency range. This fact evidenced a slight decrease in the protective capacity of the passive film for the treated specimens.

Figure 3. Bode diagram (Z-module) obtained after OCP for austenitic stainless steel ISO 5832-1 in PBS at 37°C.

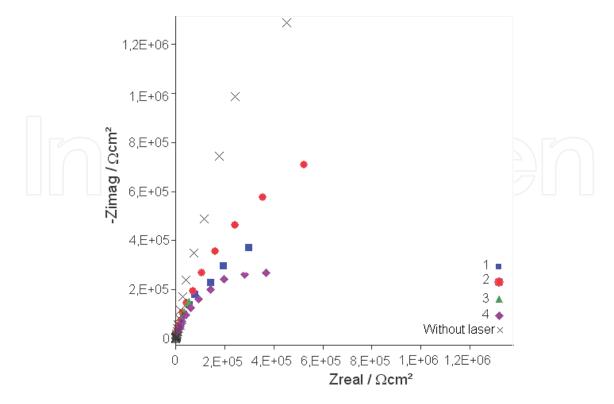
For the same period of immersion from the open circuit corrosion potential, Nyquist impedance diagrams exhibit capacitive behavior, typical of passive materials, and showed lower-Z imaginary values for the specimens with laser treatment; when compared to the specimens without laser beam application. In **Figure 4**, for the same frequency value, the lower impedances were associated with the laser labeled specimen in condition 3, followed by the marking conditions with parameters 4, 1 and 2.

Figure 4. Nyquist diagram obtained after OCP for austenitic stainless steel ISO 5832-1 in PBS at 37°C for the specimens.

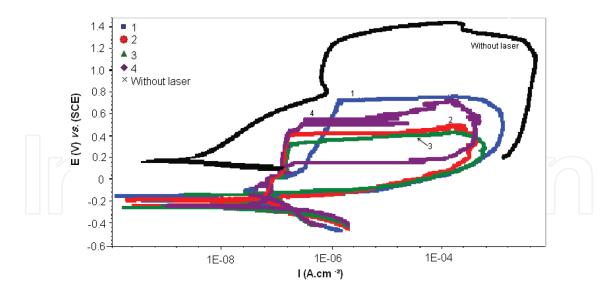
Figure 5 presents the cyclic polarization curves for specimens with and without laser marks. This result represents the laser effect on the susceptibility to corrosion of this stainless steel; the curves presented values of passive film breakdown from about +0.3 V (ECS) to +0.8 V (ECS).

Figure 5. Potentiodynamic polarization curves for unmarked and laser marked ISO 5832-1 stainless steel samples obtained in phosphate-buffered saline solution (PBS).

The EIS results were supported by the cyclic potentiodynamic polarization curves. The lower resistance to pitting corrosion was associated with the laser treated specimens; this is explained by the thermal effect of the process on the homogeneity of the microstructure of this analyzed biomaterial, which reduces the potential for breaking the passive film.

This variability is expected for heterogeneous surfaces such as the specimens with markings via laser beam, where the conditions of the specimens under conditions 1 and 4 showed higher resistance to localized corrosion. It is noted that the film breaking potentials, for all laser marked conditions, are below the specimens without laser marks, that is, polished to $1 \mu m$.

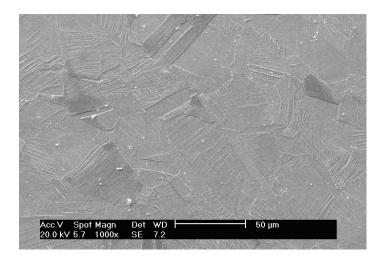
Figure 6. SEM microstructure of ISO 5832-1 austenitic stainless steel surface.

The microstructure of the ISO 5832-1 austenitic stainless steel, widely used for biomaterial application, is presented in **Figure 6**.

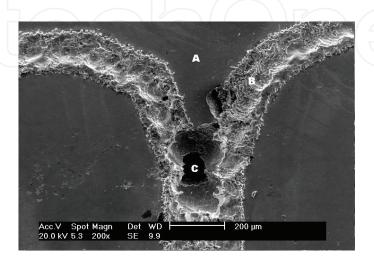
Figure 7 shows that pitting susceptibility is increased in the laser affected areas of the stainless steel surface.

Figure 7. SEM image of the ISO 5832-1 stainless steel surface after polarization tests. (A) Region without laser, (B) laser marked region and (C) laser marked region showing pits associated to the melted areas.
