# Seismic Crack Investigation in an Earth Dam by Centrifugal Loading Test

Akira Kobayashi and Akira Murakami

There are many Earth-fill dams in Japan, which are mostly used for irrigation use. Most of these dams in Japan were constructed by experience over 100 years ago. There are so many irrigation dams, which suffered earthquake damage in the past. Due to the damages, the cracks at the crest in the dam-axis direction have been reported in many cases. For the rock-fill dam recently constructed, the crack on the crest in the dam-axis direction has also been found in the case of a large earthquake. The mechanism of such a crack has not been discussed well. In this study, to clarify the mechanism of a crack in the dam-axis direction, a centrifugal loading test was applied to the dam with a 50 G gravity field. As a result, the critical level of strain was observed at the crest of the model, and it was found that the horizontal displacement at the upper part of the dam was excessive. It can be concluded from the study that the seismic cracks in the dam-axis direction occurred due to the excessive tensile stress, which was not considered in the design process.

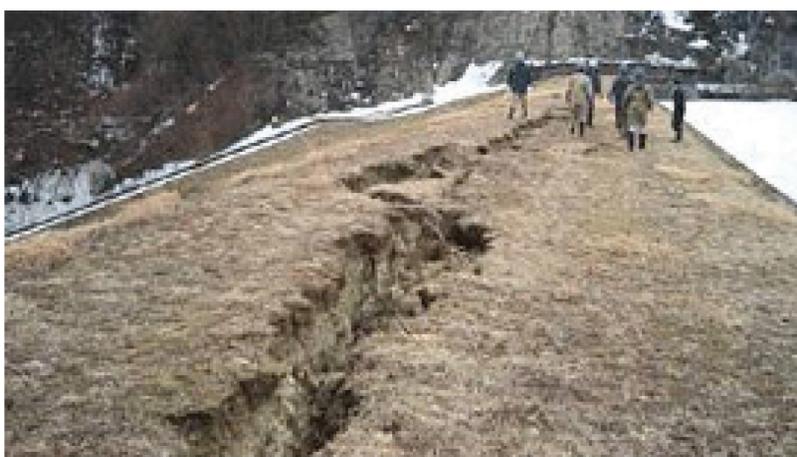
Many irrigation dams were not designed for earthquake resistance, and the cracks at the crest in the direction of the dam axis are remarkable. **Figure 1** shows the example of the crack at the crest of the Earth-fill dam. The relatively big open crack occurred. This type of open crack can be seen in the damaged Earth-fill dam so often. Not only the old Earth-fill dam but also the recent rock-fill dam has a crack in the dam-axis direction when the big earthquake hit. **Figure 2** shows the crack situation at the crest of the rock-fill dam constructed in 1988. This dam was designed for earthquake resistance. Although the acceleration was not measured, it was inferred that relatively big acceleration occurred because the earthquake inducing the crack was in 2011 off the Pacific coast of Tohoku. The open crack was propagated at a 3 m depth from the crest. The cracks shown in the figures cannot be seen to be induced by shear failure. The earthquake resistance is examined for shear failure with the slip-circle method according to the standard. It is difficult to

**Figure 1.** Crack at the Earth-fill dam.

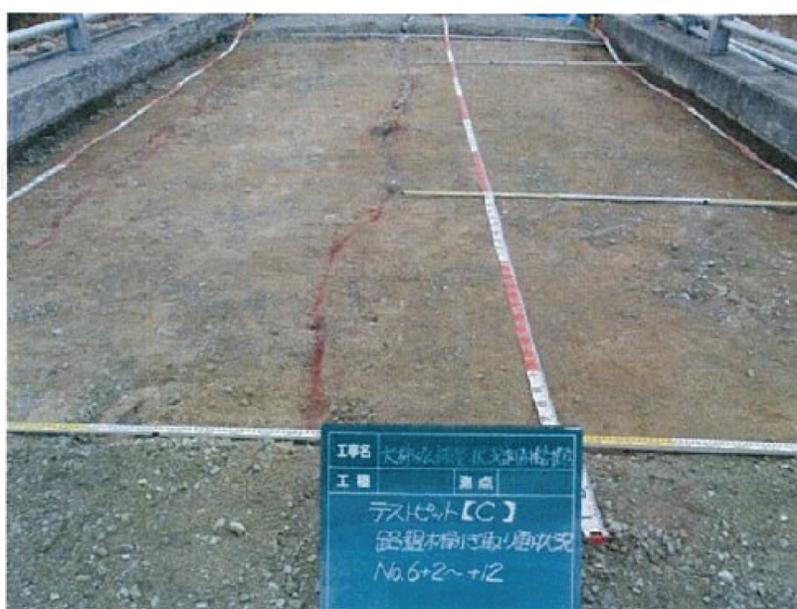
**Figure 2.** Crack at the rock-fill dam.

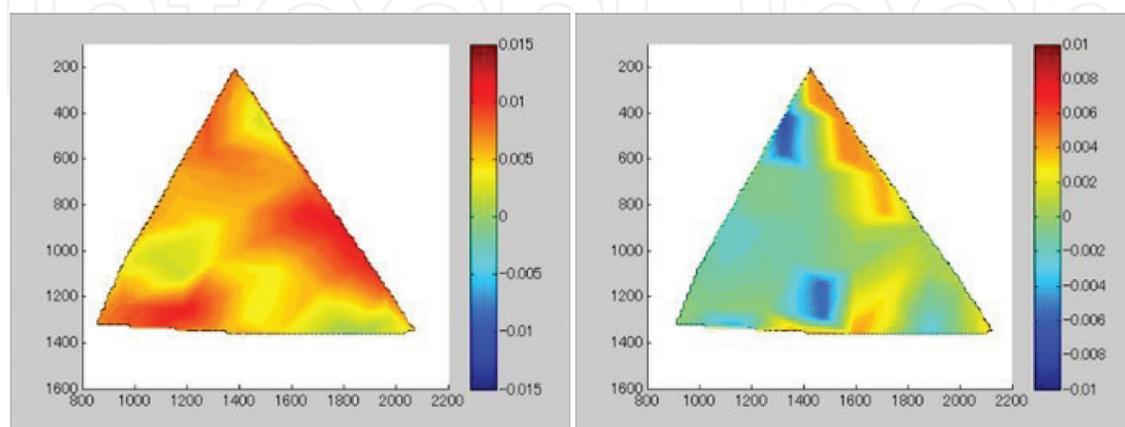
As mentioned earlier, the previous studies focused on the seismic response, slope sliding and deformation and so the situation of the surface of the dam was focused. On the other hand, the authors investigated the behavior of the cross section by 1-G shaking table test [2] as mentioned earlier. **Figure 3** is the strain distribution of the model used for 1-G shaking table test. By using

**Figure 3.** Strain distribution by 1-G shaking test [2]: (a) shear strain and (b) volumetric strain.

image analysis, the behavior of cross section was observed. It was found that the shear stain became large at the slope, and the large volumetric strain was observed at the upper part of the dam. In this study, a similar image analysis is used for the centrifugal loading test.

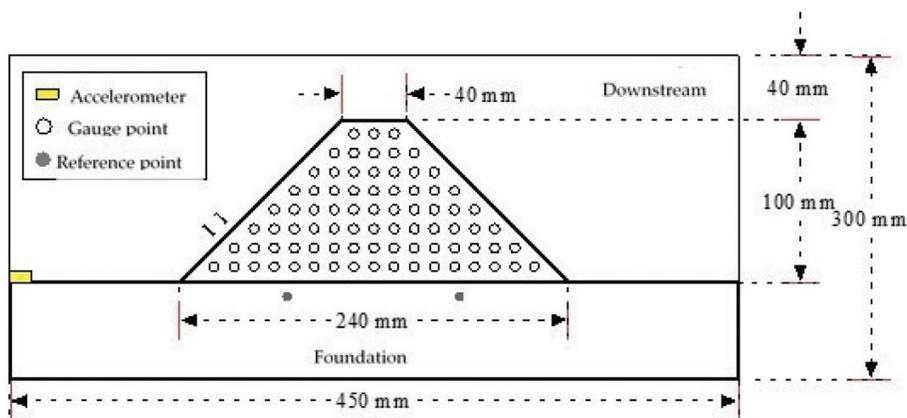
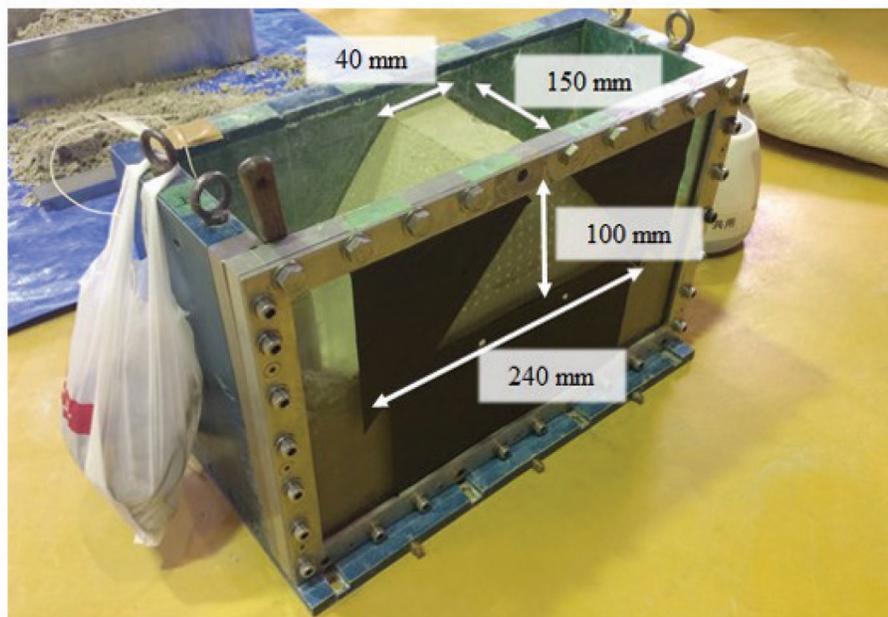
The centrifugal loading tests were conducted under 50-G with a 1/50 scaled model. In this experiment, the model with a height of 100 mm and upstream and downstream gradients of 1:1 was used. **Figure 4** shows the schematic view of the model. The model was made from

**Figure 4.** Schematic view of the model and soil box for centrifugal loading test. (a) Schematic view of the model; and (b) the situation of soil box for centrifugal loading test.

Figure 11 shows the change in shear strain distribution. The situation starts from the left end of shaking, moves to the center and right end, and then reverses to the center and finally returns to the left end. The positive value means the shear strain at downstream shown in Figure 4(a), which coincides with the right-hand side. The time

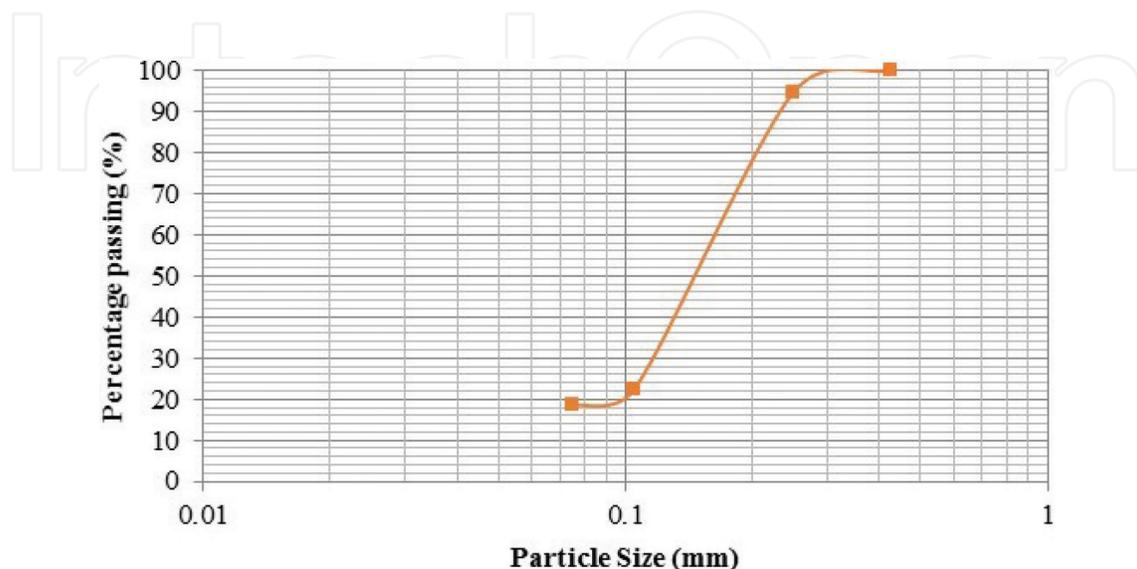
No. 7 silica sand and kaolin clay with the mixture ratio of 8:2 by dry weight. **Figure 5** shows the particle distribution of the mixture. The water content of the mixture was 13%. In order to evaluate the seismic behavior of the model, the gauge points were placed on the surface of the embankment model and the reference points were set at the foundation. The total number of the points is 82. To reduce the friction between embankment model and wall of the soil box, the silicone grease was painted on the wall surface. The accelerometers were installed on the foundation. The foundation was made of rigid material. By assuming that the distance of the reference points on the rigid foundation is not changed, the coordinate of the gauge points is calibrated.

**Figure 5.** Particle size distribution used for the embankment model.

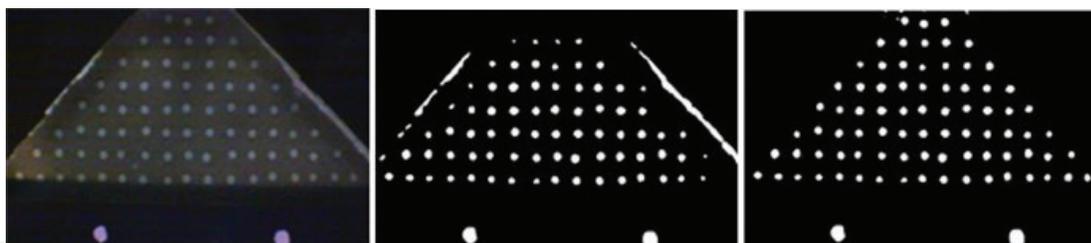
Firstly, the static image is taken before the model is tested. While the model is excited, continuous images are taken by the high-speed camera of which the shooting speed is 1000 fps. The images are transformed into black and white binary images. The noise reduction is, then, carried out as shown in **Figure 6**. The number of the points is confirmed to be 82 at this stage. Then, the coordinates of the gauge points are measured in the unit of pixels by calculating the center position of each white element representing the gauge point. Finally, the distance between two reference points at the foundation, which was precisely 150 mm, is measured in the unit of pixels. The scale calibration is carried out by the distance of reference points and the coordinate of the gauge points is calculated as the relative location of the reference point in the unit of mm. By repeating this procedure for all dynamic images, the displacement variation of each gauge point can be obtained.

Figure 6. Examples of image analysis process: (a) picture image; (b) binary image; and (c) noise reduction result.

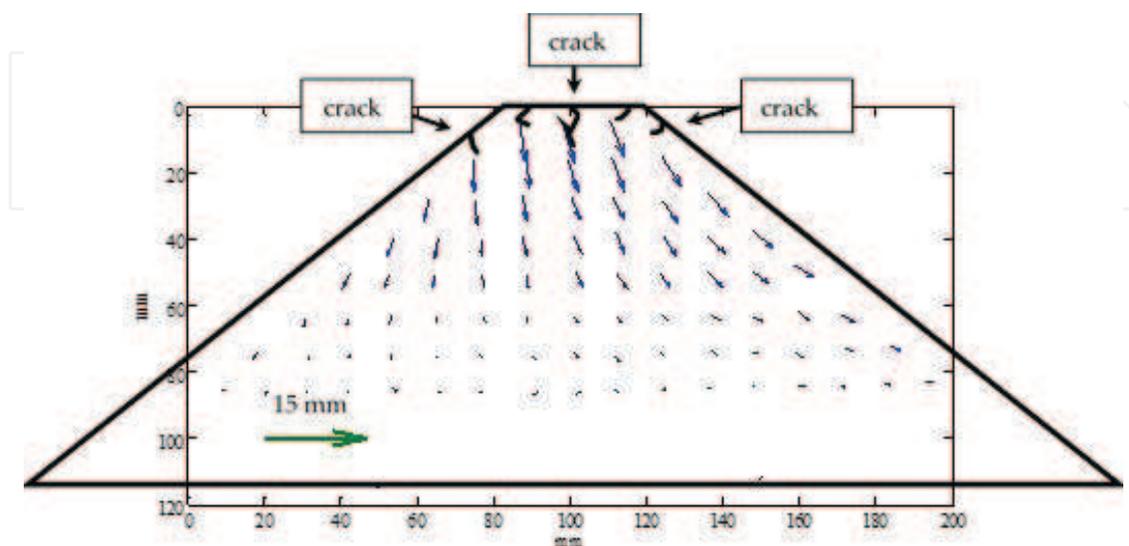
By using the method mentioned above, the behavior of the cross section is examined. **Figure 7** shows the final displacement vector distribution after experiment and the situation of cracks. The cracks occurred at the upper part of the dam body of which the situation is explained later. The downward displacement vector is large at the upper part while the displacement at the lower part is minimal.

Figure 7. Displacement vector distribution after experiment.

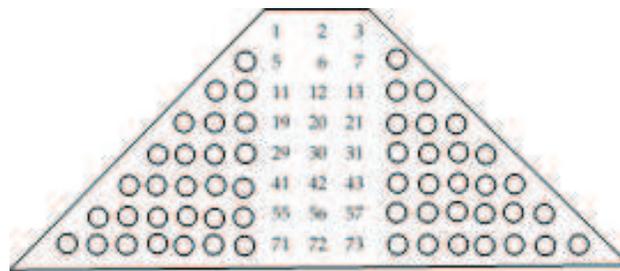
The gauge points shown by the number in **Figure 8** are focused on highlighting the deformation pattern. The downward displacement at the vertical centerline of the dam body, of which

Figure 8. Number of gauge points highlighted for observation.

Then, to observe the horizontal deformation, the change in the horizontal distance between two gauge points is investigated. For example, at the upper most part of the dam, the horizontal distance of gauge points 1 and 3 is presented (see Figure 8). Figure 10 shows the change in the horizontal distances at various heights of the dam with time, in which the legend means the number of gauge points used for the distance calculation. While the horizontal distance becomes large at the height of the middle, the number of 29–31, at the early stage, the ones at the upper parts, the number of 1–3 and 5–7, gradually increase with time. The upper parts have a significant change in the horizontal distance finally. Entirely, the center part of the dam has the horizontal tension behavior except for the lowest part.

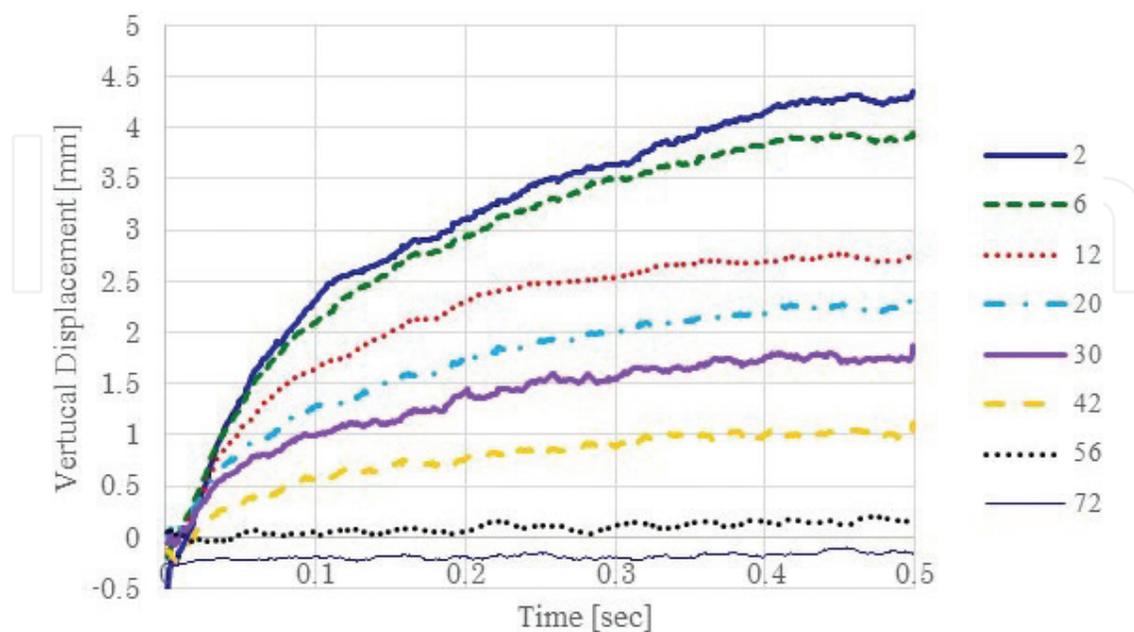
the number is from 2 to 72, is shown in Figure 9. To observe the tendency of the settlement, the displacement is averaged with the period of 0.02 s which is the same as the period of shaking. The downward displacement becomes gradually large with the height of the gauge point. The deformation continues during the experiment at the upper part while the displacement at the lower part does not change so much during the experiment. It is found that the deformation of the upper part occupies the settlement of the dam.

Figure 9. Downward displacement at the centerline of the dam.

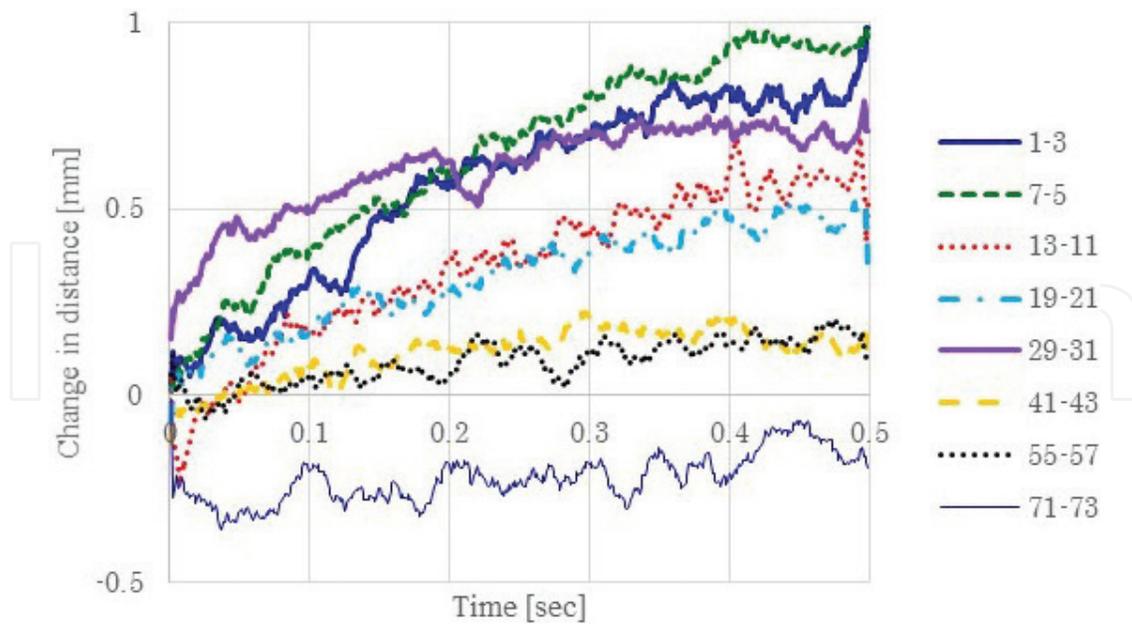
Figure 10. Change in the horizontal distance at the centerline of the dam.

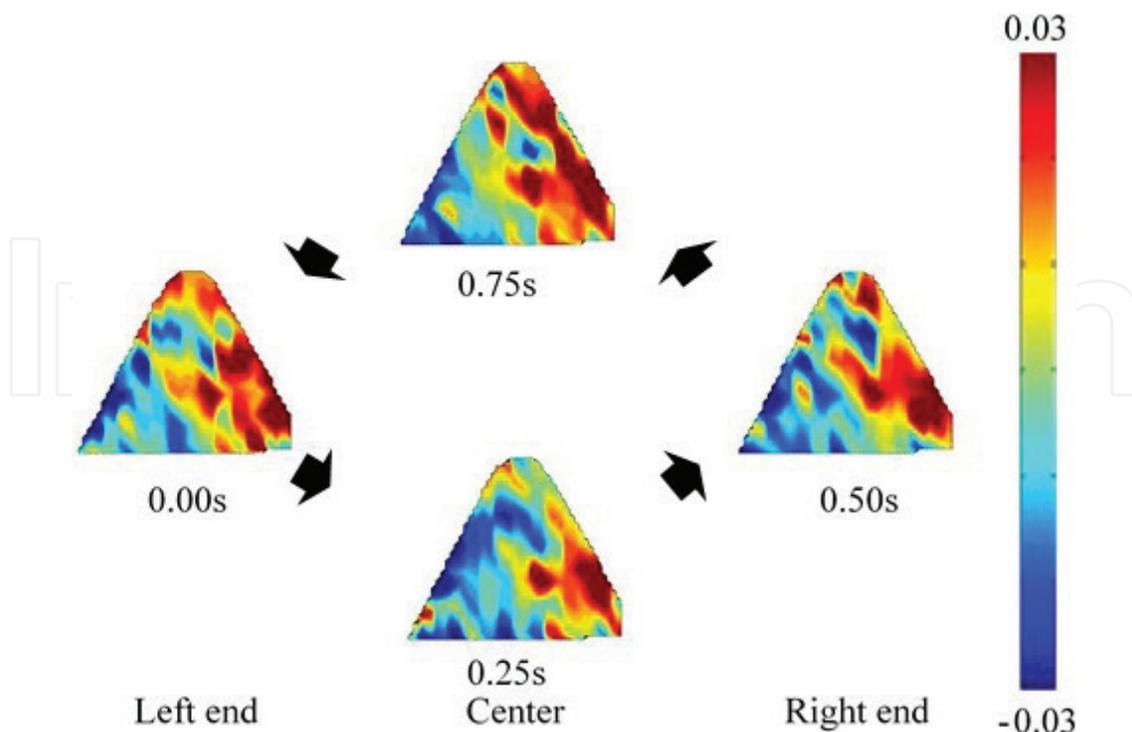
Figure 11. Change in shear strain distribution.

means the corresponding actual one. The shear strain to upstream direction occupies the upstream lower part, while the downstream side of the dam shows the shear strain at the downstream direction. The shear strain in both directions becomes larger at the lower part than the upper part.

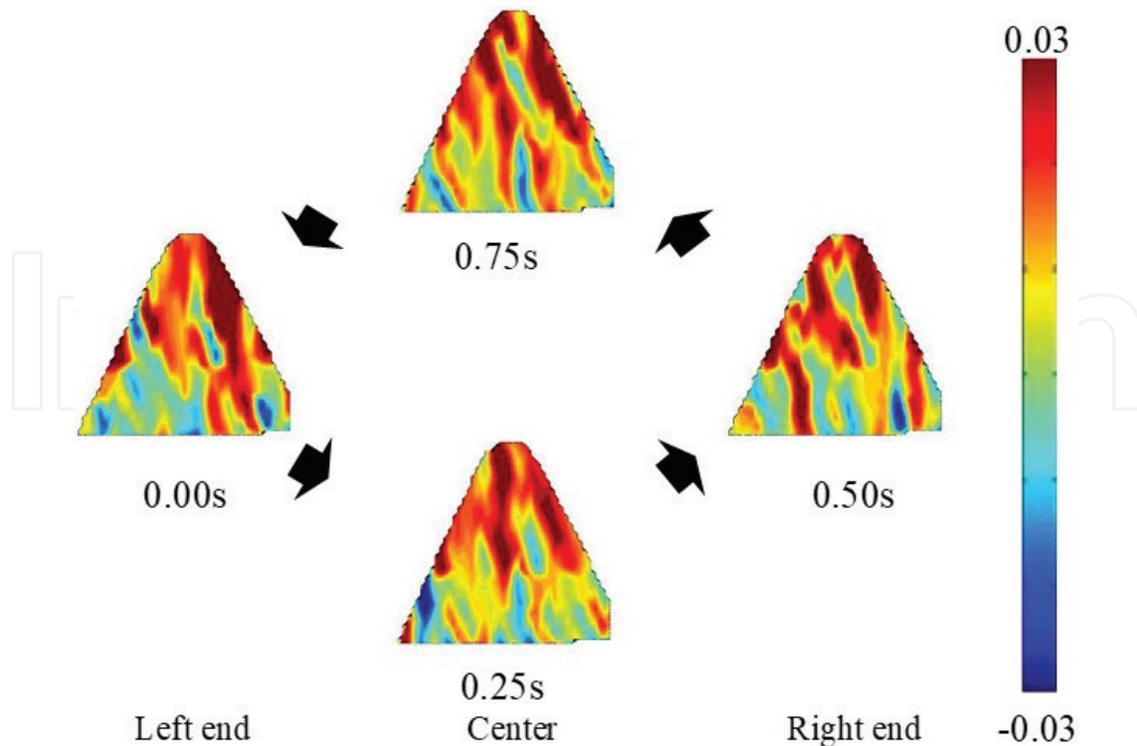
**Figure 12** indicates the volumetric strain distribution change. The positive value means the extension. It is found that the extension occurs at the upper part during the shaking. At the lower part, the extension and compression distribute apparently, and so the striped pattern can be seen. It is shown that the part showing the extension strain coincides with the part indicating the horizontal tension behavior explained (see **Figure 11**).

**Figure 12.** Change in volumetric strain distribution.

the upstream side has the compression strain, and the downstream side has the extension strain for Case 1. On the other hand, Case 2 shows that the extension and compression strain distribute alternatively. This stripe pattern can be seen in the centrifugal loading test as shown in Figure 12. However, the large extension strain cannot be seen in the numerical simulation.

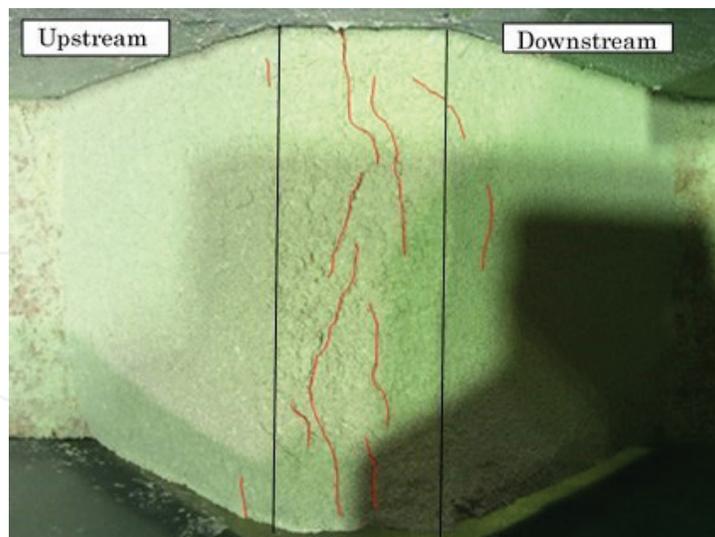
The situation of the crest after the test is shown in **Figure 13**. The crack is marked with the red line. The crack in the dam-axis direction can be seen at the center of the crest as shown at the actual damage site. The sliding behavior cannot be found at the slope of the dam. In order to investigate the deformation situation at the crest, an additional experiment is carried out, at which the gauge points are set at the crest and slope as shown in **Figure 14**. As the situation was photographed from the top, the strain is estimated just for the horizontal plane (**Figure 15**). Therefore, the obtained strain is not the one on the slope but the apparent strain on the horizontal plane. Only the strain distribution at the crest is the accurate value as a strain.

Figure 13. Cracks at the crest after the experiment.

On the other hand, while the volumetric strain also shows the stripe pattern, the direction of the strain development is dam-axis one, which coincides with the crack situation shown in Figure 13. It can be found that the crack shown in Figure 13 is caused by the extension strain at the crest.

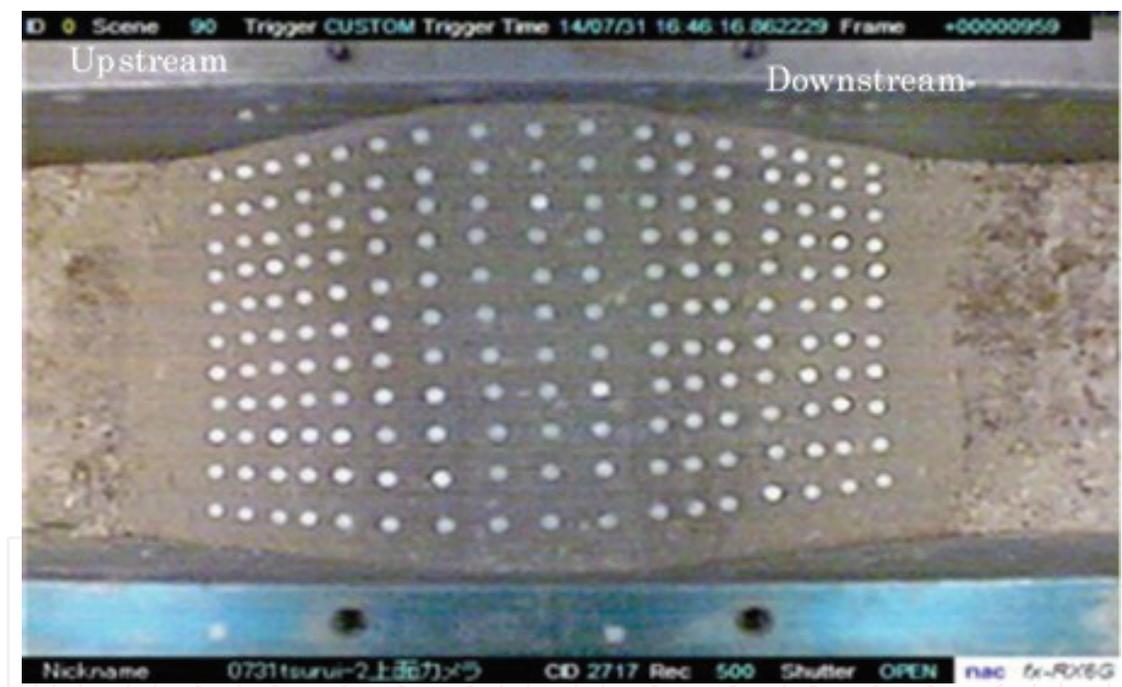
Figure 14. The gauge points on the crest and the slope. (a-1) Left end: shear strain; (a-2) left end: volumetric strain; (b-1) center: shear strain; (b-2) center: volumetric strain; (c-1) right end; shear strain; (c-2) right end: volumetric strain; (d-1) center: shear strain; (d-2) center: volumetric strain.

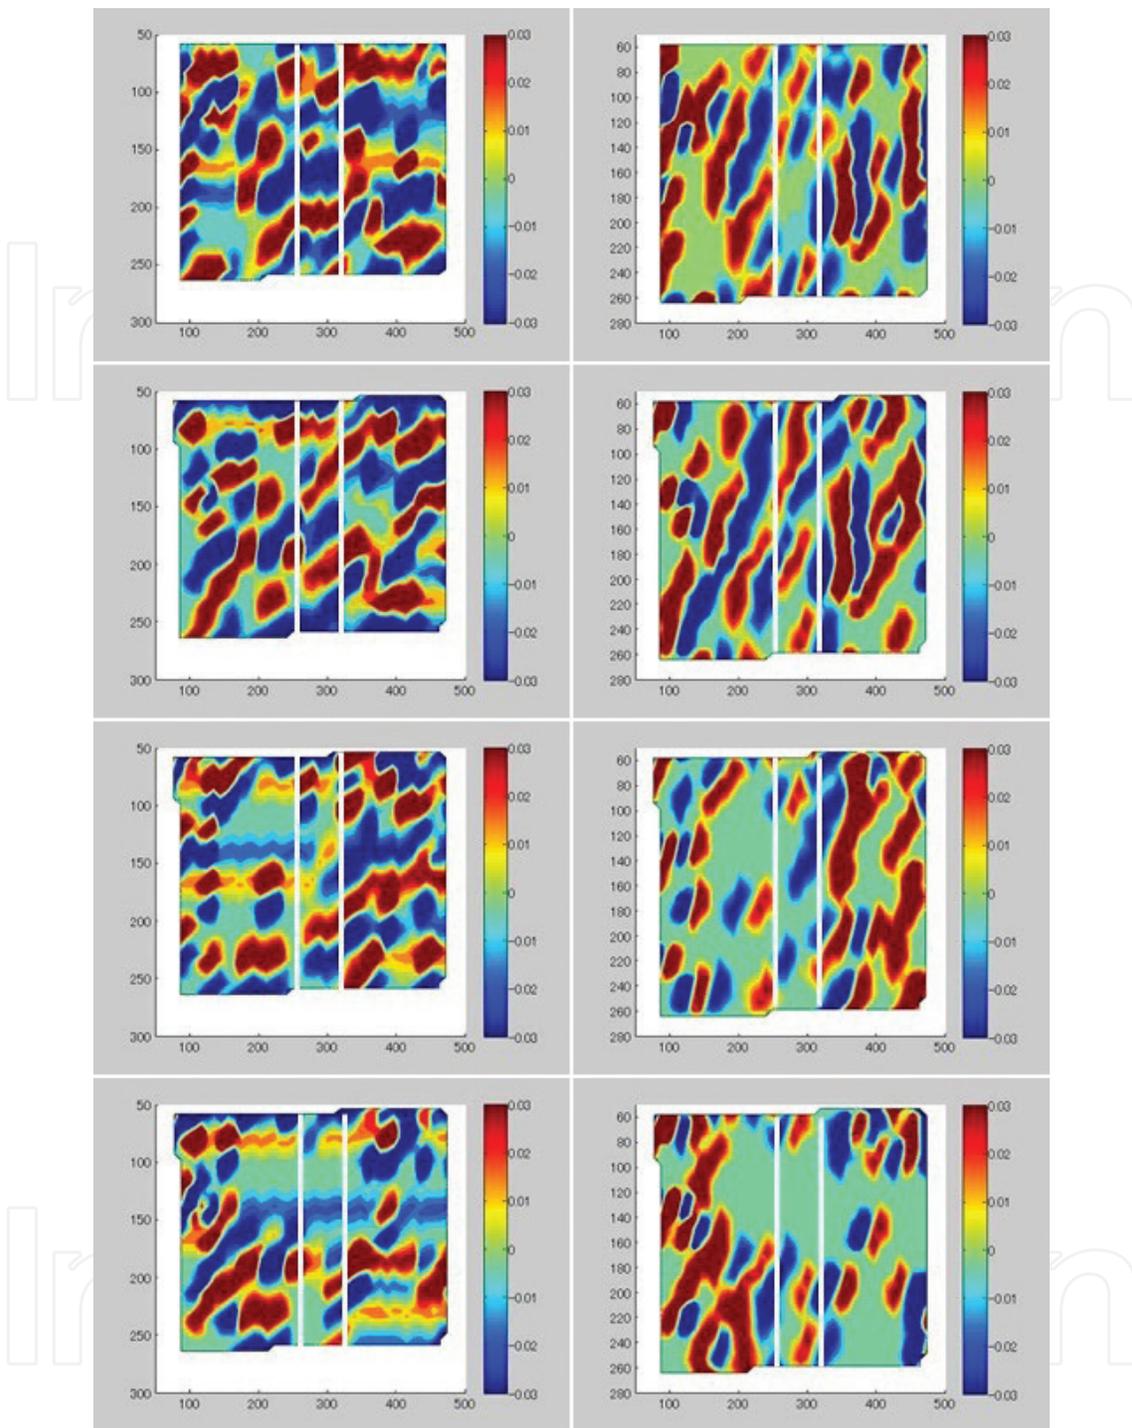
The shear strain is shown to develop to the upstream and downstream direction near the wall of the sand box. These results may be caused by the friction between wall and dam model. The direction of shear strain distributes alternatively, and the large shear strain develops in the upstream and downstream direction.

Figure 15. Shear and volumetric strain at the crest and slope.

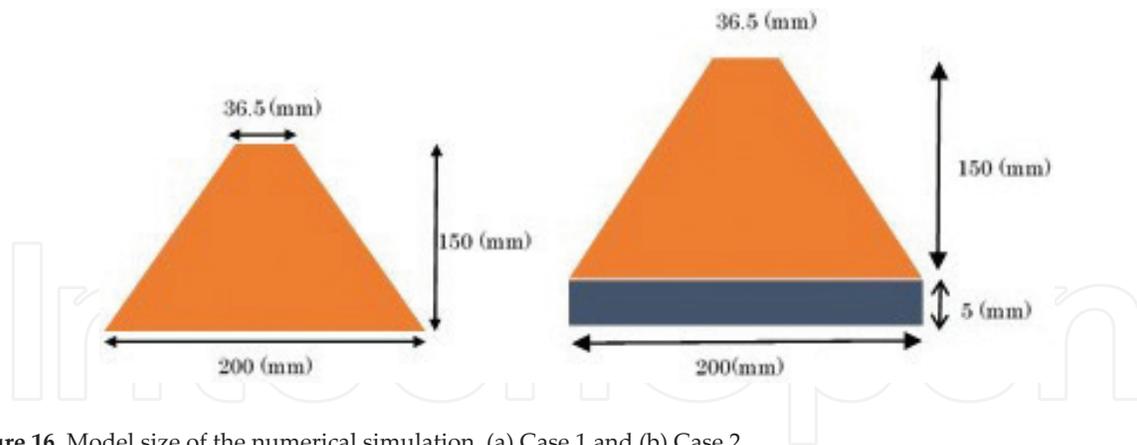
To investigate the reproducibility of the extension strain distribution by numerical simulation, the dam model of which size is the same as the 1-G shaking test [2] is simulated. In this study, two cases are examined. The first one is the case in which the dam body is directly shaken at the bottom of the dam. The second one is the case in which the thin base is added under the dam. The objective of the second case is to input the inhomogeneous wave into the dam body. When a given wave is subjected to the bottom of the base, the shaking of the bottom of the dam body becomes a little inhomogeneous, while the amplitude is not so different. The dam body has a height of 150 mm and upstream and downstream gradients of 1:0.545. As the slope gradient is steep, the shaking would be intensified at the upper part.

**Figure 16** shows the schematic view of the models and **Table 1** indicates the material properties. By setting the elastic modulus of the base a little smaller than that of the dam, the shaking situation at the bottom of dam body becomes inhomogeneous by the different behavior of reflected wave depending on the location.

Figure 16. Model size of the numerical simulation. (a) Case 1 and (b) Case 2.

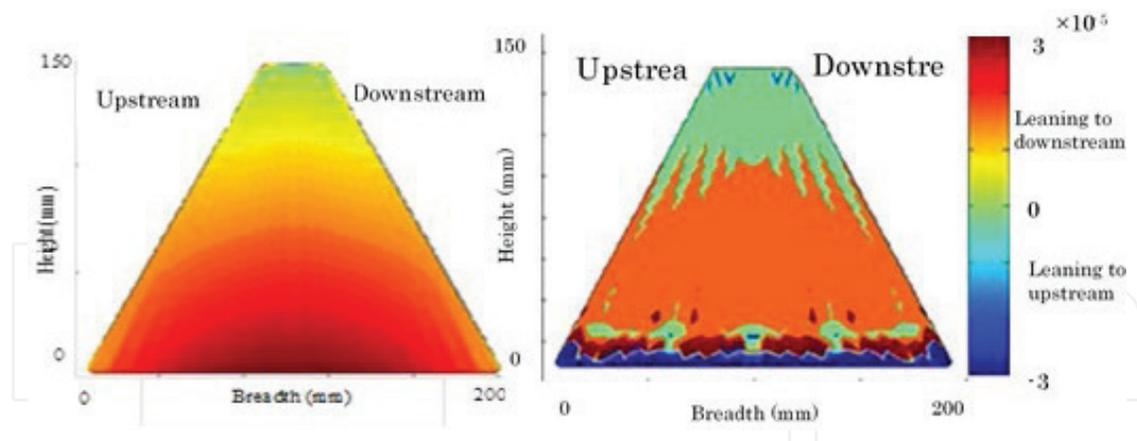
**Figure 17** shows the shear strain distribution and **Figure 18** indicates the volumetric strain distribution at the time when the model locates the center of shaking from downstream to upstream. It is found that the large shear strain occurs at the lower part for both cases while the direction is different for the case. Although Case 1 shows that the shear strain to the same direction occurs, the shear strain to the different direction is distributed for Case 2. For the volumetric strain, the maximum value is shown at the top and both ends of the bottom, and

Figure 17. Shear strain distribution of the numerical simulation. (a) Case 1 and (b) Case 2.

analyses. The distribution of the shear strain is also quite different from the observed one. As a present conclusion, the ordinary elasto-plastic model is not suitable for the dynamic analysis of the dam.

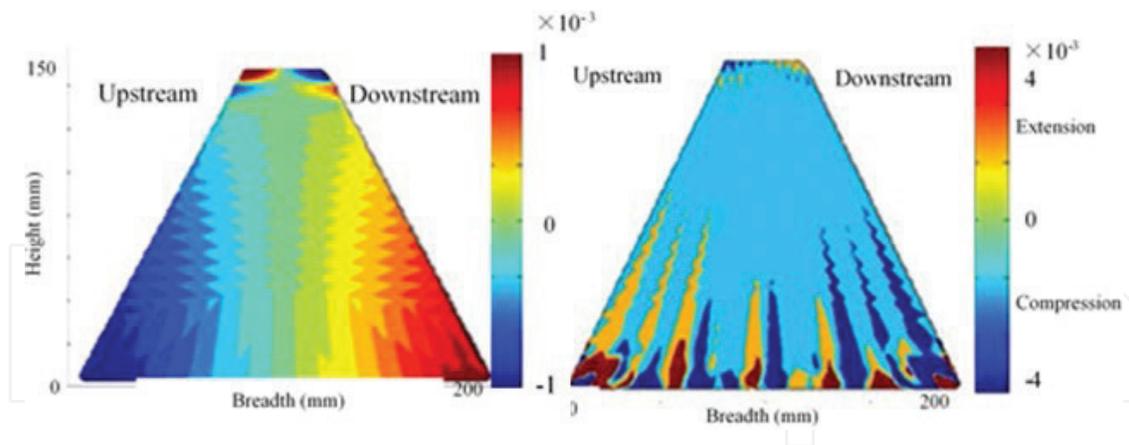
**Figure 18.** Volumetric strain distribution of the numerical simulation. (a) Case 1 and (b) Case 2.

As a result of the numerical simulation, the analysis results are different from the experimental results. In particular, the large extension strain at the upper part cannot be realized by the
