Generator Insulation-Aging On-Line Monitoring Technique Based on Fiber Optic Detecting Technology

Peter Kung

Abstract

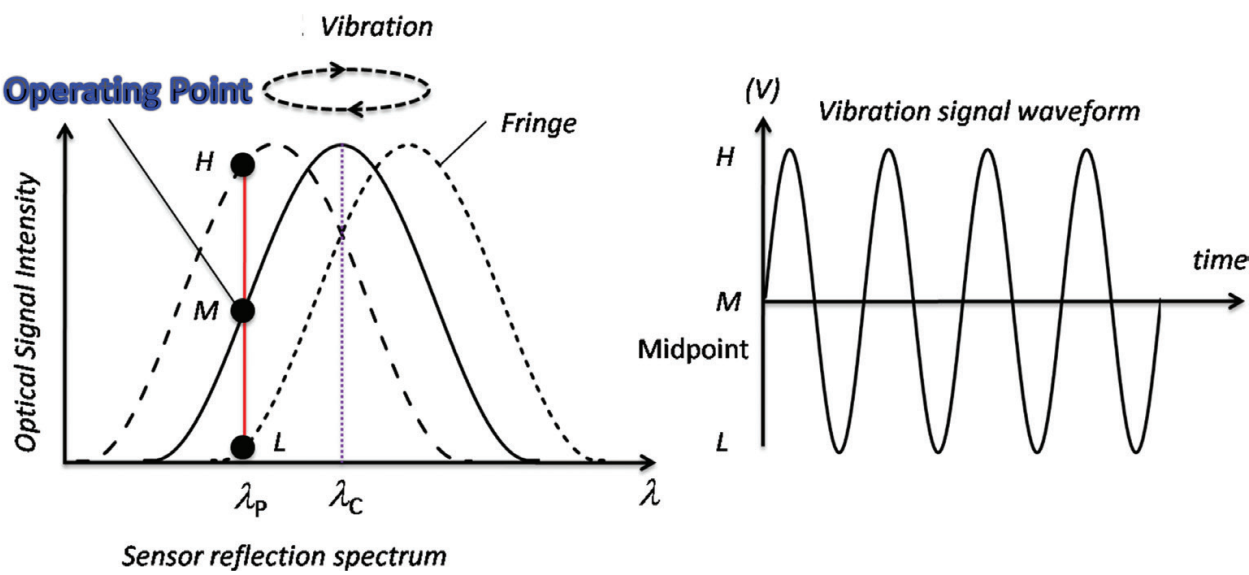
Figure 8. The principle of optical fiber sensing.

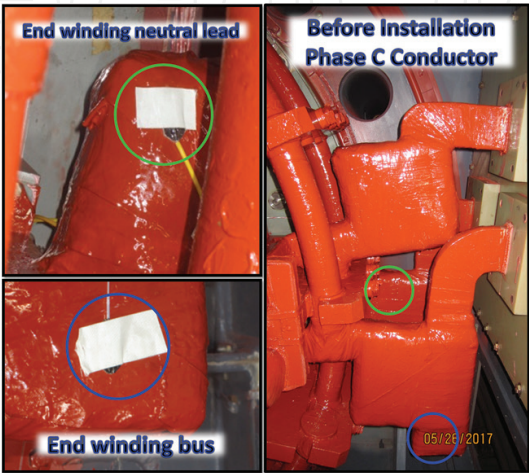
Figure 12. System diagram for temperature and vibration detection. Courtesy of QPS Photonics.

There are two types of sensors. One of them makes use of the Brillouin technology where two laser beams are fed into the same fiber optic loop and both lasers have very close center wavelengths that are made to beat against each other, generating a beat frequency. This beat frequency is sensitive to any index changes in the fiber as hot spots. Hence, it is able to report their location along the sensing fiber. The temperature sensor forms a loop inside the slot. In the middle of it a single point temperature (yet distributed for vibration) sensor is installed (see **Figure 14**). The top slightly bluish fiber together with the bottom yellow fiber are the Brillouin temperature sensing loop; the dark hexagon houses the temperature sensing cavity with vibration sensitivity for the whole length of the fiber extension. The whole length of the slot, which measures five meters long, has its vibration captured. The single point temperature measurement provides a temperature reference for the Brillouin hot spot temperature sensing measurement.

Besides the Brillouin hot spots sensor and the in-slot vibration sensor, two other cavity vibration sensors were installed. One is coupled with the end winding lead and another one with the end winding bus, all are done on the neutral phase of the generator. All sensing fibers

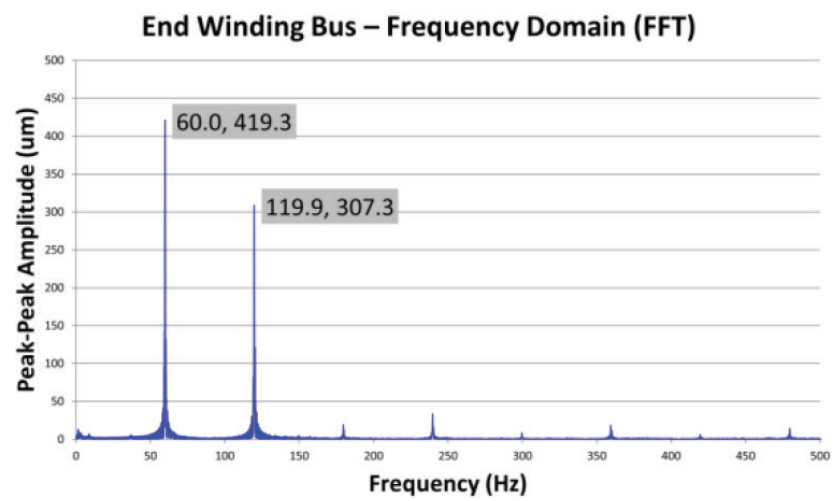
Figure 19. End winding bus frequency domain. Courtesy of QPS Photonics.

A third vibration sensor was mounted on the neutral end winding bus (see **Figure 17**). Once again, the vibration observed here is also consistent as depicted below in **Figure 19**.

Larger vibration amplitude is shown: 1xLF component measured 16.5-mil peak-to-peak and 2xLF measured 12.1-mil peak-to-peak. It seems that gas-fired generators vibrate much more than the coal-fired generators. Plant experts informed all participants of the field test that it may be related to the generator design where the bearing is coupled to the frame. Vibration was so strong in similar machines that cracks developed.

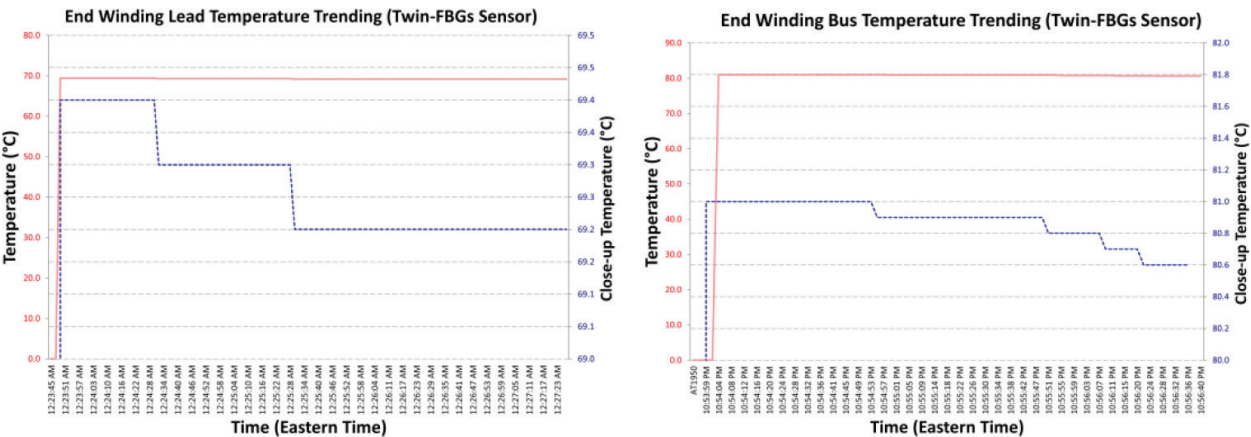
Figure 22. At left, end winding lead temperature measurement for about 5 min. At right, end winding bus temperature measurement for about 3 min. Courtesy of QPS Photonics.

The end winding lead of **Figure 22** (left) showed a temperature consistent with the slot as well as the end winding bus plotted in **Figure 22** (right). All of them read close to each other, there does not seem to be any problem.

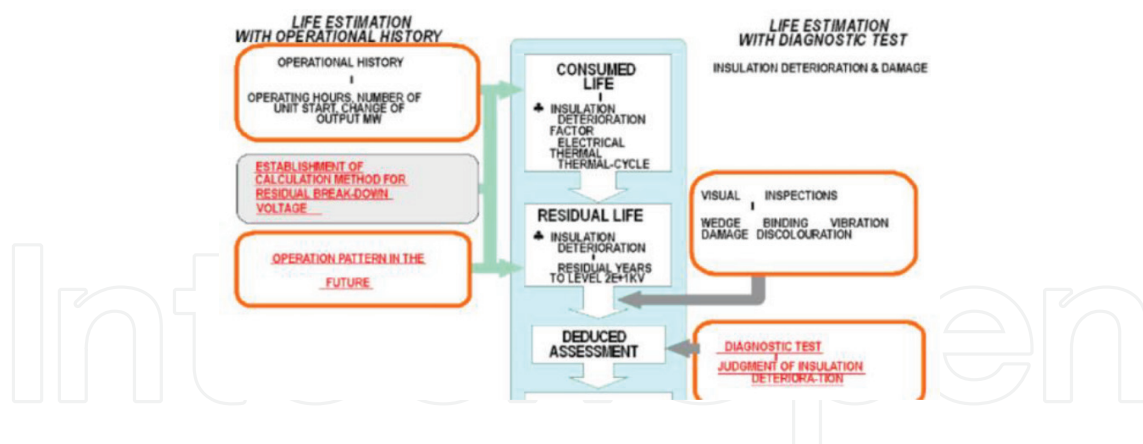
Figure 24. Damage model that allows residual life predictions.

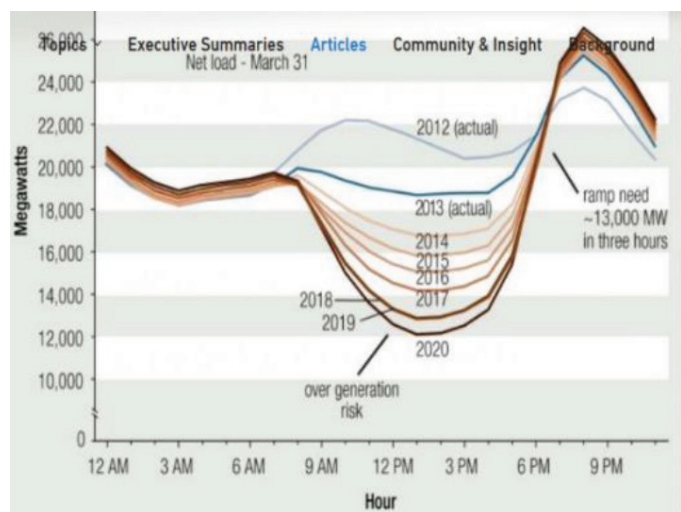
Figure 25. Graph showing gas generators must be turned on and off to adapt to the supply of the renewables.

It is now possible to simplify the problem into an intuitive model that does not involve complex mathematics [42–46]. The methodology is described below and can be used to analyze the measured data from these fiber optic sensors. It has been known that gas generators are frequently subjected to many daily start-stop events: the winds are usually stronger during the night and the sun shines more strongly late morning and afternoon. When these renewable energies become abundant, gas turbines must be turned off for the total power to not overload the power grid (see **Figure 25**).

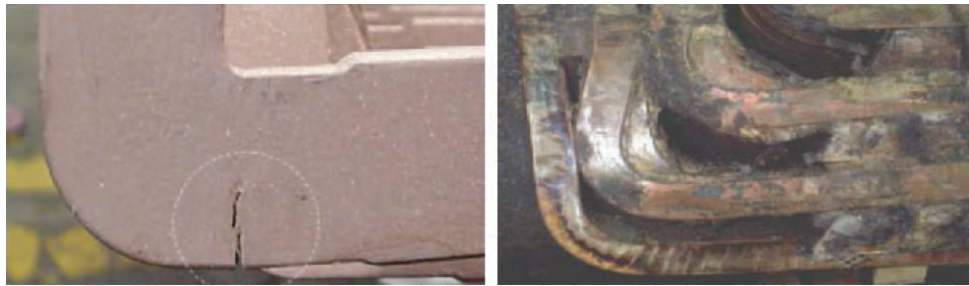
Figure 26. Cracking of copper turns and also bowing of the rotor.

Frequent start-stop cycles can cause stresses due to coefficient of expansion differences between different materials used inside the generator (see **Figure 26**).
