# Cumulative Tensile Damage and Consolidation Effects on Fracture Properties of Sandstone

Martin Šperl and Miloš Drdácý

## Abstract

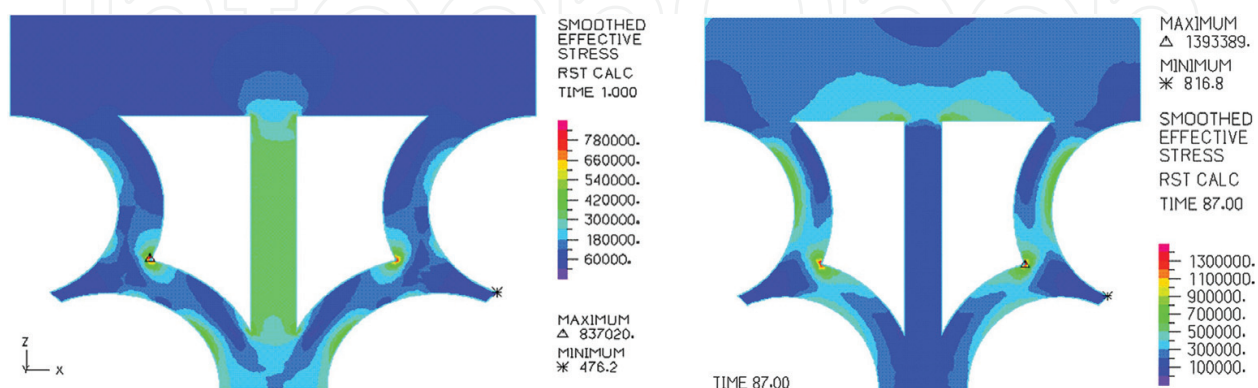
**Figure 1.** Distribution of the effective stress in the slice for coordinate  $y = 1.37$ ; 3D model of own weight (left) and 3D model of warming up (right) [1, 2]. (Image by P. Beran).

The second author of this paper investigated the case of a severe failure of the sandstone tracery of the triforium of St. Vitus Cathedral, where repeated uneven humidity loading (wetting and drying) and temperature loading (heating and cooling) were the cause of the collapse. A detailed survey discovered that this type of damage was present or had been repaired on most of the tracery arches of the triforium, where further failures subsequently occurred. The extent of the dangerous stresses was verified using simple thermal loading modeling and computations. It was proved that the state of stress in the damaged places reached or surpassed the material strength levels (**Figure 1**) [2].

The triforium tracery elements are chiseled out of a single piece of sandstone. They are connected with the lower window beam of the nave or the transept. The triforium structure is situated on the border between the exterior and the interior, and its ceiling plates are exposed to the exterior environment forming the roof structure. The temperature of the air fluctuates in the exterior and the interior of the cathedral. The stone elements of the triforium include parts of different proportions that have been composed into a single unit. Due to rapid changes in the ambient temperature, situations can arise when the temperature of the massive parts is different from the temperature of the subtler elements. This situation generates a stress inside

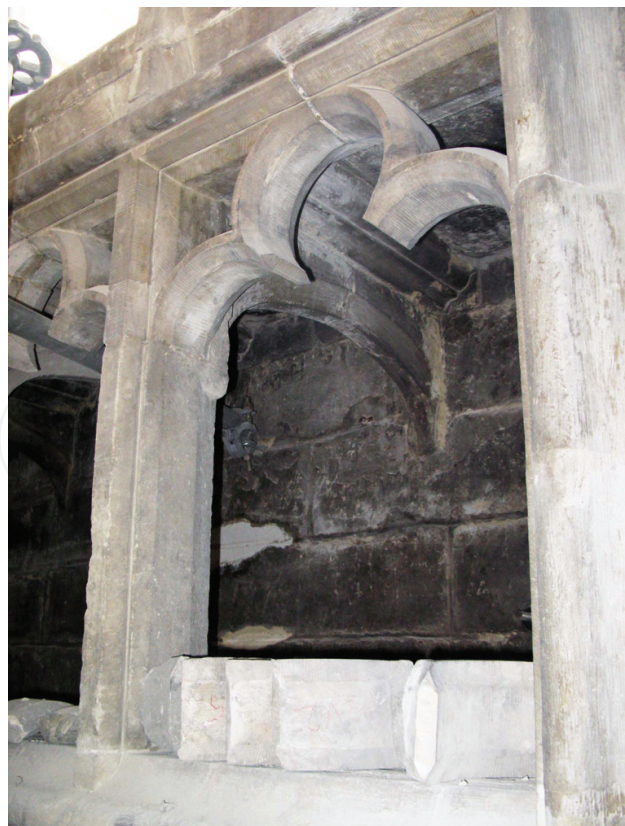
**Figure 2.** Repaired tracery with damaged elements in Notre Dame du Sablon (photo by M. Drdácý).

Similar damage has been observed on other historic buildings, for example, on the church of Notre Dame du Sablon in Brussels (see **Figure 2**) where several failed original elements have been replaced.

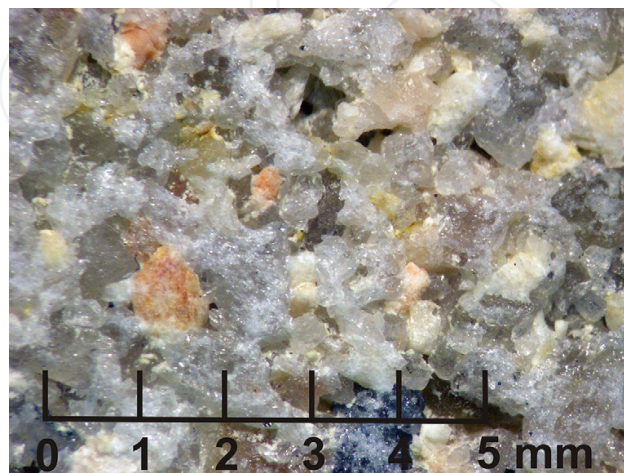
**Figure 3.** Macro photo of the Božanov sandstone (arkose) structure (photo J. Frankl).

Božanov stone is a grayish beige gross grain strong arkose sandstone without marked layering (**Figure 3**). The material used in the tests was extracted from the 11th arch of the Charles Bridge parapet wall, which had to be replaced during recent repairs. It has a rather deeply located detachment crack parallel to the surface, probably due to some previous surface treatment which had locked moisture inside the stone. The material can be characterized as a quasi-brittle inelastic silicate composite.

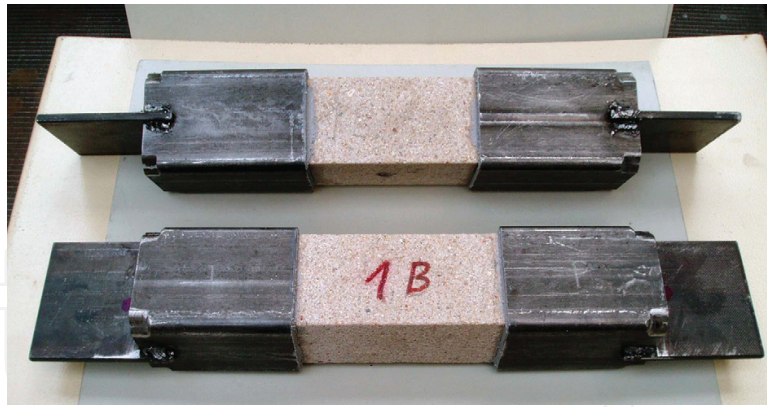
**Figure 4.** Test compression/tension specimens (photo by M. Šperl).

Test specimens  $50 \times 50 \times 200 \text{ mm}^3$  in dimensions were fixed into rectangular steel tubes with axially welded flat steel hangers, which served to fix the set into the hydraulic grips of the loading frame (**Figure 4**). Two-component Sikadur-31 CF RAP resin was used for gluing. The fixtures had to be prepared with great precision in order to ensure perfect alignment and perpendicular arrangement for tension and combined loading. The specimens in prismatic form were cut with negligible geometrical imperfections in a precise prismatic form.

Twelve experiments were carried out—four on the specimens from **Figure 4** and eight on prismatic beams cut out of the broken parts after the tension tests. The tests therefore involved (i) compression, (ii) very-low-cycle fatigue, (iii) tension, (iv) fatigue (an alternating nonsymmetrical cycle)—all on the specimens from **Figure 4**—and (v) three-point bending tests on small size beams with a  $20 \times 20 \text{ mm}^2$  cross section.

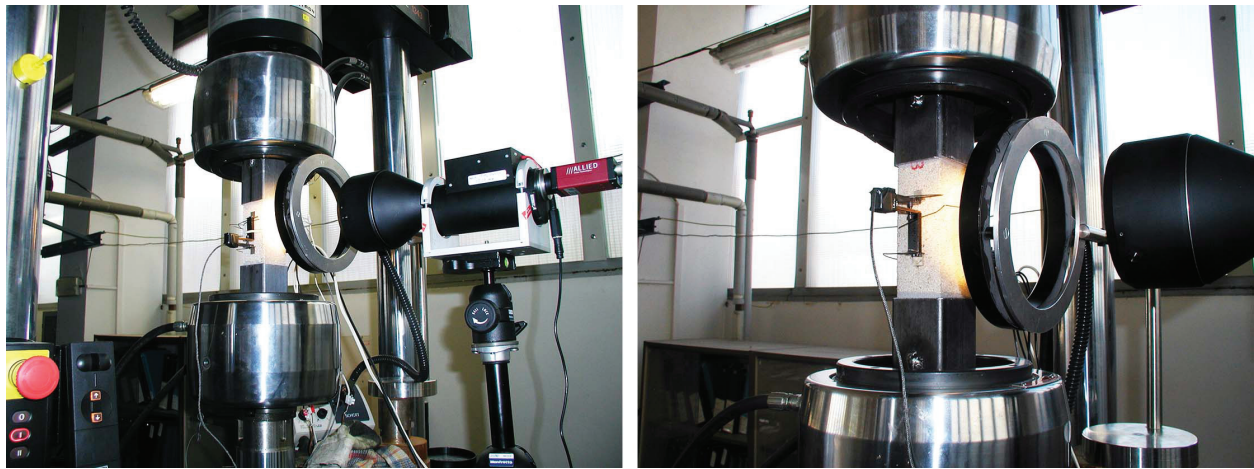
**Figure 5.** Arrangement of pure tension tests on the stone specimens (photo by M. Šperl).

The specimens were loaded into an Instron 1343 electrohydraulic testing frame with force capacity of 100 kN (**Figure 5**) using an Instron 100 kN load cell, a FastTrack 8800 controller, two Instron extensometers type 2620-602 (accuracy class 1, with maximum possible error of 0.5% of the read value, measurement base  $l_0 = 50 \text{ mm}$ ), and WaveMatrix measurement software. The extensometers were placed on opposite sides of the specimen, and their read values were arithmetically averaged. The contacts on the surface of the stone were provided with glued thin aluminum sheets to protect the extensometer wedges. The deformations were also

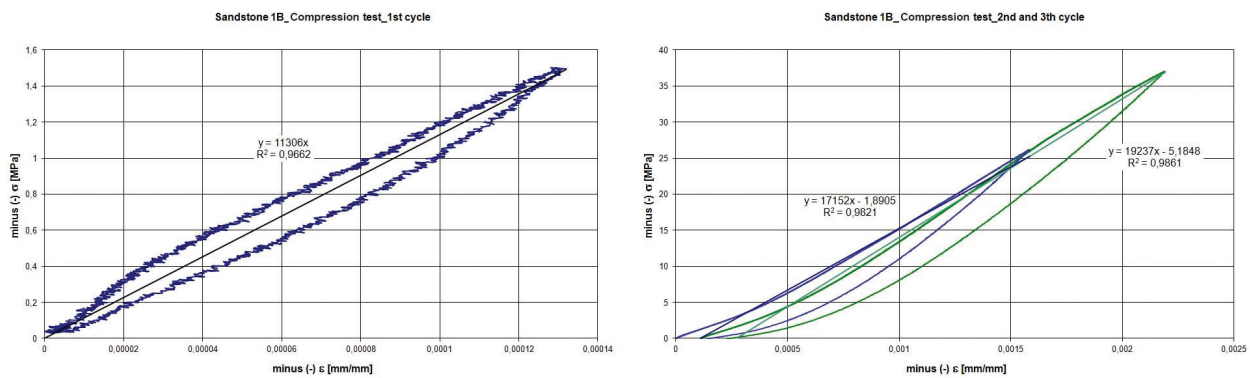
**Figure 6** First compression loading cycle (left) and second and third loading cycles (right), with corresponding linear approximations.

The compression force was applied in three stages:  $-1.5$ ,  $-26$ , and  $-37 \text{ MPa}$ . Deformation was measured during the tests in order to study the change in Young's modulus and the Poisson number with relation to applied load (**Figures 6 and 7**). Hysteresis and irreversible deformation were observed, and the Poisson number reached a value of 0.23. The diagram shows that the tested sandstone increased in stiffness with an increasing number of compression cycles at the beginning of the tests. The change in the slope of the interpolated linear approximations of the load-displacement diagrams reflects this fact. The modulus of elasticity rose from an initial value of  $11,360 \text{ MPa}$  to a value of  $19,237 \text{ MPa}$  for the third cycle of loading, i.e., a 70% increase. This differs from the results of other tests on sandstone as presented in the cited literature. At the same time, hysteresis occurs with irreversible deformations. During the first loading cycle to  $-1.5 \text{ MPa}$ , no irreversible deformation was observed. It seems that irreversible deformation occurs after the material has been subjected to some limit compression load. The Czech standard for tests on natural stone prescribes that the modulus of elasticity is to be evaluated after three loading cycles.

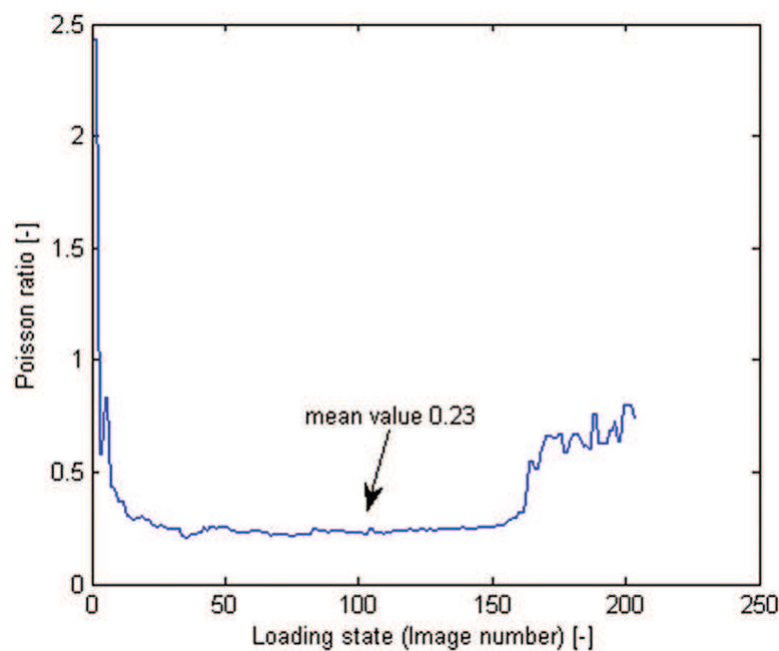
**Figure 7** Poisson ratio measured using the DIC method.

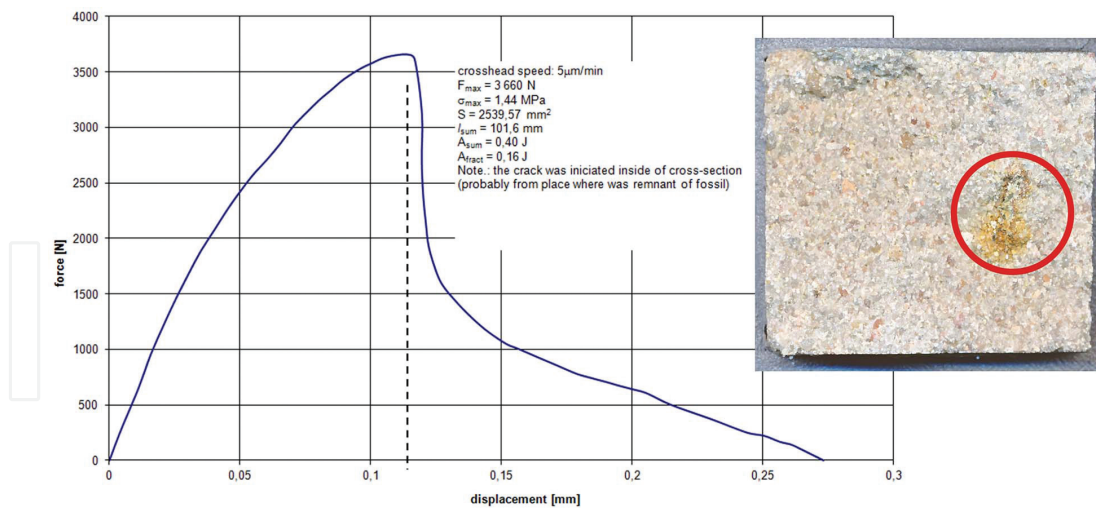
**Figure 8.** Load-crosshead displacement diagram for the tension test with a calculation of the absorbed energies and an indication of the probable place with an initial defect in the cross section of the specimen.

defect present within the specimen (**Figure 8**). The load-displacement graph shows the overall energy absorbed during the test (0.4 J) and during crack growth (0.16 J). This corresponds to the behavior of highly brittle material. The strength decreased (to 1.43 MPa) due to the defect in the material. The course of the stress and deformation up to fracture can be described well by means of a suitable power function (see **Figure 9**), which presents a detailed diagram.

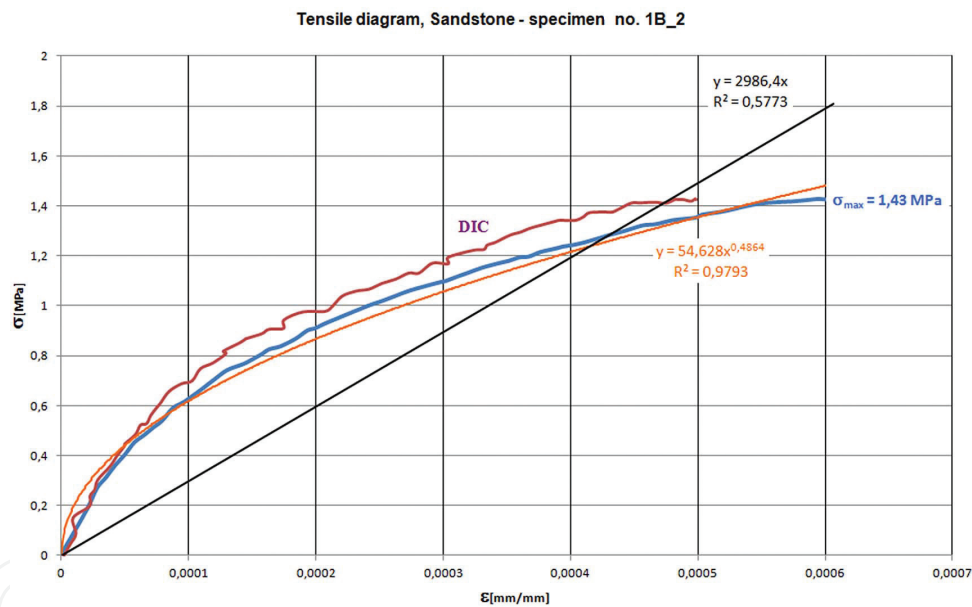
**Figure 9.** Tension diagram of the tested Božanov sandstone, comparing the conservative measurement with the DIC measurement and presenting a suitable power function approximation.

It follows from **Figure 9** that a suitable power function appropriately describes the material behavior up to rupture. The tangent to the curve gives the modulus of elasticity value:

The DIC record exhibits a slight difference in comparison with the conservative measurement approach. This may be caused by a small change in the geometric relations between the specimen and the camera objective during loading. However, the agreement is still very good.

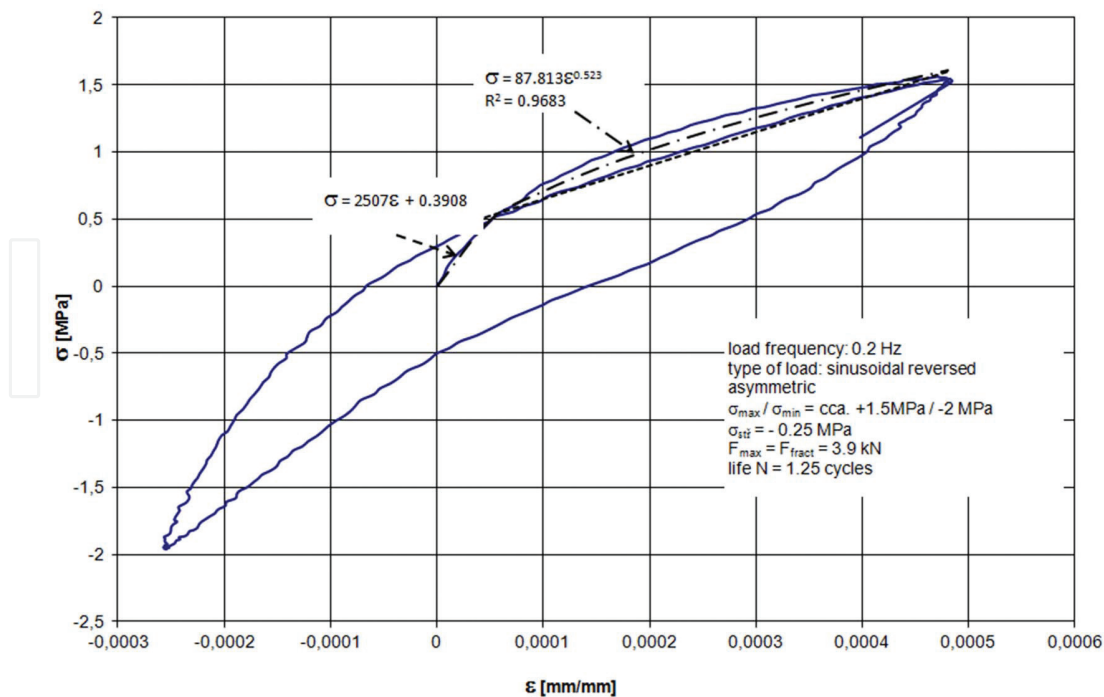
**Figure 10.** Low-cycle fatigue diagram.

A sinusoidal altering nonsymmetrical loading cycle with stress limits of +1.5 and −2 MPa was applied during the very-low-fatigue test. The mean value of the stress was −0.25 MPa, the stress double amplitude was 3.5 MPa, and the frequency of loading was 0.2 Hz (**Figure 10**).

**Figure 10** also indicates that a power function can be used to approximate the first loading course. The parameters of the constant however are different from that of the previous case. This could be a result of the presence of an interior defect in the first case or merely the wide distribution of the material's characteristics. The change in the fatigue loop's tension branch is also noteworthy. In comparison to the first cycle, it is significantly straighter and more horizontal. It is even possible to approximate it with a linear function. It signifies considerable damage to the material resulting from the first loading cycle, corresponding to the stress applied. The hysteresis exhibited by this specimen is quite high. The compression component is steeper than the tension component [14].

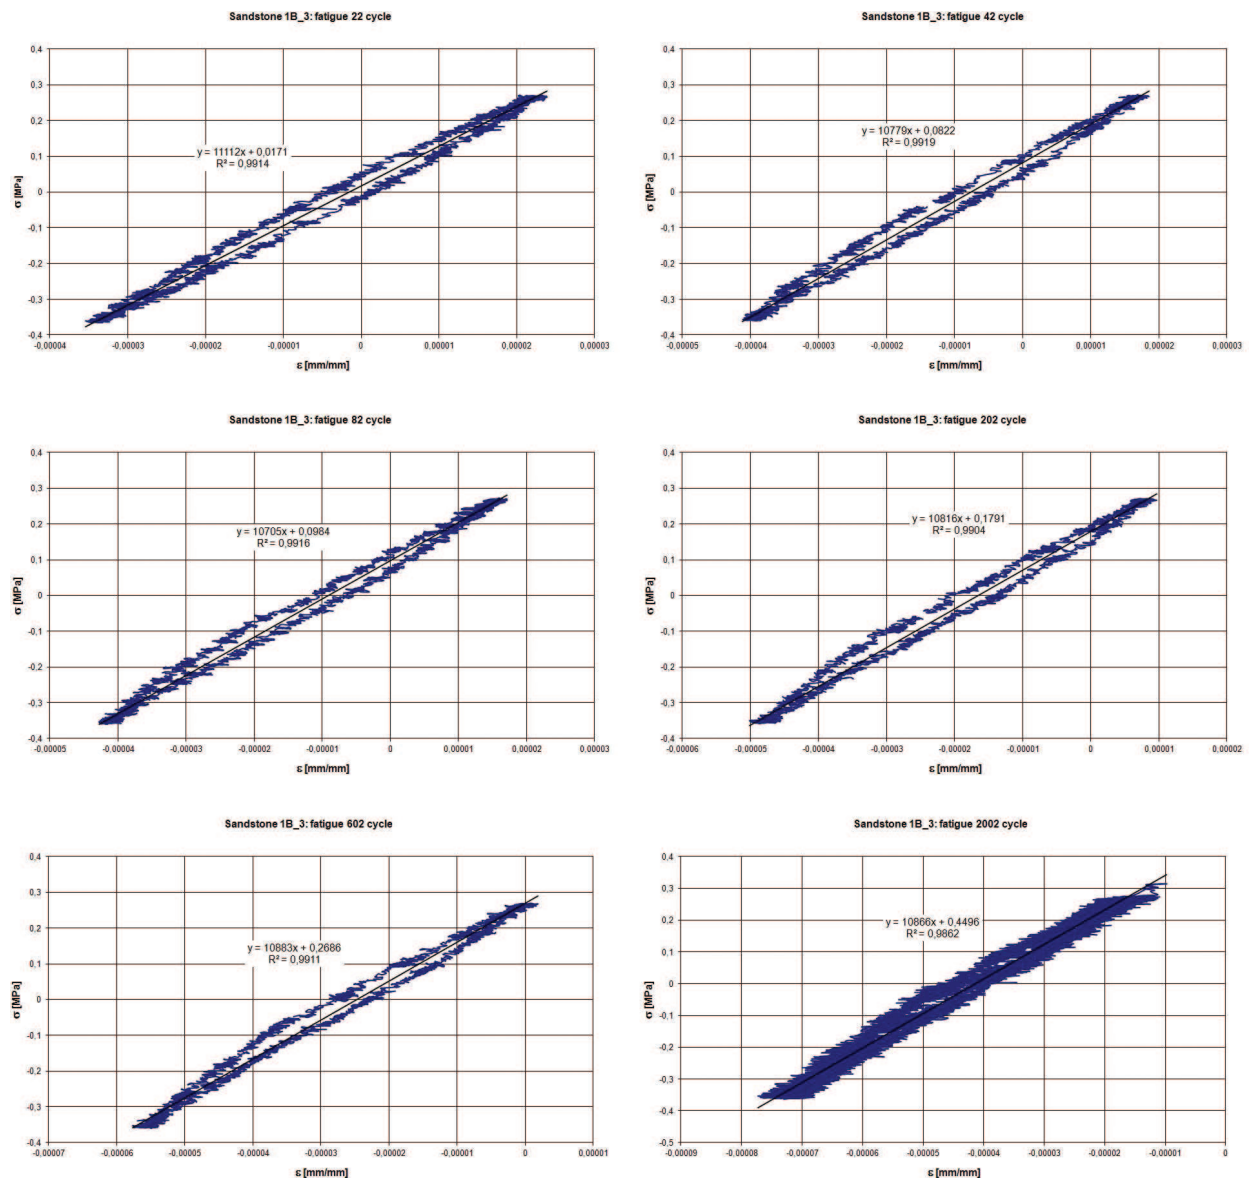
**Figure 11.** Stress-strain ratios after a given number of cycles: 22 (top left), 42 (top right), 82 (center left), 202 (center right), 602 (bottom left), and 2002 (bottom right).

The nonsymmetrical altering sinusoidal loading cycle was also used in the fatigue tests, with stress limits of +0.265 and -0.354 MPa. There were two modes of cycling velocity used—for the main loading sequence a frequency of 0.25 and 0.01 Hz at certain stages for groups of three cycles measuring deformations, based on which the second cycle was evaluated and the E modulus calculated. Such detailed measurements were attained up to 2000 cycles. The specimen was then loaded to the point of failure. The asymmetry characteristics of the cycle were kept the same to allow for comparability of results ( $R = -1.33$  and stress span  $\Delta\sigma = 0.619$  MPa). The overall lifespan reached 224,908 loading cycles. Typical results are presented in **Figure 11**.

In **Figure 11**, the observed shift of the measured data toward negative strain values with the increasing number of cycles is caused by thermal dilation of the specimens. The average change in temperature in the testing hall was about 4°C. The temperature change dilations were checked by computations, taking into account the coefficient of dilation of sandstone equal to  $\alpha = 10 \times 10^{-6} \text{ K}^{-1}$  and the equation  $\Delta l = \alpha \cdot \Delta T \cdot l$ . **Figure 13** presents examples of the temperature drift.

The modulus of elasticity may be a good parameter for assessing damage accumulation, though it is difficult to measure on real structures (see **Figure 11**). In the next series of tests, the correlation between the modulus of elasticity and NDT techniques will be studied, especially ultrasonic measurements for possible application in situ.

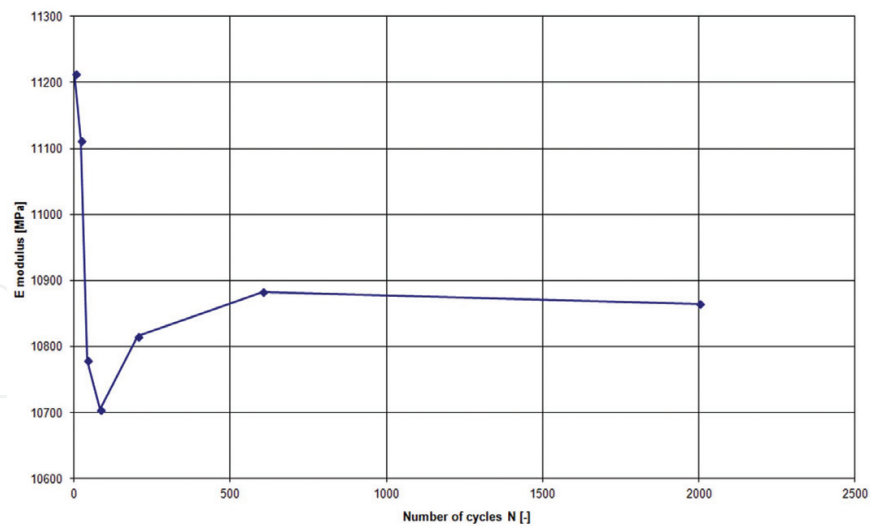
**Figure 12.** Change in the modulus of elasticity during cycling.

The modulus of elasticity  $E$  changed during the cycling. Its value dropped from the initial figure of 11,214–10,705 MPa after 82 loading cycles (a decrease of about 5%). Then the value stabilized around 10,865 MPa after 2002 cycles (**Figure 12**). The change was influenced by fatigue damage in the material.

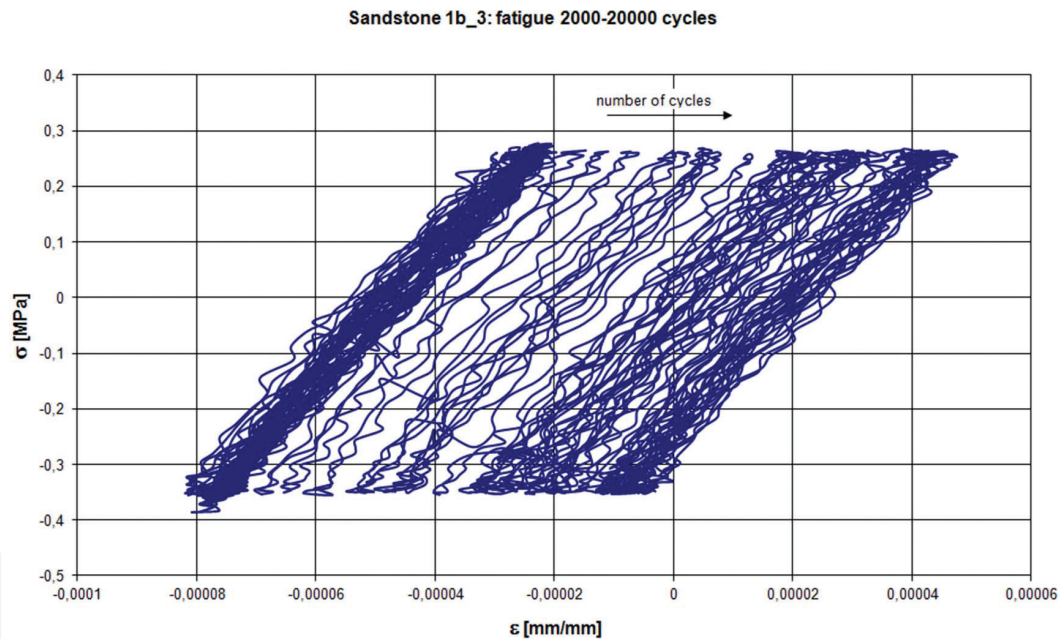
**Figure 13.** Temperature caused a drift in specimen deformation due to dilation (2000–20,000 cycles).

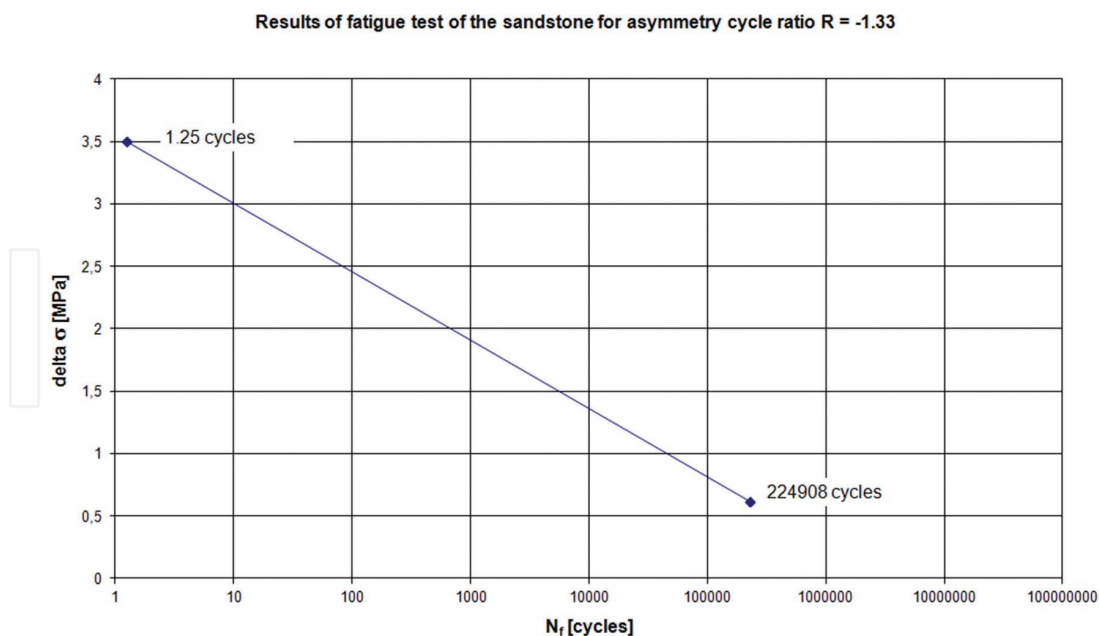
**Figure 14.** Fatigue test results for Božanov sandstone for cycle asymmetry of  $R = -1.33$ .

**Figure 14** presents a very rough representation of the probable life estimate of the tested sandstone between two applied stress levels. Of course, many more tests will be required before the true Wöhler curve can be constructed.

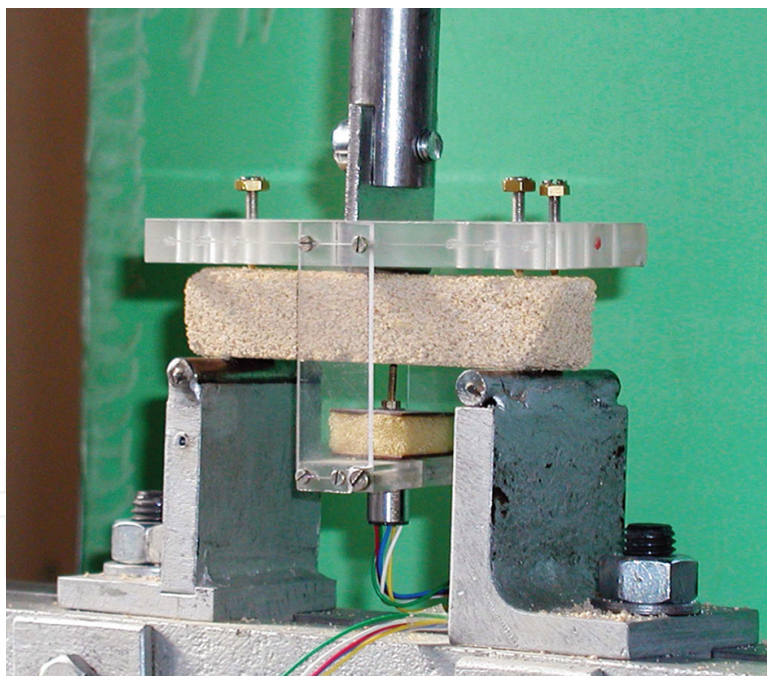
**Figure 15.** Three-point bending test arrangement (photo O. Vála).

After the uniaxial and fatigue tests, small beams with a cross section of  $20 \times 20 \text{ mm}^2$  were prepared from the broken specimens and were subjected to three-point bending loading (**Figure 15**). The measured flexural strength reached much higher values (about 4.5 MPa) than the strength in the tension tests, which was influenced by a rather low span to height ratio (about 3.75).

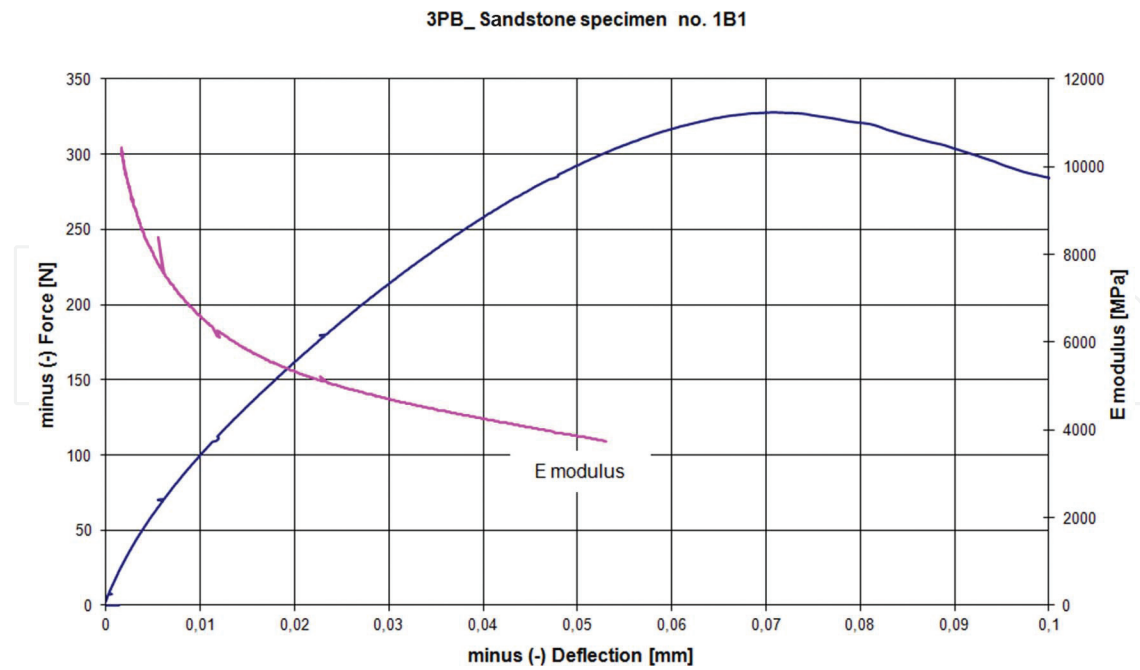
**Figure 16.** Loading force-deflection diagram during three-point bending testing and calculated modulus of elasticity.

However, the moduli of elasticity were lower than those measured during the previous tests (though still higher than those measured by the first author on thin plates during tests on the characteristics of the Charles Bridge sandstone—Čechová et al. [13]). It is clear that both the load-displacement diagram and the change in the modulus of elasticity can be well approximated by a suitable mathematical model (**Figure 16**).
