New Additions to Existing Built Heritage and Their Contributions to Sustainable Development: Cases from Ankara, Turkey

Gulsen Disli

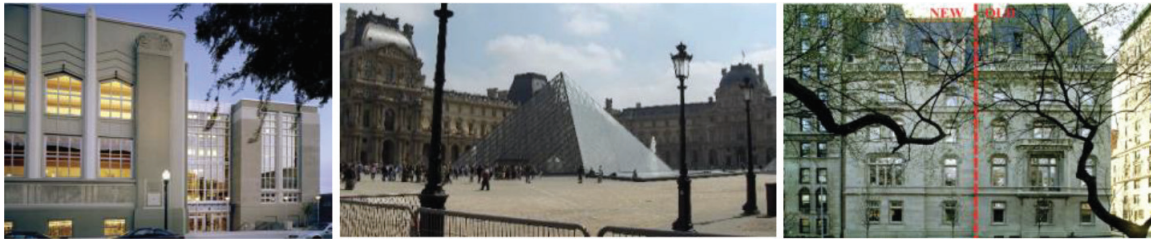
Figure 1.
 New additions designed according to three different approaches: Standard, contrasting, and identical [3, 7, 39, 40].

According to “The Secretary of the Interior’s Standards for the Treatment of Historic Properties with Guidelines for Preserving, Rehabilitating, Restoring & Reconstructing Historic Buildings”, White (p. 38) categorizes the various recommended and discouraged methodologies toward additions to historic buildings in three groups: standard, contrasting, and identical [7] (**Figure 1**). Standard approach is explained as “compatible,” but “differentiated” from the old, thus ensuring that it “subordinates” to the historic building [7]. Also known as abstraction, in this approach, a new addition should be similar, but slightly different from the original building [6]. As another approach, contrasting style is defined as in “extreme contrast” to the old, thus avoids potential misunderstanding of what is original and what is new [6, 7]. On the other hand, in identical approach, new additions are almost the same with the old, in terms of style, design elements, material, scale, and detail [6, 7]. Semes similarly defines four possible strategies in designing new construction in a historic setting and calls them as the following; “(1) literal replication, (2) invention within the same or a related style, (3) abstract reference, and (4) intentional opposition [38].”

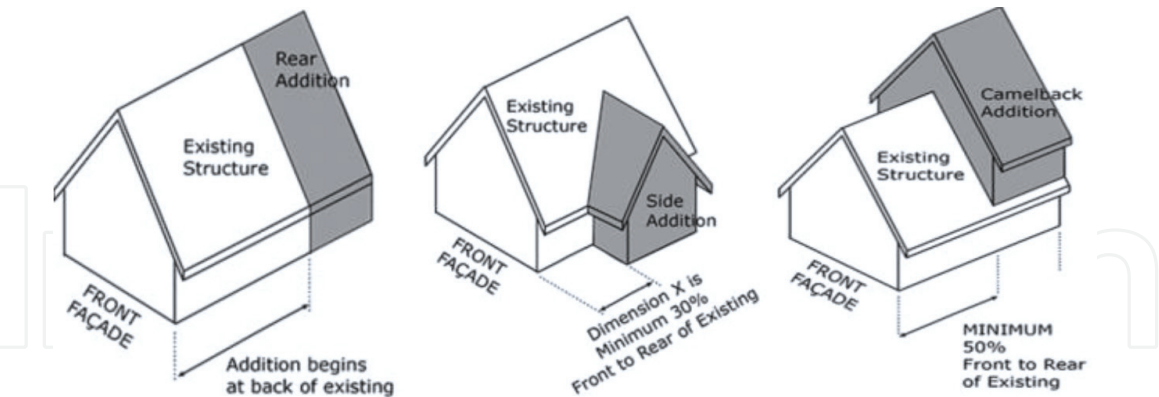
Figure 2.
Drawings showing different types of appropriate additions according to the City of Houston historic preservation manual, 2015 [7].

According to the historic preservation standards, primary exterior new additions include [1, 3, 4, 7, 41] (**Figures 2 and 3**);

- Rear additions,
- Side additions,
- Camelback (second story) additions,
- Rooftop additions, and
- Storefronts.

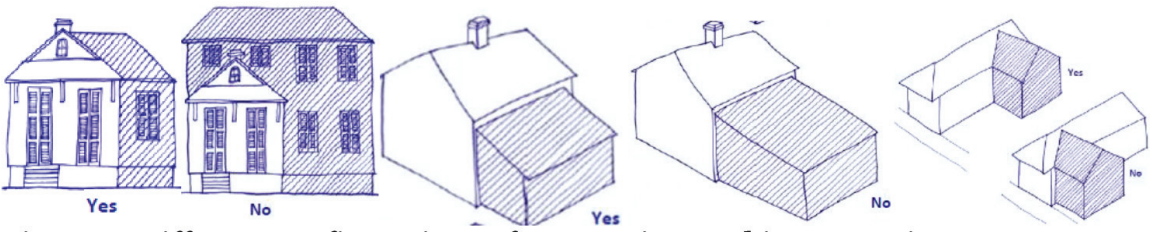
Figure 3.
Different configurations of appropriate and inappropriate new additions to historic buildings [37].

There are also front and basement additions observable in historic buildings. But, especially the front additions are mostly avoided or even prohibited in order not to hinder the visibility of the original building from the street side [37].

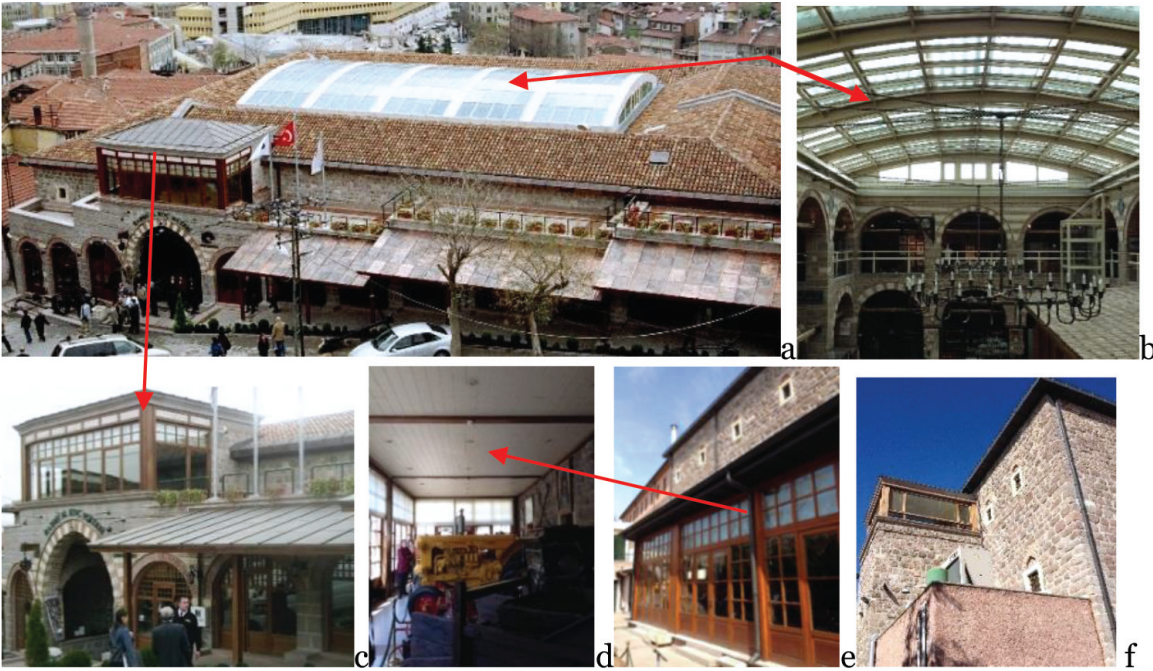
Figure 5.
Çengel khan: Rooftop addition covering the courtyard, exterior (a) [56] and interior views (b), completion of side walls above the entrance vault and storefront additions (c) and views from rear additions (d, e, and f) [39].

It is located in historic Ulus district, on the southwest side of the castle (**Figure 4**). According to its inscription panel, it was built in 1522–1523 by Rustem Pasha [28, 55]. It has an open-courtyard plan type constructed in masonry technique with stone and brick. Thanks to the sloppy topography of the site, two-story building has also a basement floor on the southwest side. The only entrance to the building is from the northeast façade, along which shops/stores are aligned. Its latest restoration was completed in 2005, and the building has started to be used as a museum with stores and a café, hence created new job opportunities. Adaptation of Çengel Khan to an exclusive cultural, social, and educational place attracts many local and international tourists. During the latest restoration, a steel and glass rooftop was added above the central courtyard, and thus, the courtyard could be used as an exhibition hall (**Figure 5**). Another new addition is observable on the basement floor, in the form of a rectangular room with large wooden windows at the southwest facade, used as a permanent exhibition area (**Figure 5**). On that facade, there is another rear addition located above the masonry walls (**Figure 5**). Similarly, wood and glass storefronts with wooden pillars and slightly sloppy awnings alongside the northeast façade of the building were added during the last restoration works (**Figure 5**). The masjid above the entrance vault changed its function, and this part was renovated with large wooden windows and started to be used as a café (**Figure 5**). Hence, in Çengel Khan, front, rear, rooftop, and storefront exterior additions are observable, all attached during 2003–2005 restoration works in order to meet the requirements of new function and usage of the building (**Figures 5 and 6**). Interior additions, on the other hand, are mostly seen in wet spaces and in the form of mechanical installations (**Figure 7**). Scale of interventions in both exterior and interior new additions is small, reversible, and differentiated with its material, form, and color, thus compatible with the old building.

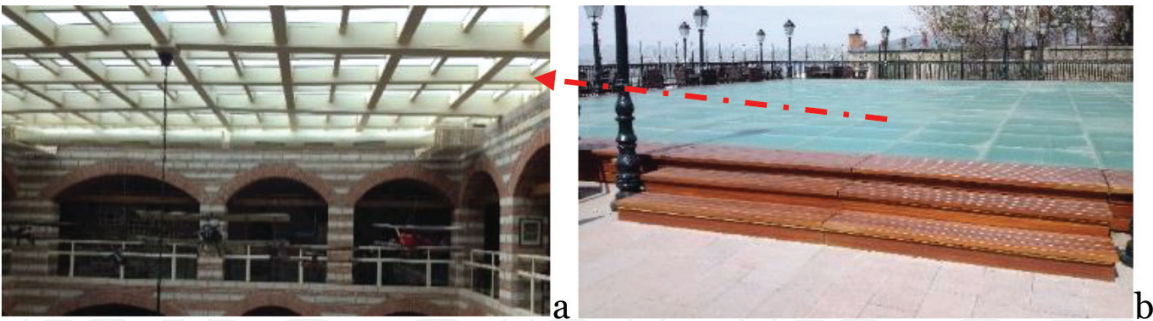
Figure 8.
Interior (a) and exterior (b) views of rooftop addition in Zağfiran Khan [39].

and adapted to a museum by Rahmi M. Koç Museum and Culture Foundation in 2012–2016. The upper level has been adapted for a restaurant with an open terrace. Regarding its contemporary exterior additions, Zağfiran Khan has a major side addition attached to its west facade and a rooftop addition above the central courtyard (Figures 8–10). New additions are clearly modern in their use of material, massing, and space arrangement. Rooftop architecture has a flat form built with glass and steel material (Figure 8). It creates a visual richness on the terrace of the restaurant and at the same time, enables permanent exhibition in the courtyard beneath. Side addition on the west side has similarly been created for various functional reasons, such as wet spaces, restaurant, and service halls for the stairs and elevators. Its facade is covered with glass material (Figure 9). Interior additions are mostly seen in west side addition, and in the old part, as door passageways and mechanical installations (Figure 11). In Zağfiran Khan, all those new additions exhibit present day appearance by means of contrasting style with

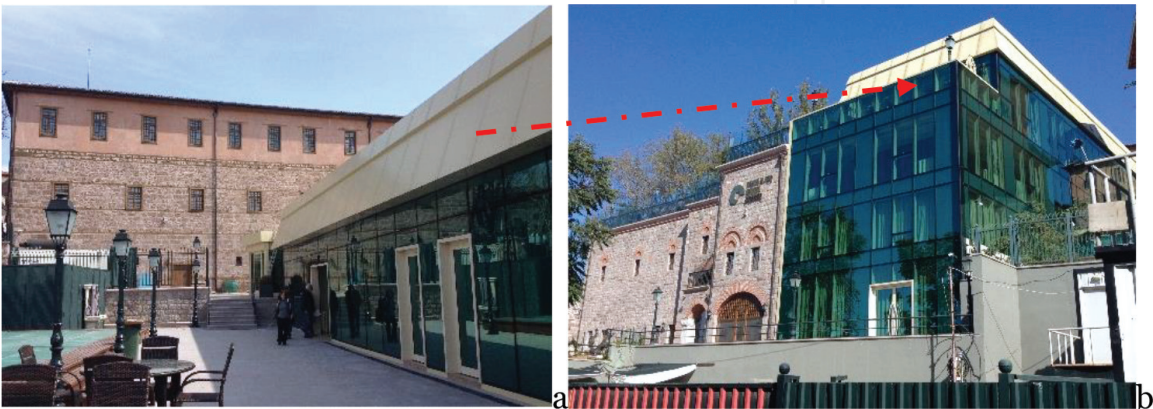
Figure 9.
Side addition of Zağfiran Khan; views from the restaurant, terrace (a), and whole south and west façade of the side addition (b) [39].

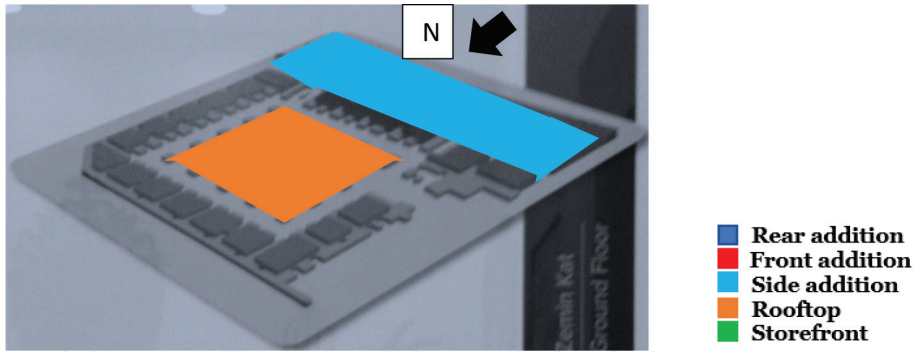
Figure 10. Schematic plan drawing of Zağfiran Khan with new additions shown in different colors (source: Redrawn from [57]).

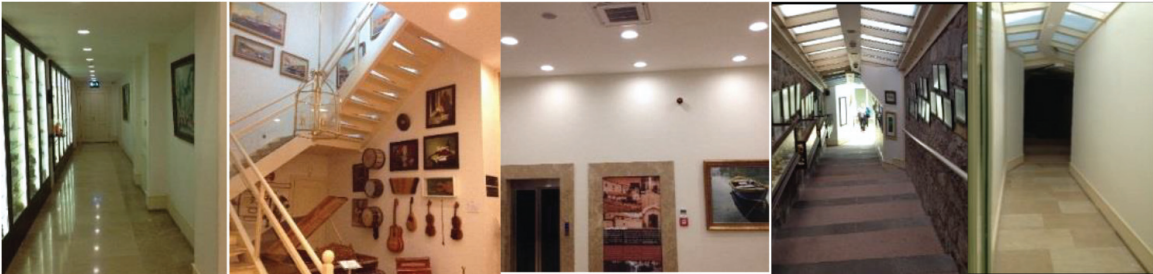
Figure 11. Interior new additions of Zağfiran Khan; stairs, elevator, wet spaces, and newly added passageway between Çengel Han and Zağfiran Khan [39].

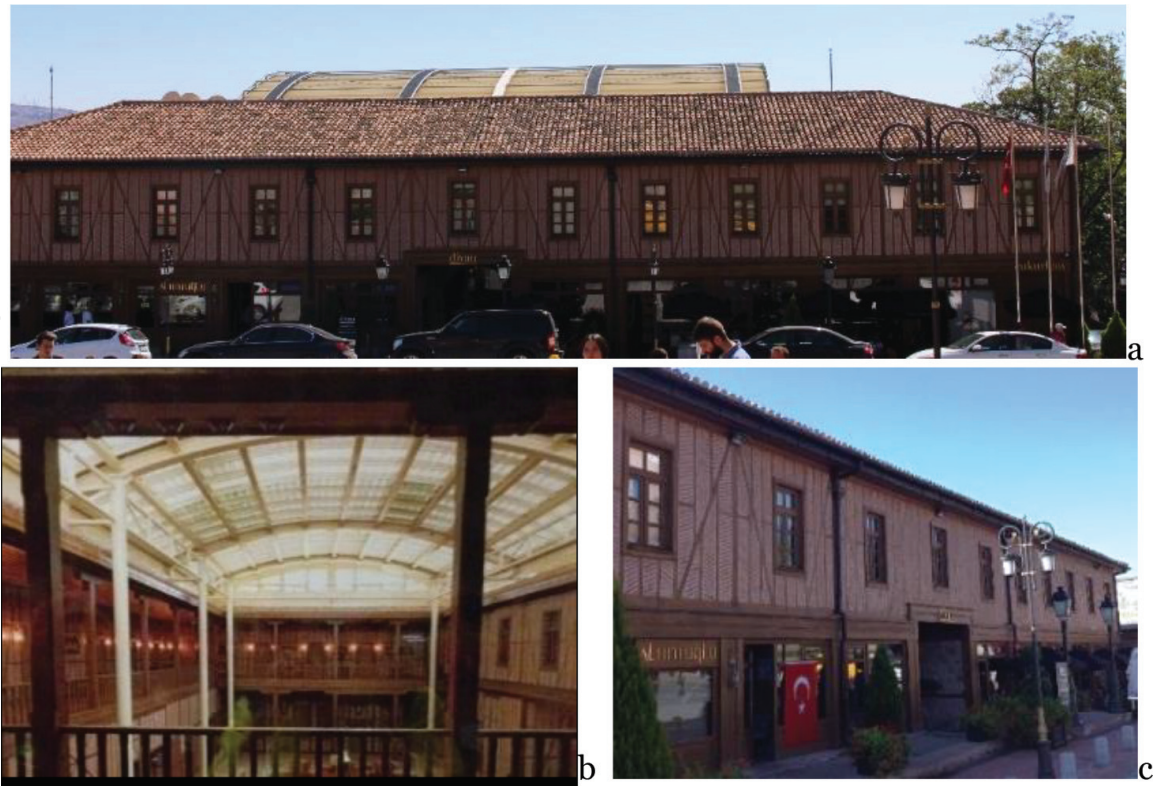
Figure 12.
Çukur khan: Rooftop addition (a and b) and storefronts (c) [39, 57].

It was constructed in the sixteenth century with rubble stone foundation walls. Above the rubble stone foundation are wooden pillars and trusses with mud-brick infill. The two-story building has a wooden hipped roof. The building is located in Atpazarı, next to Çengel Khan. It has an open courtyard plan type, surrounded by semi-open riwaqs, and the rooms behind. Entrance to the building is provided on the north side [28]. It lost its historic character and character defining features to a great extent during its repair works in 1950s [26]. Hence, it was in a ruined condition before its last restoration which was completed in 2010. During the last adaptations, the building was converted to a boutique hotel with all the rooms having a different concept. Hence, it still retains its original accommodation use, and with the renovated shops on the north façade, it continues to provide public access/use and preserves its streetscape character. During its restoration in 2007–2010, its open courtyard was covered with a rooftop, and thus the space below could serve as a bar restaurant (**Figures 12 and 13**). This rooftop addition exhibits a contrasting approach in terms of material (glass and steel) selection and construction technique, so can easily be distinguishable from the original. The entire storefronts on the north facade, that were too deteriorated to repair or were not existent, were replaced with wood and glass material, by using the physical evidence as a model as suggested in The Secretary of the Interior's Standards for Rehabilitation and Guidelines for Rehabilitating Historic Buildings (**Figure 12**) [4]. Both the new rooftop and storefront additions are compatible with the size, scale, and massing of the historic

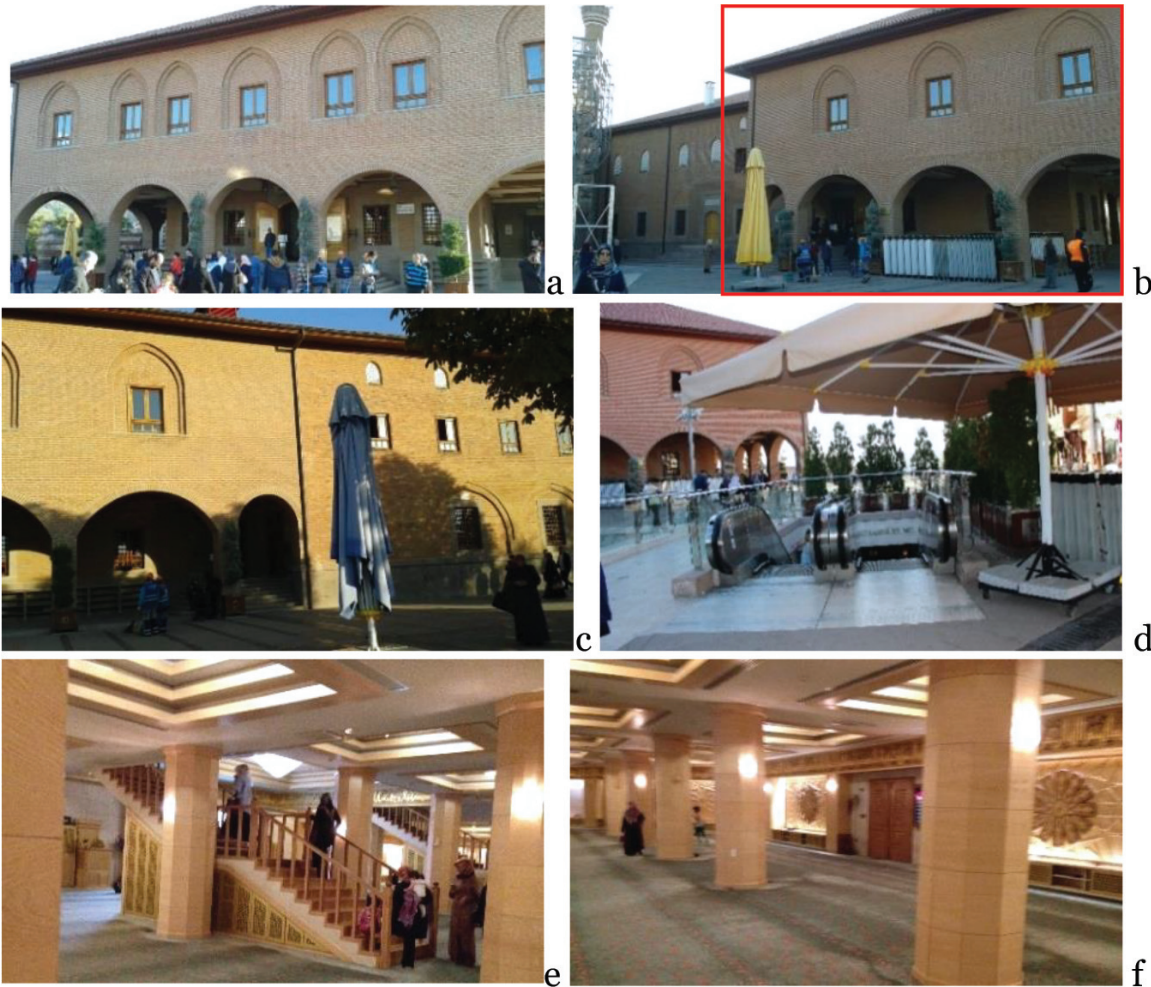
Figure 14. Hacı Bayram-ı Veli mosque new exterior additions on the north side ((a) view from the north, (b) view from the east, and (c) view from the west) and views from the basement addition (d, e, and f) [39].

The building was constructed in 1427/1428 [26]. It is located in historic Ulus district, attached to August Temple of Roman period on the east side. Main prayer space has a rectangular plan, covered with a flat wooden ceiling, above which is a hipped roof with tile covering. Main body walls were built with brick material. On the south side of the mosque, there is Hacı Bayram-ı Veli Tomb, which has a square plan covered with a dome above [58]. The mosque undertook comprehensive repair works between 1703–1730 and 1757–1774, later in nineteenth century, in 1941, and in 1970 [26, 56, 58–60]. Especially during the last 80 years, the mosque was enlarged with new exterior additions, causing severe lost in its architectural and historic entity [58]. Late comers’ portico on the north side of the mosque was enlarged, and a riwaq was added on the north, east, and west sides. Also, a basement floor was added for women’s praying and for wet spaces. The first addition was conducted on the west side of the mosque with a vaulted gateway beneath, in early eighteenth century repairs [56]. Later, in 1941, late comers’ portico was enlarged with a concrete addition covered with tile material [56]. It took its present-day appearance during its latest restorations completed in 2011 (**Figures 14 and 15**). At present, the front addition on the north side, together with its side riwaqs, is nearly larger than the original façade of the building. Though the old and new are at the same height, have similar material, and color, because of the location and massing of the new additions, the original building is suppressed by the new and cannot be perceived from the north side. Similarly with the basement addition, the square area

of the building was enlarged 2.5 times larger than the original size of the mosque itself [58]. Hence, in Hacı Bayram-ı Veli Mosque, exterior additions were applied with standard approach in the form of front and side additions, and basement addition exhibits the contrasting approach. They are all incompatible with the old building according to the international standards. On the other hand, regarding the interior alterations, providing access to the wet spaces and women’s prayer space by means of a newly added escalator exemplifies the social responsibility role of new designs, taking into consideration of physically disabled and handicapped.

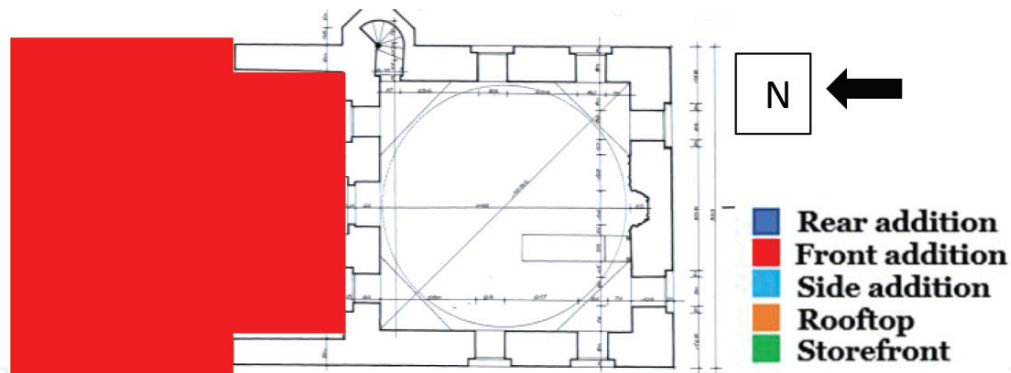
Figure 17.
Front addition in Kursunlu mosque located on the north side of the historic building (source: Rearranged from [56]).

It is located in Ulus district, Samanpazarı area. Though the mosque does not have an inscription panel, it is dated to the sixteenth century [26, 55, 59]. It has a square main prayer area covered with a dome. Main body walls were built with alternating rows of stone and brick, and window arches and minaret were built with brick material. There is a minaret on the northeast side of the main prayer hall. The minaret was rebuilt after the earthquake in 1921 [26, 59]. The mosque was restored in 1914 and in 1990, and its late comers’ portico on the north side was replaced with concrete two-story addition in 1972 repairs [28, 56] (**Figures 16 and 17**). Today, this front side addition is used for women’s prayer area and for religious education of the children, but the original function of the main building is still continued. Its basement floor is allocated for wet spaces and water depot. The material used for the new addition—concrete columns and beams—is incompatible with the original building and also incompatible in terms of historic preservation rules. In addition, neither its massing and location nor its material is size respectful to the old building,

and in that, the perception of old building is blocked from its north façade. Although, international guidelines suggest the control of mass, proportion, volume, material, color, and placing of new additions, in Kursunlu Mosque, and none of these criteria are observable.

dominate the historic fabric. In Kursunlu Mosque, the concrete attachment on the north side is also incompatible in terms of material selection.
