# Biodegradation of Sheep Wool Geotextiles Designed for Erosion Control

*Jan Broda*

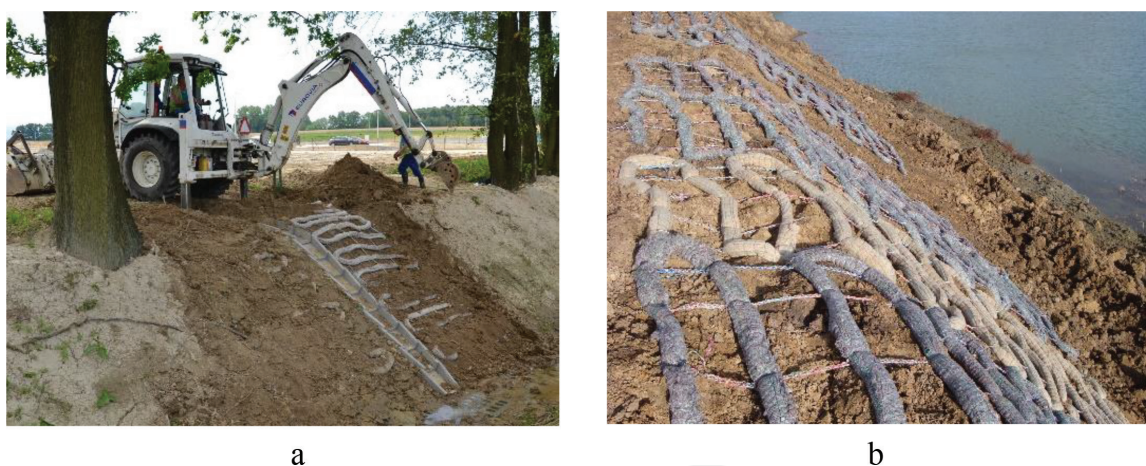
**Figure 1.** Installation of the geotextiles, (a) bank of the drainage ditch in Miedzyrzecze, (b) slope in the abandoned gravel pit in Nieboczowy.

In the preliminary research, the samples of ropes made from the wool nonwoven were buried in the experimental site located in the university campus. Then, the geotextiles formed from the meandrically arranged thick ropes were used for the renovation of the bank of the drainage ditch damaged by water surface erosion. In further investigations, the similar wool geotextiles were used for stabilisation of steep slope prone to sliding in the abandoned gravel pit. In both places, the segments of geotextiles were spread on the surface of the slopes and anchored to the slopes with metal “U-shape” pins. Finally, the geotextiles were covered with a layer of topsoil (**Figure 1**).

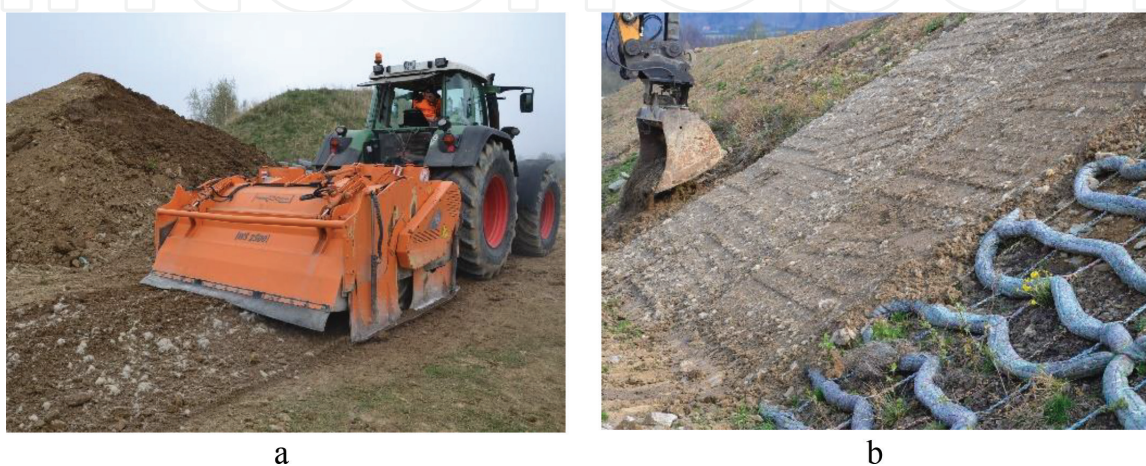
**Figure 2.** Installation of the geotextiles in Lipnik, (a) mixing fibres with the soil, (b) the geotextiles covered with a layer of soil mixed with fibres.

located between flat terraces artificially formed on a gently sloping hill. In this case, the geotextiles were covered with soil reinforced with loose wool fibres (**Figure 2**).
