Historic Masonry

*Noemi Graciela Maldonado, Pablo Martín,
Gerardo González del Solar and María Domizio*

Abstract

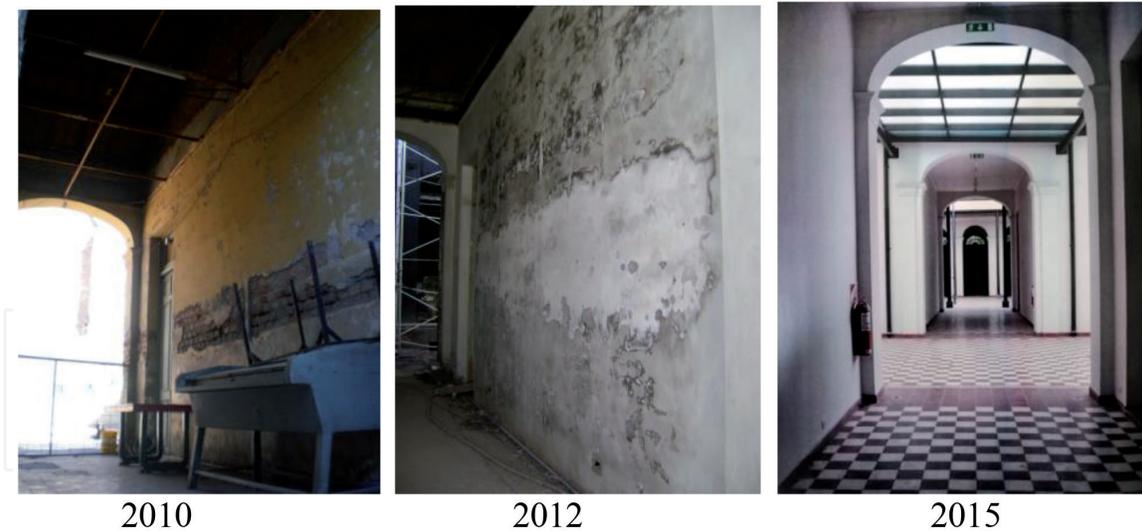
Figure 6.
Evolution of the mortar compatibility process during rehabilitation of school building [2].

As far as mortars are complex systems, different approaches can be used for their characterisation. Nowadays, the reconstruction of the original composition is quite complex and requires the application of various and complementary techniques. In addition, the technological culture of making lime mortars has been lost, although from the economic point of view they would be of lower cost [7]. The need for mortar compatibility has led to the design of specific products to avoid damage by chemical reactions as shown in **Figure 6** [2].

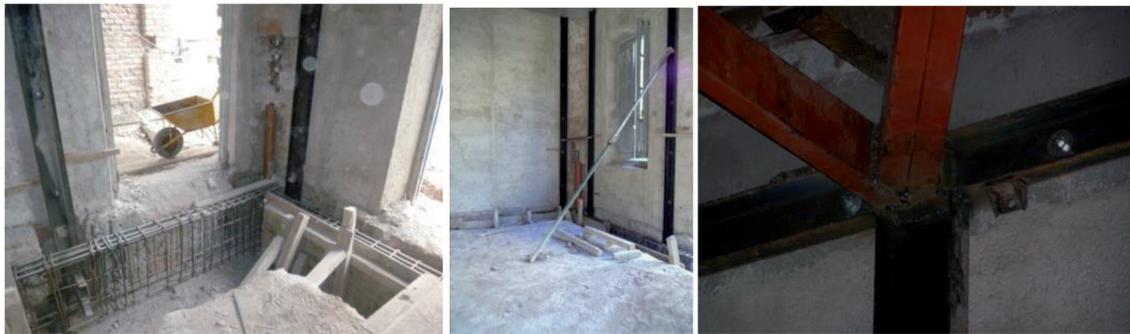
Figure 11.
Reinforcement of foundations and reversible metallic structures in columns and lattice, Mitre school, 2012.

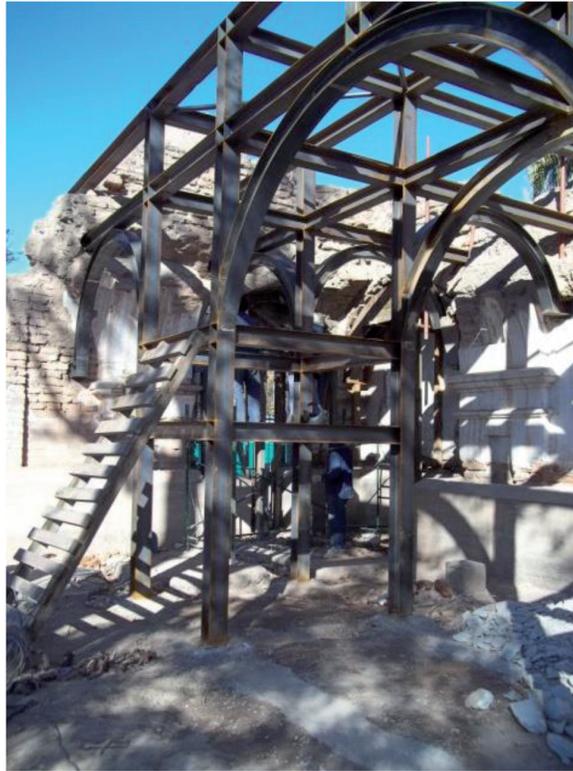
Figure 13.
Support structure of masonry blocks, Saint Francis Ruins, 2011.

- Interventions for the local mechanisms (in case of a prevailing out-of-plane response, **Figure 12**)
- Interventions on blocky structures (where the kinematic mechanisms must be prevented: obelisks, towers and also arches and vaults, **Figure 13**) [19]
