Stress Corrosion Cracking Behavior of Materials

Alireza Khalifeh

Abstract

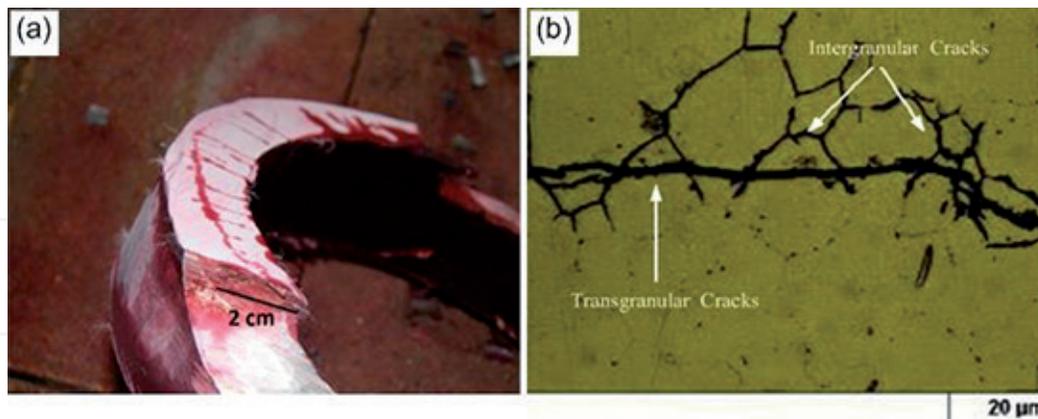
Figure 1. Macroscopic and microscopic feature of the stress corrosion cracking: (a) Cross-section of a failed tube and formation of macro branching cracks on it. (b) Optical micrograph of a typical SCC in AISI316L stainless steel exposed to chlorides [3, 4].

In macroscopic scale, SCC failures appear to be brittle even if the material is ductile, and stress level is lower than design stress. The cracks in SCC are not mechanical but are caused by corrosion. A typical growth and developments of cracking by cause of the stress corrosion cracking phenomenon in AISI316L stainless steel are shown in **Figure 1a**.

The branches developed, intergranular and transgranular cracks are the character of stress corrosion cracking in microscopic levels, **Figure 1b**. In intergranular mode, the cracks proceed along grain boundaries while transgranular cracks grow across the grains [3]. The mode of crack proceeds depends on the material microstructure and environment.

When austenitic stainless steel grades contain more than 0.03 wt% that are exposed to temperature from 415 to 850°C, their microstructure becomes sentient to precipitation of chromium carbides ($M_{23}C$) along grain boundaries called as sensitization [11, 12]. Constitution of Cr enrichment carbides along with grain boundaries may severely evacuate the area aside to the grain boundaries from free chromium and render them sensitive to rapid corrosion in presence of aggressive agents such as chloride, caustic, and polythionic acid [4, 12, 13]. Grain boundary dissolution aside tensile stress lead the component made of these ductile alloys to brittle fracture. An example of the SCC failure in an austenitic stainless steel is shown in **Figure 1**.

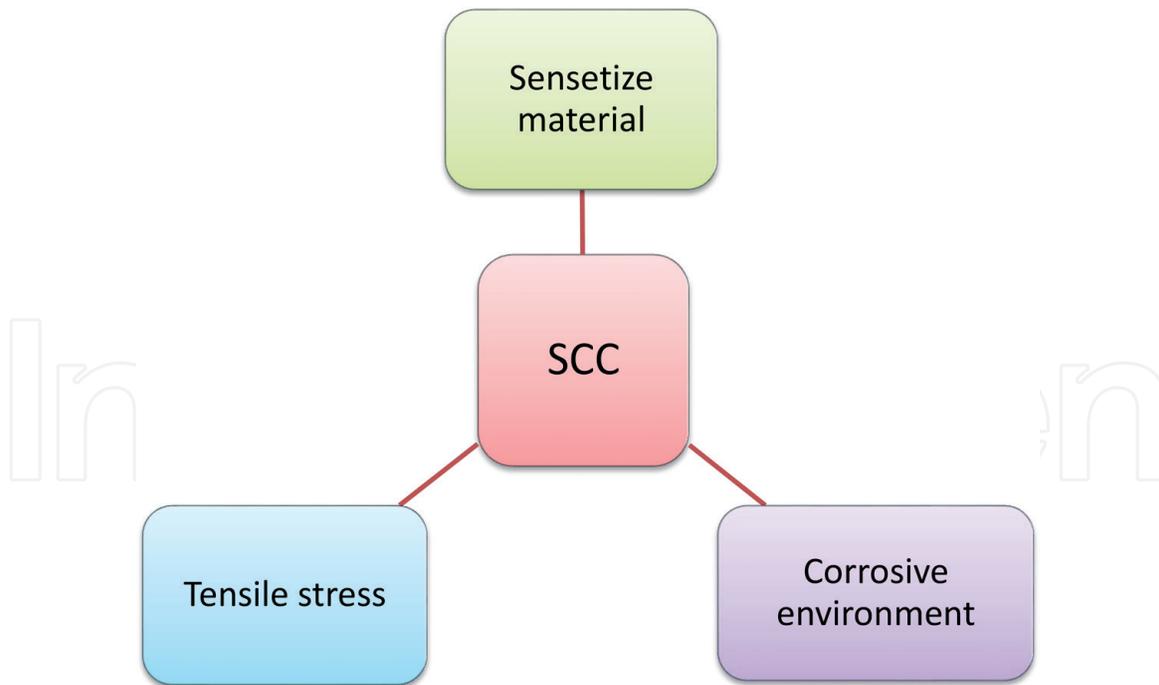
Figure 2.
Essential parameters for occurring SCC.

Three key elements are essential for initiation and growth of the stress corrosion cracking: a sensitized material, a specific environment, and adequate tensile stress. It is shown in **Figure 2**.

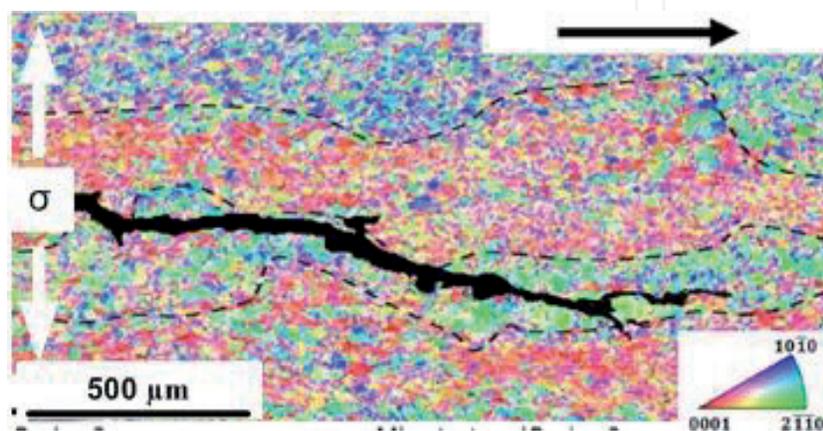
Figure 3. IPF map of the SCC crack growth in a wrought Ti-811 specimen. Crack propagation extended along planar slip (0001) [33].

The significant corrosion resistance of Ti alloys under oxidizing media is a result of formation of the protective passive TiO_2 film on the surface. For Ti-811 grade, instinctive passivation arises in 3.5% sodium chloride HCl solution [31]. However, the passive protective layer will be destroyed if load applied is over the yield stress of the oxide film, and corrosive environment will then expose to the fresh metal and lead to SCC [32]. In Ti alloys systems, oxygen and aluminum additions enhance SCC sensitivity and change the slip condition to a planar slip [33]. Slip plan growth of SCC cracks in this grade of Ti alloys is shown in **Figure 3**.

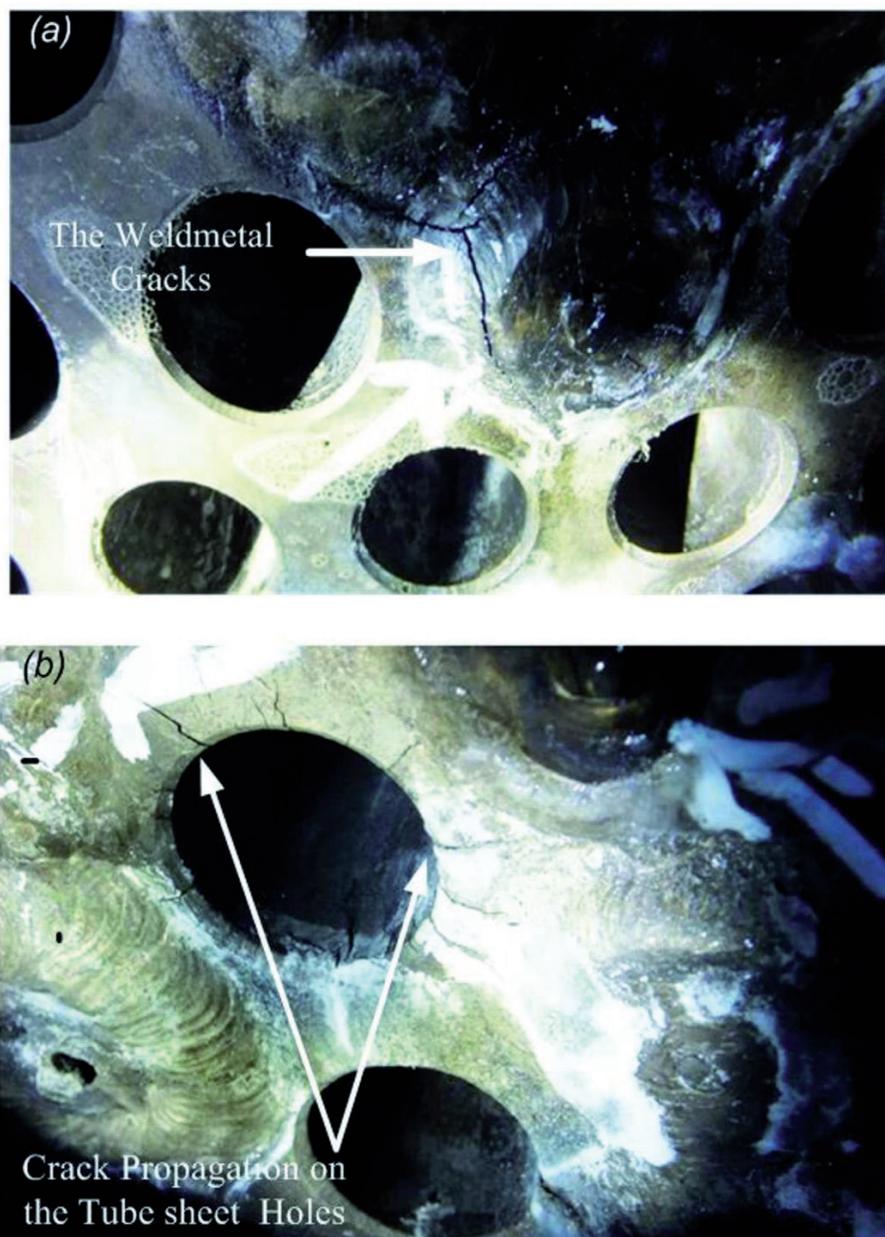
Figure 4. Two sources of stress in the SCC: (a) welding residual stress and (b) mechanical residual stress [3].

The main source of stress attributed to stress corrosion cracking comes from the residual stress. The well-known sources of the residual stress are welding and fabrication processes. Residual stress due to welding plays an imperative role in the stress corrosion cracking of metal alloys. In this area, two factors are determined. First, the welding residual stress by the cause of nonuniform temperature changes during welding, which can be computed by Eq. (1). Second, in some of the steel

grades, the solid-state austenite to martensite transformation in the time of cooling generates a significant value of the residual stresses [53]. In carbon and low alloy steels, martensite is formed by quenching of the austenite containing carbon atoms at such a fast cooling rate that carbon atoms do not have a chance to diffuse out from the crystal structure and form cementite. The trapped carbon atoms in octahedral interstitial sites of iron atoms, generating a body-centered tetragonal (bct) structure that is in super saturation, relate to the ferrite with body-centered cubic (bcc) structure [54]. Therefore, during this phase transformation, the volume of metal increases, and a significant residual stress is also produced [54]. In austenitic stainless steel, there are no phase transformation processes, and so this mechanism does not attribute in their welding residual stress. An example of SCC in the weld area of an austenitic stainless steel component is shown in **Figure 4a**.

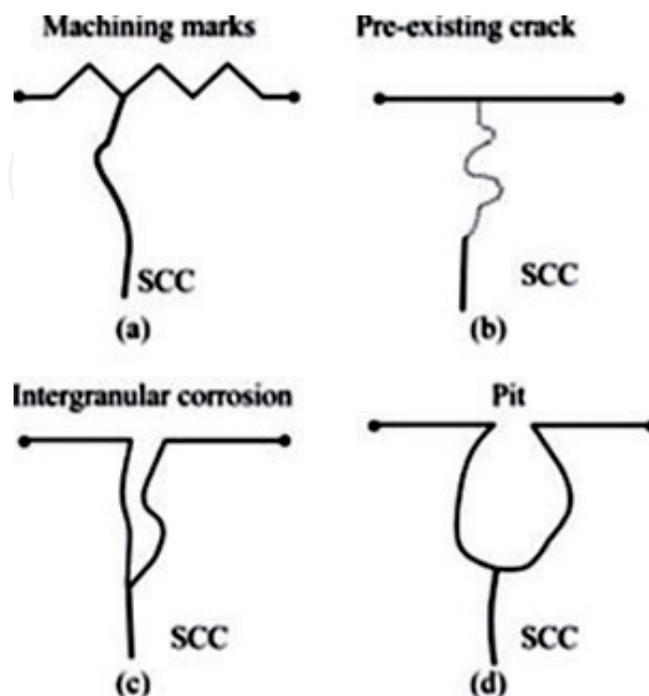
Figure 5. The sources of SCC sites (a) machining marks, (b) pre-existing crack, (c) intergranular corrosion, and (d) pit [28].

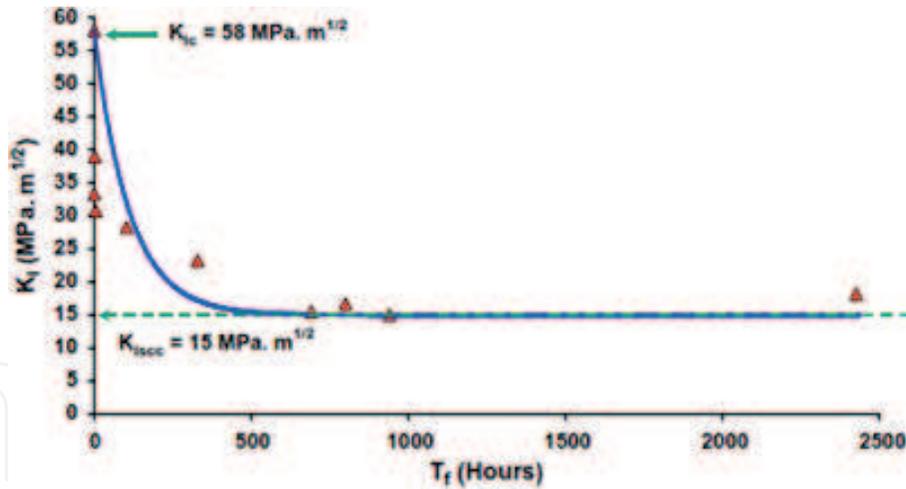
Figure 6. K_I vs. T_f of AISI4340 steel in 3.5% NaCl at ambient temperature [59].

According to this relation, there is a critical size of flaw which led a component to brittle fracture. Investigation has shown that for the structure expose to corrosive environments, the scenario is quite different [58]. The corrosive environments cause a significant drop in this property of the materials [59]. This typically is shown in **Figure 6**. As it is seen from the graph, the K_{Ic} in presence of aggressive agents shown by K_{Isc} is much lower than its value in normal conditions. This means in corrosive environments prone to SCC, a smaller flaw size led the components to catastrophic brittle fractures. Susceptibility of existing cracks to environmentally assisted propagation is a critical consideration for designers while selecting proper materials for environments prone to this form of corrosion [58].

Example 1. Compare the critical crack length for 4340 steel exposed to dry environment and 3.5% NaCl at room temperature:

If we assume that the applied load is on the magnitude of yield stress (Y.S), the critical crack depth, a_{cr} , exists above a size that the stress intensity factor exceeds K_{Ic} or K_{Isc} . In presence of this condition, the failure occurs in a brittle mode. Based on Eq. (3):

The results show that the a_{cr} in presence of corrosive agents is about 15 times lower than the normal condition.

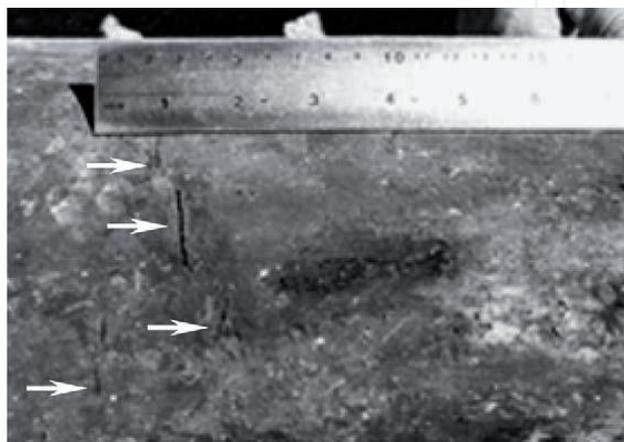
Figure 7.
Macroscopic observation of the cracking area.

In April 2004, an oil transportation pipeline in north part of Iran failed and caused oil leaking. Visual inspections revealed macrocracks and shallow pits on the external surface of the corroded area (**Figure 7**). Optical observation

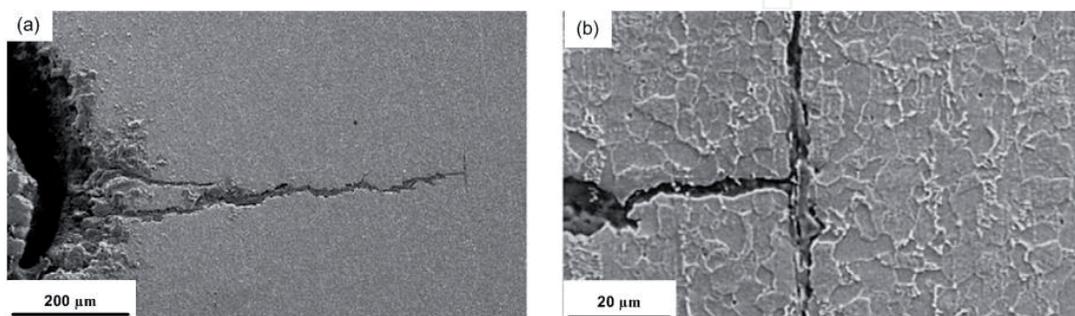
Figure 8. (a) Initiating of cracks from pitting on the surface of the carbon steel pipe and its branched development (unetched), (b) intergranular crack growth in the microstructure (etched) [60].

indicated that cracks were started from the bottom of the pits and extended into the wall thickness as shown in **Figure 8**. There was a main singular crack and some branched cracks at the end. The crack features are characteristics of a stress corrosion cracking [60].

The oil transportation pipe line is made of API 5 L X52 carbon steel that is coated by polyethylene tape coating. The utilized polyethylene coating on the external surface of the carbon steel pipe gets loose and separated in some areas. As a consequence, the surface of the underground steel pipeline was uncovered to the wet soil environment. Because of the chemical reactions and the formation of carbonate-bicarbonate solution and arise of underweight stress due to rain fall and land sliding, condition was provided for SCC. Further to SCC, sulfate reducing bacteria (SRB) activities around the pipelines have accelerated corrosion and the failure process.

Utilizing a high level of negative potential (1.2 V Cu/CuSO₄) in cathodic protection provides condition for production of carbonate and bicarbonate which induced SCC. Therefore, controlling of the potential can be effective in reduction of these failures.

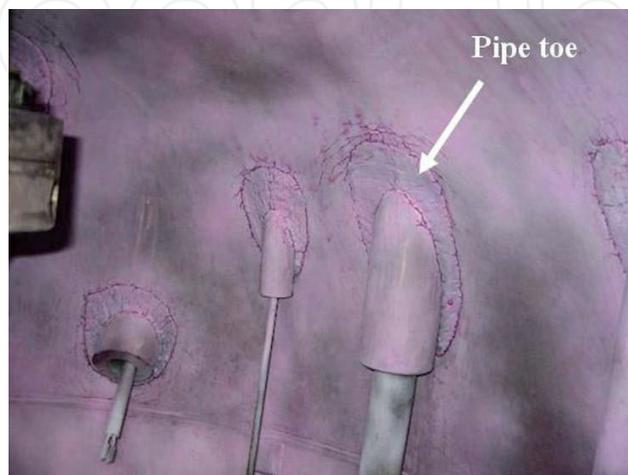
Figure 9.
Cracks in heat affected zone of the weld toe.

A vertical hydro-processing reactor failed only after 1 month operation. Penetrant testing (PT) revealed some cracks on the inner surface of the component. The cracks are mostly found to be initiated from the heat affected zone or HAZ of the weldments. The cracks were extended in perpendicular to the weld in the head side (**Figure 9**). Metallographic investigation showed that all the cracks had propagated essentially in transgranular mode, and they had the appearance of branching as it is shown in **Figure 10**. These features indicate occurrence of the stress corrosion cracking on the reactor [44].

- Decreasing the magnitude of stress. As welding residual stress is a main source of stress attributed to the stress corrosion cracking, decreasing its order should decline the possibility of SCC. It means that the reactor should be stress relieved after welding.

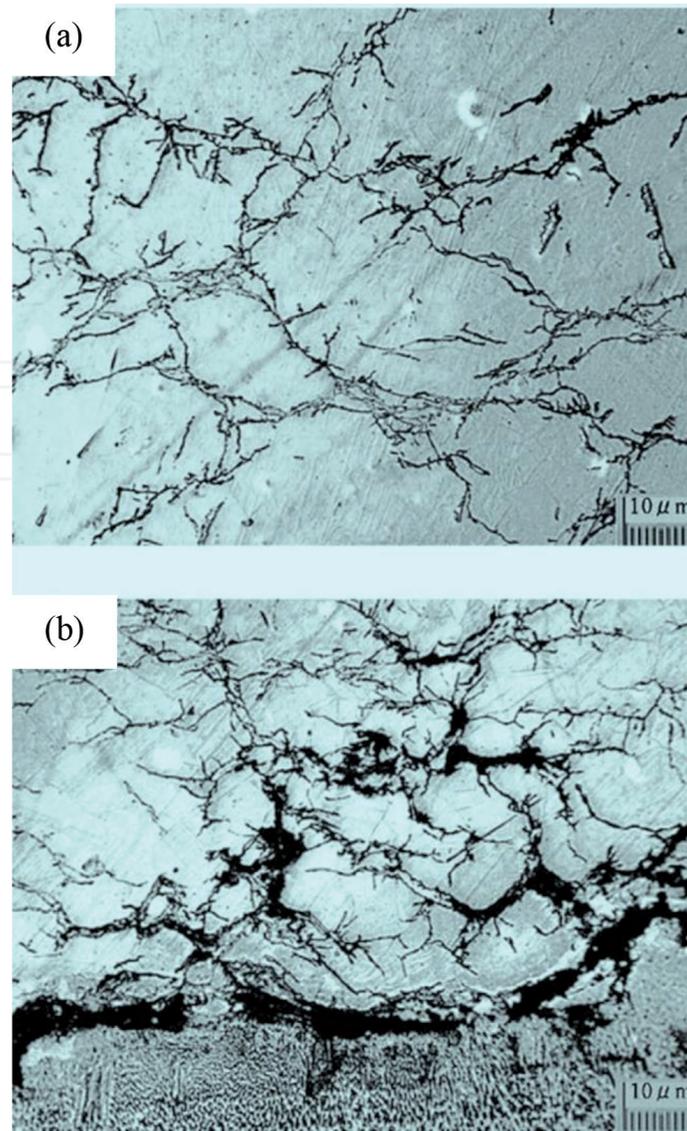
Figure 10.
The stress corrosion cracking: (a) heat affected zone and (b) the weld line.

The reactor has a thickness of 45 mm. Welding was used in manufacturing processes. A high magnitude of the welding residual stress is created (in

magnitude of the ultimate strength) during welding operation. The chloride ions came from the catalysts. For the utilized catalyst, the chloride concentration is over 60 ppm. The operating temperature of the equipment is 200°C. Investigations have shown a chloride concentration of 10 ppm is enough to motivate SCC in an austenitic stainless steel grade if the metal temperature is over 60°C [2]. Therefore, chloride SCC is responsible for the failure of the reactor.

- The main cause of failures is the presence of high concentration of chlorides. Therefore, decreasing the concentration of this aggressive agent in the catalyst can be an effective approach. Experience on the other reactor used in the same operational conditions shows that the concentration of chloride in the catalyst should be less than 60 ppm for the AISI 316L material.
- Selecting more resistant materials to SCC. Since AISI 316L cannot tolerate such a high concentration of chloride, more corrosion-resistant alloys, such as duplex stainless steel, should be utilized if the concentration of the chloride in the catalyst cannot decrease to a proper level.

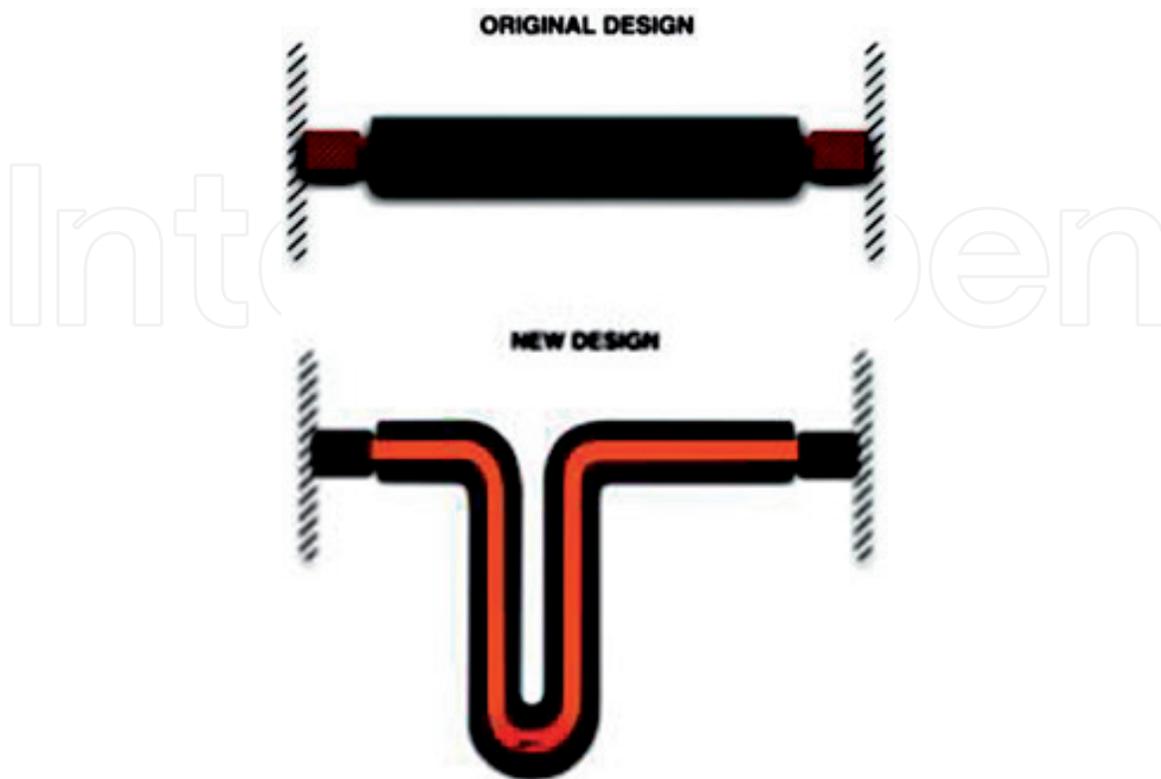
Figure 11.
New and old design of refrigerating system.

Copper alloy C12200 tubes of a refrigerant failed in bend area (**Figure 11**). Failures were occurred only after approximately 6 months of services. The cracked area is shown in **Figure 12**. SEM image of fractured areas revealed the branch cracked through the microstructure, **Figure 13**, which is characteristic of a stress corrosion cracking phenomenon [61].

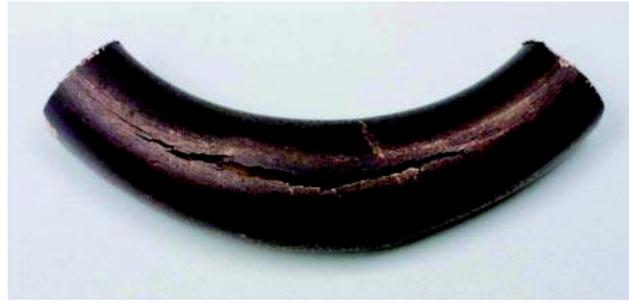
Figure 12.
Macroscopic image cracked copper tube.

enhanced in consequence of the cold work operation for bending the tube at an angle of 180° . Stress cycling and/or repeated loading increased the sensitivity to ammonia stress corrosion cracking as a result of the service-induced oscillational loading from the other components linked to the tube.

Cold work operation generated high magnitude of residual stress which is responsible for the tube failure. Hence, it is suggested that the copper tubing be annealed after the bending operation in order to eliminate the adverse impacts of the cold working and also decrease the residual stresses available for ammonia stress corrosion cracking. Another recommendation is to avoid the installation of the tube under stress condition.

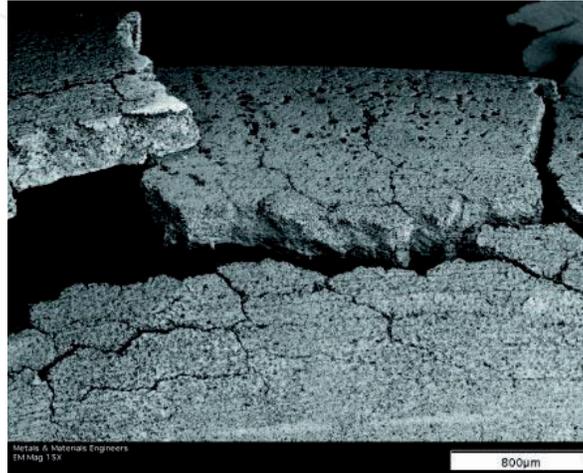
Figure 13.
SEM image of the intergranular crack growth in the copper tube.

The phosphorized copper alloy tube failed due to SCC induced by a moist ammonia environment related the black foam insulation. Although the resistance of copper alloy under dry ammonia environment is notable, gathering of moisture ease by the bent tube geometry provokes the tubing to be exposed to wet ammonia, which is substantially more. The sensitivity of the copper tubing to SCC was
