# Translational Rock-Block Slides in a Tertiary Flyschoid Complexes of Southern Piedmont Region (North-West Italy)

*Fabio Luino and Laura Turconi*

## Abstract

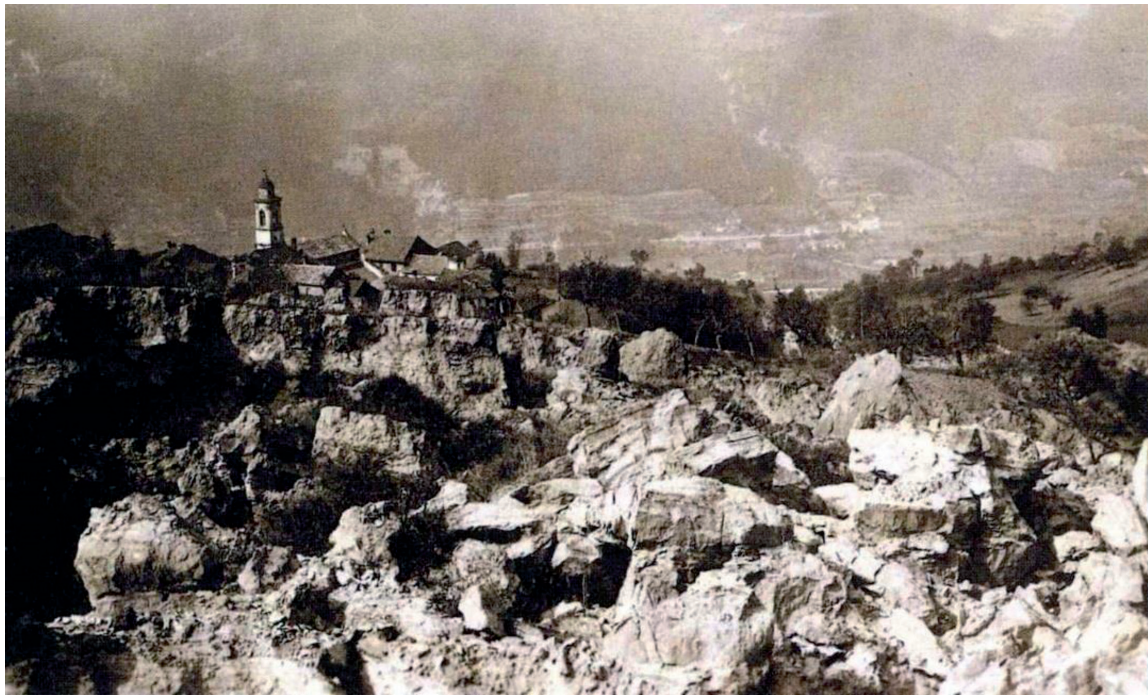
**Figure 2.**  
*May 16, 1926: Levice rock-block slides, top view. The large disjointed clods are evident.*

During an intense rainfall period on May 16, 1926, a translational landslide occurred near the village of Levice [15], involving a surface area of 3 ha (**Figure 2**). According to eyewitness accounts, long cracks appeared less than an hour before large fractures 20–25 m in depth opened in the slope. There were no victims, and no buildings were destroyed, but meadows and vineyards were damaged.

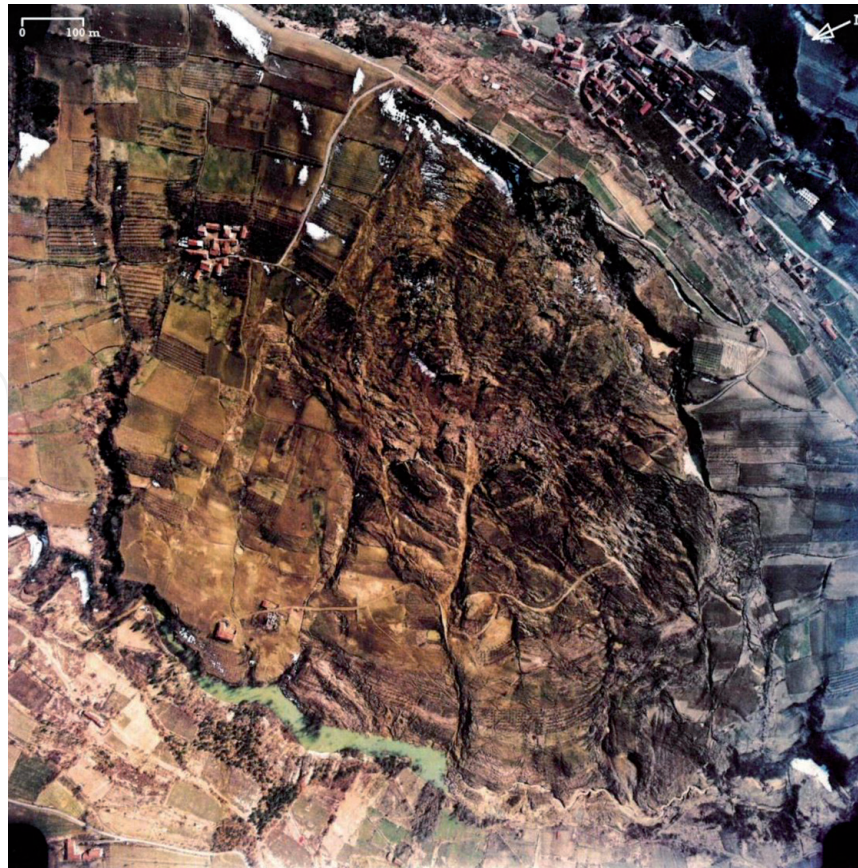
**Figure 5.**

*Aerial photograph of the huge translational rock-block slide at Somano (February 1974). The movement stopped at the opposite slope causing a dam and consequent small lake of the Gamba stream.*

In February and March 1972 and February 1974, several translational landslides occurred in the Langhe hills [8, 22]. Some of the movements affected entire slopes and caused severe damage to rural buildings, main highways, secondary roads, and agricultural activities (in particular vineyards and wineries). Two of these landslides, the Somano and Arnulfi rock-block slides, were extensively studied. The Somano landslide occurred on March 13, 1972 and was reactivated on February 18, 1974. With an area of almost 1 km<sup>2</sup> and a volume of about 10 million m<sup>3</sup>, it was the largest rock-block slide to occur in the Langhe in the twentieth century (**Figure 5**).

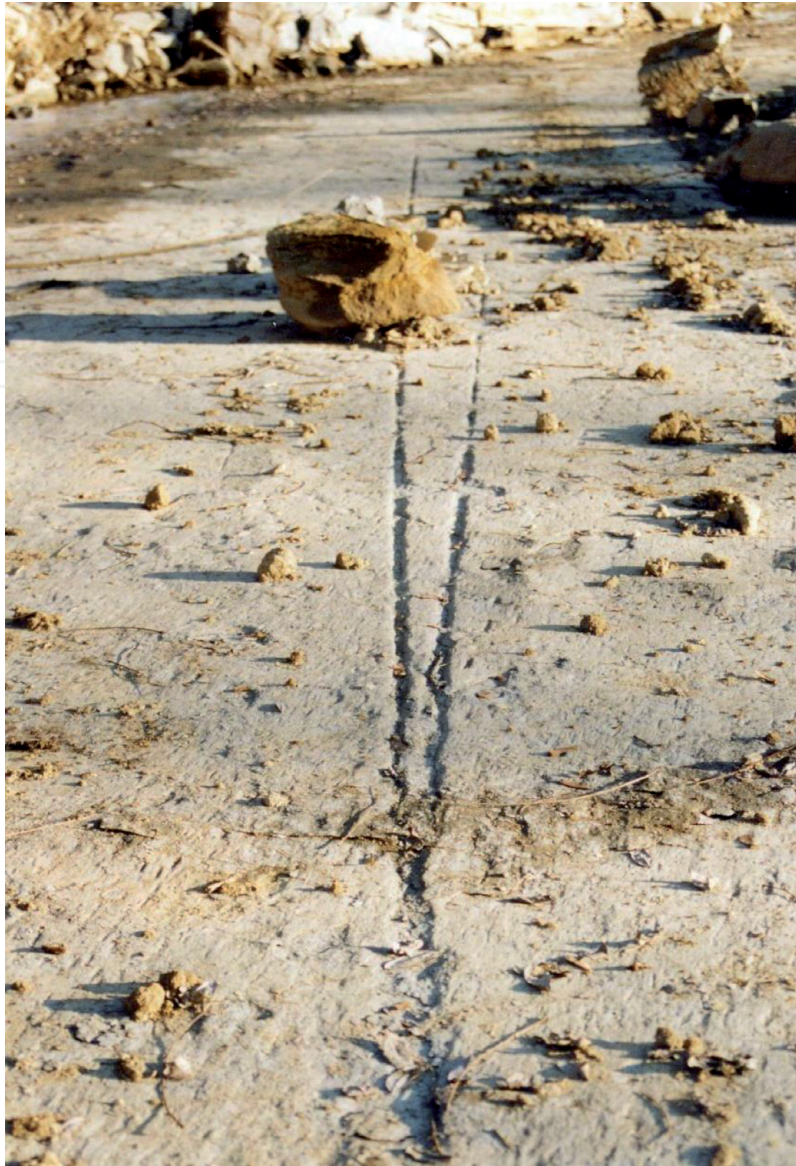
**Figure 8.**  
*Sliding surface of the Murazzano landslide taken from uphill: The shallow tracks left by the sliding rock blocks are evident.*

TRBSs develop along bedding planes on slopes with gradients that vary from 8 to 15°, with 11° as the most common angle (**Figure 7**). They usually correspond to joints that form the interface between sandy-arenaceous and marly silty levels. The dominant direction of translation is nearly always parallel with the dip of the strata, even when the dip direction of the slope face is different. In the latter case, landslides develop at right angles to the slope. At the end of the movement, the sliding surfaces appear as a smooth, inclined plane that sometimes shows the shallow tracks left by the sliding rock block (**Figure 8**).

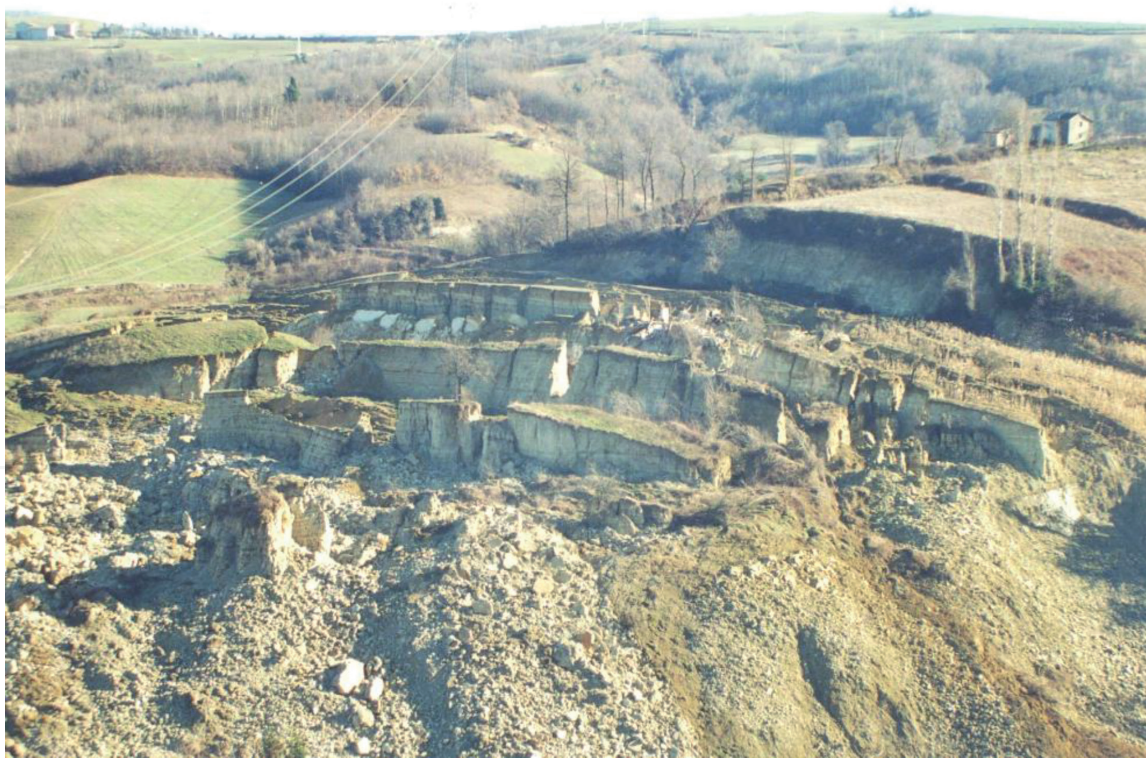
**Figure 9.**  
*Murazzano Cascina Fascinea farmhouse, one of the most evident landslides of the 1994 event with an area of about 7.4 ha. The clods detached and moved for over 80 m had a height of 8–10 m.*

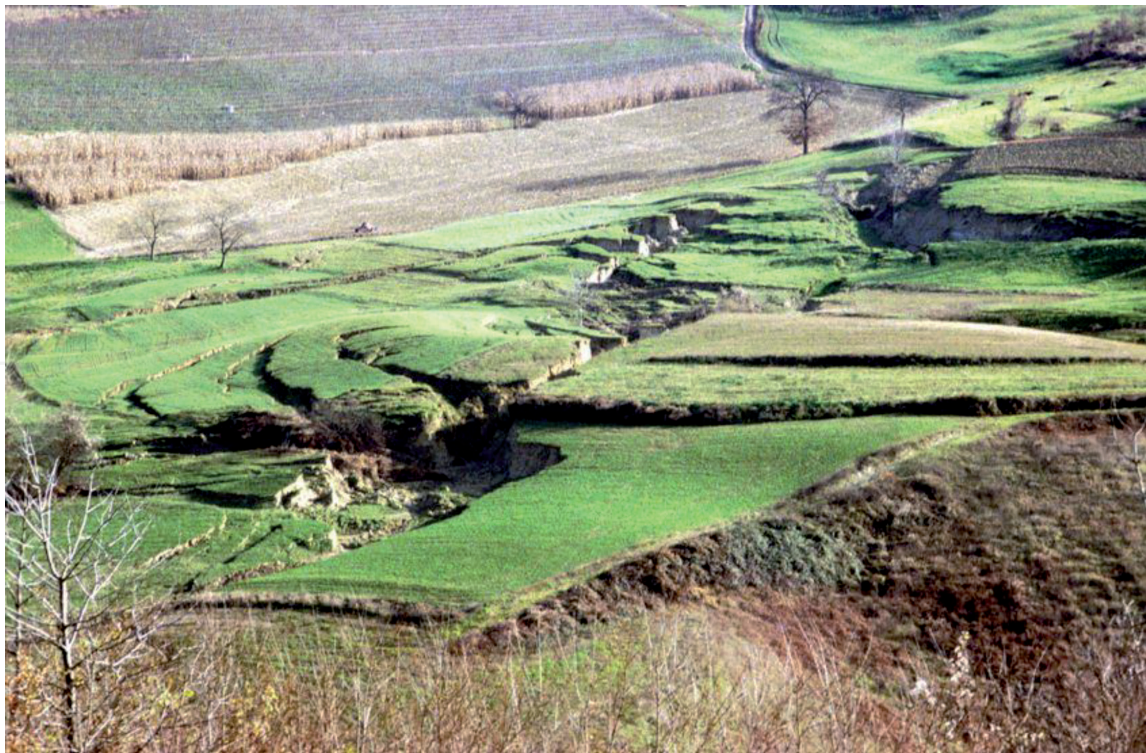
**Figure 13.**

*Spectacular example of rock-block slide in a second stage characterized by a period of quiescence that can last for several years. During this time, the density of fracture systems increases greatly, leading to vertical displacements and the formation of morphological steps. Cracks can be some hundreds of meters long, often coinciding with the perimetrical fractures of older translational block slides.*

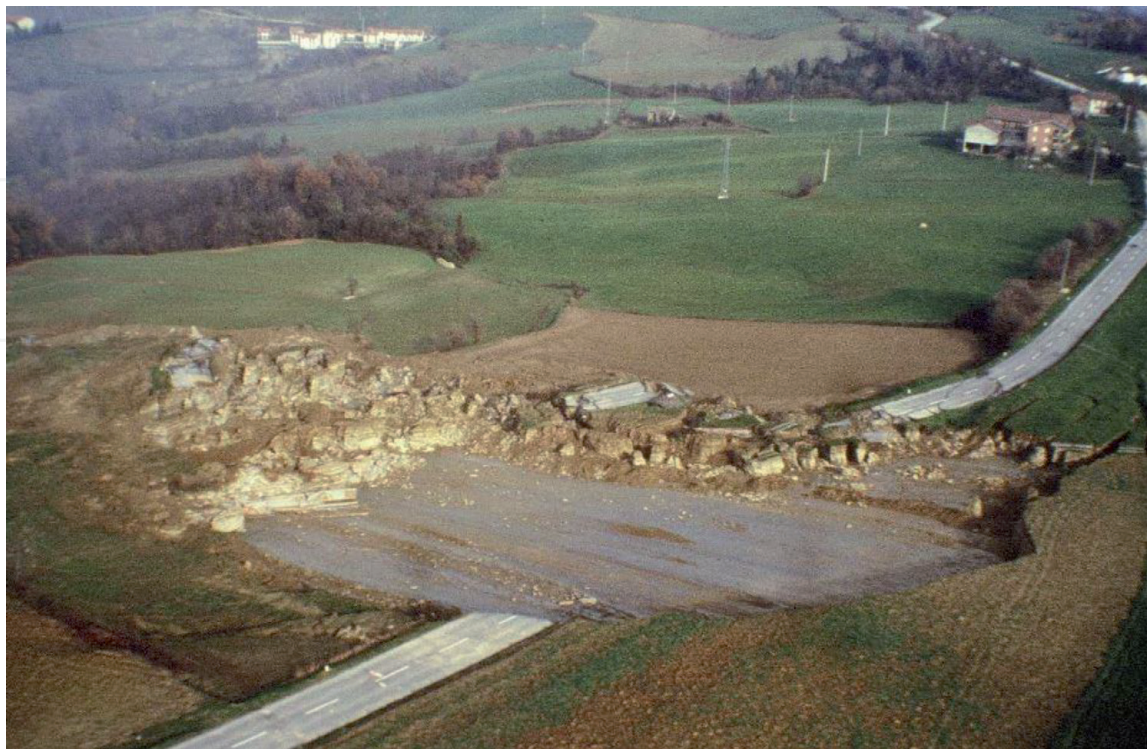
**Figure 17.**

*Murazzano rock-block slide, one of the most showy TRBSs triggered in November 1994, here shot a week later when a temporary road had already been restored. The clods moved along a surface with a gradient of  $9.8^\circ$  for a distance of about 80–100 m. The crown was located about 20–25 m upstream of the provincial road.*

It has been repeatedly observed that the slope cuts for the opening of service roads, exposing the cracked substrate and thus facilitating the infiltration of water into the subsoil are preferential places for the development of the first movement of land, with extensive opening of the cracks and subsequent propagation of the instability in the closest zones (**Figure 17**).
