# Anchorage Pile Strengthening of Shale Slopes and Cementing Falling Stone Blocks by Mixture of Melted Waste Plastics/Asphalt and Fly Ash for Slope Stability in Asphaltite Open Pit Mining Site in Avgamasya, Şırnak

*Yıldırım İsmail Tosun*

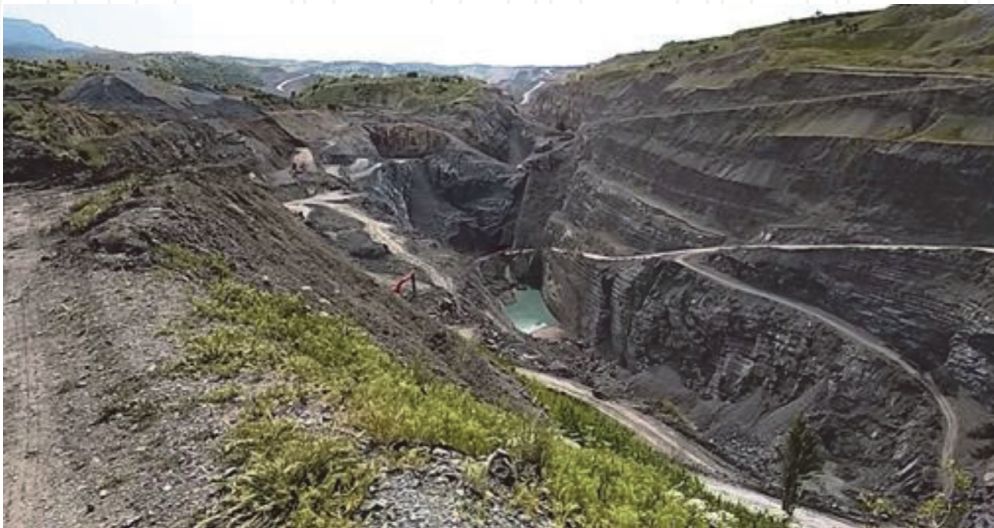
**Figure 2.**  
*Avgamasya No. 1 pit Şırnak asphaltite coal mine site and survey area.*

In recent years, both the opening of our university in our city and the migration movement from rural to provinces have also affected the coal economy in Şırnak. Open pit mining excavation and asphaltite production increased in different excavated pits in the area. A total of 500,000 asphaltite excavation by Asphaltite open pit mining with 20 separate pits continued to increase rapidly in Şırnak. Equipment and safety demands have also increased due to excessive extraction. This increase in demand caused people who are not competent in excavating in open pit mining production to enter the hauling, the control mechanism of dumping ability, modeling slopes to control the intensive stability, and areas that are not included in the development plan that are rapidly foreseen to mining development and safety. A vast majority of the excavations in the Avgamasya open pit No. 1, 2, 3, 4 were excavated without adequate ground research. In the asphaltite mining of Şırnak, there were generally adjacent open pits in Silopi, Uludere. It is believed that such new open pits in Şırnak have been developed due to the neighboring hard condition of rock cracks, rock fallings, landslides, and sometimes the existing collapsed pits (or structural damage caused by the rotation of the equipment) or hydrological ground problems. Finally, Şırnak Avgamasya No. 2 landslide caused 8 workers' death, closing the excavation work. For these reasons, the investigation of the new buildings to be built in our province and the ground conditions on the basis of regional and parcels of new areas to be developed has become essential [18, 19]. The unconditional expectations related to this study were also defined for this region such as the influence of the ground water, rock cracks and slope design, and explosion exchange dynamics leading to landslide. GEO5 software and manual stability analysis showed high risk area for plotting (**Figure 2**).

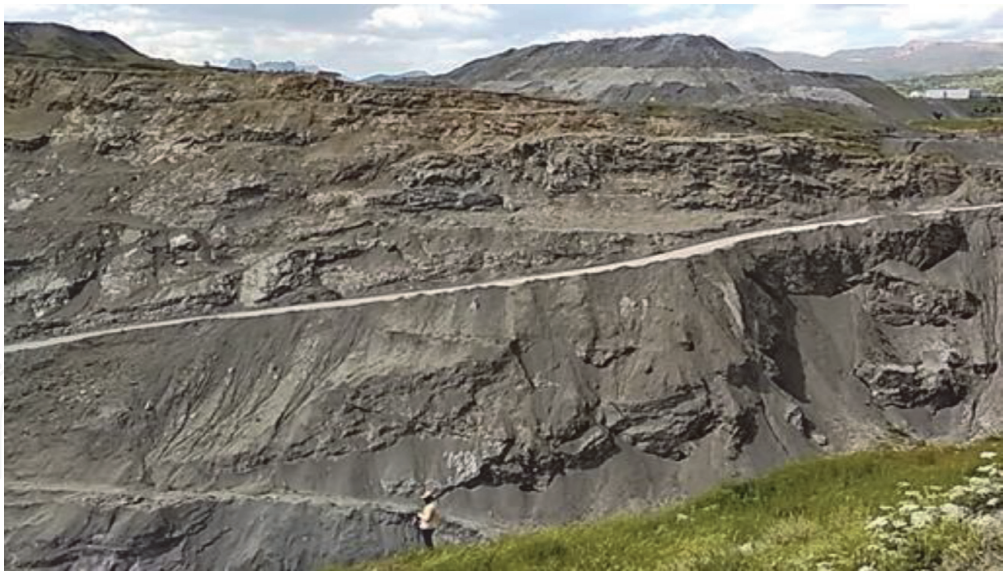
**Figure 3.**  
*North face of Avgamasya No. 1 pit Şırnak asphaltite coal mine site and survey area.*

The surface of new alluvial deposits starting from city center to the south of Avgamasya open pit 1 (**Figure 3**) in the study area is gray marl shale. This part is generally covered with silty soil, and some parts of it consist of sandy and clayey zones. It has been determined that the new alluvium continues in the drilling up to 35 m by the Special Provincial Administration [32]. Slope Rubble is located south of the Stream in the study area.
