Construction Materials and Dam Foundation While Memve'ele Dam Building in the Craton's Region of South Cameroon

Sylvestre M. Ntomba, Christelle R. Magnekou Takamte, Dieudonné Bisso and Joseph Mvondo Ondo

Abstract

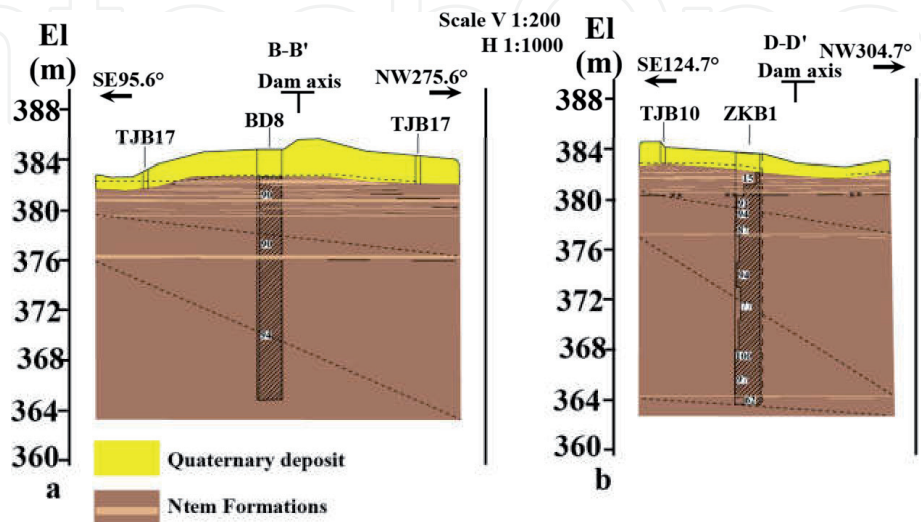
Figure 1. Geological units in the Memve’ele displaying quaternary deposit underlain by Ntem formation based on borehole information. Note uneven thickness of quaternary deposit between (a) and (b).

The in situ investigation in the Memve’ele dam site, comprised detail observation, description of geological units observed in the field and in the borehole cores and the laboratory tests include tests for petrographic analysis and on rock samples. The investigation resulted in the geology of dam site display two geological units based on borehole information and surface investigation (**Figures 1 and 2a**) [4]. These two geological units are named quaternary deposits and lower Precambrian Ntem Formations. Sometimes, Ntem Formations emerge and appear highly to moderately weathered down to elevation 386 m below which is slightly weathered diabase. The quaternary deposits are composed of full weathered soil covers with uneven thickness underlain by Ntem Formations in the dam site (**Figure 2a**). Full weathered soil covers with weak thickness occur up to Ntem Formations along the dam axis particularly. The plasticity index ($15 < Ip < 40$) and the clay content (A-7-5 type) of soil are generally on the high side, but the clay content roughly met the requirement. The subsurface strata are described in the **Figure 3**. The mineral assemblages of Ntem Formations indicate a high grade metamorphism which corresponds to granulite to amphibolite facies metamorphic conditions. Slightly

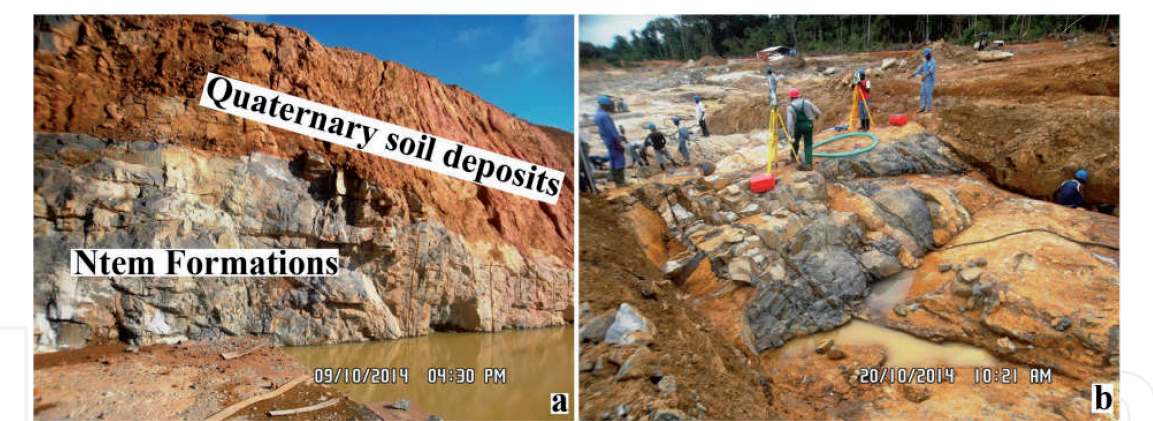
Figure 2.
(a) Quaternary soil deposits underlain by Ntem formations that represent two geological units found in the whole dam site and (b) fractured and slightly weathered rock mass.

(Figure 2b) and densely jointed zones are found at rocky outcrops, dominantly striking NE30° ~ 40° and E-W with moderate to steep dipping angles (Figure 4a and b), indicating an outline sub-parallel for all tectonic features (gneissosity, shear zone, fault and jointed rocks). The quantitative description and statistical distributions of discontinuities of Ntem Formations derived from boreholes and those obtained from the geomechanical mapping through scan line at the dam site [5]. The stereographic projection can give an overall view of the number of dominant discontinuity sets of joint and bedding directions within the rock mass. A plot of contoured pole concentration is dominant along the mean direction of N034.44 SE (Figure 4c). Quantitative description of discontinuities shows that spacing is extremely close to moderate (0–0.1 m and 30–40 m), their length vary from 1 to 50 m with small

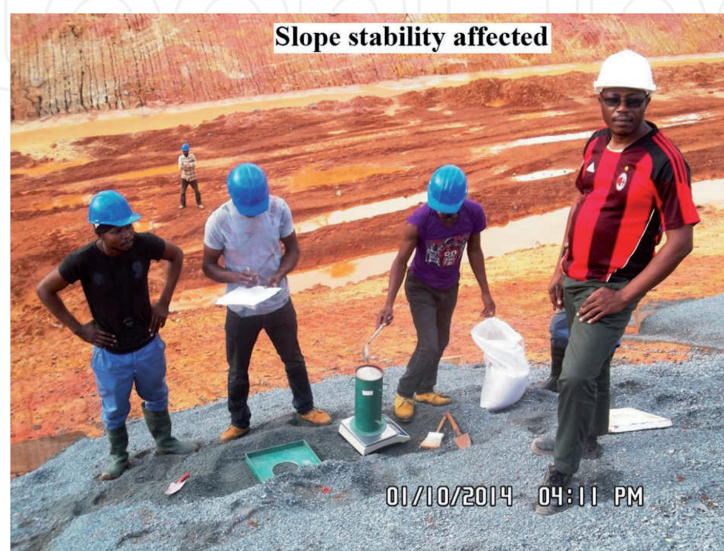
Figure 5.
Slope stability affected by raining water.

A geotechnical investigation into quaternary deposits that have represented construction materials and dam foundation of Memve'ele dam is described in this topic. Many boreholes were drilled by drilling rig to assess the geotechnical of the quaternary deposits from borrow areas and in the dam foundation site. The investigation of three borrows areas and dam sites comprised mainly laboratory tests of soil deposits. The results of mechanical tests are presented in **Table 1**. The specific gravity values vary from 2.60 to 2.76; wet and dry densities are ranged from 1.51 to 1.61 g/cm³ and 1.23 to 1.55 g/cm³ respectively; porosity values vary between 0.700 and 1.190%; liquid limit values vary between 58.4 and 76.2 wt. %; plasticity limit values are ranged between 28.3 and 40.1 wt. %. The deformation modulus values vary between 1.9 and 9.9 MPa; the coefficient of permeability varies between 8.62E-04 and 3.35E-05 cm/s. As per the exploration well, the reserve estimations is 182.39 × 10⁴ m³. However, slope occurs with erosion marks (**Figure 5**) after raining seasons.

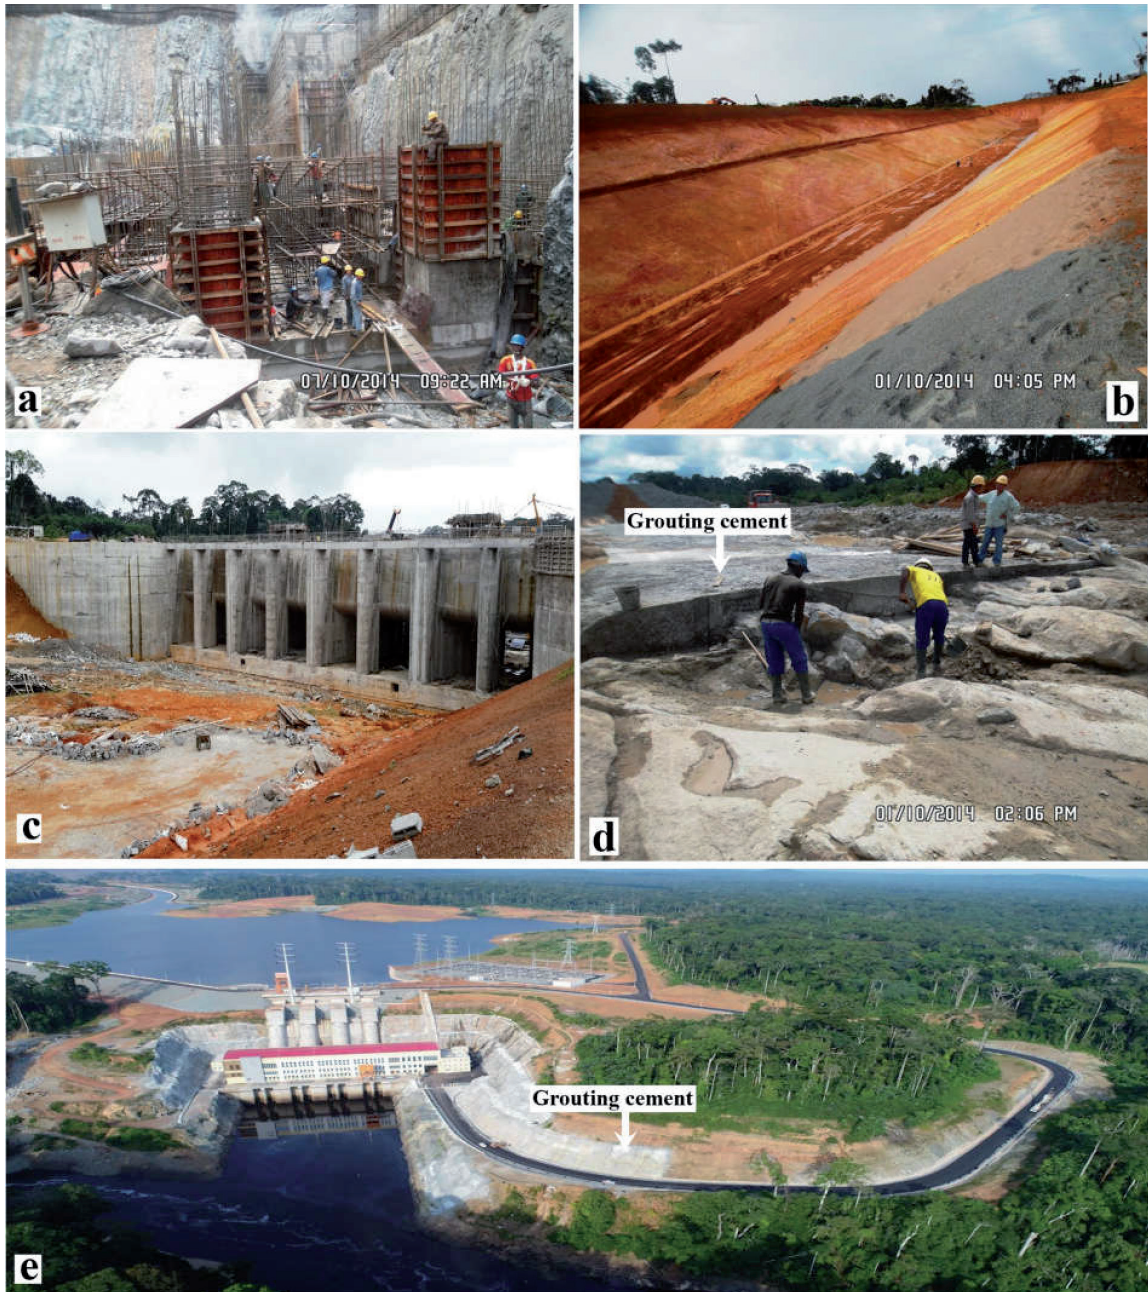
Figure 8.
(a–c) Display different usages of Ntem formations and quaternary soil deposits; (d and e) amendment of Ntem formations and slope formed by quaternary soil deposits with grouting cement.

Ntem Formation conditions indicate that they are hard qualities in respect to physical properties and good resistance against scouring. The excavated quantity of rock material from the structure foundation is nearly 300×10^4 m³ and it has been used for obtaining crushed aggregate and ripping rap materials for dam construction. However, conditions of site with rocks and alluvial deposits indicate very good and relatively poor geological conditions which can constitute dam foundation materials [11]. Concerning dam foundation, evidence of two dam foundation materials is observed and some requirement needs. The thickness of upper residual soil where is weak in the dam axis can be move to obtain Ntem Formations as foundation materials but where, soil deposit is more thickened, it can be used as also foundation materials. This study has shown that Ntem Formations are fractured and weathered. These site conditions have contributed to improve it in excavating the weathered materials and using vegetable cover and Grouting Intensity Number (GIN) [12] for cover slope and introducing the cement grouting through fractures (Figure 8). This method leads to reinforce Ntem Formations and slope stability. Overall dam structure can be fitted on the quaternary soil deposits and Ntem Formations.
