Techniques to Evaluate and Remediate the Slope Stability in Overconsolidated Clay

Herman Peiffer

In this chapter, the origin and remediation of an important sliding in the overconsolidated Boom Clay in Kruibeke (Belgium) is discussed. Local and environmental factors caused an unstable slope about 30 m deep. A larger sensitivity to erosion resulted finally in the instability of the slope. Because of the formation of fine cracks in the soil there was a possibility for the water to penetrate in the clay close to the surface, resulting in the presence of higher water pressures. Also, the presence of the excavator on top of the slope during exploitation had an important impact on the stress state of the soil. Both an analytical and numerical approach were used to estimate the factor of safety. Because of the change of the soil characteristics, the factor of safety decreases, which can be estimated through a numerical analysis (using the Strength Reduction Method). This chapter also discussed the applied techniques for the remediation using numerical analysis. Also, the importance of the field test is discussed. An integrated approach, using numerical analysis and field tests in combin

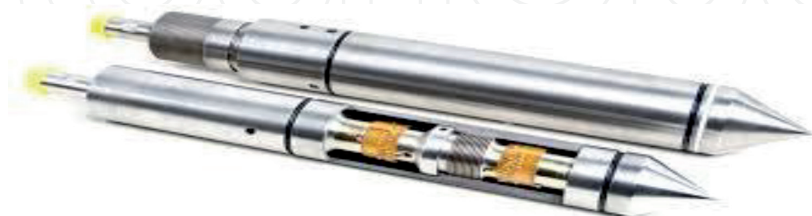
Figure 3.
The CPT-cone.

The test method consists of pushing an instrumented cone, with the tip facing down, into the ground at a controlled rate of 2 cm/s. The typical cone tip has a cross-sectional area of 10 cm², corresponding to a diameter of 36 mm (**Figure 3**).

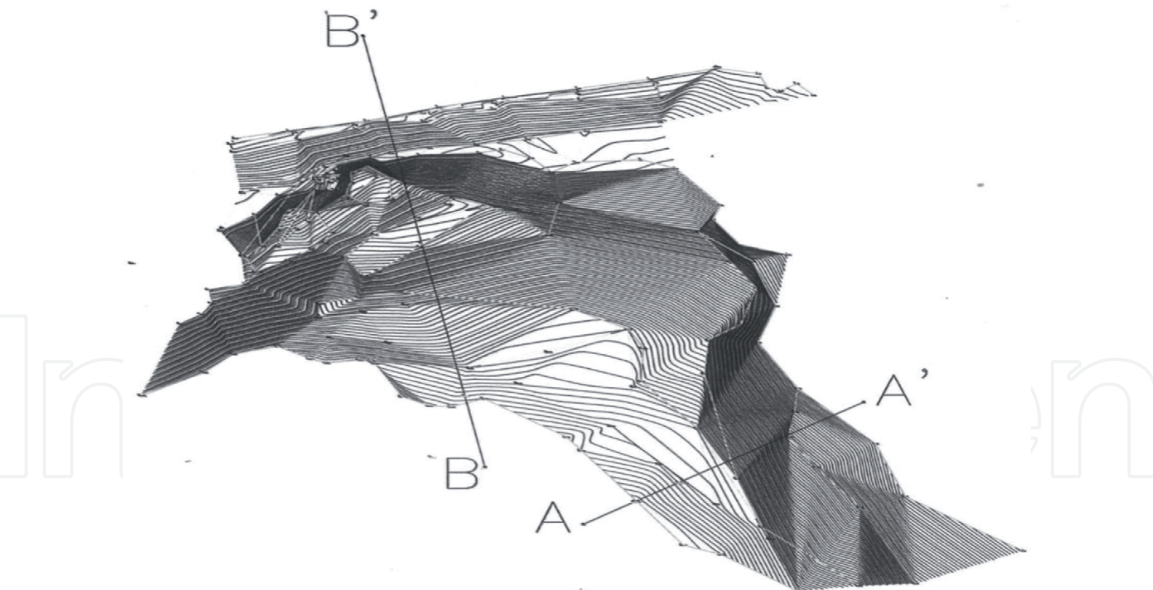
Figure 9.
Print of the NE-corner.

The extent of the affected zone can be seen in the **Figure 9**. This is a CAD-translation of the zone presented in **Figure 2a**. Two profiles (cross-sections) are also presented in **Figures 10** and **11**. The general Belgian reference system for the heights indicated as 'm TAW' refers to the height above sea level. The arrows on the figures refer to measurement points.

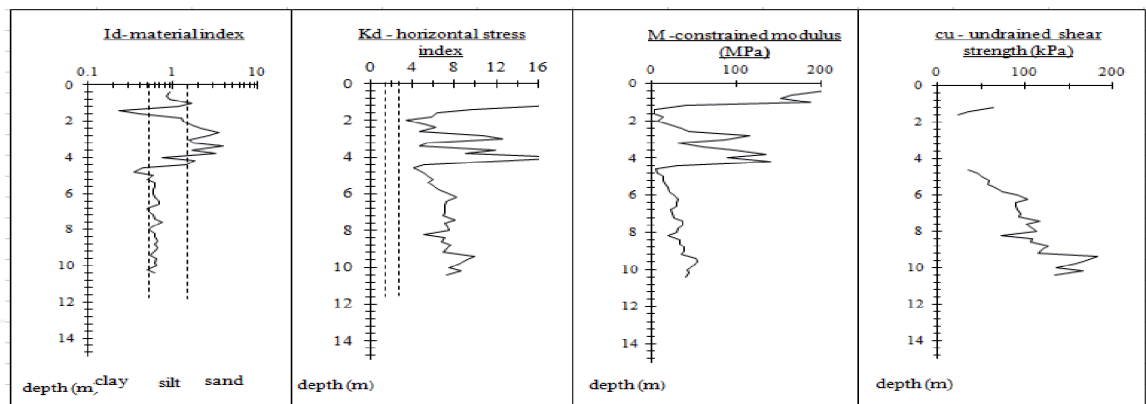
Figure 12.
DMT results in Kruibeke.

The tests allow for good identification of the soil. In the column on the left side, the results for the material index I_d are presented. Based on I_d , it is possible to make a reliable interpretation of the nature of the soil. One can identify in this graph a top layer of sand to silt and starting from a depth of about 4.5 m, a silty clay layer (the Boom Clay). In the second column, the horizontal stress index K_d is presented. A K_d -value between the two dashed lines ($K_d = 1.8$ and $K_d = 2.4$) refers to a normally consolidated soil. A K_d -value higher than 2.4 refers to an overconsolidated soil (OC), as can be seen for the Boom Clay.

Also, the stiffness (constrained modulus M) and the strength (undrained shear strength c_u) can be determined out of the basic measurements of the DMT. Both an undrained shear strength of 100 to 150 kPa and a constrained modulus up to 35 MPa refer to very stiff clay.

The profile confirms the results of the undisturbed sampling of the soil. This section focused on the horizontal stress index K_d . This parameter reflects the ratio of horizontal stress to vertical stress (**Figure 12**).

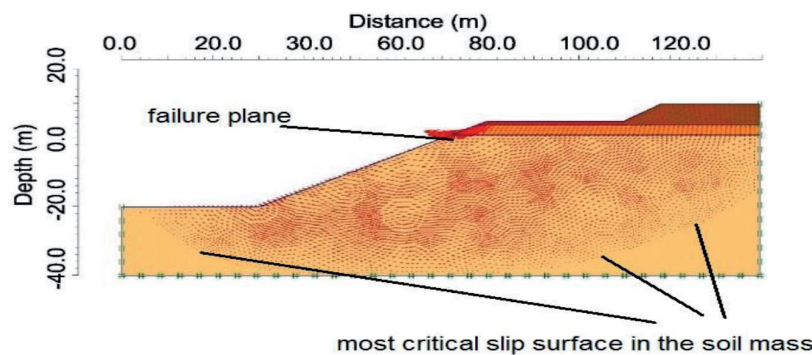
Figure 15.
PLAXIS-analysis and measurement of the slope after sliding (as adapted from Peiffer (2016) [5]).

Figure 15 [19] presents the calculated critical horizontal disequilibrium taking into account the presence of the groundwater and the piezometric site conditions. The red dots are points where the soil becomes plastic. The higher the density of the red dots, the more plastic the soil will behave, finally resulting in failure when there is no equilibrium of the soil stresses anymore. At the failure (the dark red line in **Figure 15**) zone, one can clearly detect the position of the sliding plane.

Out of these theoretical results, it became clear that the installation of drains would play an important role in rehabilitation.
