# Asphalt Fill Strengthening of Free Slip Surfaces of Shale Slopes in Asphaltite Open Quarry: Stability Analysis of Free Sliding Surface for Wet Shale Slopes in Avgamasya Asphaltite Open Quarry No 2. Site

*Yıldırım İsmail Tosun*

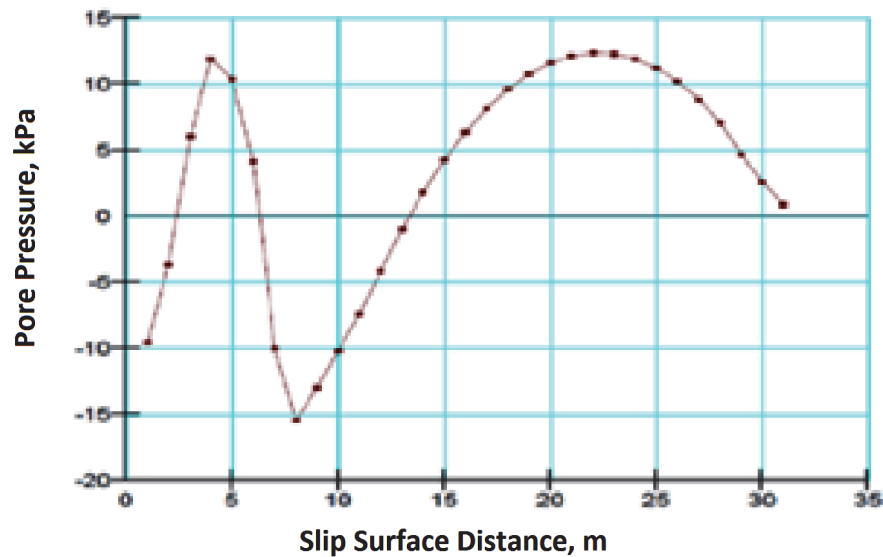
**Figure 4.**  
*S1 and S2 slope free slip surface slip surface water saturation.*

Therefore, the existing design was updated in this way and the safety coefficient of the slopes was obtained over 1.5 when the asphalt cohesive support structure was filled with 2 m filling as seen in Figure 4. As a result, the long-term security conditions of the shale slopes could only be achieved with these suggested measurements. and pillar cabled support. Cracks occurring in the S1 S2 and S3 slope as

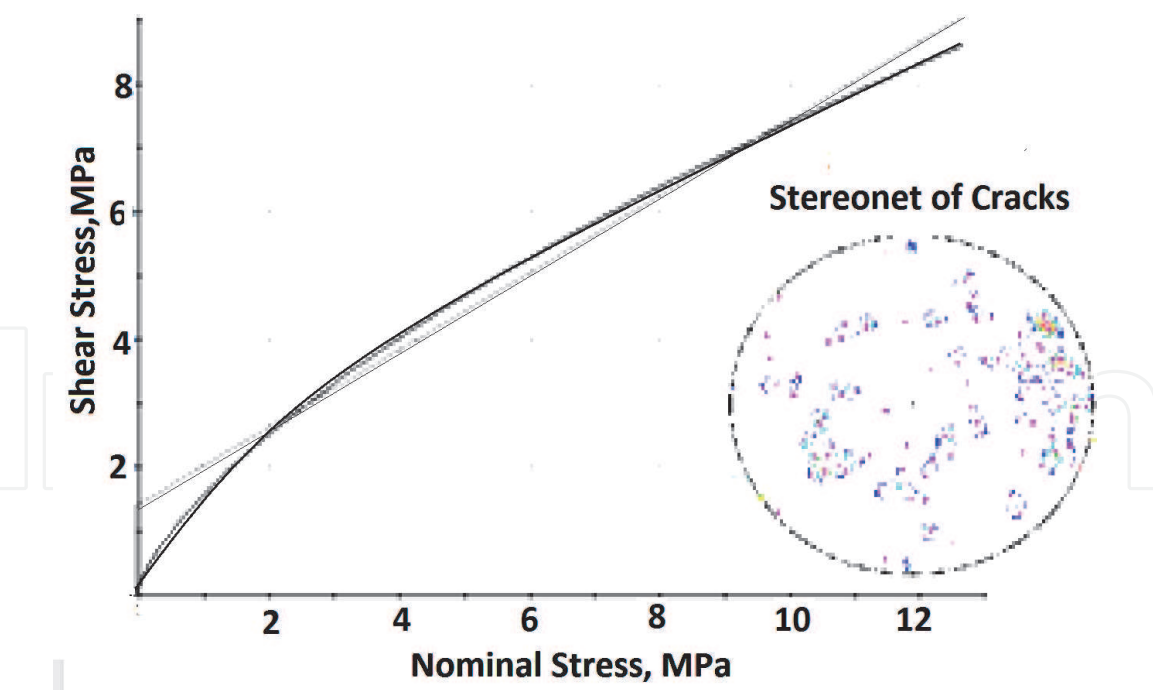
Figure 5.  
Typical Mohr coulomb envelope of the Asphaltite mine shale rocks studied.

Regarding the crack distribution and density orientation and intersection with water perched tables shown (**Figure 5**) as shear risk factor  $R_c$ .

Changes in the microstructure and mineralogy of the clay matrix, which appeared homogenous macroscopically, were determined in the microscopic examination of the samples subjected to experiments. As seen in **Figure 5**, the brown, dark brown and black regions usually contain clay matrix and rarely scattered calcite lumps in it. The areas seen in more gray tones form fine-grained anhydrides dispersed in fine-grained clays and form calcite-rich clay matrix. The anhydrite content and distribution in the clay matrix varies in sections. Besides, different types of matrix can be found in the same example.

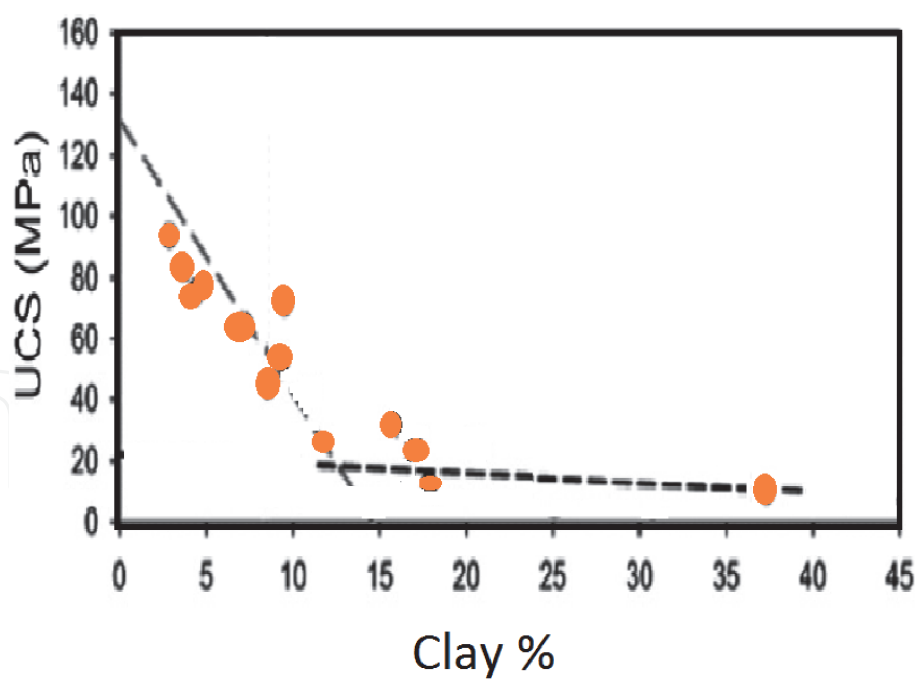
**Figure 9.**  
Change of  $\sigma$  uniaxial compressive strength value according to clay content.

After these results, the relations between mass distribution of clays and  $\sigma_c$  under uniaxial conditions are evaluated in **Figure 9**. The standard test results similar to the  $\sigma$  values were obtained in uniaxial compression strength were encountered. When the clay content is more than 7–10%, the  $\sigma_c$  values decrease with an almost constant orientation.

Thus, in conditions where the clay content is less than 7–10%,  $\sigma_c$  values  $\tau$  show a significant increase with the decrease of the clay percentage. In view of these results, it is thought that the initial fractures were controlled by the mechanical properties of the claystone levels, as the claystone levels were weaker than the low calcite belt levels.

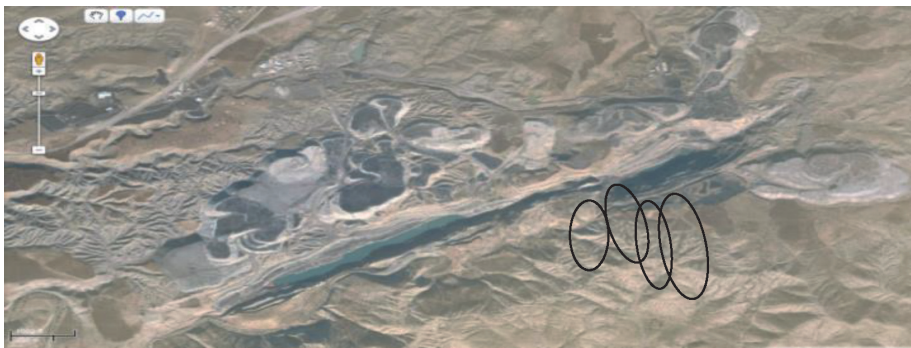
**Figure 10.**  
Free rock slide and falling site in Şırnak Asphaltite open quarry No 2, satellite view 1/18000.

The presence of chlorite belts is shown in claystone matrices of different type belts and different anisotropic strength properties together in the same sample. In the slip area of Avgamasya Open Pit quarry No 2. shale face the sliding shale formations is shown in **Figures 10 and 11**.

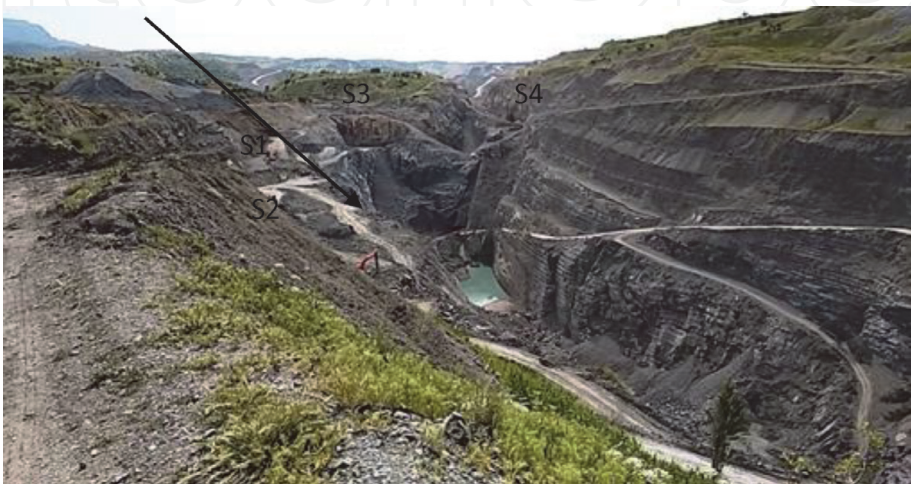
**Figure 11.**  
Free rock slide and falling site in Şırnak Asphaltite open quarry No 2, free slide over excavation area, 1/1000.

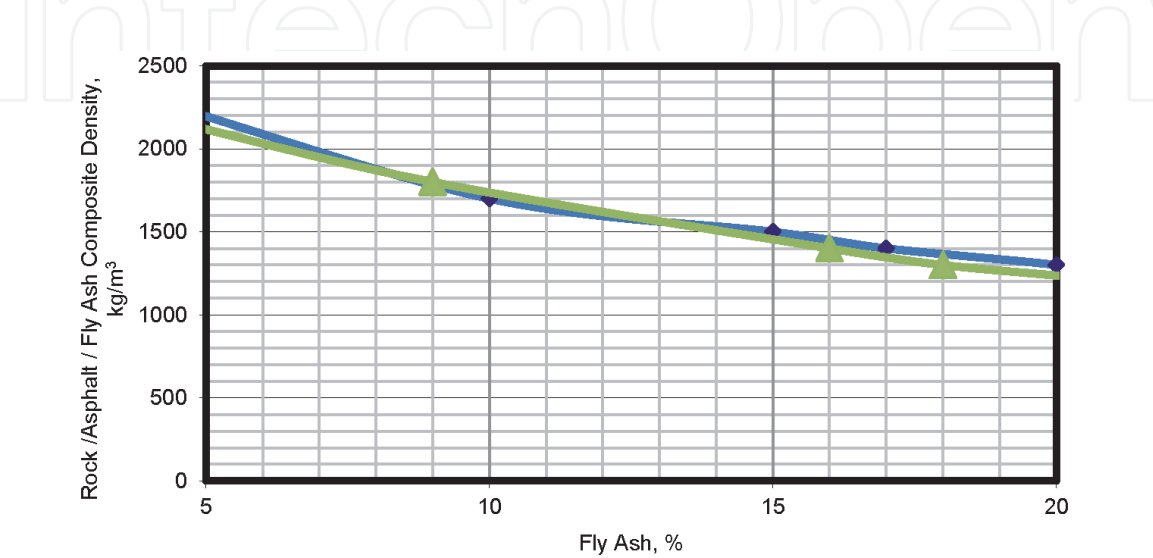
**Figure 15.**  
*The Bulk Density of the asphalt/fly ash filled Rock composite regarding Fly Ash Addition Vol%.*

The stability was increased by compost rock cracks filled with asphalt/fly ash density reducing the water sorption content of uniaxial test blocks for 25 volume % rock cavity by 85% asphalt and 15% fly ash filling as shown in **Figure 15**.
