The Hintze Ribeiro Bridge Collapse and the Lessons Learned

José Simão Antunes Do Carmo

Abstract

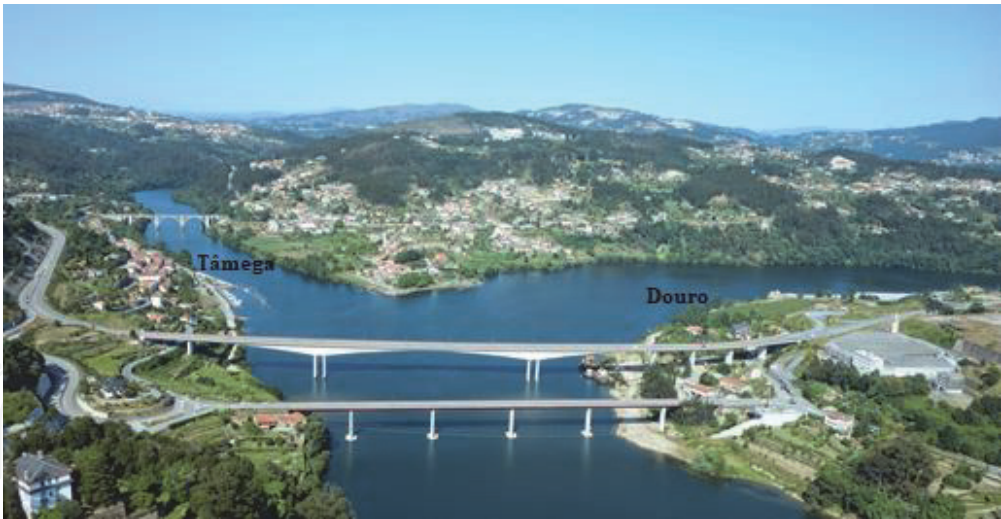
Figure 1.
An actual perspective of the entre-os-Rios village. The second bridge seen in this perspective did not exist in 2001. The Hintze Ribeiro bridge was located in the same section as the first bridge (the nearest) seen in this image (adapted from [2]).

This bridge was built at the end of the 19th century over a curve of the Douro River, near the mouth of the Tâmega River. In the 1980s, a dam was built downstream (Crestuma–Lever), whose reservoir reached the bridge and began affecting its pillars. Upstream of the section where the Hintze Ribeiro Bridge was located are Carrapatelo Dam on the Douro River and Torrão Dam on the Tâmega River (Figure 1).

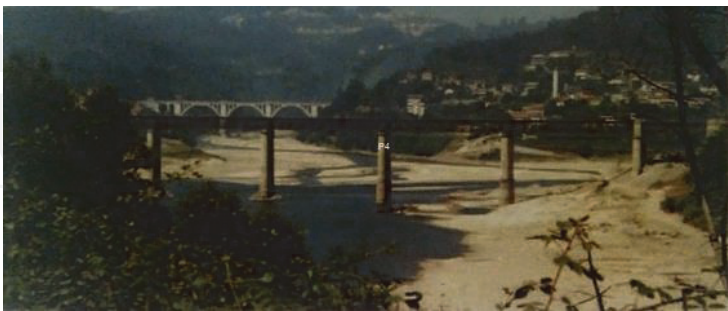
Figure 3.
Photo of the Hintze Ribeiro bridge taken in the late 1970s before the construction of Crestuma-lever dam [5]. As in Figure 2, designations P1 to P6 were used for the pillars of the bridge starting from the right bank (in the figure, from left to right).

on a sand deposit that existed until 1975, as shown in **Figure 2** [3, 4]. In addition, looking at **Figure 2**, it can be seen that P2 and P3 were protected by rockfill. The P3 protection is seen more clearly in **Figure 3**.

upstream of the Hintze Ribeiro Bridge. With the increase in sand extraction from the 1970s onward, the sand deposit around P4 and P5 pillars (**Figure 2**) began decreasing due to direct extraction, having almost disappeared by 1982, as reported in a survey carried out in that year. This is also clearly shown in **Figure 3**.

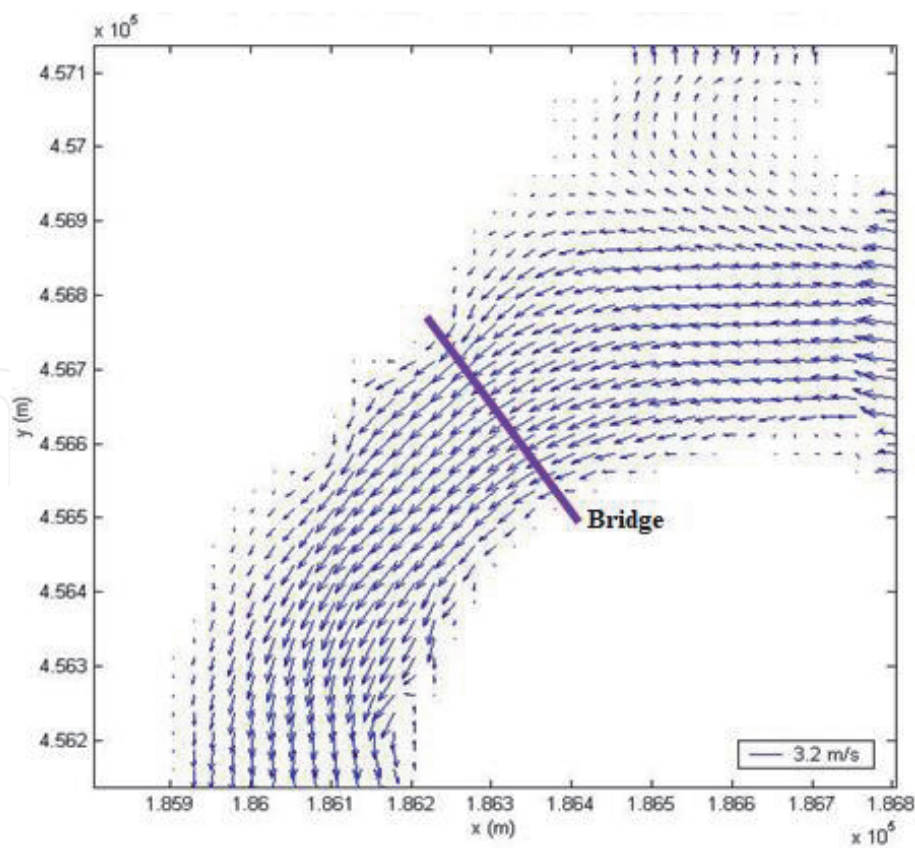
Figure 9. Velocity field obtained on 4 march 2001 at approximately 12:00 p.m., considering a bathymetry of 2000 without large depressions near the pillars. Note that the flow distribution is 10,000 m³/s at Carrapatelo dam and 2,000 m³/s at Torrão dam, therefore with a 5:1 ratio.

Figure 9 shows one of these situations, which corresponds to the velocity field obtained on 4 March 2001 at approximately 12:00 p.m.

The river flows released by the Torrão and Carrapatelo dams are expected to have influenced the velocity field near the bridge. Indeed, the velocity field corresponding to a given total flow should have changed depending on whether the total flow was released only from Carrapatelo Dam, only from Torrão Dam, or in different quantities from each dam. When the major floods occurred, the most likely flow distributions would have been in the order of $10,000\text{ m}^3/\text{s}$ at Carrapatelo Dam, while at Torrão Dam, they would not have exceeded $2000\text{ m}^3/\text{s}$, keeping a 5:1 ratio. The numerical computation made it possible to verify that, in most cases, the flow from Torrão Dam was diverted by the flow from Carrapatelo Dam to the right bank of the river, as shown in **Figure 9**.
