# Structural Health Monitoring of Existing Reinforced Cement Concrete Buildings and Bridge Using Nondestructive Evaluation with Repair Methodology

*Aman Kumar, Jasvir Singh Rattan, Nishant Raj Kapoor, Ajay Kumar and Rahul Kumar*

## Abstract

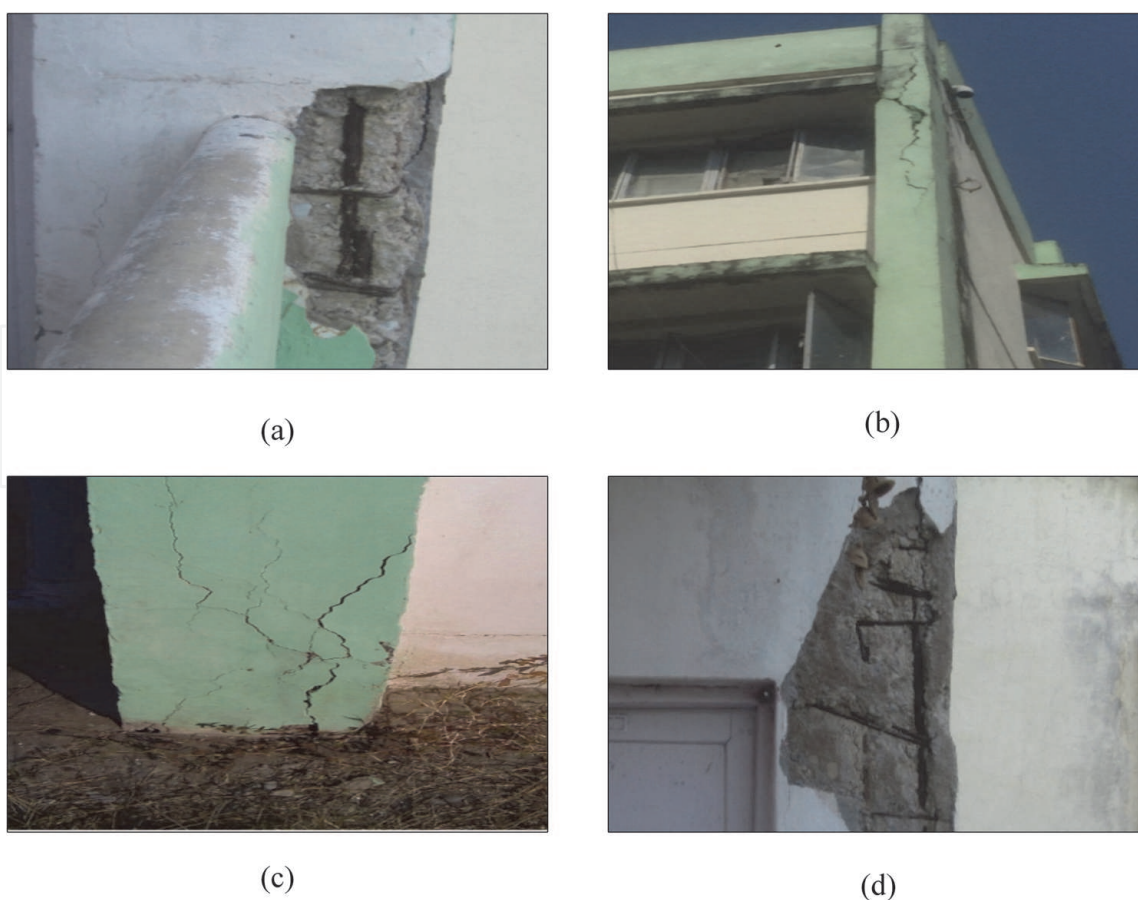
- a. From the investigation, it was observed that the exterior columns of the building were having vertical cracks and spalling at some of the locations.
- b. Dampness and efflorescence on walls were also observed, especially at the lower level of the building.

**Figure 3.**  
*Damage detection (a) spalling of concrete, (b) vertical cracks on column surface, (c) cracks in the bottom of column, (d) corrosion in steel.*

- e. Spalling of concrete and exposed corroded reinforcement in exterior columns of both the buildings.
- f. Ground floor and the first floor of the building were attacked by termite.
- g. Backside staircase along with the servant quarter of the building was completely damaged.
- h. Brick tiles on the terrace of the building were damaged due to ingress of moisture through them.
- i. Due to growth of plants on the terrace of the building and the rainwater pipes, there were damages.

The visual inspection checks found the presence of efflorescence, permeable, and unsound concrete, cracks, and gradual disintegration of concrete, spalling of concrete and cracking, etc. The flow chart of the visual inspection is shown in **Figure 2** [19–25]. Different types of distresses such as cracks, spalling, and corrosion in the building are shown in **Figure 3**.

- The strengthening of outer columns of the building needs to be done with jacketing with micro-concrete, and reinforcement is to be provided where steel has rusted more than 20%.
- All the traps and manholes should be repaired to prevent the seepage into the foundations from such locations.
- Water tanks on the roof are causing dampness due to the overflow of water or due to leakage, all the tanks should be repaired, and overflow should be stopped by providing a suitable float valve.
- Exposed concrete was found to be carbonated and hence should be provided with anti-carbonation coating if the spalling of cover concrete has not started.
- If the spalling of cover concrete is taking place, the same should be repaired by treating the affected reinforcement and repairing the cover with micro-concrete.

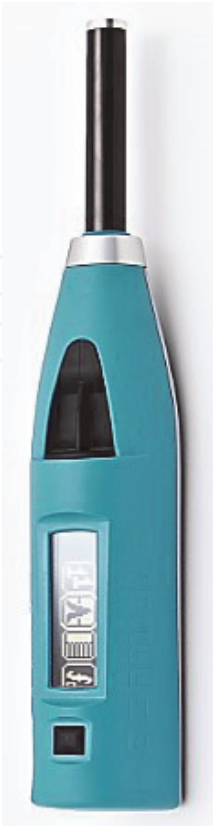
This is the fastest method to evaluate the quality of concrete based on hardness, which is indicated by rebound number. If the strength of concrete is high, the rebound number is also high. The principle of this test is that when the plunger of the rebound hammer is pressed against the surface of the concrete, the spring controlled the mass rebounds and the extent of such rebound depends upon the surface hardness of the concrete. The surface hardness of the concrete gives the rebound number, which is further related to the compressive strength of the concrete. In latest rebound hammer, there is no need for angle correction. The average

Figure 4.  
Rebound hammer.

value of rebound hammer for a different quality of concrete as per Indian Standard IS: 13311 Part-21992 is given in **Table 1 (Figure 4)** [26].

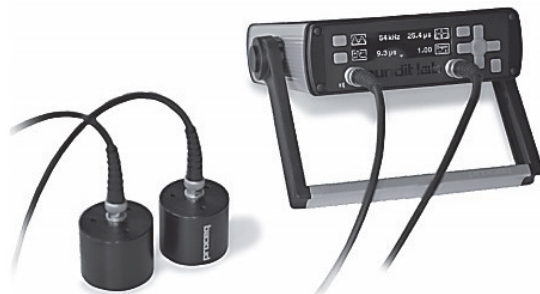
UPV Test method is generally used for determination of uniformity of concrete, to find crack depth, honeycombing, and to check the condition assessment of deterioration of concrete. The principle of this test is based on the propagation of electroacoustic pulse through the concrete pathway and then calculating the transit time taken, for a known distance. UPV mainly depends on the elastic modulus of the concrete. The general guidelines for quality of concrete as per Indian Standard IS: 13311 Part-11992 are given in **Table 2 (Figure 5)** [27].

**Figure 5.**  
*UPV.*

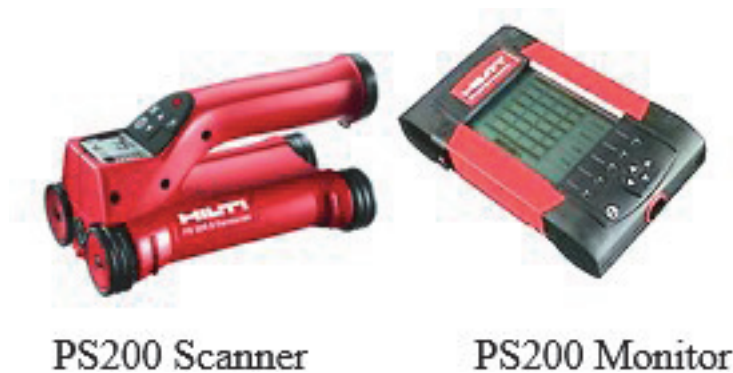
Ferro scanner is a device used to locate reinforcing bars and to estimate the diameter and depth of cover. This device is based on interactions between the bars and low-frequency electromagnetic fields. The ferro scanner works on the principle of electromagnetic induction, in which alternating magnetic field induces an electrical potential in an electrical circle intersected by the field. The test for reinforcement scanning is done with the help of HILTI PS 200 Ferro scan [29], a portable system for detecting rebar in concrete structures. The tools help in obtaining a real image of the reinforcement and evaluate the reinforcement mesh. HILTI PS 200 Ferro scan records the depth and positions of rebars over long stretches and obtains average coverage and statistics of the rebar diameter. The tools consist of image scanner that records the data, then the recorded data is transferred to the monitor for further analysis at the site itself. The major analysis is done on the computer by the analysis software to produce reports of the recorded data, and later the data is further submitted to the structural consultant for preparation of structural drawing, thereby ensuring the stability of the structure. The major limitations of this test are that the interferences may occur in images due to scraps of reinforcement in concrete, tie wires near rebars cross, and aggregates with ferromagnetic properties (Figure 7).

**Figure 7.** Ferro-scanner.
