# Desertification and Its Control along the Qinghai-Tibet Railway

Yuguo Liu, Jiufu Luo, Jinxing Zhou and Ming Cui

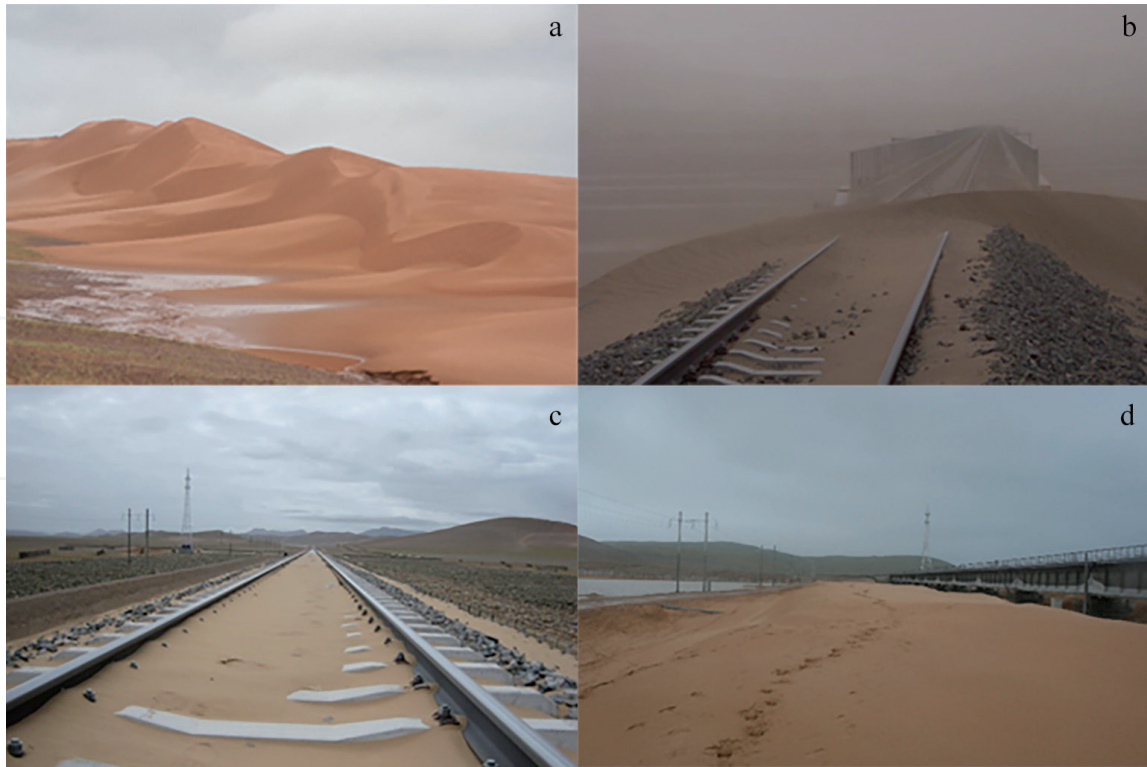
**Figure 1.**  
 Sand disasters along the Qinghai-Tibet Railway. (a) Hongliang River section, (b) Tuotuo River section, (c) Za'gya Zangbo section, (d) Cuona Lake section.

In terms of space, the sand disasters along the Qinghai-Tibet Railway are mainly distributed from Golmud (K815 + 380) to Tibet's Cuona Lake (K1531 + 280). The sand damage in this section is not evenly distributed, mainly concentrated in the Hongliang River (K1104 + 690), Tuotuo River (K1224 + 810), Za'gya Zangbo (K1445 + 560) river valleys, and the areas on both sides of the river and Cuona Lake section (K1528 + 710 to K1531 + 280) and other areas [6]. The railway section with severe sand damage is 78.8 km (**Figure 1**).

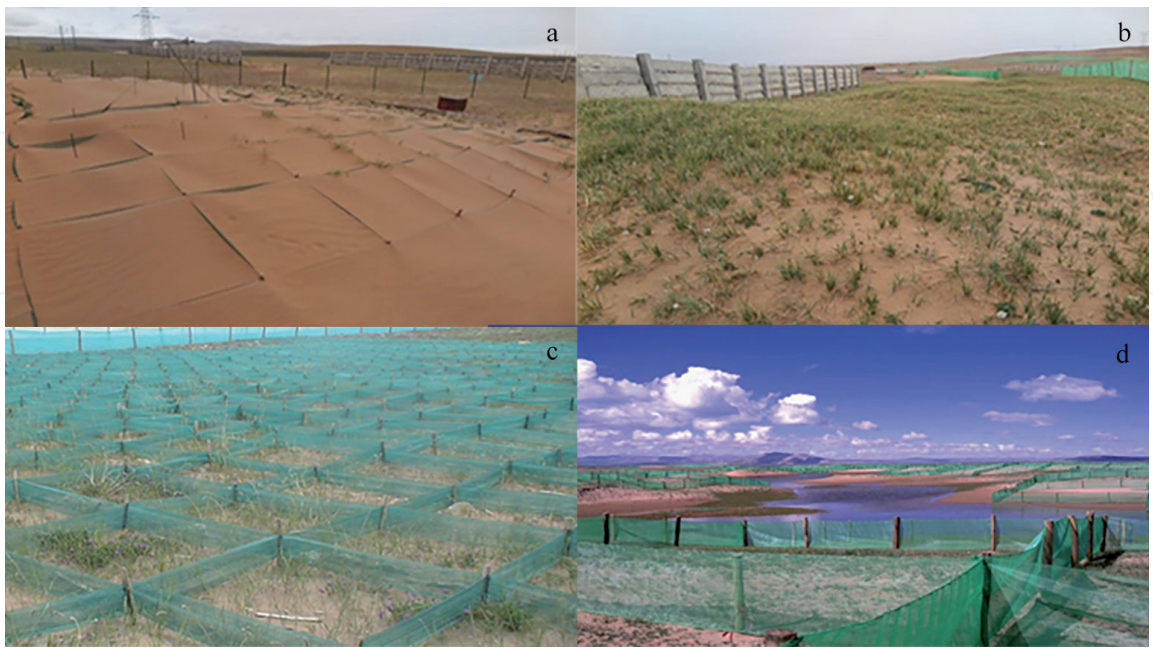
**Figure 2.**  
*Sand prevention and control technology along the Qinghai-Tibet Railway. (a) The promotion and application of the concept of “sand fixing in the distance”. (b) Biological measures + engineering measures realize the control of sand materials from the source. (c) Low vertical net sand barriers are combined with biological measures to control sand sources. (d) High vertical net sand barriers are combined with biological measures to control sand sources.*

In view of this, on the basis of scientifically determining the characteristics and mechanism of sand damage along the Qinghai-Tibet Railway, and fully combining the natural conditions and the degree of land desertification along the Qinghai-Tibet Railway, the wind-sand disaster prevention system along the Qinghai-Tibet Railway has been explored and developed. It broke the traditional governance model of “distant resistance and adjacent fixation”. The system mainly includes: (1) proposed the “source control, comprehensive prevention and control” governance technology model. By clarifying the source and path of sand materials, the protection and restoration of the source can be carried out to achieve source control. (2) Developed a governance technology system that combines “fixation, resistance, and transmission”. Based on the site conditions of sand-damaged sections and the suitability of sand-fixing materials, a series of “sand-fixing” technologies suitable for use along the Qinghai-Tibet Railway has been developed, including the use of soil modification and mulching technology, planting bag technology, and multi-grass mixed planting technology for rapid vegetation reconstruction and rapid sand fixation technology using environmentally friendly chemical sand fixation agents. The “blocking” sand technology mainly refers to the use of new High-density polyethylene (HDPE) sand barrier materials. By comparing the single-width sand transport under the conditions of natural sand transport and HDPE sand fixation barriers, the sand control efficiency of HDPE below 1 m from the ground surface can reach 67.82%, of which the sand control efficiency can reach 86.34% below 20 cm from the ground surface. The sand transport technology is mainly to invent the sand transport railway subgrade. It is mainly suitable for the severe sandstorm section of railway embankment where the main wind direction is single and the angle is large or perpendicular to the railway line, in order to reduce the threat of sandstorm. (3) Invented the technology of combining biological sand fixation with engineering sand control. It combined high vertical sand barriers, cement board grid sand barriers and vegetation restoration measures. The cold-resistant, drought-resistant, and sand-tolerant native plants selected by the project were used as vegetation restoration materials, including *Elymus*, *Poa*, and *Fescue* species [15, 16].

The above-mentioned sand disaster control technology has been demonstrated and promoted in the severely sand-hazard sections of the Qinghai-Tibet Railway such as Hongliang River, Xiushui River, Beilu River, Tuotuo River, Tongtian River, Za'gya Zangbo, Cuona Lake, etc (**Figure 2**). The Qinghai-Tibet Railway Company adopted it in the prevention and control of the 78.8 km railway section of severe sand damage. It overcomes the shortcomings of using long-distance resistance and adjacent fixation in the past to intercept sand near the railway subgrade. This has effectively curbed the occurrence of railway sand disasters. Thus, the safe operation of the Qinghai-Tibet Railway is ensured.
