# Influence of Immersion Lithography on Wafer Edge Defectivity

K. Jami, I. Pollentier, S. Vedula and G. Blumenstock

Source: Lithography, Book edited by: Michael Wang,  
ISBN 978-953-307-064-3, pp. 656, February 2010, INTECH, Croatia, downloaded from SCIYO.COM

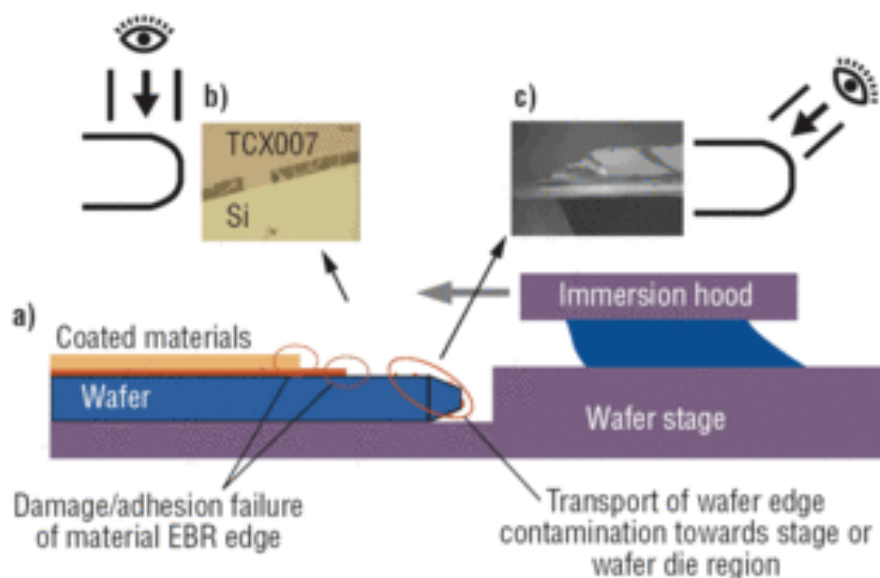
Fig. 1. a) Schematic representation of possible defect issues with immersion lithography; b) example of damaged photoresist material inspected with top-down optical microscope; and c) example of damaged residues at the wafer edge, inspected by tilted SEM (45°).

Immersion lithography [1-4] has changed the way we view defectivity issues at the wafer edge significantly. During the immersion exposure sequence, the wafer edge is in contact with the water from the immersion hood (IH), introducing additional concerns beyond direct contact of resist with the scanner. First, when the IH is scanning in the EBR region, its movement can damage material edges (Fig. 1a). IMEC's program on immersion lithography found that, for example, photoresist material can partially peel off during the IH pass (Fig. 1b).

A second concern involves the cleanliness of the wafer edge outside the EBR edges. The IH pass wets not only the near-edge top surface, but also the curved wafer edge and even part of the bottom surface. Defects can be released from this area and re-deposited either on the wafer or on the wafer stage. In the first case, there will be a direct impact on the wafer defectivity. In the latter case, defects present on the wafer stage can be transported onto wafers in subsequent wafer processing. IMEC's program on immersion lithography found that resist residues left on the curved wafer part by an incomplete EBR step can be damaged by the IH pass, releasing fragments into the system (Fig. 1c).

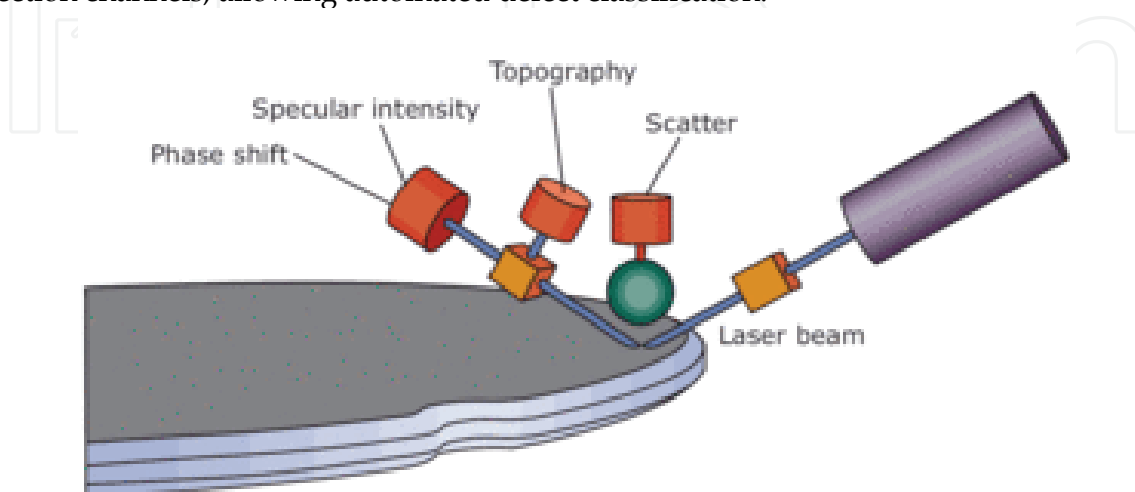
The new measurement system for wafer edge defect inspection (Fig. 2) is based on a laser source directed to the wafer edge surface. Three detectors simultaneously collect the scattered light, the specular or reflected light and the phase difference between different polarization states. As the laser scans the wafer edge surface, each signal can be converted into an image. Each type of defect produces a specific combination of signals from the three detection channels, allowing automated defect classification.

Fig. 2. Schematic representation of the VisEdge measurement principle.

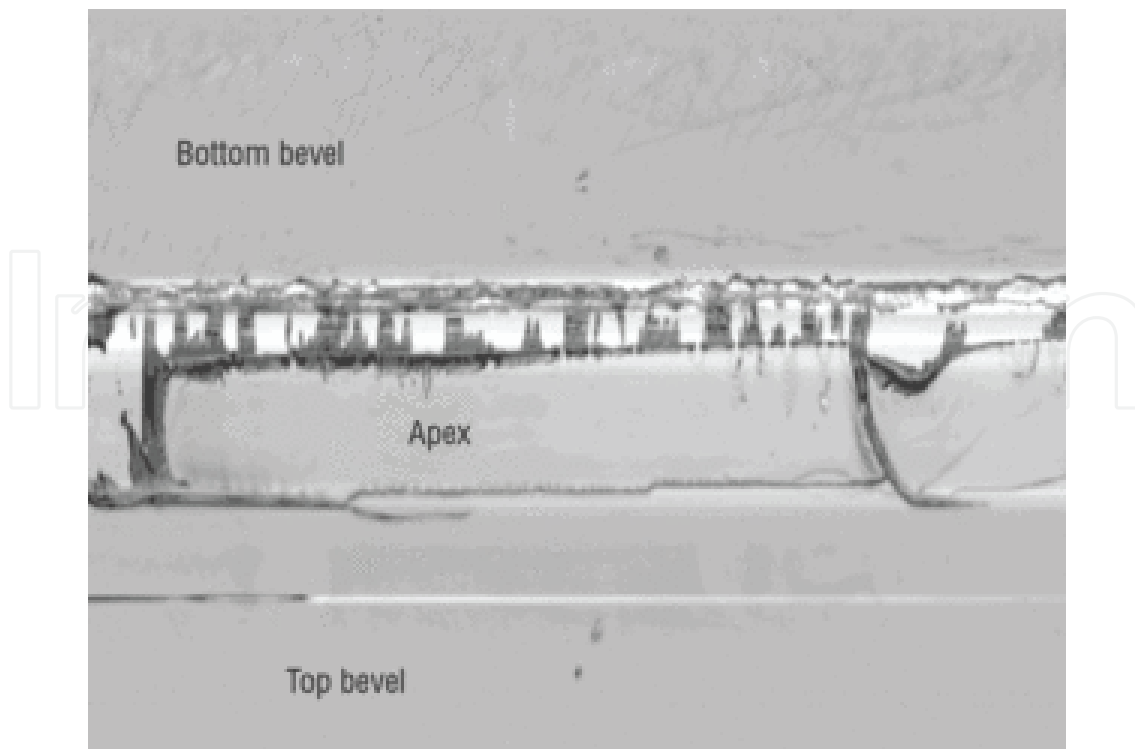
Fig. 3. Example of a specular image using the new technology showing part of the bevel/apex region. This kind of representation is valuable for the evaluation of wafer edge quality.

For wafer edge cleanliness, a high-resolution view of the wafer edge is typically more useful. Here, the images view only a few millimeter of the edge. Figure 3 uses this representation to show resist flakes observed along the apex-bevel regions in the specular channel.

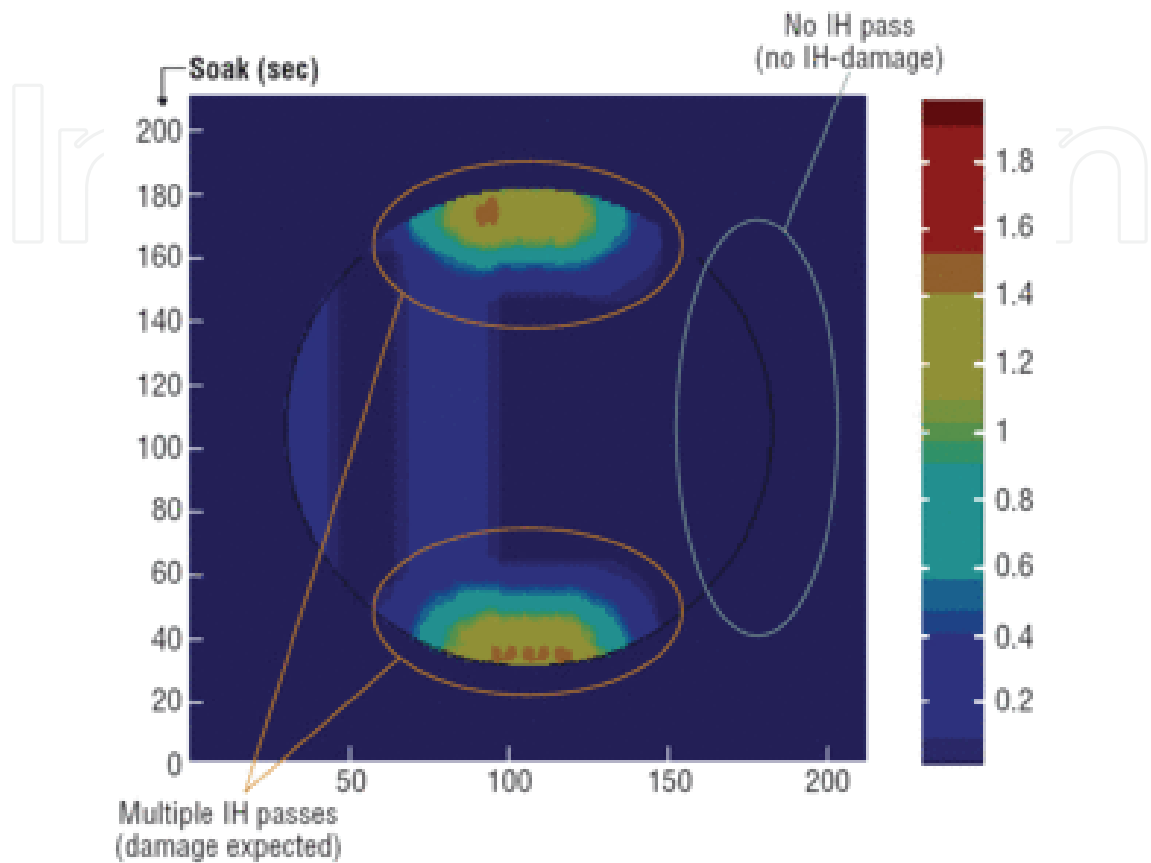
We experimented with three resists with different chemistries (**Fig. 4**). Sensitivity to edge damage was expected to vary across the three resist types. A dedicated exposure job spatially separated the areas where flakes are expected and where they are not expected. One section, consisting of two rows of 11 fields, was exposed close to the wafer edge at the opposite side of the notch. A similar area of two rows of 11 fields was exposed in the region of the notch. During the exposure of these  $2 \times 11$  sections at both locations near the wafer

edge (Region II), the IH makes continuous up- and down-scans over the wafer edge area, increasing the probability of defect generation. The exposure job was also designed so that on another part of the wafer (Region I, on the right hand side), the immersion hood did not pass over the wafer edge. In Region I, no flake-like defects were expected.

Fig. 4. IH exposure sequence for edge flake characterization.

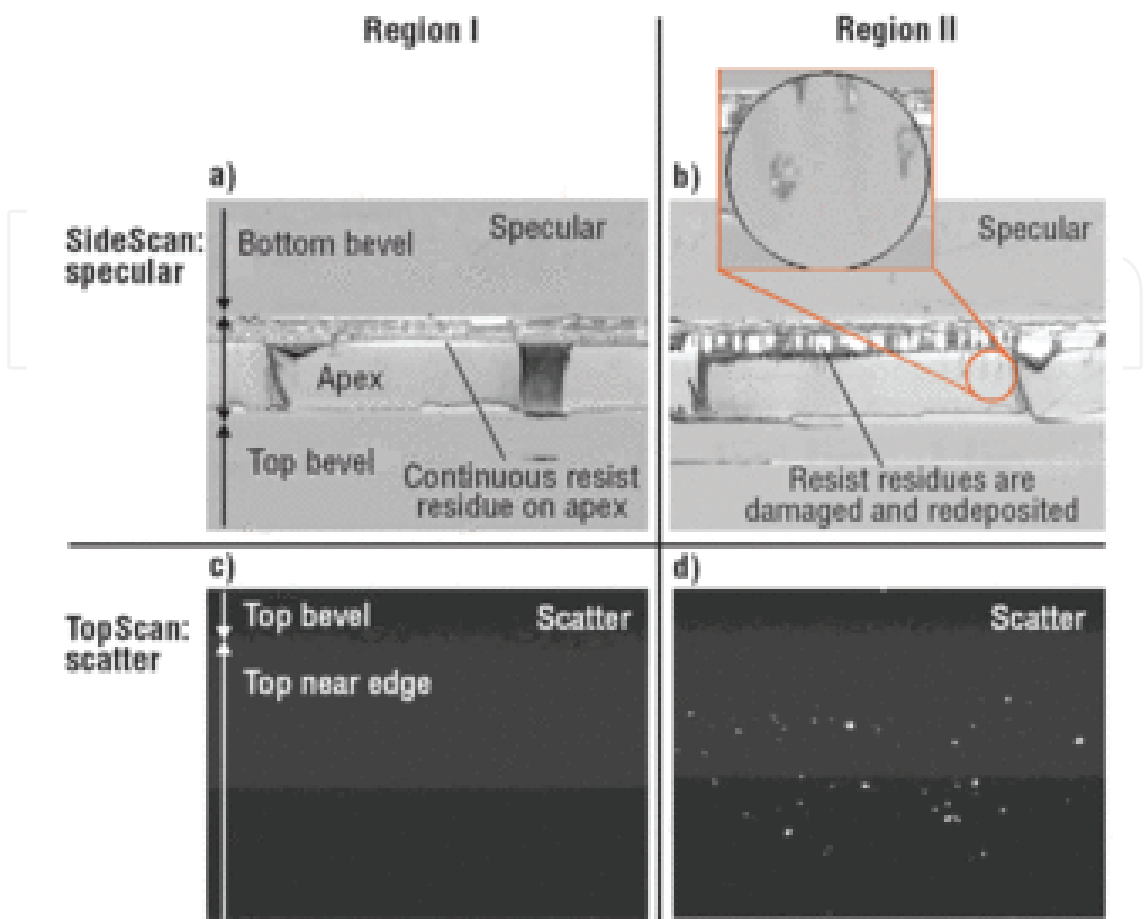
The specular images of regions with resist residues clearly showed differences in reflected intensity: dark areas in the resist residues refer to thick layers, while light areas indicate much thinner layers. The results obtained from Resist Type A are detailed below. We compared the SideScan images of areas where the IH did and did not pass. Figure 5a is a typical SideScan specular image for region I (where the IH did not pass). Differences in thick and thin resist residues are visible, but no fragments of the resist residues are evident. In contrast, in Fig. 5b, taken from Region II, indicated that parts from the thick residue at the bottom of the apex were released. The close-up in the image indicates that some of these edge flakes were re-deposited on the apex closer to the top. To determine whether any of these edge flakes end up on the top region (where edge die can be damaged), we analyzed the TopScan image of the corresponding areas of Fig. 5a and 5b using the scatter channel, as shown in Figs. 5c and 5d. In Region II, a lot of particles were detected, while in Region I, no particles were observed in the images. This observation was encouraging for further ADC work. Classification of the edge region flakes was found to vary by the defect location. Re-deposited edge flakes on the apex side were best classified using their signal in the specular

Fig. 5. Specular and scatter images from Region I (a and c) and Region II (b and d) of a test wafer. IH damage is more likely in Region II.

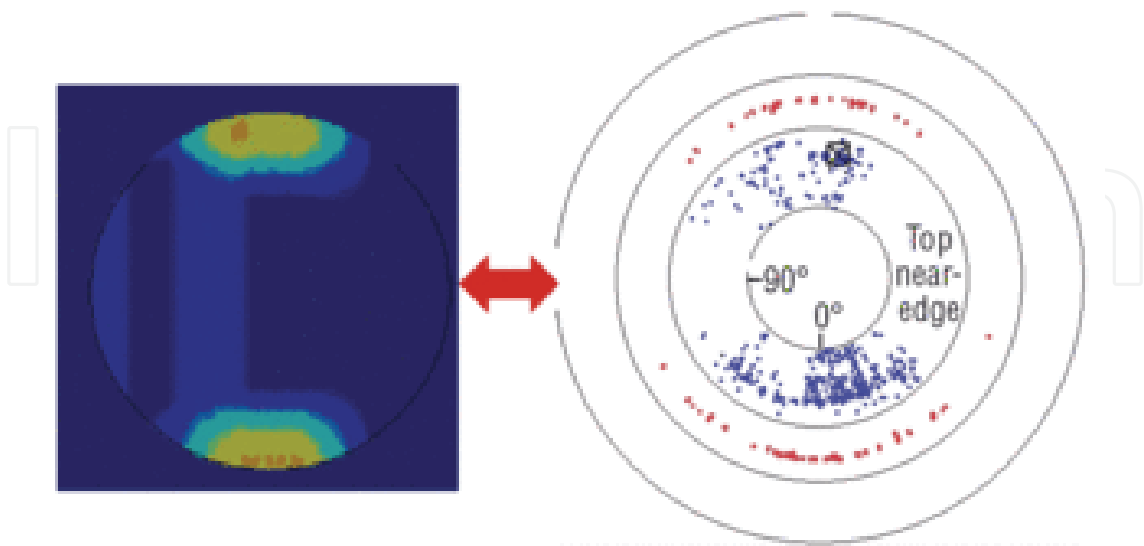
Fig. 6. Immersion characterization (quantification of edge flakes at wafer edge); the flakes on the apex and top near edge can be quantified by composite analysis of SideScan and TopScan signals.

channel of the SideScan image. For re-deposited defects in the top near-edge region, a combination of signals in the specular and scatter channels gave more accurate classification. Once all the measurement parameters for both areas are fixed, they can be combined in a single measurement sequence that provides defect classification and mapping for all the wafer edge areas of interest. (Fig. 6).

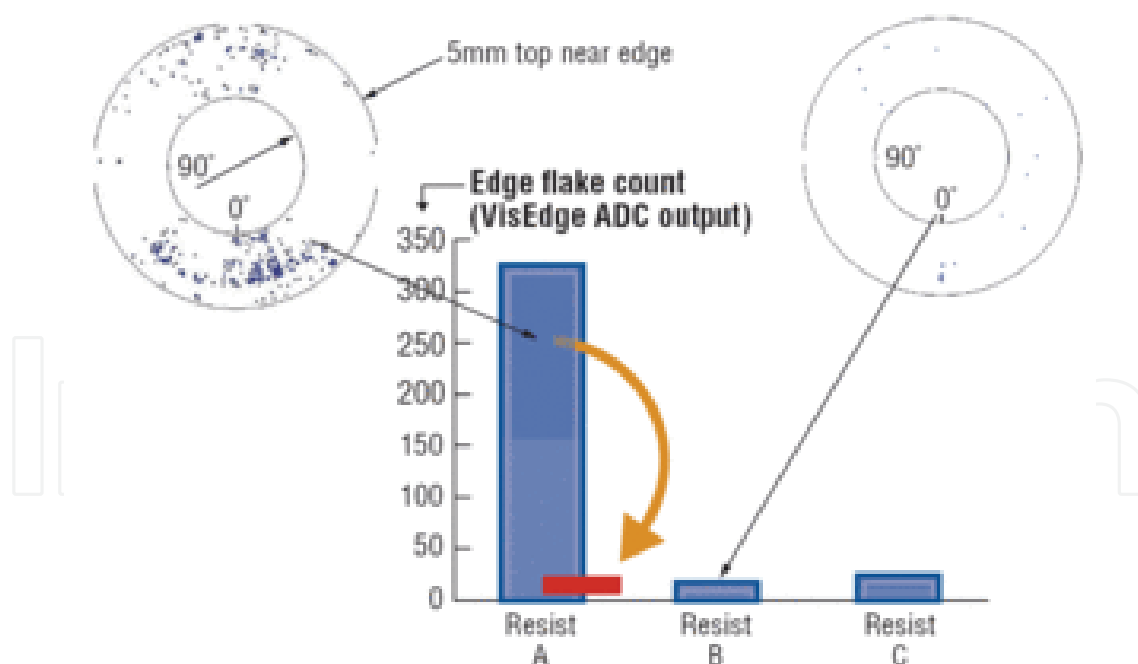
Fig. 7. Edge flake defects as a function of resist chemistry and EBR recipe.

When the same immersion exposure was used, significantly fewer edge flakes were detected in the near top region for Resist B and C than for Resist A (Fig. 7). Moreover, the residual defects were less confined to the exposure zone, so some of these defects might be caused by coating and wafer handling. In the TopScan images, no clear sign of damage was seen. Clearly the choice of resist chemistry can be important to prevent these kinds of defects.

As indicated earlier, resist residues can be optimized by changing the EBR recipe on the coat track. Resist A showed several hundred defect flakes with the regular (short) EBR sequence. After optimization, this resist achieved defect values similar to the background values obtained with the non-flaking resists B and C.
