# On-Site Bridge Inspection by 950 keV/3.95 MeV Portable X-Band Linac X-Ray Sources

*Mitsuru Uesaka, Yuki Mitsuya, Katsuhiko Dobashi,  
Joichi Kusano, Eiji Yoshida, Yoshinobu Oshima  
and Masahiro Ishida*

## Abstract

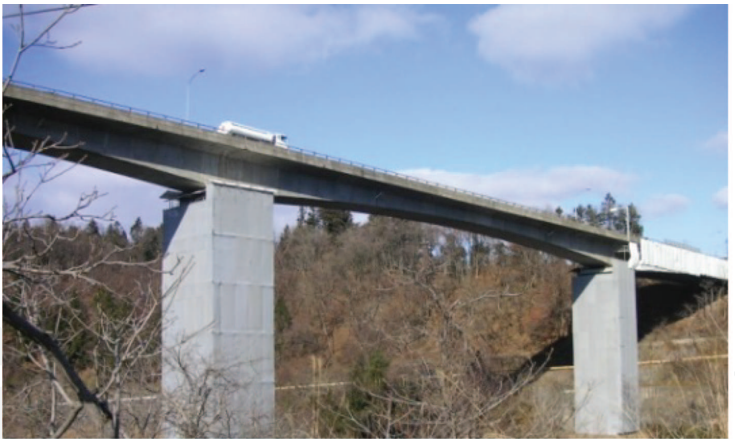
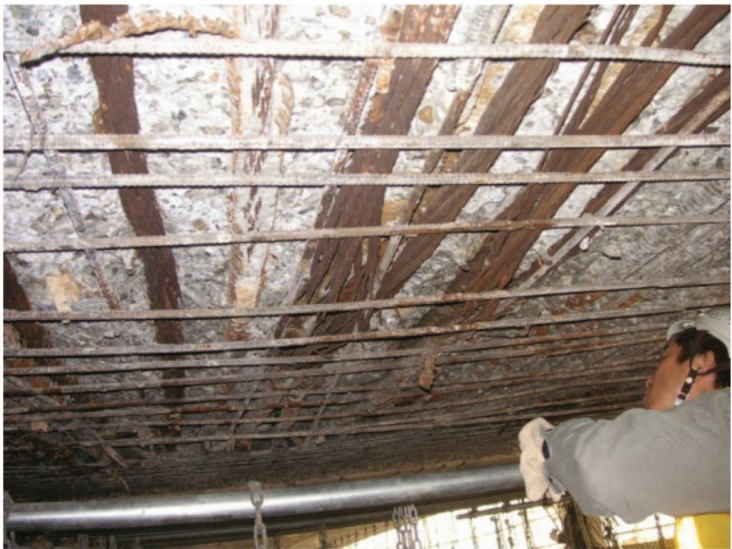
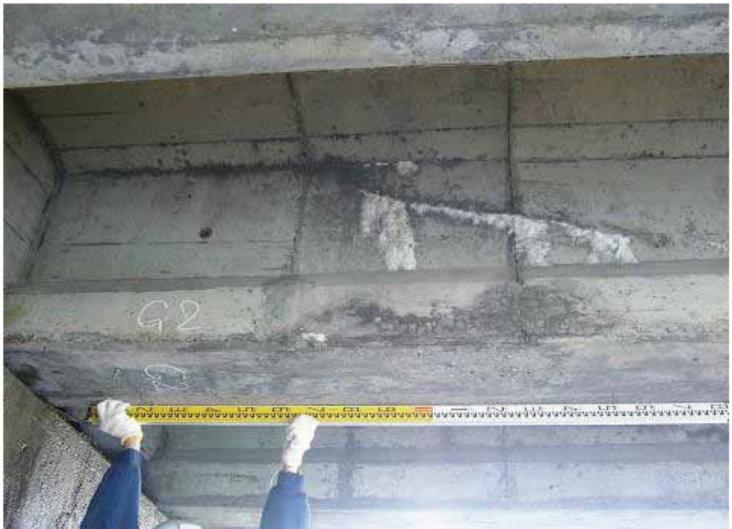
**Figure 1.**  
*Images of degraded bridge and parts. (i) Whole view of the bridge, (ii) degraded surface, and (iii) crack and leak of Ca components.*

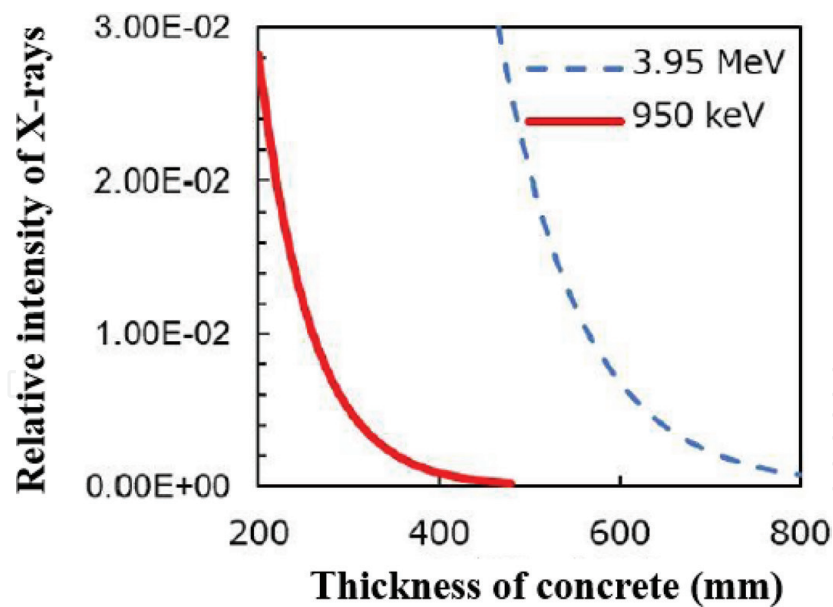
**Figure 4.**  
*Calculated results of attenuation for the X-rays in concrete from the 950 keV/3.95 MeV X-ray sources.*

Calculated attenuations in concrete for the X-rays from the 950 keV/3.95 MeV sources are shown in **Figure 4**. The results indicate that concrete with thicknesses of up to 400 mm and 800 mm can be penetrated by the 950 keV/3.95 MeV sources, respectively.

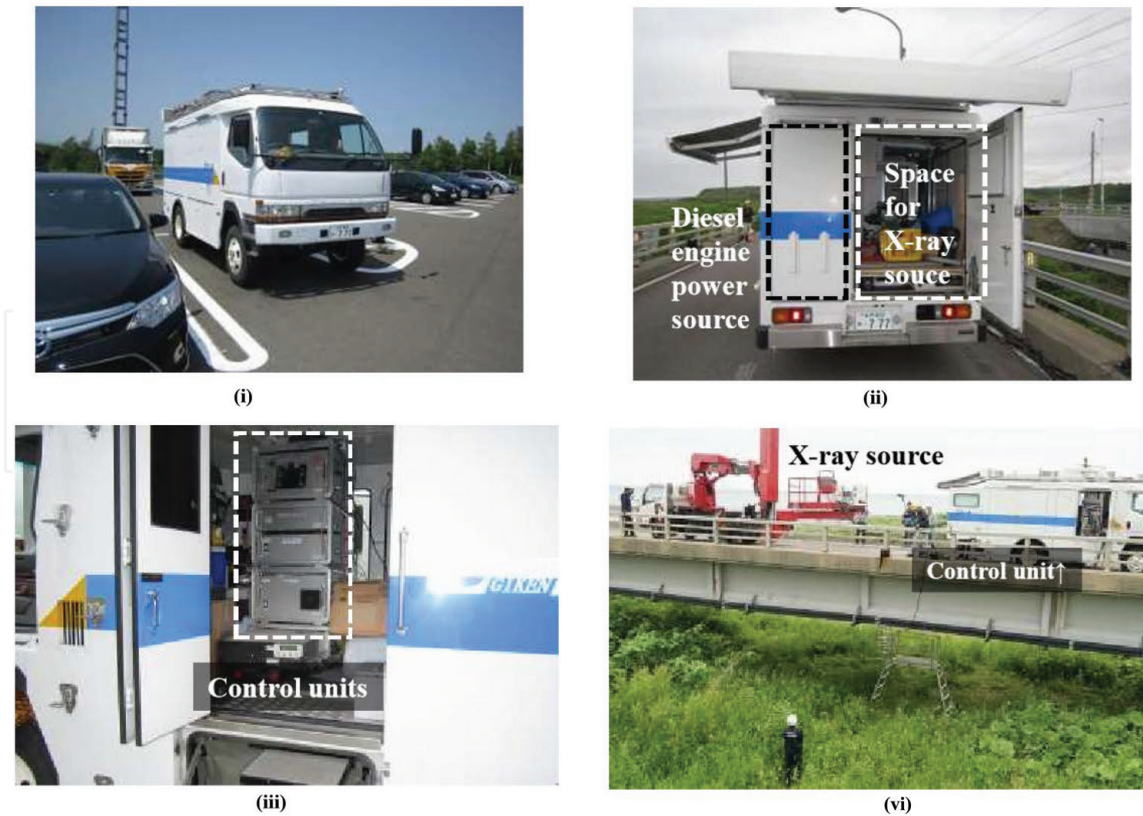
**Figure 17.** Special inspection car for the 950 keV/3.95 MeV X-ray sources. (i) Front view, (ii) Back view, (iii) Control units, and (iv) On site set-up.

Our collaborator, Kanto Giken Co. (Tokai, Ibaraki, Japan), developed a new special inspection car for the X-ray sources as shown in **Figure 17**. It can carry the X-ray sources, detectors, computers, and inspectors and contains a diesel engine 100 V power source. Some diesel engine power sources have poor quality unstable output voltage and frequency (50 and 60 Hz in east and west Japan, respectively). The electric power source of the magnetron may be sensitive to such instability. To avoid this, we decided to acquire our own reliable diesel engine power source, which we can carry to perform on-site X-ray inspections anywhere in Japan.
