# The Importance of Emissivity on Monitoring and Conservation of Wooden Structures Using Infrared Thermography

João Crisóstomo and Rui Pitarma

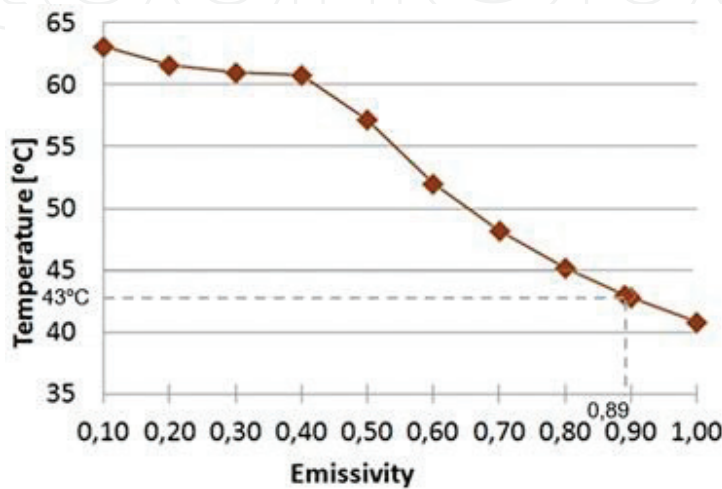
**Figure 1.**  
*Surface temperature of the wood sample as a function of the emissivity value.*

The influence on temperature by the variation of the emissivity value can be observed in **Figure 1**. This figure shows the temperature reading in the thermographic camera as a function of the emissivity introduced in the equipment. When the calibration value of 0.89 (emissivity of the surface of the wood measured with the black tape method) is entered, the average value of the surface temperature is 43°C. However, if a different emissivity value is entered in the thermographic camera, the value of the temperature reading will deviate significantly from the actual value of the surface temperature. This error is all the greater the error in the emissivity value. For example, if an emissivity of 0.40 is introduced, we obtain a mean temperature value of 61°C, significantly different from the actual value of 43°C.

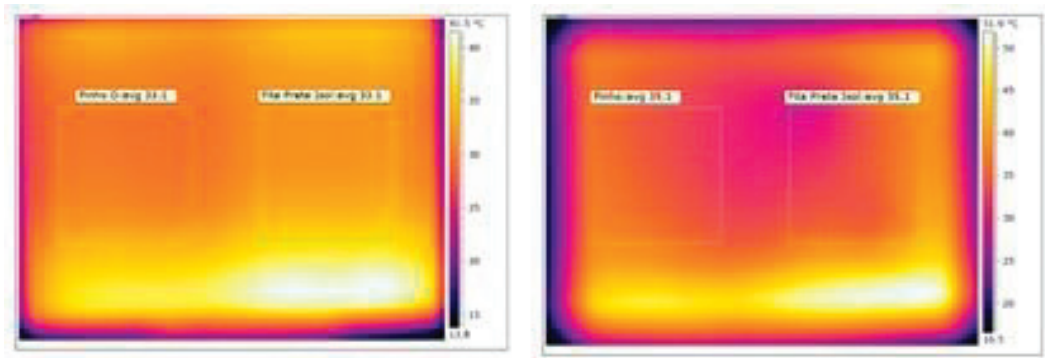
**Figure 2.**  
*Thermograms that show the heterogeneity of surface heating and inadequate focusing.*

**Figure 2** shows examples of the influence of homogeneous heating and adequate focusing in the determination of an accurate emissivity value [7]. Even with the correct emissivity value, incorrect focus or improper brightness and contrast may cause the observed surface temperature readings to be incorrect. For an accurate determination of the surface emissivity, it is necessary that the temperature of the surface is to be between 10 and 20°C above the ambient temperature. It is also important homogeneity in the heating process. **Figure 2** shows cases of thermograms where the heating was neither homogeneous, nor a correct adjustment in the focus, which led to the determination of incorrect values of emissivity and surface temperature.

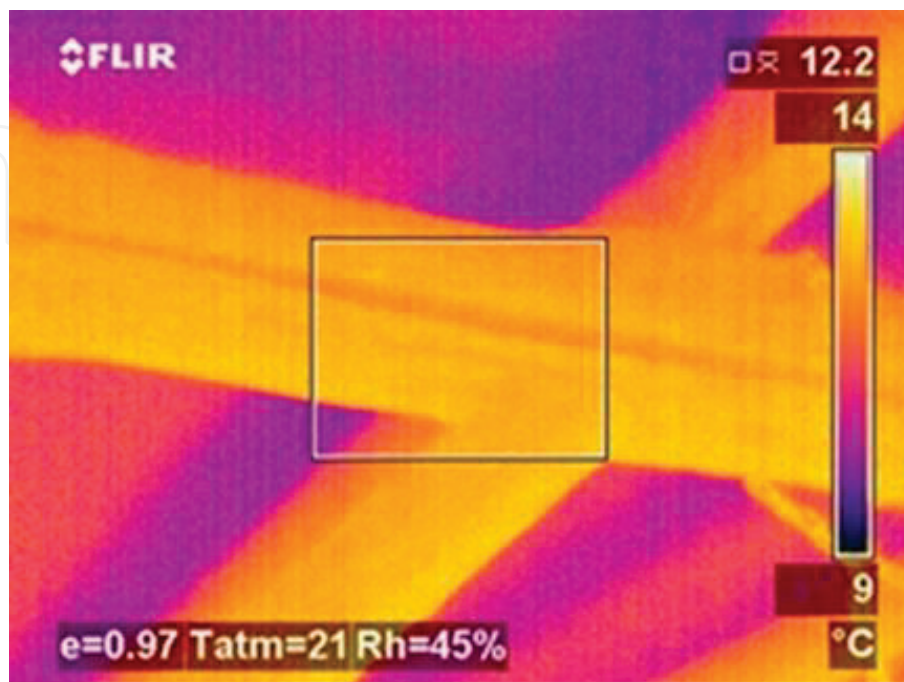
**Figure 3.**  
*Thermogram of old wooden structure: the crack is visible along the beam (passive method).*

Thus, **Figure 3** shows a thermogram obtained in the passive mode. It was taken from a wooden structure of a roof. A crack may be seen running longitudinally through the wooden beam. The crack is visible because thermal heterogeneity is visible in this part, that is, temperature values lower than the overall beam pattern, visible through darker shades. This information is obtained by comparison with the colour/temperature scale that is displayed on the right side of the thermogram.

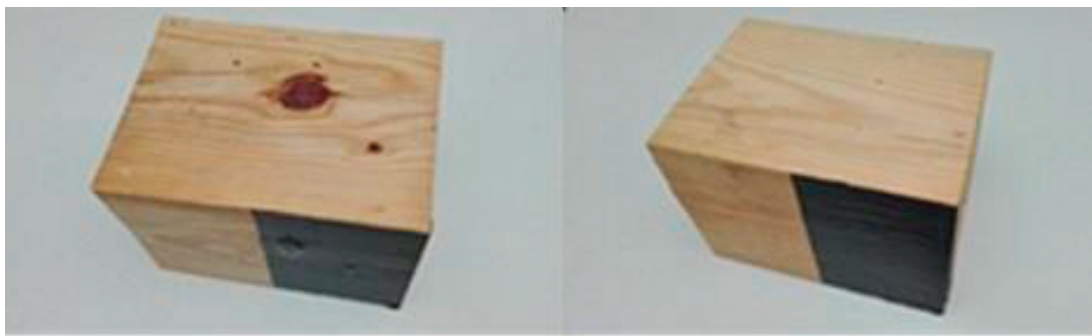
**Figure 6.**  
*Samples of Pinus pinaster Aiton: from Leiria (coast)—left side and from Serra da Estrela (inland mountains)—right side.*

The lumber samples are unfinished wood, as is often found in building structures. The dimensions of the samples are: 20 cm long along the fibres, 15 cm in the transverse dimension and 15 cm in thickness. These dimensions were defined to simulate a small section of a current beam and to minimise the effect of the environment on the surface of the object of study. **Table 4** shows the sample condition as density and water content. **Figure 6** shows the images of the two specimens.

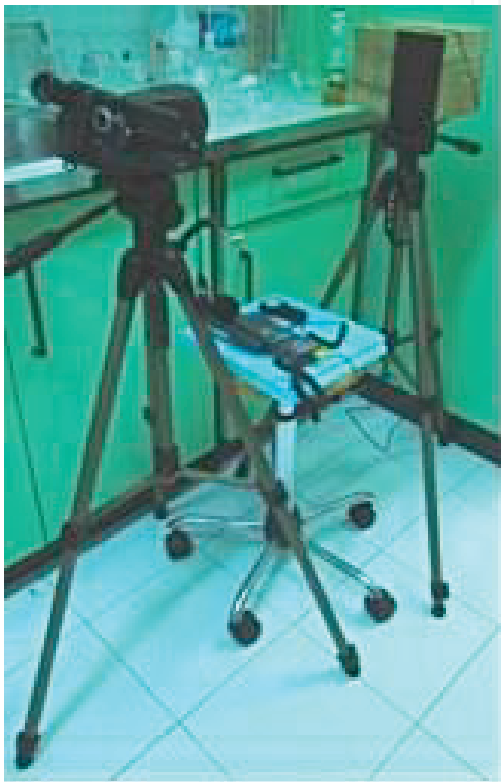
**Figure 7.**  
*Laboratory experiments (general view).*

In **Figure 7**, we can observe how the thermograms of the wood samples were made.
