Detection and Analysis of Petroleum Equipment Faults

Mihail Minescu and Ion Pana

2. Using fitness-for-service assessment method—case study

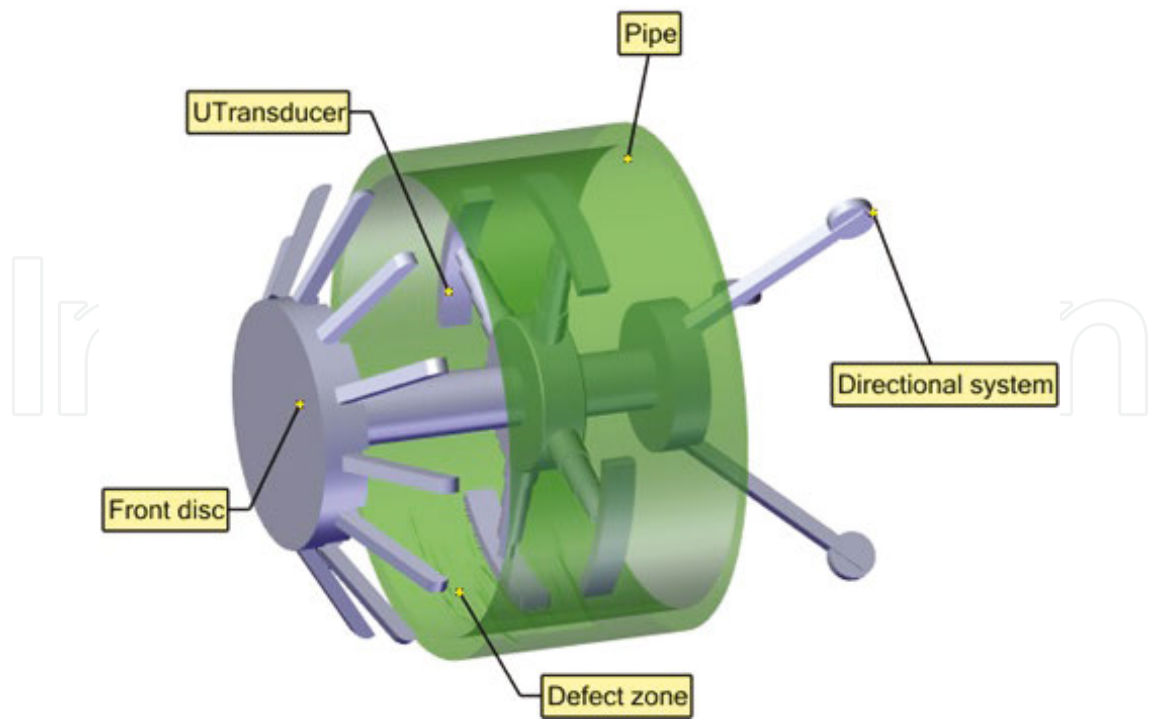
pipeline was inspected using an ultrasound method [the usual methods of inspection there are magnetic flux and ultrasound and the device is named pipeline intelligent gauge (PIG)], **Figure 1**. We used for the inspection a20″ Ultrasonic Intelligent Pig, Korsonic 324, with the following specifications: PIG diameter 350 mm; body length 850 mm; overall pig length 950 mm; temperature max. for PIG 65°C; pressure max. 50 barg; min. bend radius 3 × Internal diameter; transducer frequency 0.5 MHz; transducer focus plane; min. measurable thk 3 mm; max. measurable thk 0.7 m; inspection sensitivity ±0.1 mm; repetition rate 2300 kHz; inspection speed Max. 5 m/min; max. inspection capacity 120 h; axial sampling distance min. 3 mm; circumferential resolution 5.5 mm. The ultrasonic signal is induced directly in the wall to be inspected, EMAT technology. It notes that the procedure for determining defects of the pipelines uses three-dimensional images that are offered to users in the form of Excel files, **Table 1**. These images were obtained over the last 20 years with a precision increasingly better. The instrument measures the thickness of the pipeline in a network of points, **Figure 2**. The image is reported as an Excel file. An example is shown in **Table 1**. As the beneficiary of the contract imposed certain conditions of confidentiality, they have been used data from a pipeline segment of 8622 m. So the probability of failure calculation refers only to this segment and not to the entire pipeline. The total number of defects found was 56.824. These can be classified after the geometrical characteristics (**Table 2**) and the cause that determined the defect: manufacturing, construction, corrosion, mechanical damage and repair (**Table 3**, column 10).

Figure 1. Pipeline intelligent gauge — tip Korsonic 324 – Cala & Cdria Pipeline Services Company Ltd: Ultrasonic Transducer (UT) is mounted inside the inspection device.

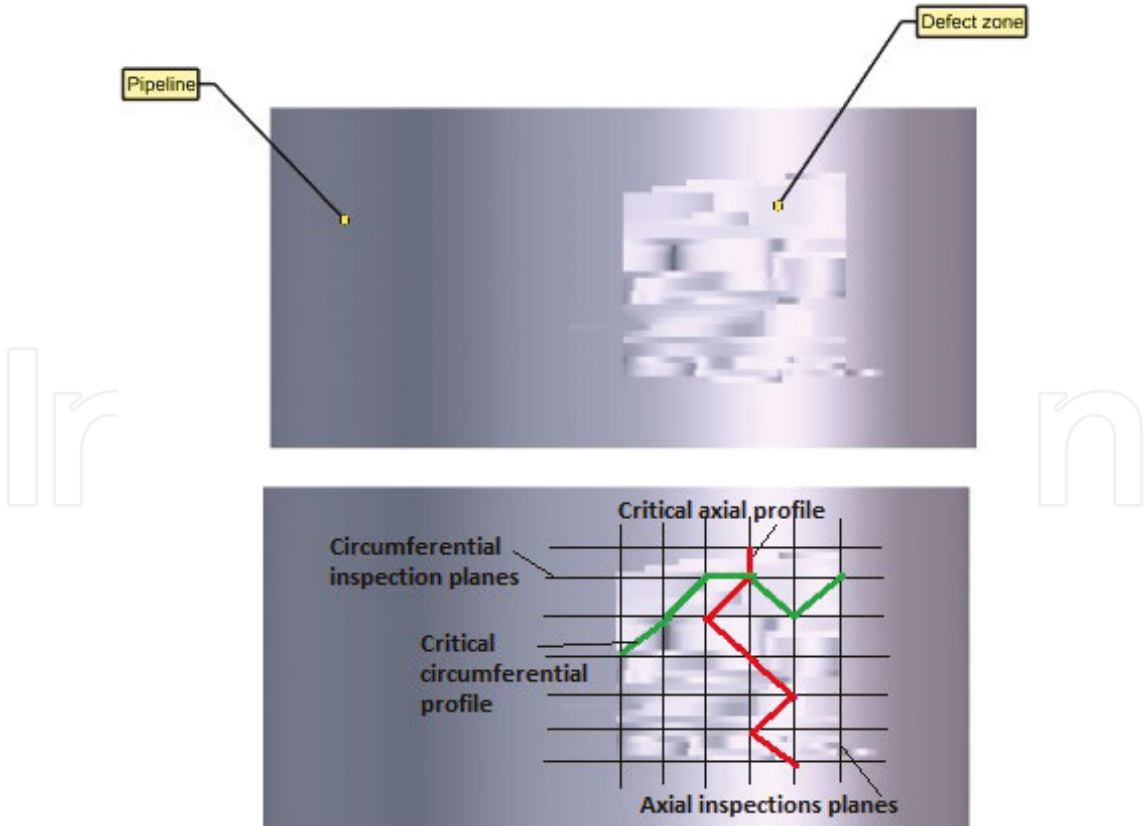
Figure 2. The results of the inspection: tridimensional images of the defects.

As it is seen a large number 55,162 corrosion defects reported by the inspection, but many of them are superficial. Defects have been chosen only to the depth of more than 20% of the thickness the pipeline; their number is 212. The geometrical elements of these defects are in **Table 3**. For the variables D, UTS and PO we considered the values from **Table 4**, [11, 21, 23]. After 8 years of operation ($T_0 = 8$ years), the probability of failure FP versus operating pressure is represented in **Figure 3** (calculated at the end of each working year).

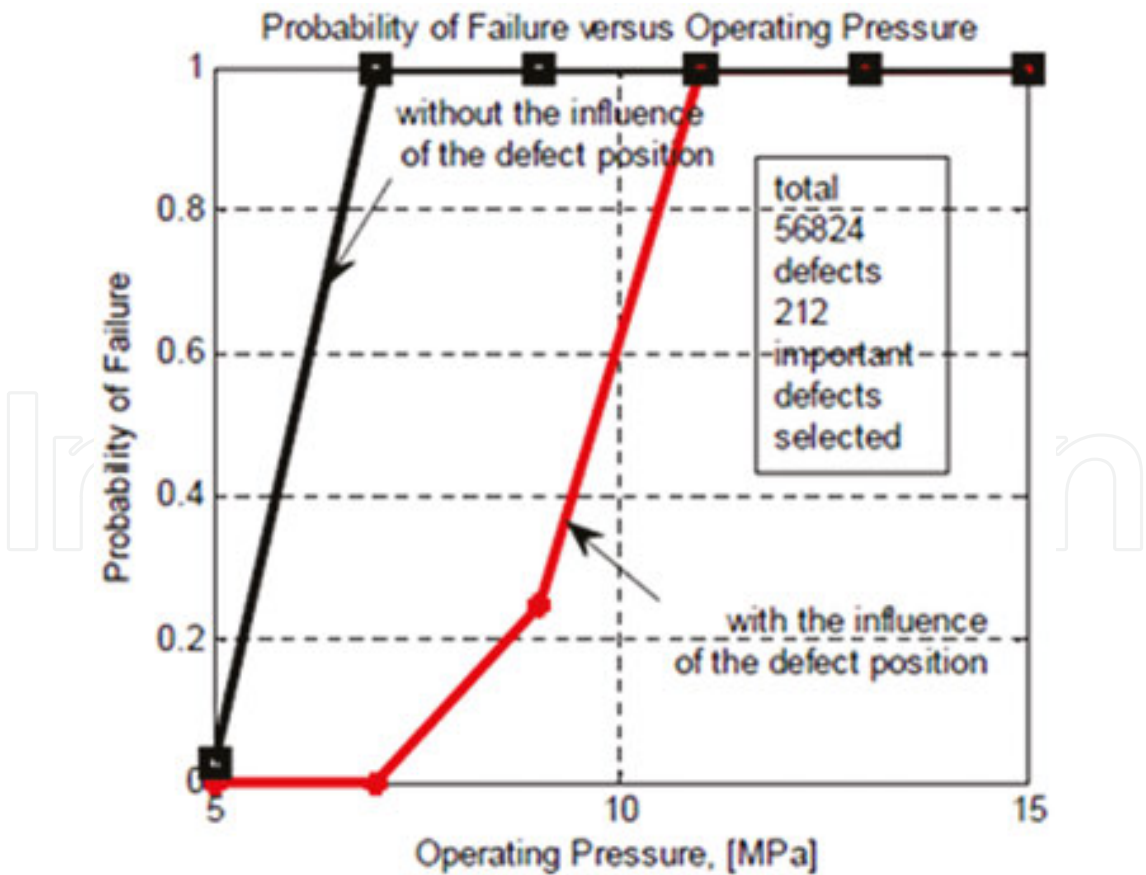
The fault location is important to value of the probability of failure FP. If we consider the operating pressure of the pipeline: FP is 0.03 for PO of 5 MPa and equal to 1 for the other pressures of operation of the pipeline. If we consider pipeline pressure at fault position then for PO of 5 and 7 MPa, FP is zero, at 9 MPa FP is equal with 0.24 and equal with 1 at 11, 13 and 15 MPa. If we choose the limit of the probability of failure of 0.5 (highly conservative methods of calculus [4] justifies this value), the first case of assessment tells us that at the work pressures above 5 MPa we could not use the pipeline. The second case of assessment tells us that we can use the pipeline at the pressures of 7 and 9 MPa, too. We have thus a lower degree of conservatism. Based on the considerations we made, it can be appreciated the defect evolution in time. It is true that these considerations include several simplifying assumptions, but also includes the results of PIG measurements. In the situation where it is considered the pipeline

Figure 3. The influence of the defect position versus the probability of failure.

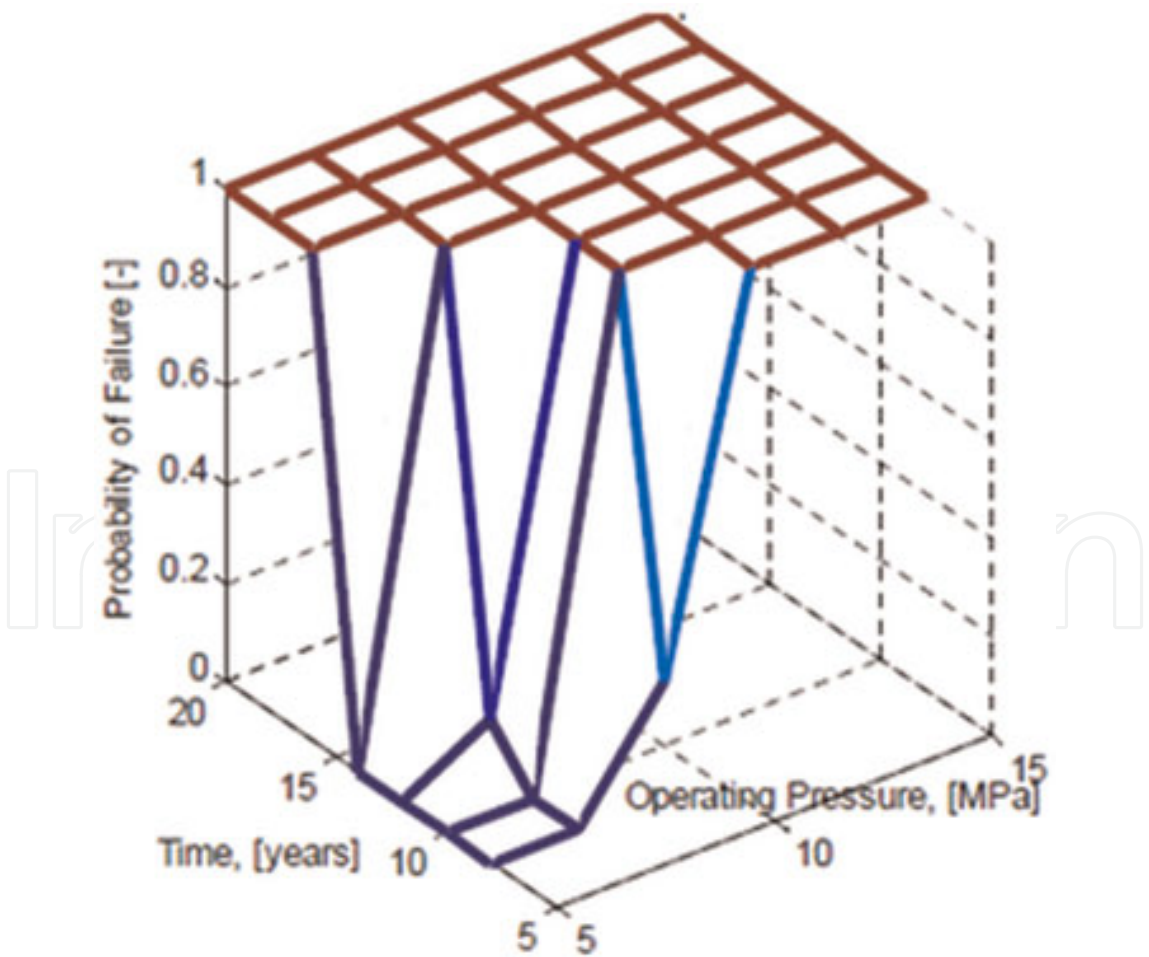
pressure at the defect position was represented the progress of defect probability of failure in time (with a step of 2 years) **Figure 4**. If the pipeline operating pressure is 5 MPa is observed that after 14 years FP grow rapidly, showing that the operator should perform repairs to the system. In the case of operating pressure of 7 MPa since the 12th year of exploitation, FP increases of and between years 12th to 14th FP rises further reaching value 1. Operation of the pipeline to 9 MPa shows a probability of failure which reaches 1 (sure failure) between years from 8th to 12th. Obviously, in situations where the probability of failure is high (it has chosen the 0.5 limit) should intervene to repair the pipeline. By choosing this limit, some defects become critical. The list of defects which should be repaired is given in **Table 5**. If these defects are repaired, then the pipeline FP falls, and it can be used safely for many years, and over a range of operating pressures as shown in **Figure 5**. The method described above was implemented on programs (in Matlab) made by the authors [22, 23]. It is generated a list of defects to be repaired every year, **Table 5** (an example for two pressures 5 and 7 MPa). If the number of the defects is high, an economic analysis of whether a repair or a replacement of the section of the pipeline is required. So we have a procedure of action based on the results of inspection and the accomplished analysis, useful in the maintenance process. The effect of the repair is seen immediately; the pipeline is less likely to fail. However, at higher operating

Figure 4. Probability of failure depending on operating pressure and time, if the critical defects are not remedied.

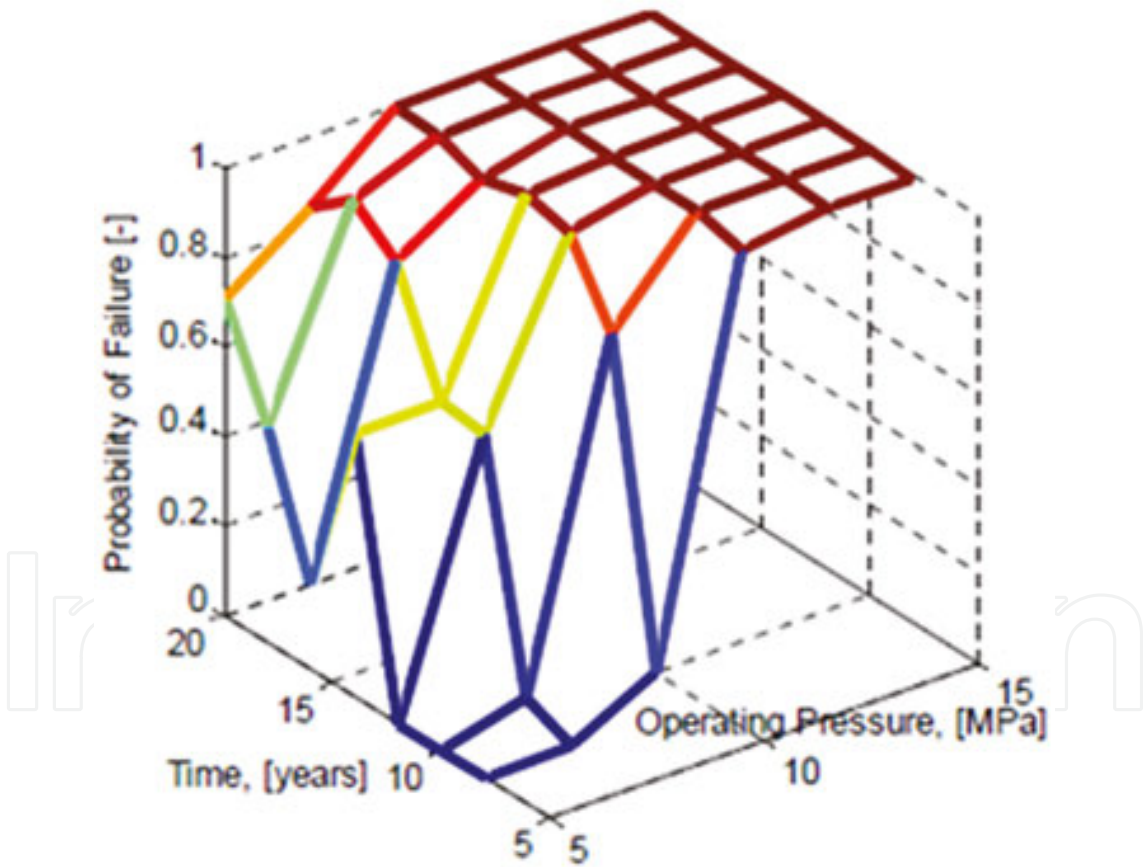
Figure 5. Probability of failure depending on operating pressure and time, when the critical defects are repaired.

Table 5. List of the defects with the probability of failure greater than 0.5, which must be repaired at the beginning of each year (example of the maintenance program).

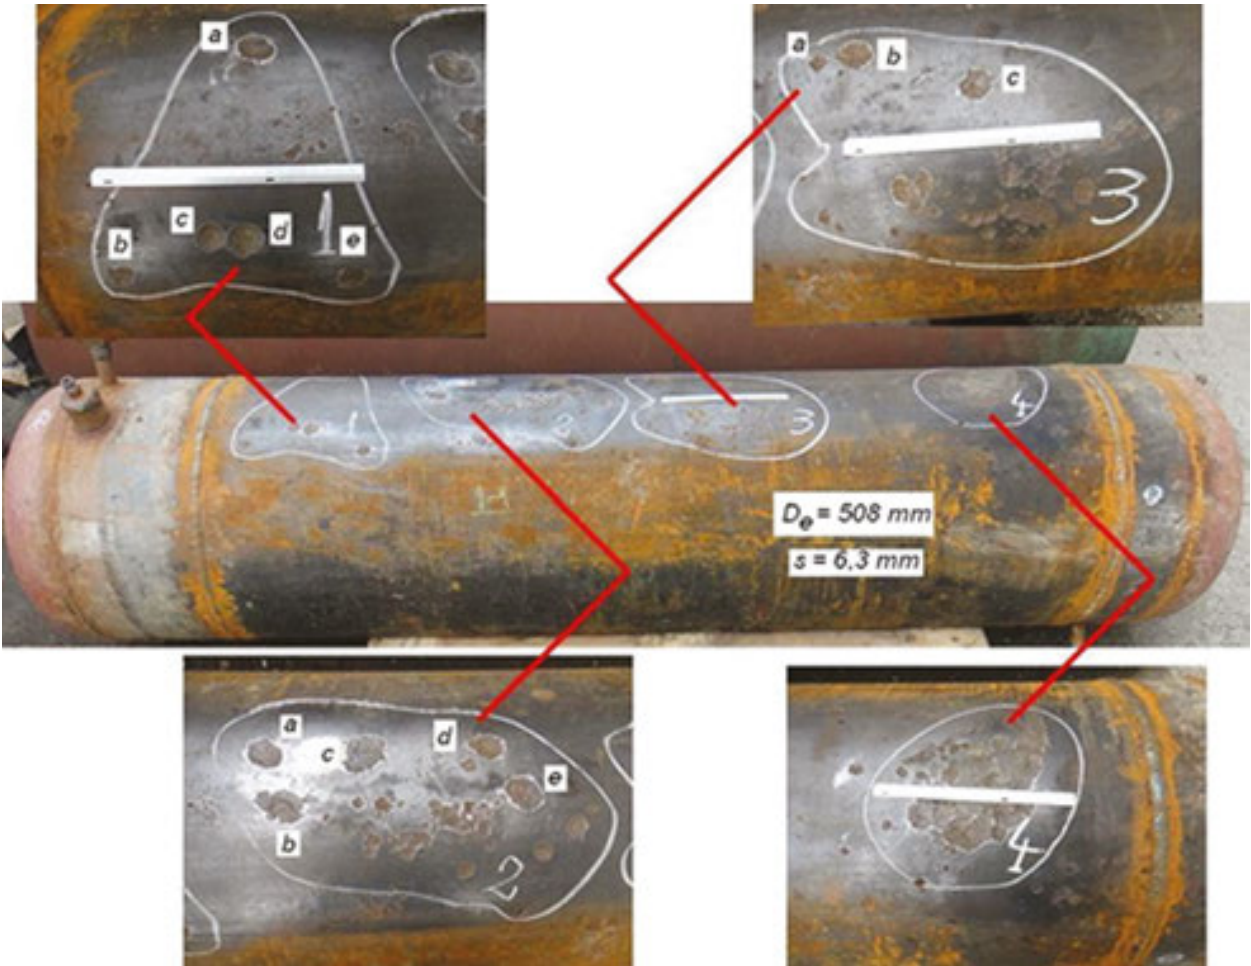
Figure 6. Defects loss of material from the sample being tested.

Table 6. The geometric characteristics of the defects type loss of material subjected to the burst pressure test.

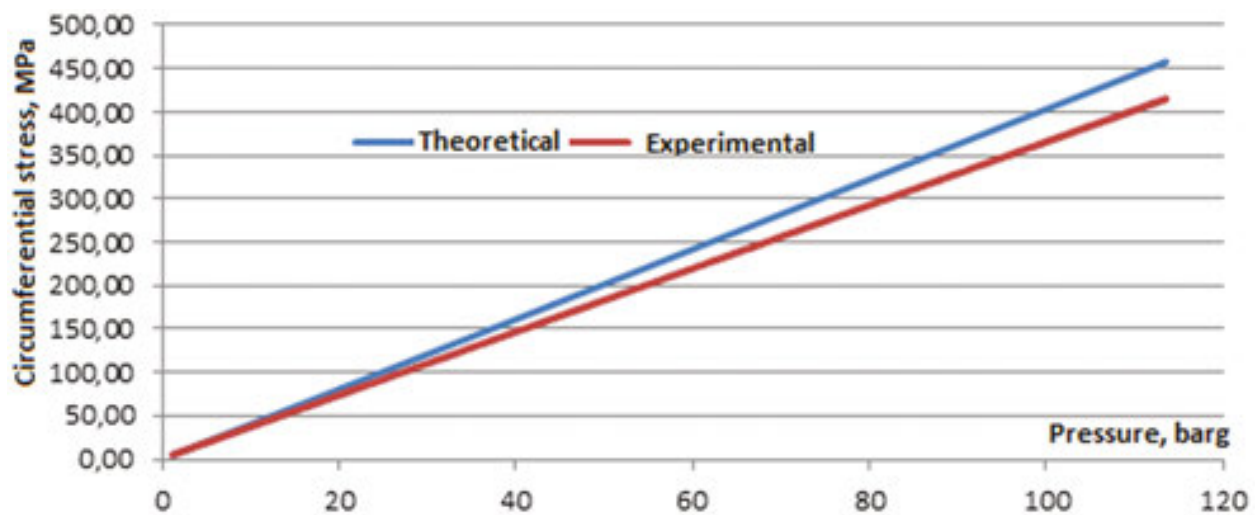
Figure 9. The results of experimental analysis (method of resistive tensometry) for sample with defects type material loss: circumferential stress.

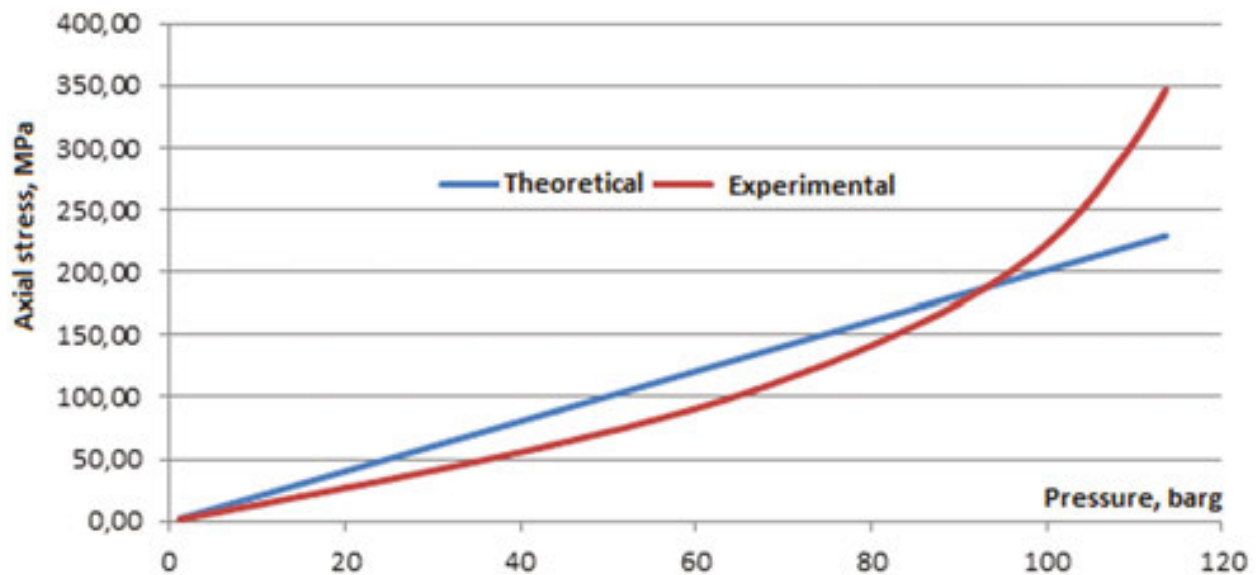
Figure 10. The results of experimental analysis (method of resistive tensometry) for sample with defects type material loss: axial stress.

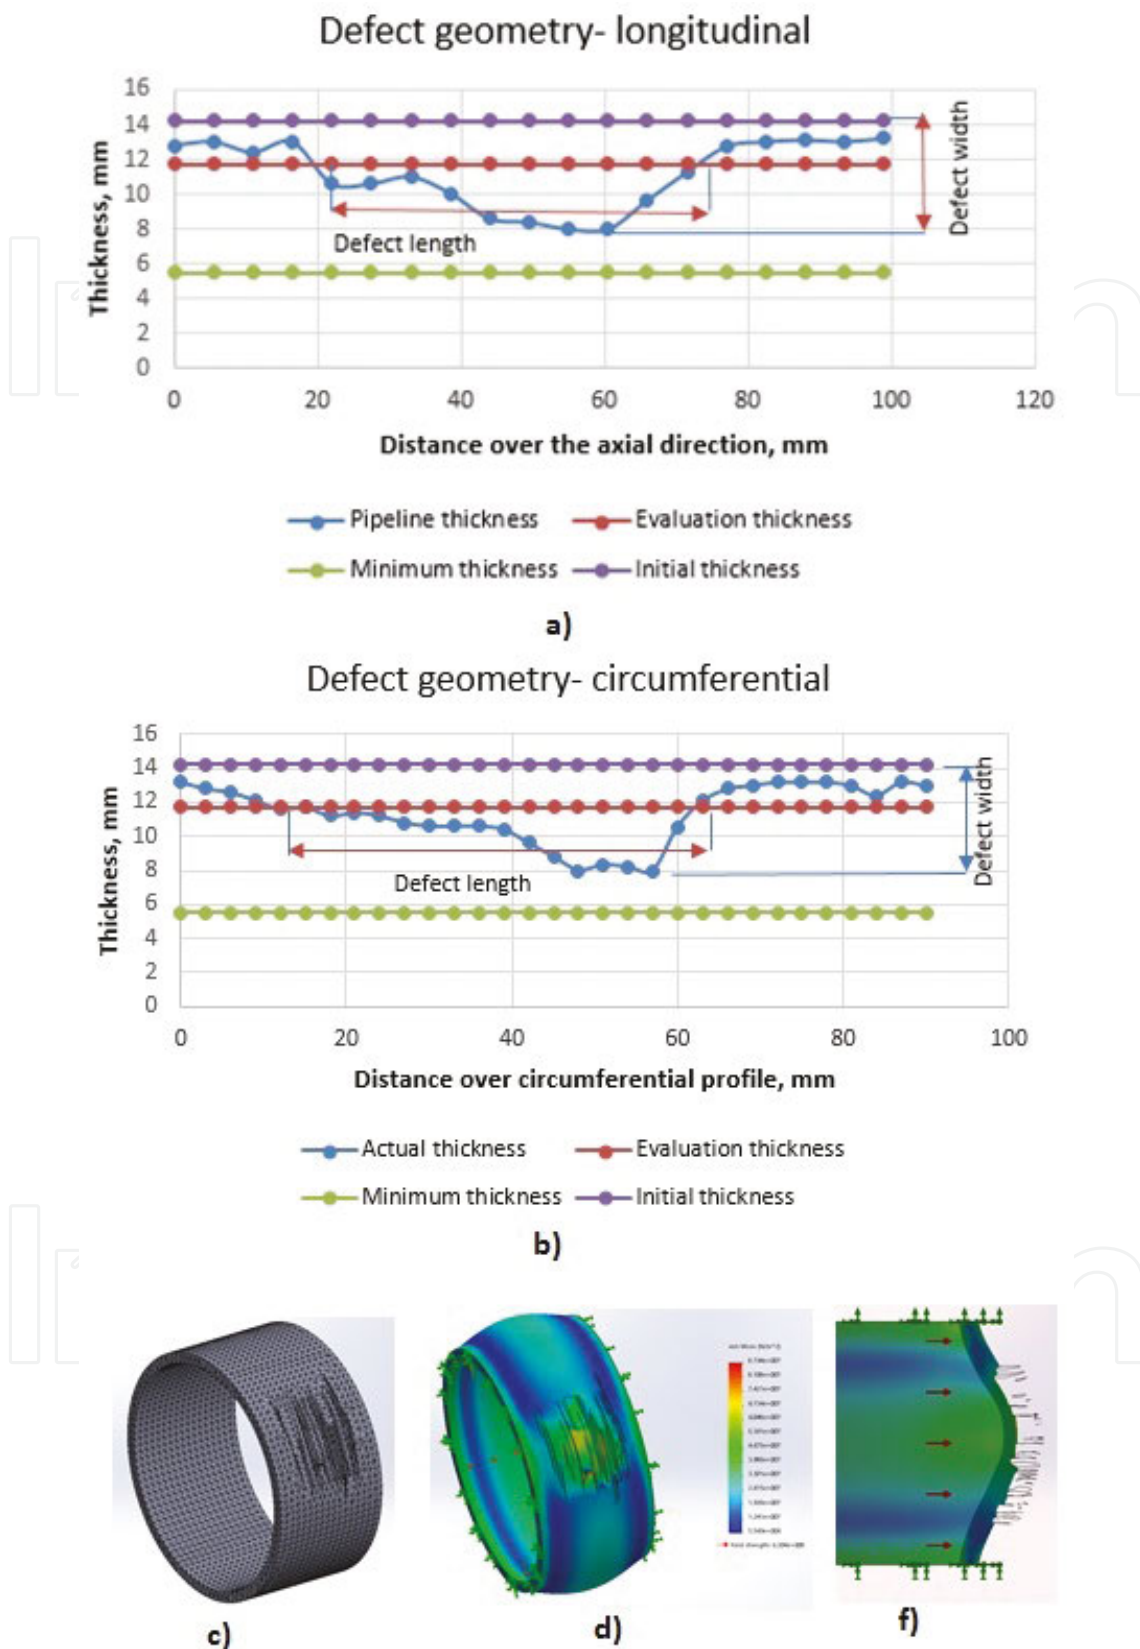
The analyzes use only defect length and depth of the defect (level 1); critical profile of the defect in the longitudinal and transverse direction (level 2) **Figure 11a** and **b**; a tridimensional image of the defect generated based on readings during inspection stage, transformed into a solid object and subjected to finite element analysis (level 3) **Figure 11c–e**. Based on the defect report (**Table 1**), we can achieve a three-dimensional model, using a mesh (**Figure 11c**) and the analyze with finite element method (**Figure 11d**). In **Figure 11**, **e** is a detail with defect zone.

Figure 11. Using different levels of analysis: (a) critical axial profile used in a Level 2 analysis; (b) critical circumferential profile used in a Level 2 analysis; (c) treedimensioal model and the mesh of finite elements for a Level 3 analysis; (d) simulation model (solidworks simulation); a detail with the defect zone.
