Contribution to the Evaluation of Silicon Carbide Surge Arresters

Arnaldo Gakiya Kanashiro and Milton Zanotti Jr.
*University of São Paulo
 Brazil*

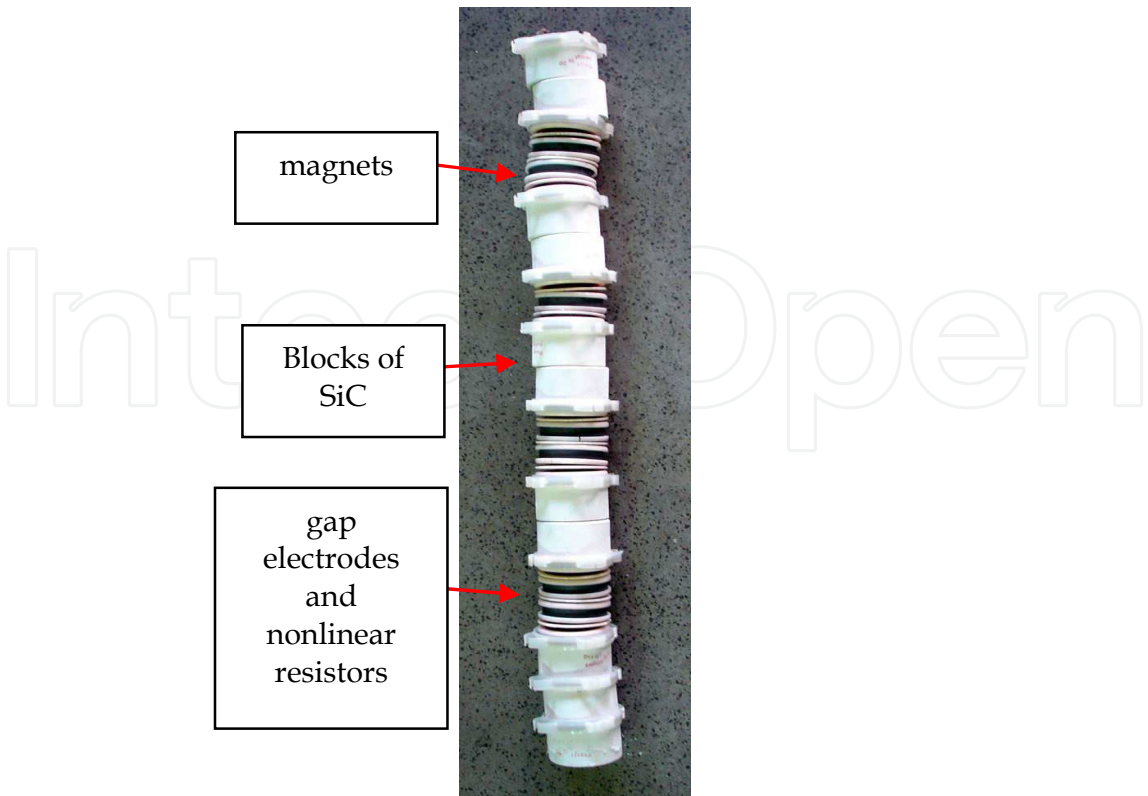
In the surge arresters A2, A4 and A6 there are permanent magnets in parallel with gap electrodes. Nonlinear resistors of SiC are placed between the gap electrodes. The dismantled surge arrester of manufacturer A can be seen in the Fig. 4.

Fig. 4. Surge arrester of manufacturer A.

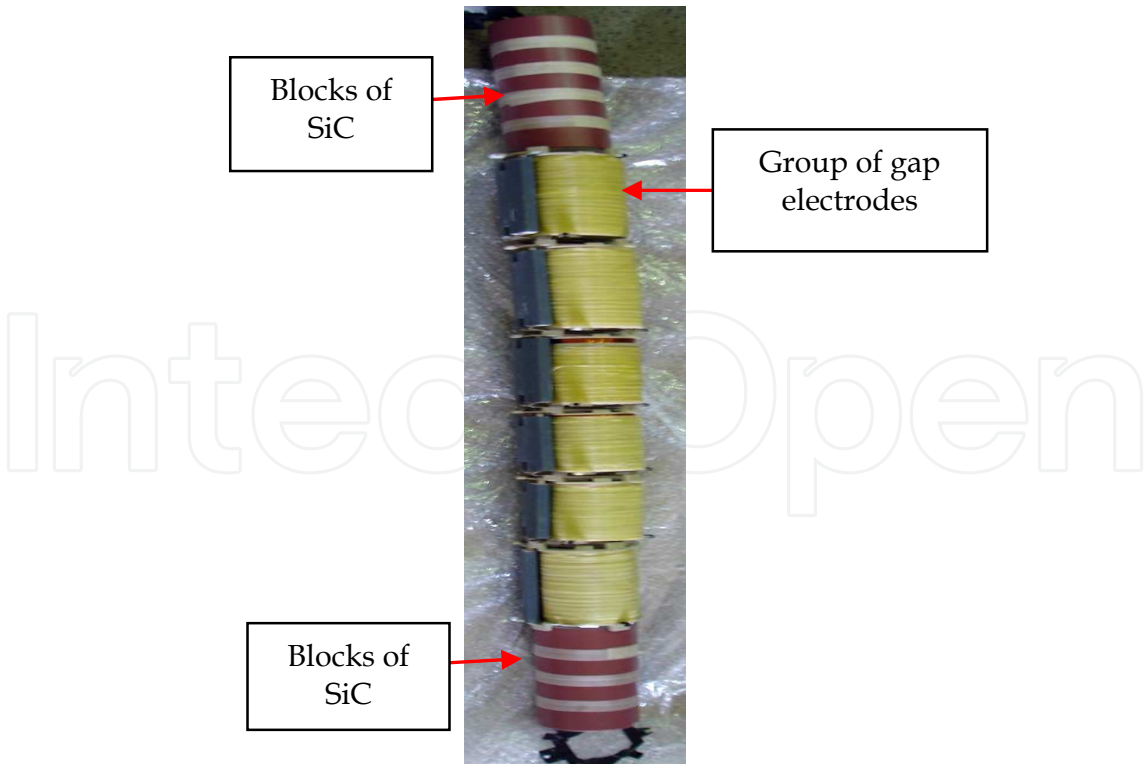
The internal components of the surge arrester C can be seen in Fig. 5. At the edges are placed coils in order to facilitate arc extinguishing. Fig. 6 shows one group of gap electrodes.

Fig. 5. Surge arrester of manufacturer C.

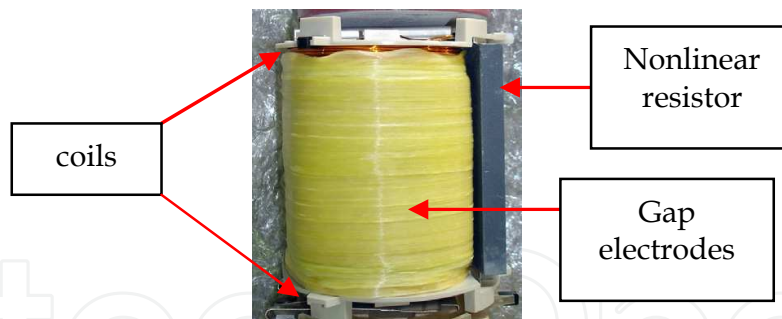
Fig. 6. Group of gap electrodes of surge arrester C.

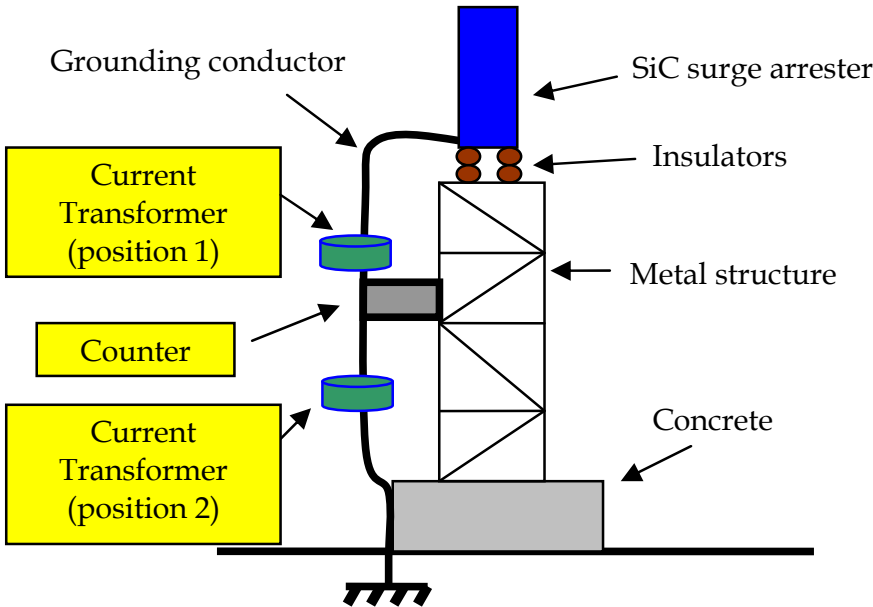
Leakage current measurements in 88 kV SiC surge arresters, in service, were performed in the Paraibuna substation first, aiming to check the viability of this technique. Details of the SiC surge arresters installation were considered, such as presence of counter discharges, grounding cable of the surge arresters, the presence of insulators in the assembled surge arresters, etc. These aspects have important influence on the results. A device, consisting of a current transformer (CT) and a digital instrument, was used in the field. The CT was placed in the grounding cable, between the discharges counter and the bottom part of the surge arrester (position 1) or after the discharge counter (position 2), as shown in Fig. 9. The aim was to investigate the interference of the installation in the results. The leakage current was measured using 60 Hz and 180 Hz frequencies. When the CT was placed in the position 2, there was interference, as shown in the oscillograms of Fig. 10.

Fig. 9. Leakage current measurement at the substation.
