Investigation of High Energy Arcing Fault Events in Nuclear Power Plants

Heinz Peter Berg¹ and Marina Röwekamp²

1. Introduction

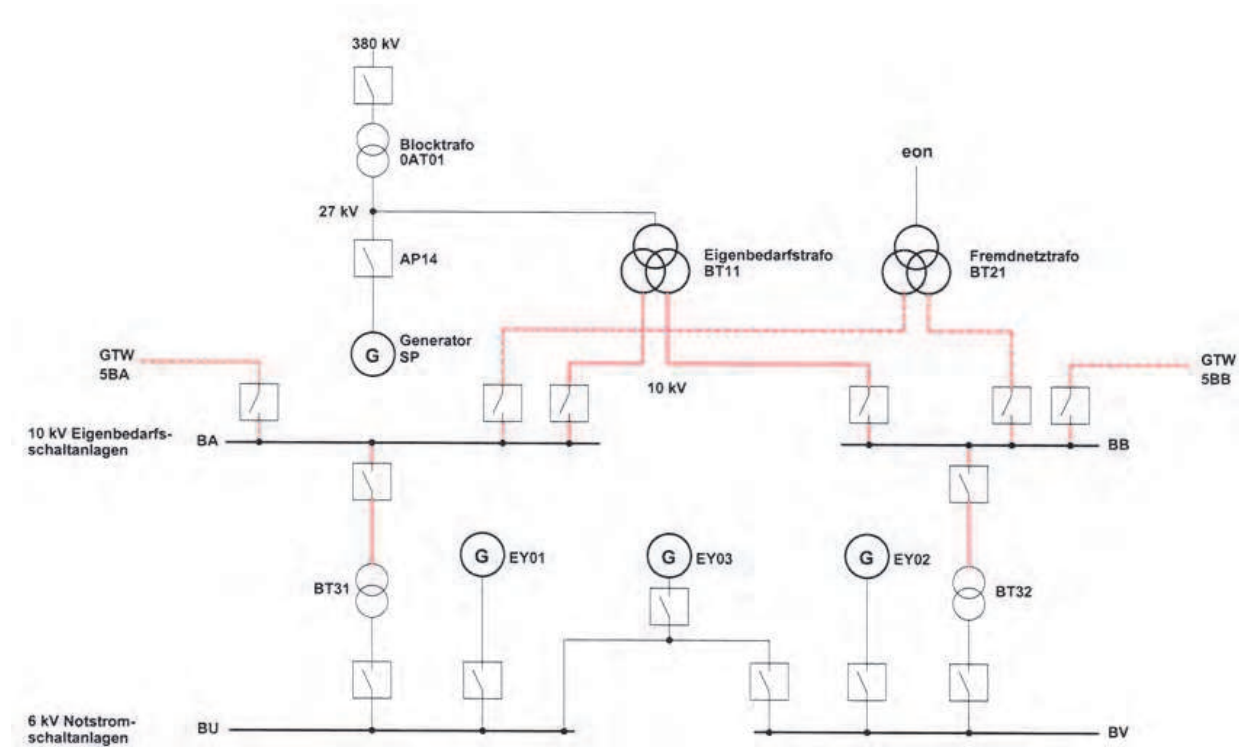
This event, which occurred in a 10 kV cable at a BWR type plant, has been analyzed in detail by the responsible expert organization on behalf of the regulator in charge (Berg & Katzer et al., 2009). Details on the electric circuit are provided in Figure 1.

Fig. 1. Scheme of the electric circuit affected

The detailed analysis led to the definite result that the event was mainly caused by ageing of the 10 kV cables. The ageing process was accelerated by the insufficient heat release inside the cable cylinder blocks.

As a corrective action, all high voltage (mainly 10 kV) cables with PVC shielding being older than 30 years were replaced by new ones.

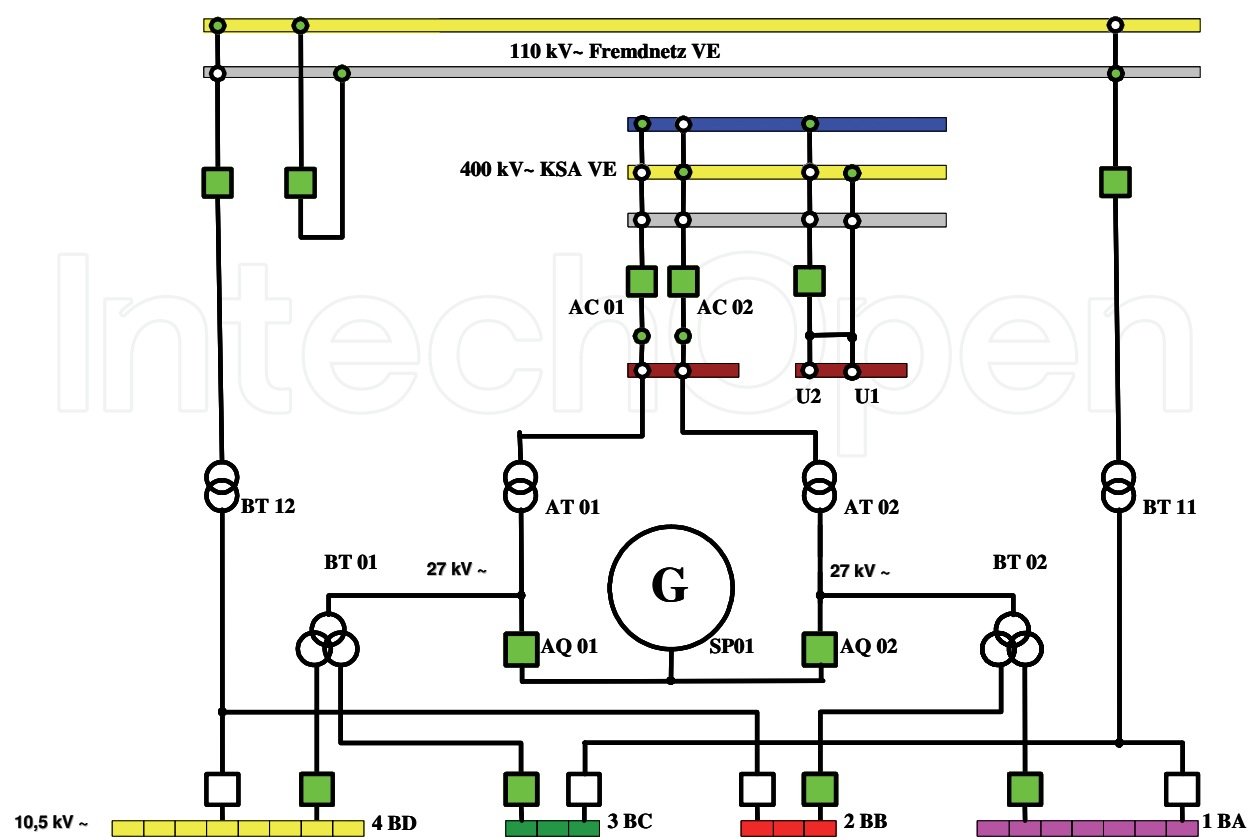
At the same time, de-excitation of the generator was actuated. The short circuit was thereby isolated. In addition, two of the four station service supply bus bars (3BC and 4BD) were switched to the 110 kV standby grid (VE). A simplified diagram is given in Figure 7 (Berg & Fritze, 2011).

Fig. 7. Simplified diagram of the station service supply and the grid connection of the nuclear power plant

A detailed root cause analysis regarding the different deviations from the expected event sequence was carried out. The cause of the fire was a short circuit in the windings of the generator transformer. Due to the damages to the transformer it was not possible to resolve the failure mechanisms in all details.
