## **Case-Based Reasoning of Man-Made Geohazards Induced by Rainfall on Transportation Systems**

Kuan-Tsung Chang, Edward Wang, Chih-Ping Kuo,  
Min-Cheng Teng and James Jin-King Liu

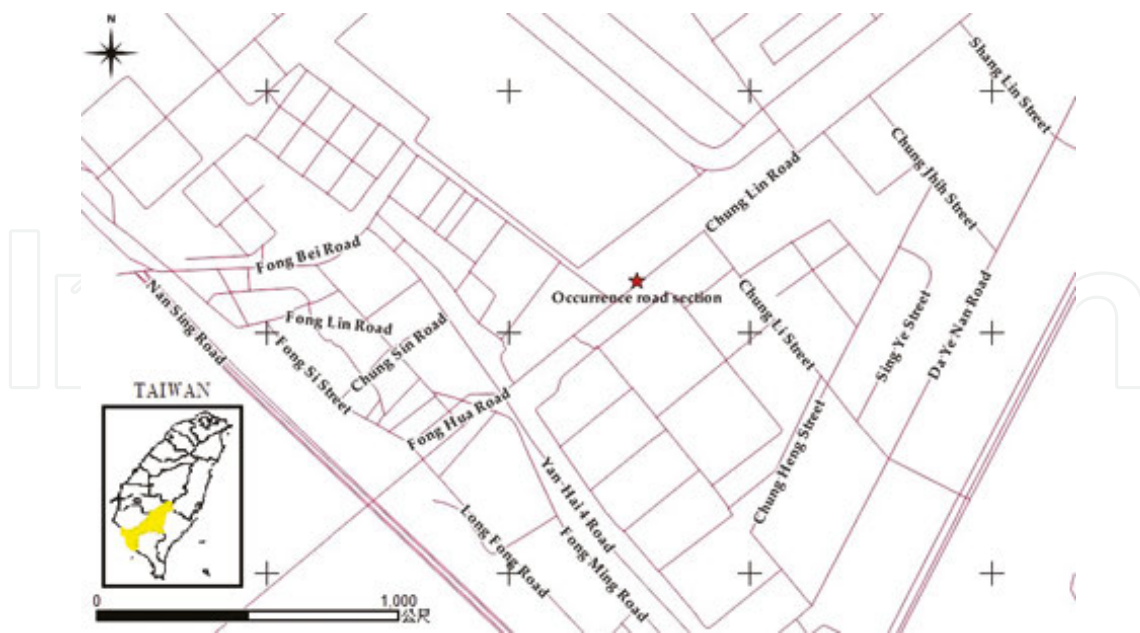
**Figure 1.** Location of the event.

**Figure 1** shows the location of the collapse of Chung Lin Road, Kaohsiung City. The collapse measured 40 m by 10 m. The site is close to the Dalin Refining plant of the Refining Business Division's Operators of The CPC Corporation, Taiwan. The plant includes a number of vulnerable facilities. The distance of the collapse to the nearby oil tanks is only a few 100 m. Fortunately, CPC executed an emergency stop of the transportation of the fluids through the pipelines, and thus no leakage or explosion was triggered.

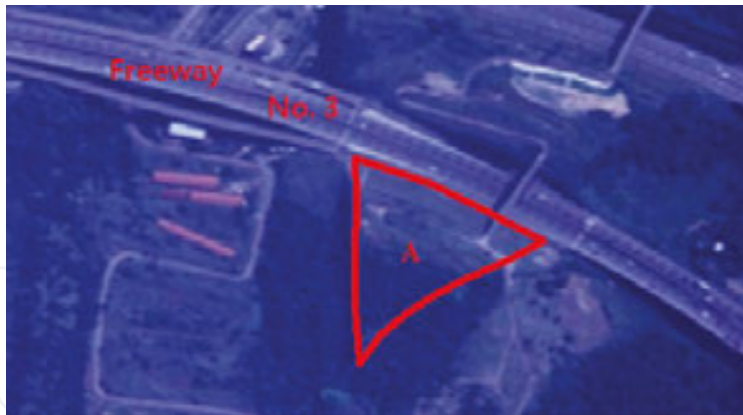
**Figure 7.** Historical photograph of the site taken by the Agricultural and Forestry Aerial Survey Institute (AFASI).

m above ground in average. Flight speed was 50 km/h. Ground resolution of the images was about 17 cm. The forward overlap between images is more than 80%. **Figure 6** is a UAV side view of the landslide captured by a rotary-wing UAV owned by the Flying Tiger Helicopter and Skyline Dynamics Co., Ltd. **Figure 7** is a historical photograph of the site taken by the Agricultural and Forestry Aerial Survey Institute (AFASI).

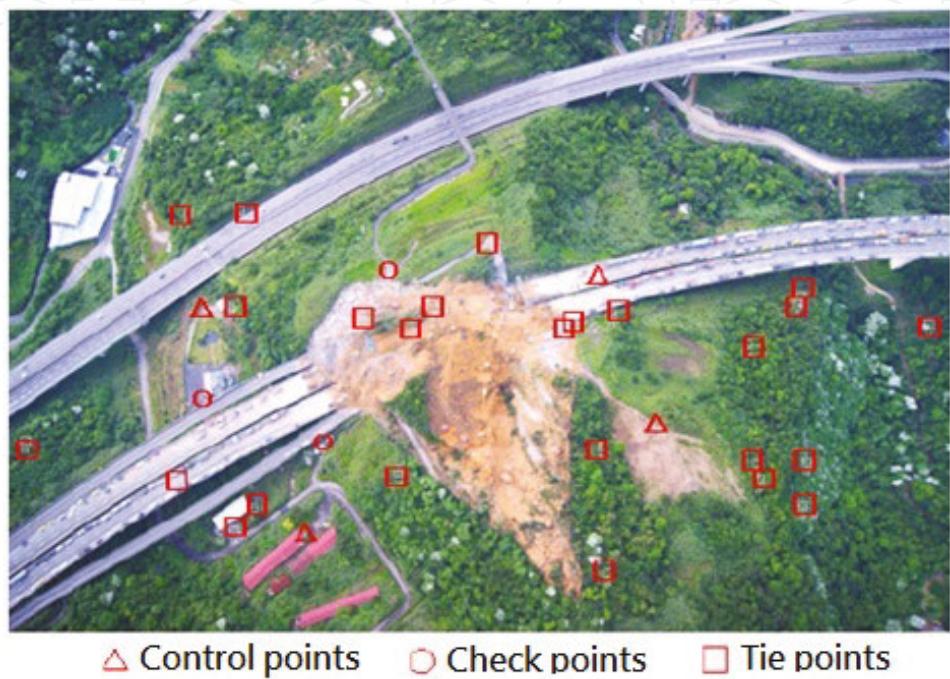
**Figure 8.** Locations of all control points, check points, and tie points [25].

To facilitate the production of stereo-pairs, the stereo-models developed for producing official electrical maps (a scale of 1 to 2500) in 2009 were used for measuring control points of ground features such as building corners and road signs. In total, one vertical control point and three full control points were captured along with three check points for subsequent accuracy assessment. In a later stage, image automatic matching and aerial triangulation were conducted with Erdas LPS and 25 tie points. **Figure 8** shows the locations of all the control points, check points, and tie points.

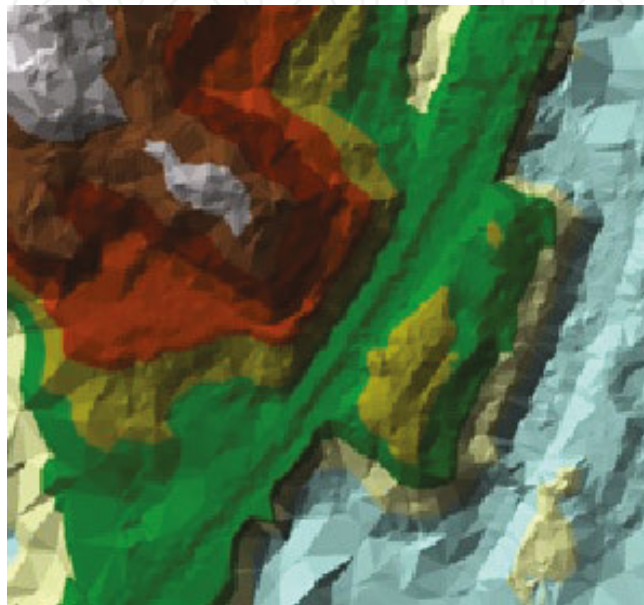
**Figure 10.** 3-D Models prior to the event [23].

Additional benefits that the decision makers can gain from the results of UAV operations include 3-D schematic models of the landslide (**Figure 10** and **Figure 11**), animated videos, topographic analysis of the landslide, and a comparison of the cross sections prior to and following the event (**Figure 12** and **Figure 13**). To facilitate the process of emergency response, a standard procedure, including UAV operations, can be beneficial and worthy of establishment.
