Failure Analysis of High Pressure High Temperature Super-Heater Outlet Header Tube in Heat Recovery Steam Generator

Ainul Akmar Mokhtar and
Muhammad Kamil Kamarul Bahrin

Abstract

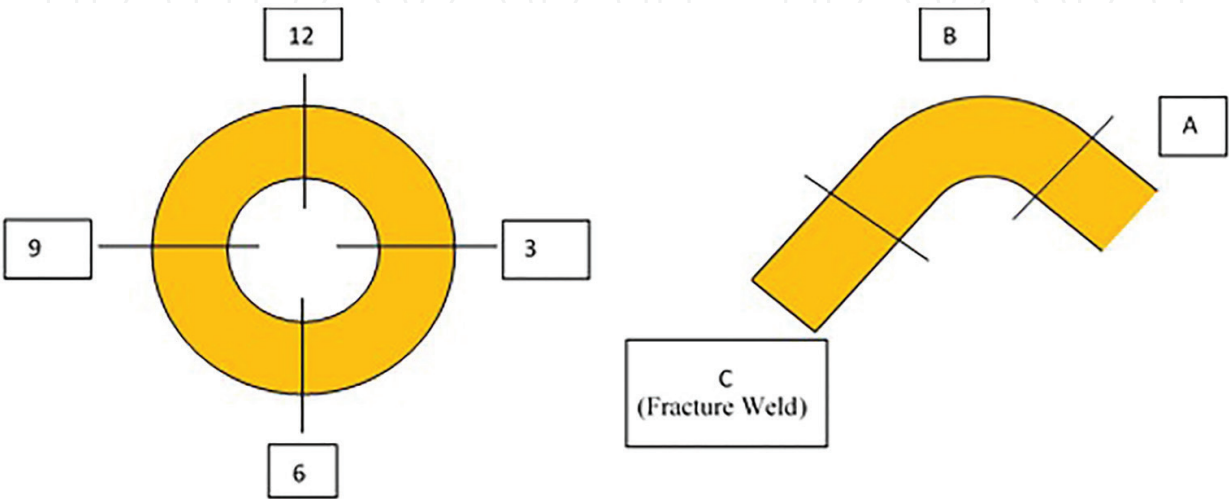
Tube 8 and Tube 18 out of five tubes were chosen for dimensional measurement since the Tube 8 may be a representative of Tube 9 and Tube 10. The tube was cut into six pieces in order to do OD and inner diameter (ID) measurement. The thickness of Tube 8 and Tube 18 was measured by ultrasonic thickness at three locations for each tube, designated as A, B and C. Four spots with respect to clock position 12, 3, 6 and 9 were measured at each location as shown in **Figure 5**. The results are recorded in **Tables 2** and **3**.

The minimum measured thickness readings were compared with the minimum required thickness from the RBI report and Doosan (HRSG OEM) report. Several locations of Tube 8 and Tube 18 showed that the wall thickness was lower than the minimum required thickness, which was considered unsafe and unacceptable. It implied that the risk of stress rupture

Figure 5. Dimensional references of thickness measurement on a tube.

was high. The significant wall thinning could be due to the excessive steam oxidation, which caused a high consumption rate of metal.

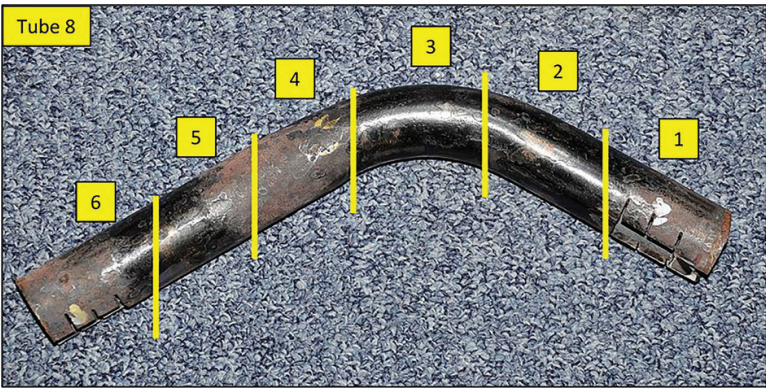
Tube 8 and Tube 18 were cut at an interval length of 50 mm. The sections are designated 1–6 as shown in **Figure 6**. The OD, ID and thickness of each cutting location were measured by Vernier calliper at the area shown in **Figure 7**. The results are recorded in **Tables 4** and **5**.

Figure 6. Tube 8 was cut into six sections.

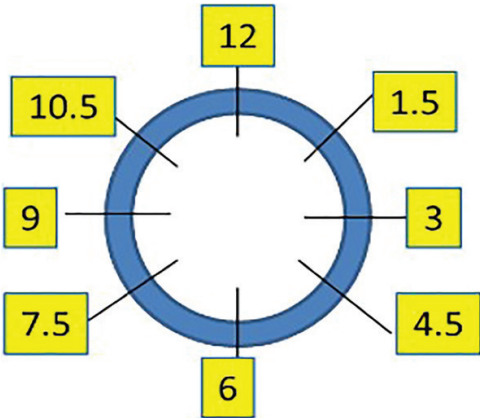
Figure 7. Dimensional reference of OD and ID tube.

The OD and ID for both tubes did not show any significant signs of tube bulging, deformation and wall thinning over the length, as compared to the design values, where OD was 31.8 mm and ID was 26.2 mm.

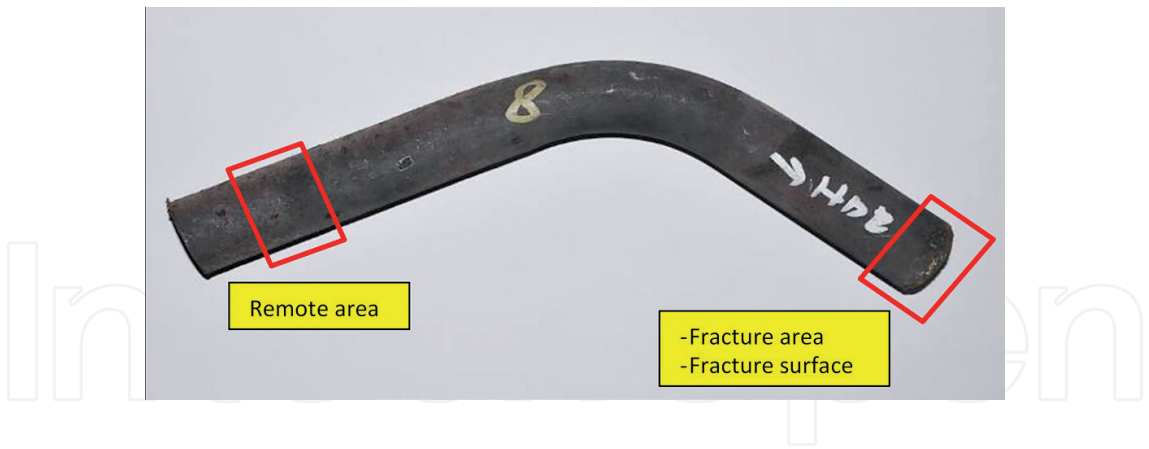
Figure 9. Dimensional reference of oxide thickness measurement.

The location of interest for internal oxide assessment for Tube 8 and Tube 18 is shown in Figure 9.
