# 3D Digital Simulation for Material Damage Mechanism Identification in a Railway Carriage Pressure Vessel

Alessandra Caggiano and Roberto Teti

<http://dx.doi.org/10.5772/intechopen.73233>

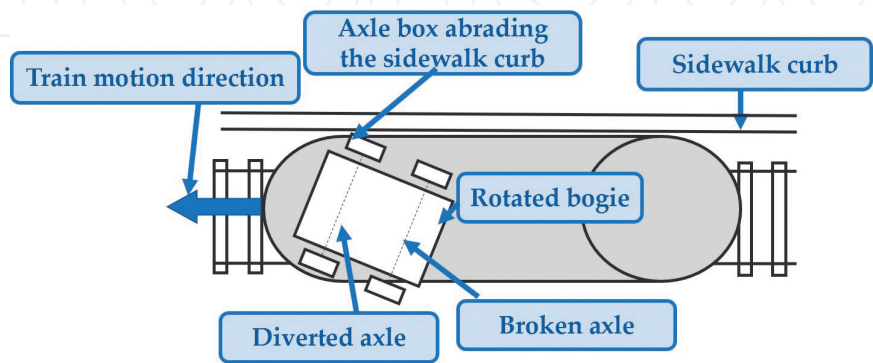
**Figure 4.** Relative positions, after derailment, of carriage no. 1, right front axle box, and sidewalk curb.

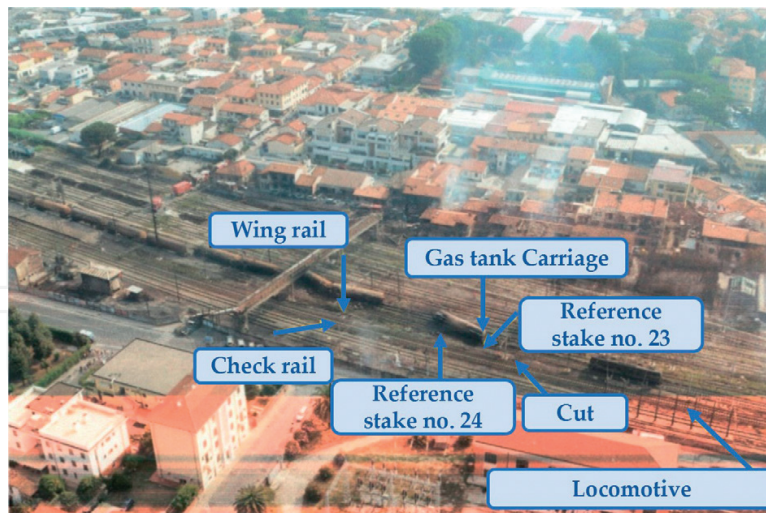
**Figure 10** shows the aerial view of the accident scenario with indication of the potentially responsible elements that could have generated the cut on the tank shell through a mechanism similar to the action of a metal cutting tool. The positions of the elements are reported in more details in **Figure 11**.

**Figure 10.** Aerial view of the accident with indication of the elements potentially responsible for the opening of the cut on the tank shell.

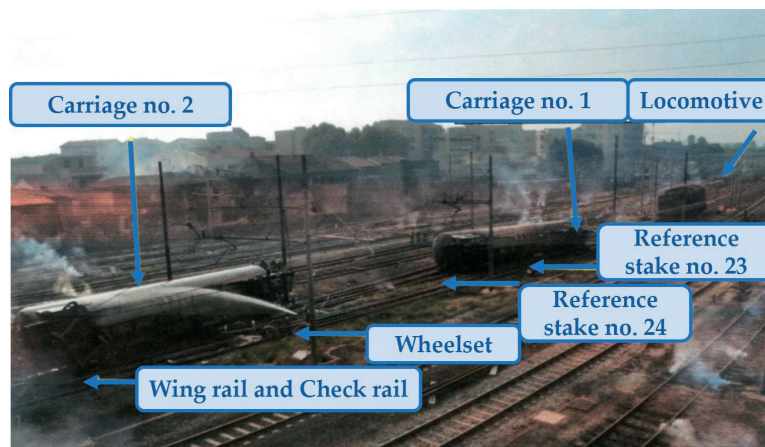
**Figure 11.** Positions of the elements potentially responsible for the cut generation on the tank shell through an action similar to metal cutting: track reference stake nos. 23 and 24, wing rail and check rail.

- Track reference stake no. 24, found at about 3 m before the back bumper of carriage no. 1.
- Wing rail and check rail [2–4] that may have been hit by diverse components of the rolling stock.

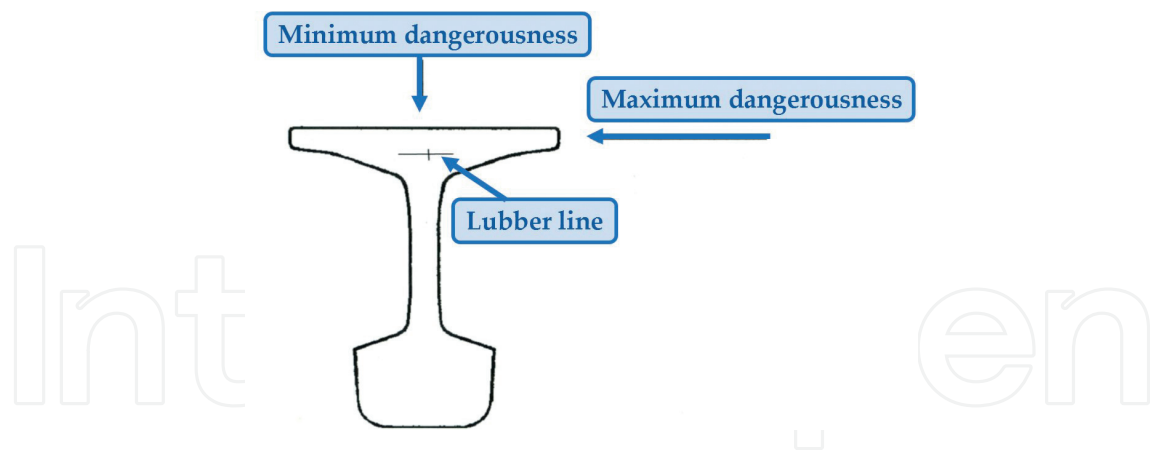
**Figure 12.** Transverse section of a track curve reference stake and directions of minimum and maximum danger grade in case of impact by a moving body against the track reference stake.

In **Figure 12**, the transverse section of a track curve reference stake is shown illustrating the variation of the degree of danger as a function of the impact direction of a moving body against the track reference stake. In the figure, two possible impact directions are considered: the one of maximum degree of danger, parallel to the lower surface of the rail chunk and the other of minimum degree of danger, perpendicular to the lower surface of the rail chunk. For intermediate impact angles, the danger increases going from a perpendicular impact to a parallel impact with reference to the lower surface of the rail chunk. In the latter case, the extremely high contact forces due to the sharp configuration of the corner of the lower surface of the rail chunk can easily determine the cutting of the sheet metal of the impacting tank shell.

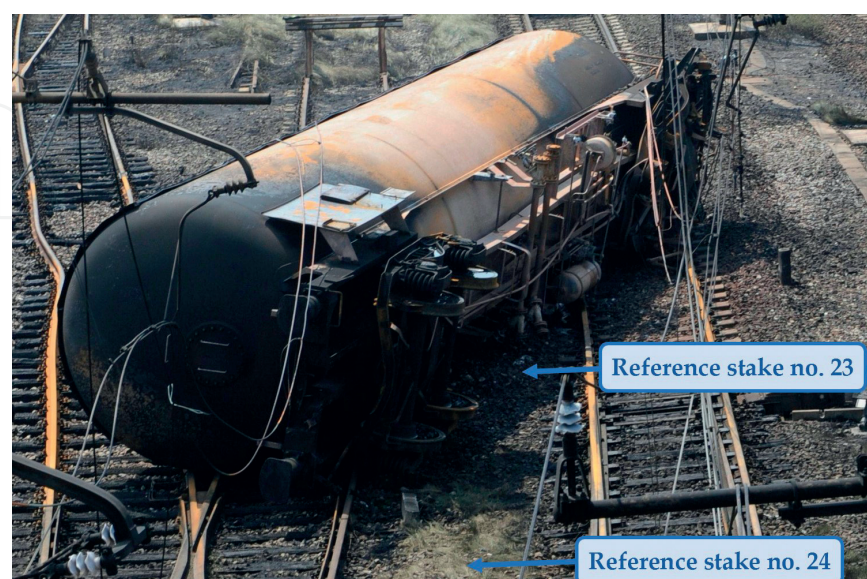
**Figure 13.** Rear view of carriage no. 1 in the accident scene and positions of track reference stake nos. 23 and 24.

**Figure 13** shows the rear view of carriage no. 1 in the accident scene and the positions of track reference stake nos. 23 and 24; the two track reference stakes are 10 m apart, as set by the technical regulations of the Italian railways.

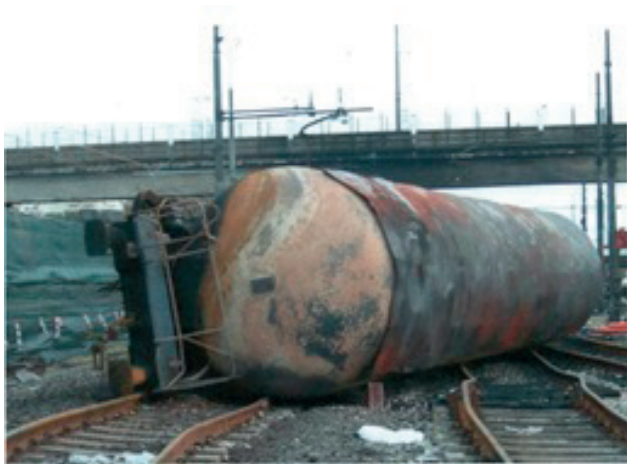
**Figure 14** shows the front view of carriage no. 1 where it can be seen that the front bumper lies on the right rail in the train motion direction of track no. 4.

**Figure 14.** Front view of carriage no. 1 in the accident scene and position of its front bumper.

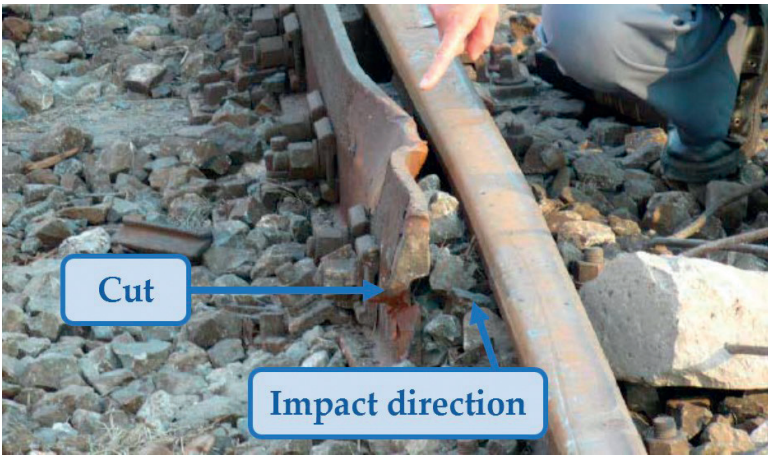
Figure 19. Check rail opposite to the wing rail photographed during the investigations on the accident site conditions.

**Figure 19** shows a detail of the deformation of the check rail opposite to the wing rail. It has been subject to a strong impact in the direction of motion of the overturned carriage no. 1. One element of the derailed material, sliding along the track, has hooked the check rail determining on it a cut and some bulges.

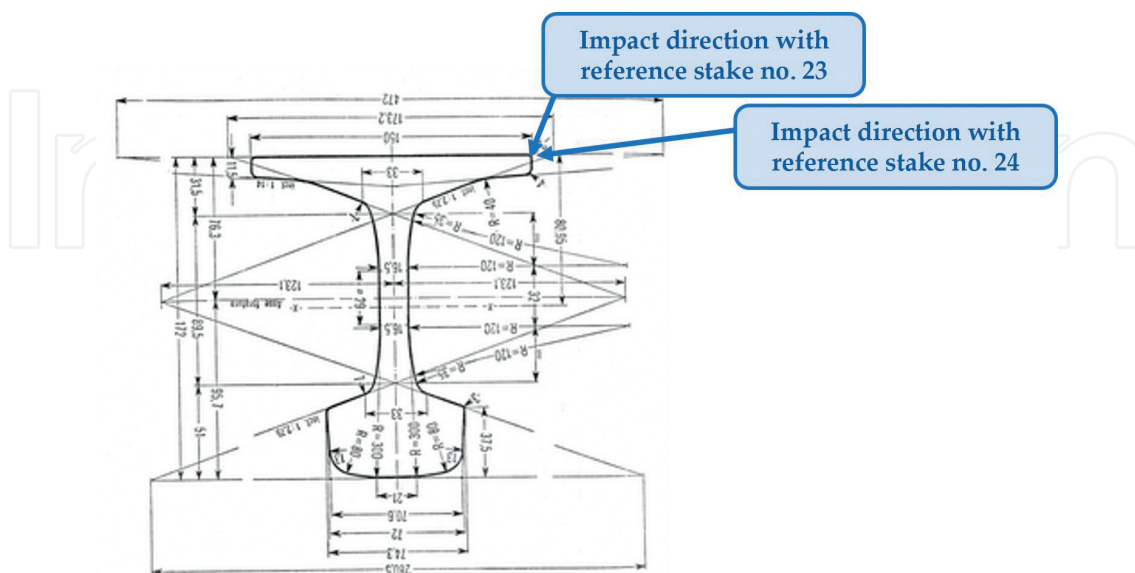
During the interaction with track reference stake no. 24, which was hit first, the tank, under the action of the applied forces, initiated a rotational motion around a vertical axis, as endorsed by the arched shape of the cut on the tank shell.

**Figure 22.** Direction of the impact between the tank of carriage no. 1 and track reference stake nos. 23 and 24.

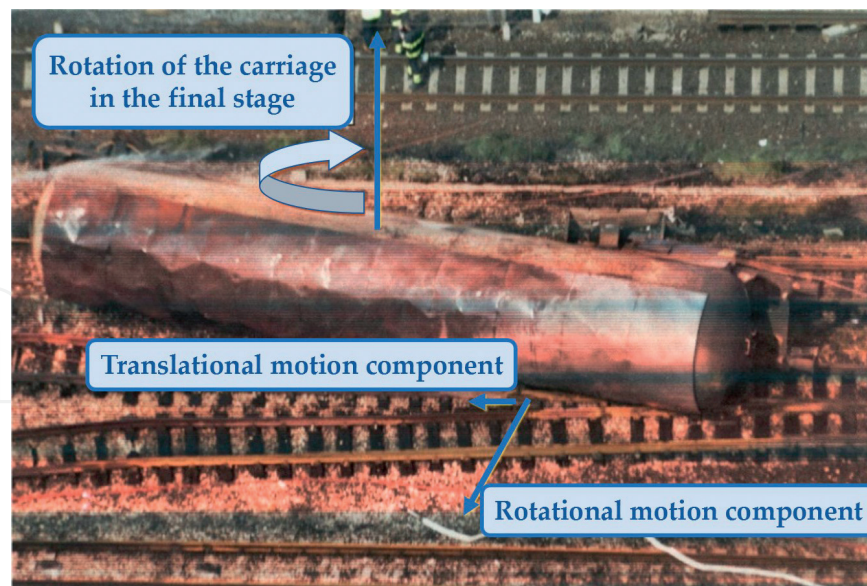
**Figure 23** illustrates the motion of tank carriage no. 1 when, after hitting track reference stake no. 24, it proceeded to hitting track reference stake no. 23. The rotation of the carriage around the vertical axis was about 5° clockwise for an observer looking at the scene from above.

**Figure 23.** Rotational motion of tank carriage no. 1 around a vertical axis.

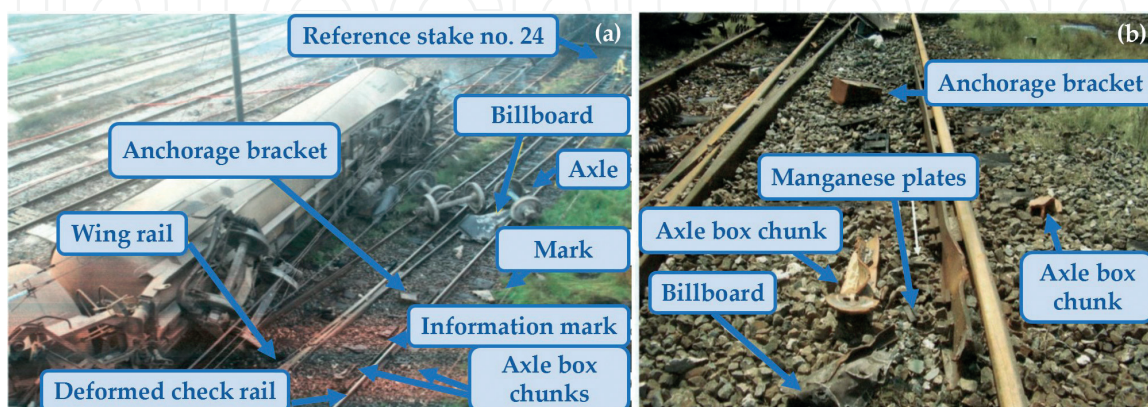
**Figure 24** shows a series of details of the core zone of railway switch 13B. The scene refers to the zone around the wing rail and the check rail as it appeared after the accident, where the following elements were found:

- The anchorage bracket of carriage no. 1, sitting at about 3.5 m beyond the position of the wing rail.
- A chunk of the right-side axle box, in the train motion direction, of the first (front) wheel set no. 85890 of the front bogie, i.e., the axle box which remained mounted on carriage no. 1 after the second (back) wheel set no. 98331 of the front bogie was detached.
- Part of the sheet metal billboard welded on the side of carriage no. 1 for the application of transport documentation.

**Figure 24.** Zone of the heart of railway switch 13B around the wing rail and the check rail immediately after the accident.

- The manganese plates making up the kinematic surface on which the axle boxes slide with respect to the axel guard

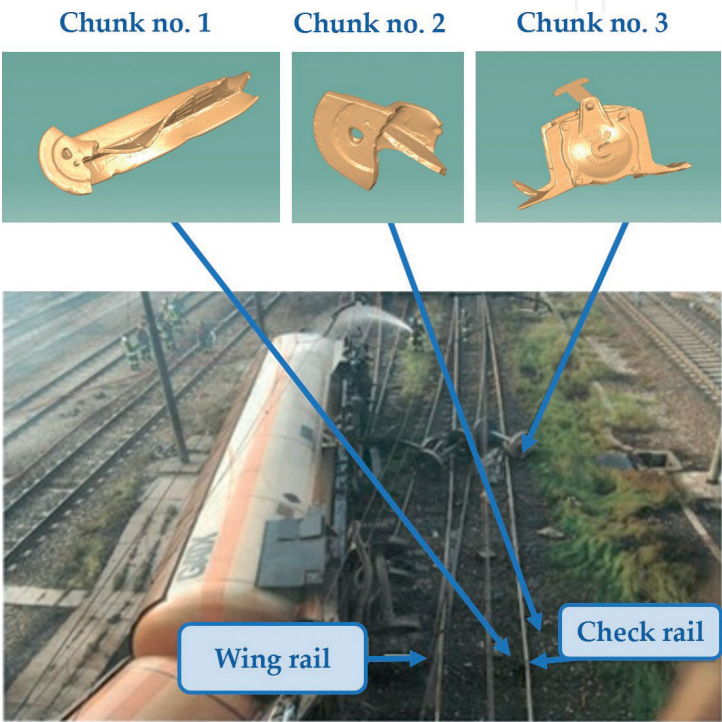
All these wreckages demonstrate that the body, which strongly deformed the check rail, was an axle box that was practically destroyed during the impact (**Figure 25**).

**Figure 25.** Position, in the accident scene, of the chunks of the right axle box of the front wheelset of the front boogie of carriage no. 1; the axle box was greatly abraded and broken into three fragments.

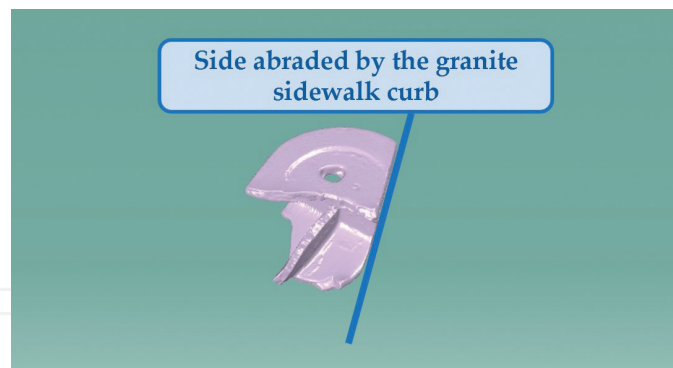
**Figure 27.** Digital twin of the chunk of the right axle box of the first wheel set of the front bogie of carriage no. 1 obtained by reverse engineering reconstruction based on geometry acquisition with a structured light optical sensor.

The front part of the right axle box—right side in the train motion direction—of the front wheel set was greatly abraded by the granite of the sidewalk curb that acted on the right front axle box just like a grinding wheel on the workpiece in a grinding process (**Figures 26b** and **27**).

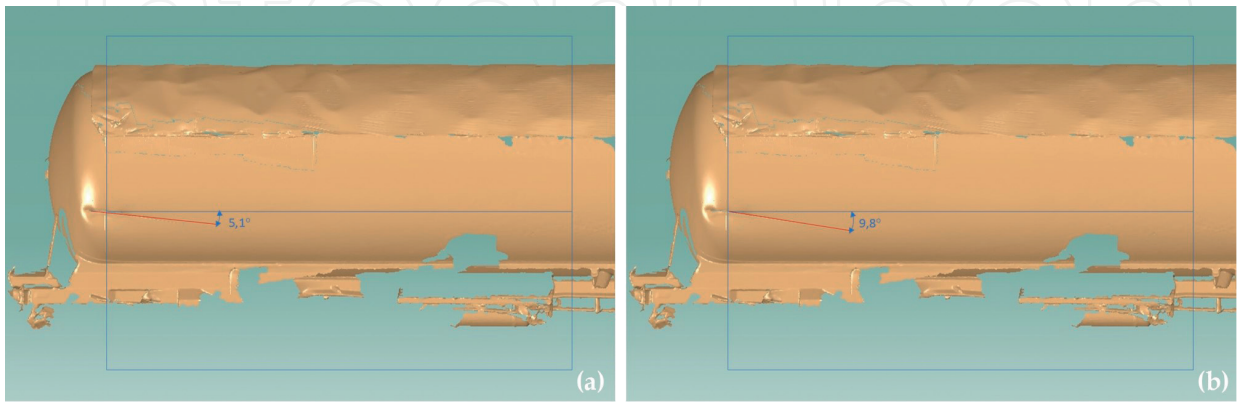
**Figure 29** shows the digital model of the tank of carriage no. 1, obtained by reverse engineering reconstruction based on geometry acquisition with a time-of-flight laser sensor. The digital model highlights the incidence angle of the cut that varies during progressing of the cutting process. The incidence angle is the angle between the generatrix of the cylindrical body of the tank and the straight-line tangent to the outline of the cut at the point of intersection between generatrix and cut.

By examining the digital models of **Figures 29** and **30b**, it can be noted that the cut starts with an incidence angle of  $5.1^\circ$  and ends with an incidence angle of  $9.8^\circ$ . Accordingly, the rotation of the tank around a vertical axis, as illustrated in **Figure 12**, was about  $5^\circ$ .

**Figure 29.** Digital twin of the tank of carriage no. 1. Obtained by reverse engineering reconstruction based on geometry acquisition with a time-of-flight laser sensor, with indication of the incidence angle of (a) beginning of the cut and (b) end of the cut.

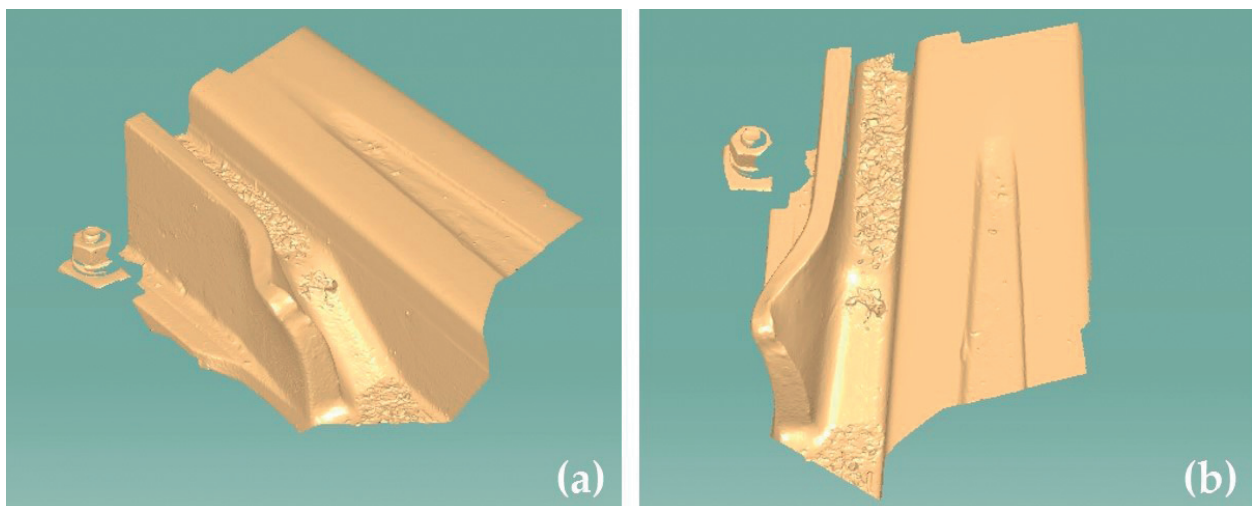
In **Figure 31**, the digital model of the wing rail, obtained by reverse engineering reconstruction based on geometry acquisition with a structured light optical sensor, is reported in side view (**Figure 31a**) and longitudinal view (**Figure 31b**). It can be noted that the blunted surface of

the extremity of the wing rail interested by the damage does not evidence traces of abrasion due to sliding.

**Figure 31.** Digital twin of the wing rail obtained by reverse engineering reconstruction based on geometry acquisition with a structured light optical sensor: (a) side view and (b) longitudinal view.

object with a sharpened corner shape and not with a blunted corner shape such as the one of the wing rail (**Figure 31**).

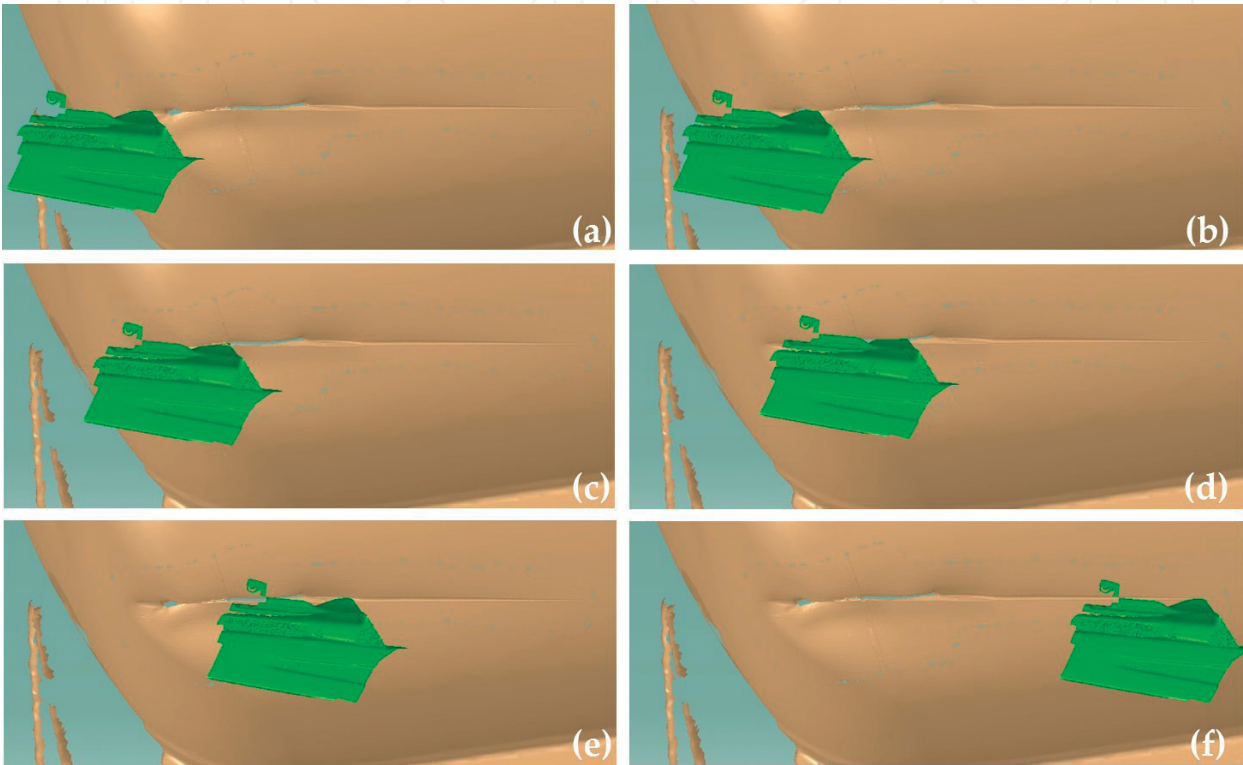
**Figure 32** illustrates the simulation of the interaction between wing rail (the digital model of which was considered fixed with respect to the ground) and the deformed area of the tank

**Figure 32.** Simulation of the interaction between wing rail and tank shell of carriage no. 1: (a) contact, (b) penetration, (c) cutting, (d) exit, (e) start of sliding, and (f) end of sliding.

Accordingly, even if from a geometrical point of view, the interaction between wing rail and tank shell is locally compatible with the cut shape, the carriage, in order to allow for the generation of the entire cut opening, should have assumed positions that are not compatible with the railway infrastructure. Furthermore, it must be considered that the final phase of the cutting process, consisting in the sliding of **Figure 32d**, was determined on the tank shell by an

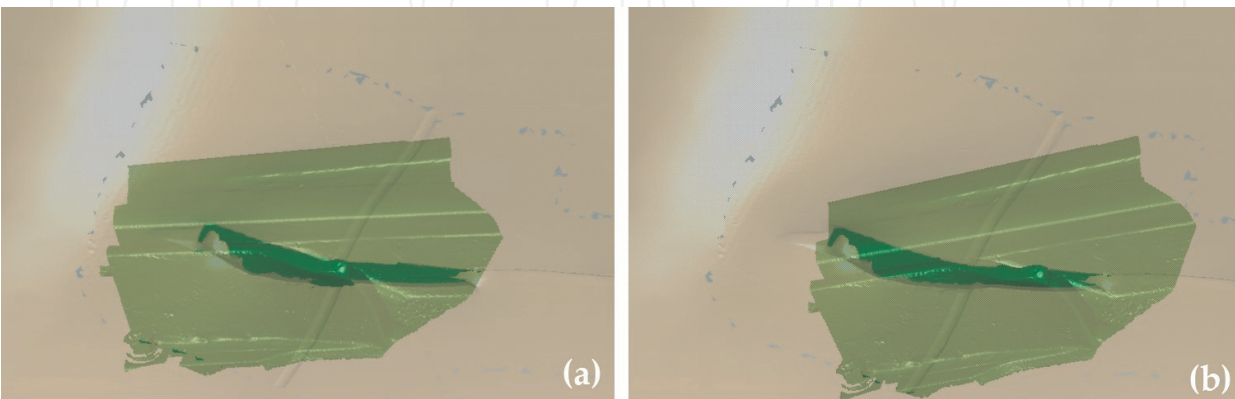
**Figure 33a** and **b** shows the details of the cutting phases corresponding to the positions of **Figure 32c** and **d**, respectively.

**Figure 33.** Details of the phases of the cutting action by the wing rail corresponding to: (a) the position of **Figure 32c** and (b) the position of **Figure 32d**.

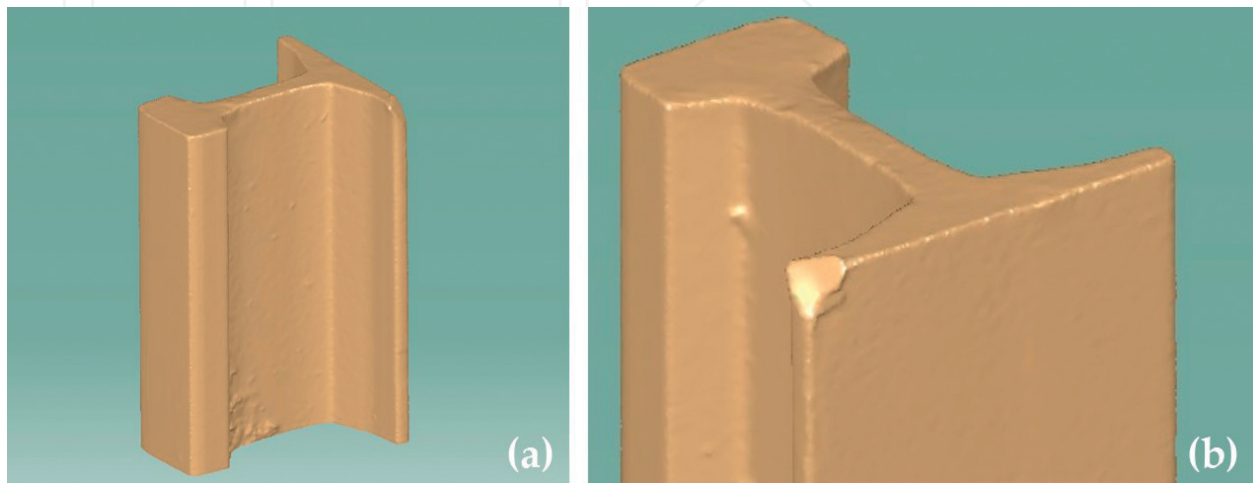
The same simulation was carried out by considering the damage caused by track reference stake no. 24, the digital model of which, realized by reverse engineering reconstruction based on geometry acquisition with a structured light optical sensor, is reported in **Figure 34**. The figure shows a view from the head side (**Figure 34a**) and from the flange side (**Figure 34b**) of the rail chunk making up the track reference stake, evidencing the highly abraded sharp corner.

**Figure 34.** Digital twin of track reference stake no. 24, obtained by reverse engineering reconstruction based on geometry acquisition with a time-of-flight laser sensor: (a) view from the head side and (b) view from the flange side, evidencing the highly abraded sharp corner.

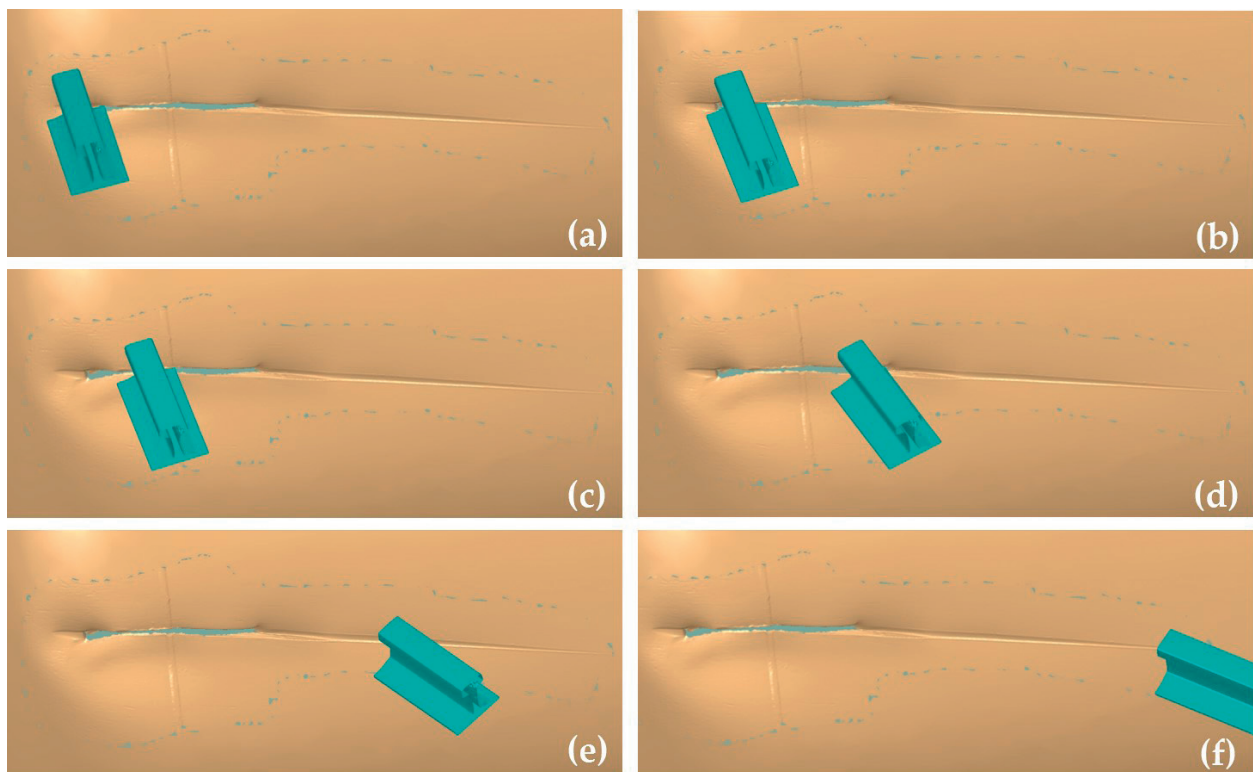
**Figure 35** shows the simulation of the interaction between track reference stake no. 24 and side of the tank shell of carriage no. 1, comprising the following phases: (a) initial contact between track reference stake and tank shell side, (b) penetration into the tank shell

side and start of cutting (c), (d) end of cutting, (e) start of sliding, and (f) end of sliding on the shell surface.

Also the analysis of this simulation confirms the geometrical compatibility between the shape of track reference stake no. 24 and the opening generated by its cutting action on the tank shell,

taking into account the yielding and knocking down of track reference stake no. 24 under the impact of tank carriage no. 1.

**Figure 35.** Simulation of the interaction between track reference stake no. 24 and tank shell side of carriage no. 1: (a) initial contact, (b) penetration, (c) start of cutting, (d) end of cutting, (e) start of sliding, and (f) end of sliding.

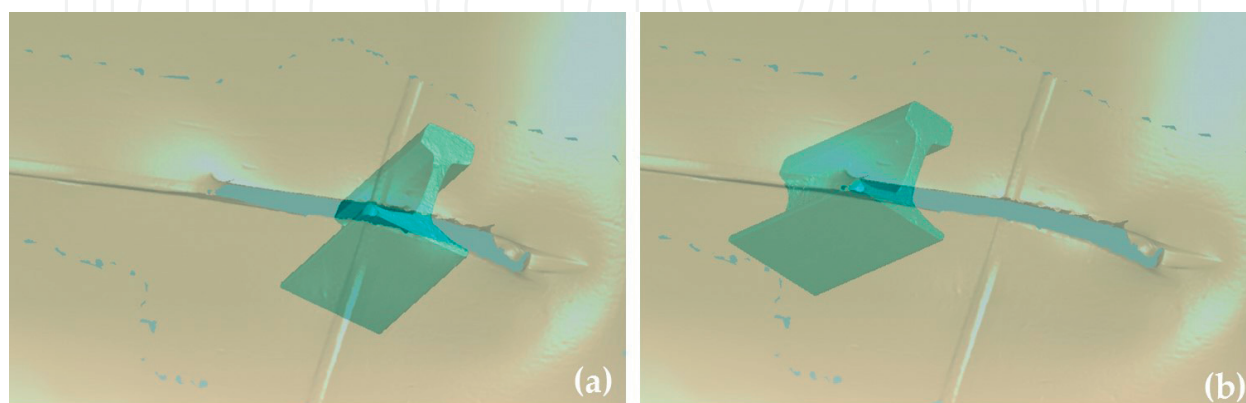
**Figure 36a** and **b** shows the details of the phases of the cutting action by track reference stake no. 24 corresponding to the positions of **Figure 35c** and **d**, respectively.

**Figure 36.** Details of the phases of the cutting action by track reference stake no. 24 corresponding to the position of (a) **Figure 35c** and (b) **Figure 35d**.

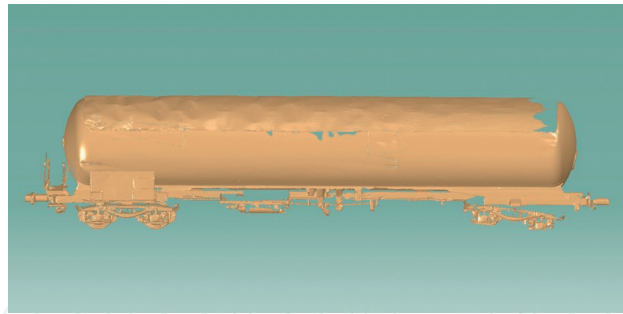
Therefore, the simulations were newly performed by considering the complete digital models of tank carriage no. 1 (**Figure 37**).

**Figure 37.** Digital model reconstruction of the entire tank carriage no. 1.

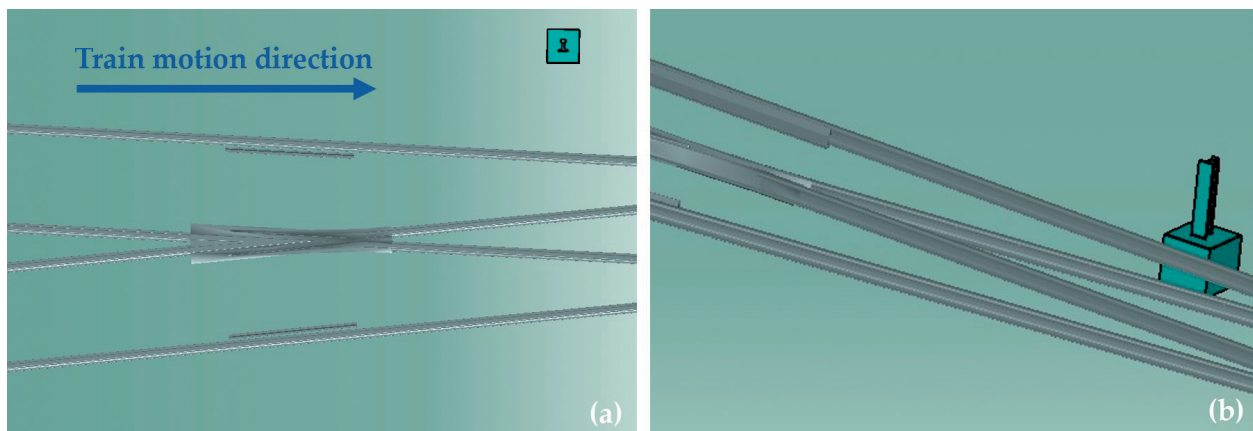
The positions assumed by tank carriage no. 1 during its impact against the elements possibly responsible for the cut were analyzed in the framework of the railway infrastructure with particular reference to the wing rail and track reference stake no. 24 (**Figure 38a and b**).

**Figure 38.** Digital model reconstruction of the railway infrastructure based on the planimetric measurements of the accident scene: (a) position of the wing rail and (b) lateral view of the position of track reference stake no. 24.

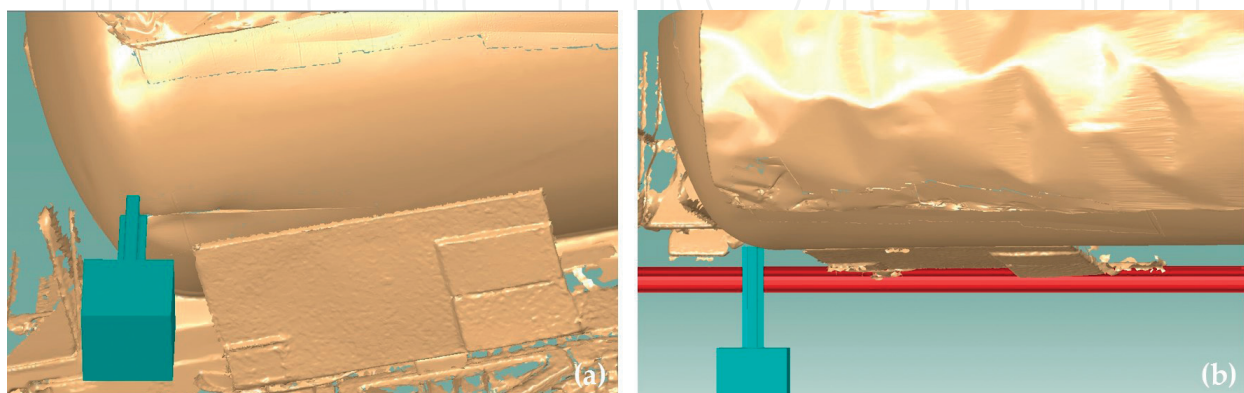
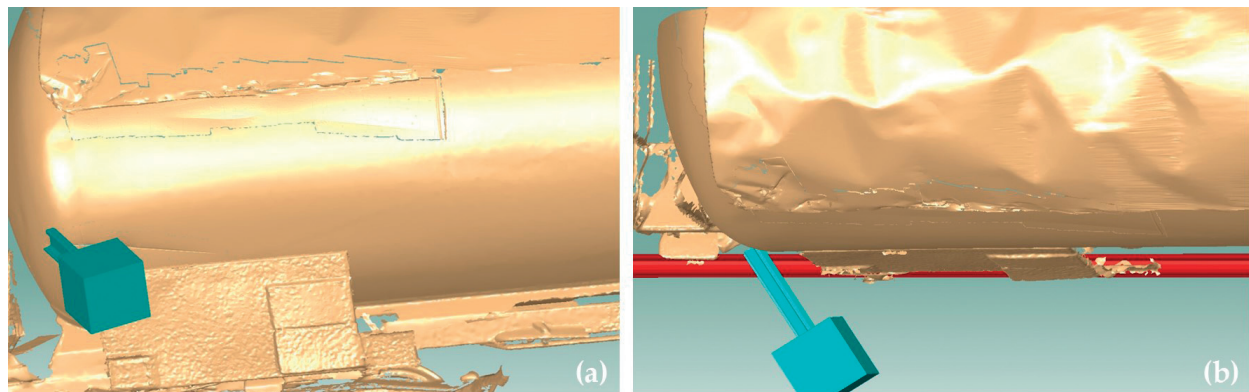
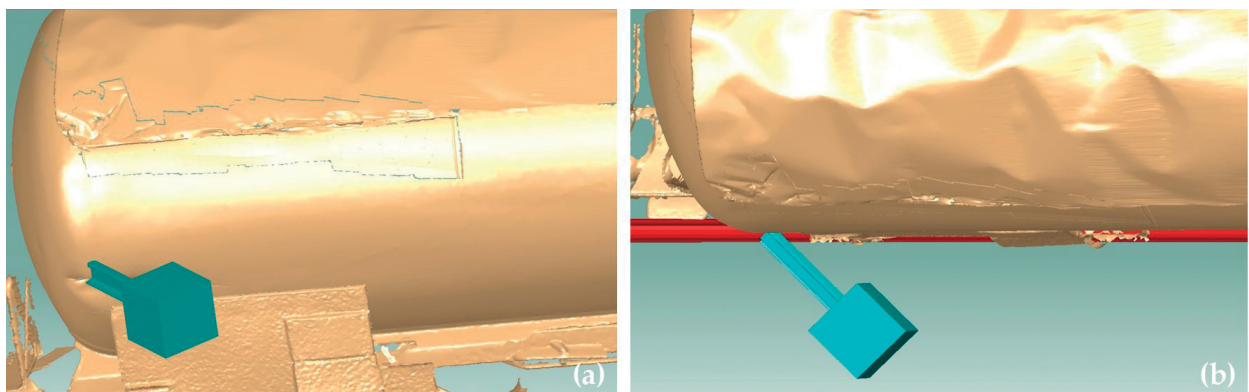
**Figures 41-44** show the positions assumed by tank carriage no. 1 under the hypothesis of impact against track reference stake no. 24. In particular, the results refer to the following phases of the cutting process: initial contact (**Figures 35a** and **41**), penetration (**Figures 35b** and **42**), cutting (**Figures 35c** and **43**), and sliding (**Figures 35d** and **44**). The simulations took into account the yielding of track reference stake no. 24, which under the impact action by the tank vessel, was tilted till it knocked down sideways (**Figure 35**).

The simulation results show that, under the hypothesis of tank shell cutting by track reference stake no. 24, no interference is evidenced between tank carriage no. 1 and the railway infrastructure during the tank shell cutting process.

Accordingly, the tank of carriage no. 1, already overturned on its left side, impacted with its front part against track reference stake no. 24, which started the cutting action by penetrating for a certain depth inside the tank shell and continued to cut the sheet metal of the tank shell till it exited from the cut opening after its knocking upon yielding of the ballast where it was grounded.

**Figure 41.** Position assumed by tank carriage no. 1 in the framework of the railway infrastructure under the hypothesis of tank shell cutting by track reference stake no. 24: initial contact phase (**Figure 35a**).

**Figure 42.** Position assumed by tank carriage no. 1 in the framework of the railway infrastructure under the hypothesis of tank shell cutting by track reference stake no. 24: penetration phase (**Figure 35b**).

**Figure 43.** Position assumed by tank carriage no. 1 in the framework of the railway infrastructure under the hypothesis of tank shell cutting by track reference stake no. 24: cutting phase (**Figure 35c**).

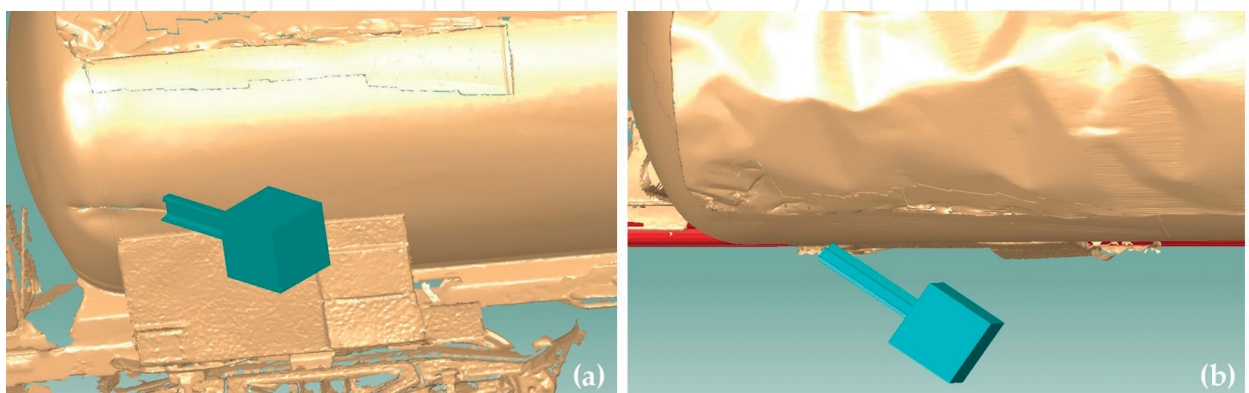
**Figure 44.** Position assumed by tank carriage no. 1 in the framework of the railway infrastructure under the hypothesis of tank shell cutting by track reference stake no. 24: sliding phase (**Figure 35d**).

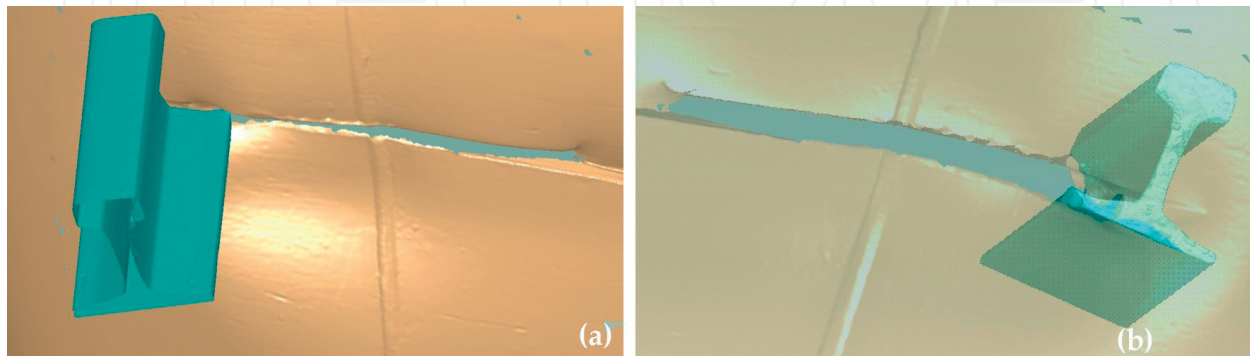
**Figure 45a and b** shows the details of the position of track reference stake no. 24 during the penetration phase into the tank shell.

**Figure 45.** Details of the position of track reference stake no. 24 during the penetration phase into the tank shell: (a) view from the outside of the tank and (b) view from the inside of the tank.

It can thus be stated that the track reference stake has been the actual cause of the cut opening on the tank shell side.
