Durability Issue for the Emperor Fasiladas Royal Palace in Gondar (Ethiopia)

Eskinder Desta Shumuye and Gashaw Assefa Bezabih

Abstract

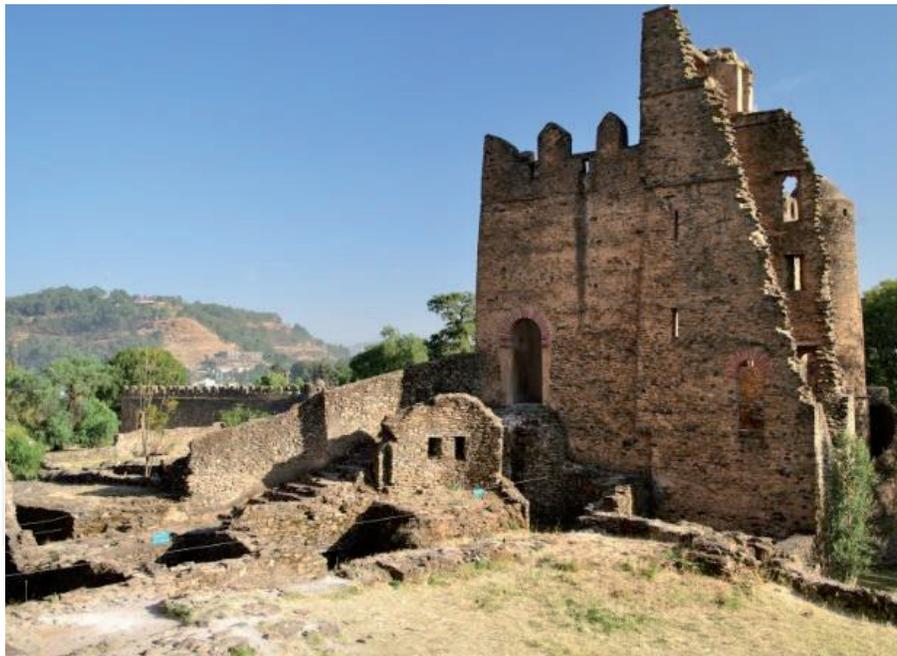
Figure 9.
Iyasu Castle Fasil at Ghebbi [29].

Even if the seismic zonation of Fasil Ghebbi is safe but in there have been a major geological incident in the Fasil Ghebbi as reported by Briggs [29] Iyasu Castle was partially damaged by earthquake in 1704 and the ground floor collapsed under the British bombardment in world war II. **Figure 9** illustrates destructive effects the earthquake that occurred on the Fasil Ghebbi at Iyasu Castle in 1704.
