A Wear Analysis Carried On Connecting Rod Bearings From Internal Combustion Engines

Juan Rodrigo Laguna-Camacho, Silvia M. Sánchez-Yáñez, Gabriel Juárez-Morales, Maria I. Cruz-Orduña, Luz M. Ramos-González, Cristóbal Cortez-Domínguez, Roberto L. Cabrera-Santiago and Javier Calderón-Sánchez

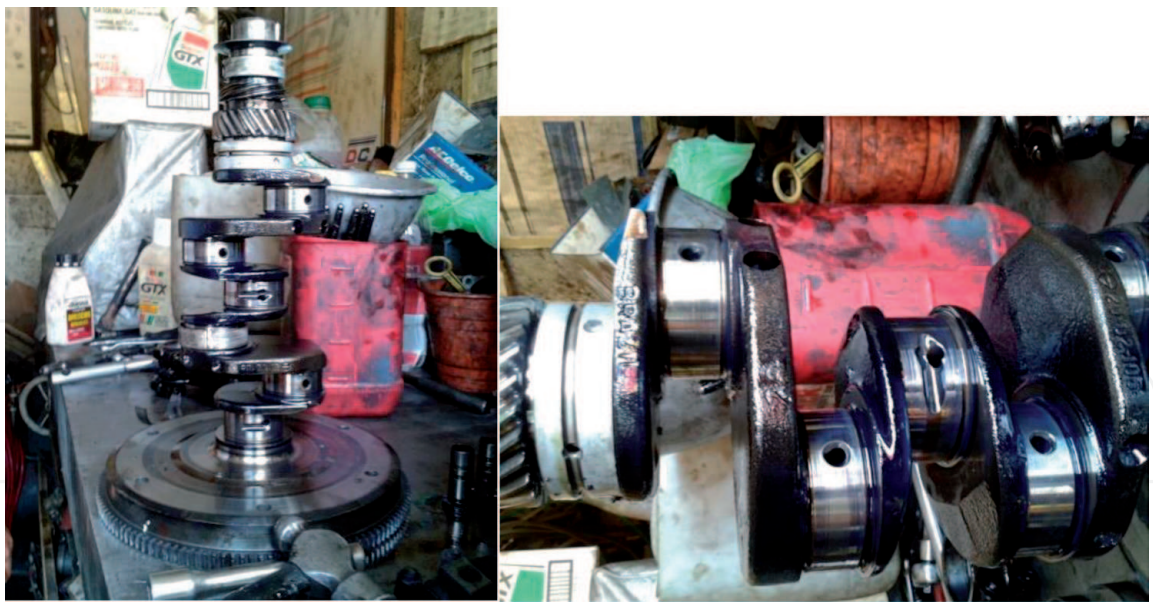
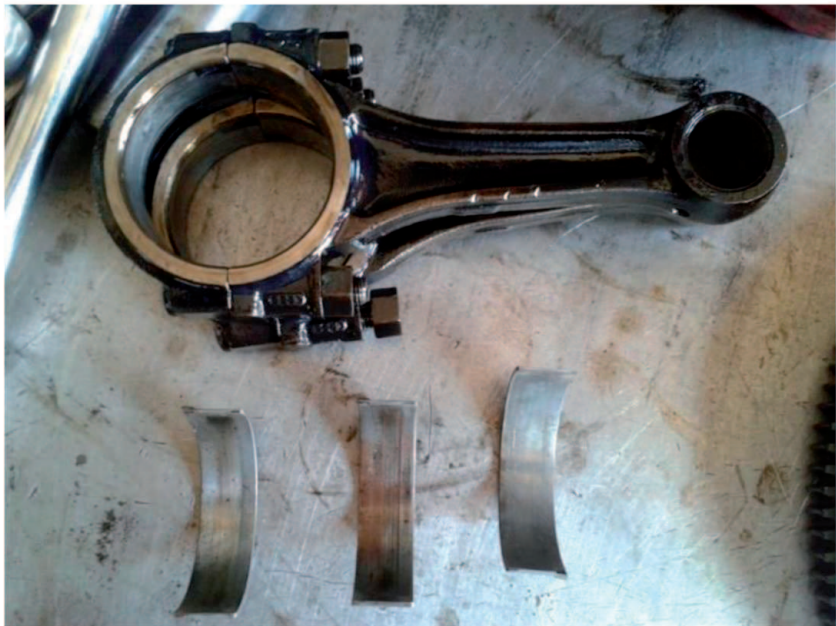
The tribological characterization of the connecting rod bearings was carried out once the worn bearings were extracted from the internal combustion engine. It was possible because the car engine was adjusted. It is important to mention that these bearings had a service life of approximately 8 years. In **Figure 2a–c**, it is possible to observe the complete crankshaft, the connecting rods, and a few worn bearings after disarming.

Figure 2.
Adjust of car engine: (a) and (b) crankshaft and (c) connecting rods and bearings.

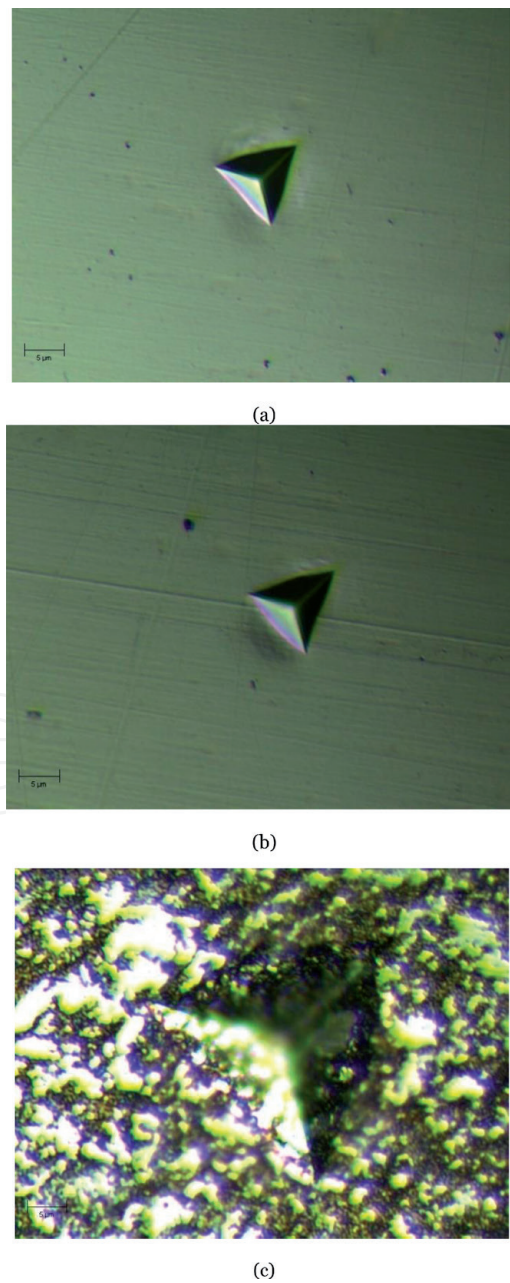
The results of the Young's modulus or modulus of elasticity (E) are shown in **Table 2** and in **Figure 7**. **Figure 8a–c** shows the traces of the pyramidal penetrator on the surface of the bearing in each of the examined areas.

Figure 8.
Hardness Vickers indentations, (a) central part, (b) outer layer, (c) inner layer.

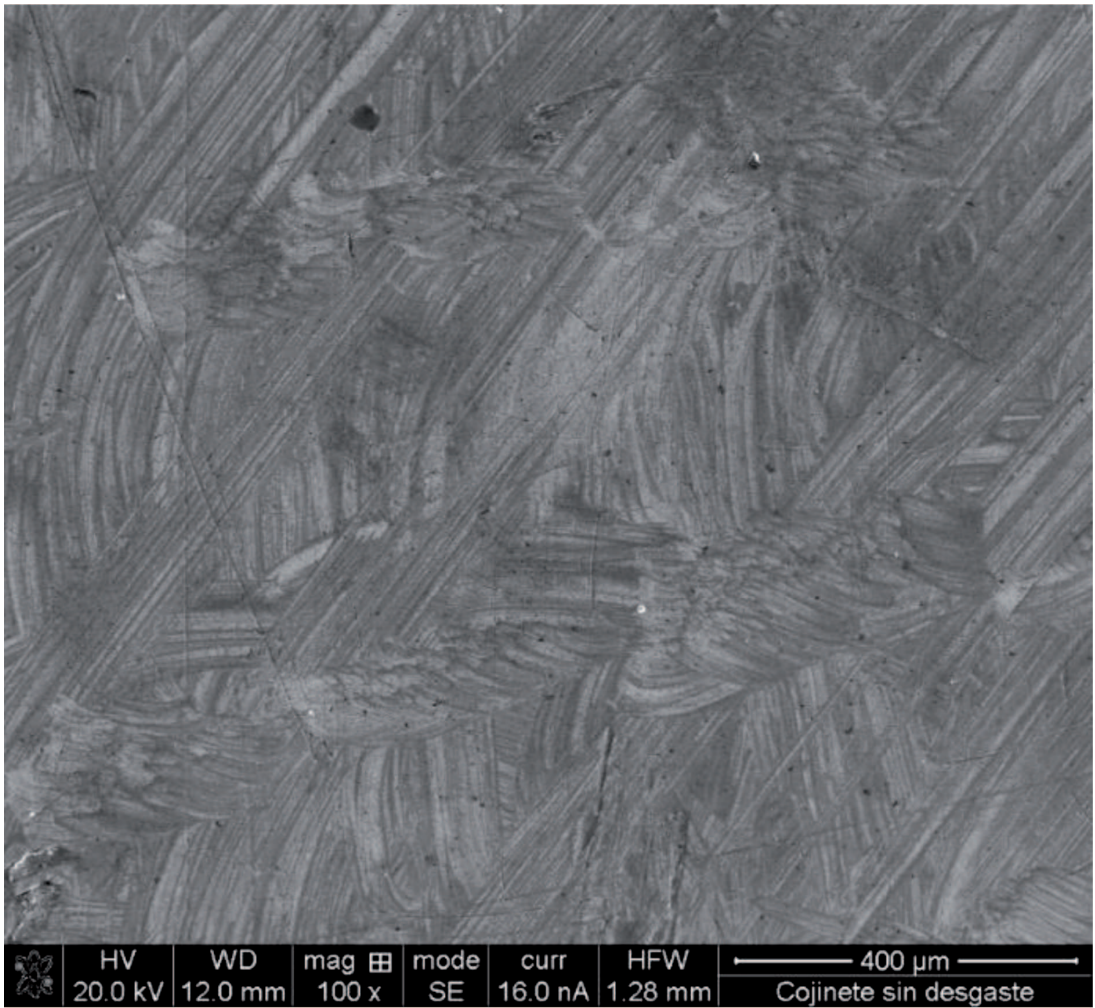
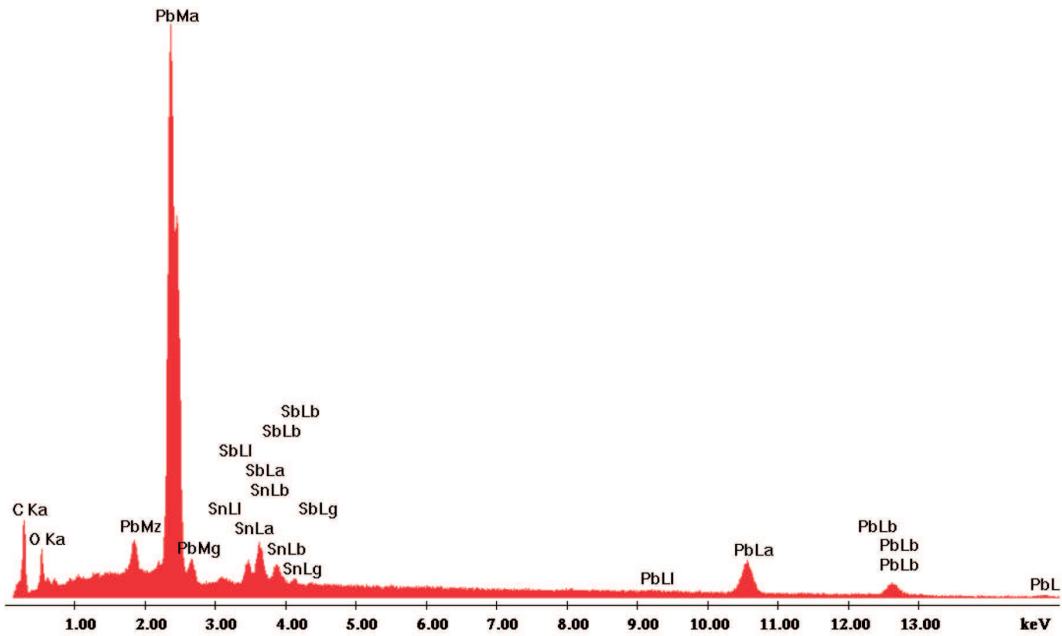
The chemical analysis was carried out using a scanning electron microscope model FE SEM JEOL JSM-7600F that can reach magnifications of $25\times$ to $1,000,000\times$ (see **Figure 11**). The unworn surface and the chemical analysis of the rod bearing layer that makes direct contact with the rod bearing journals from the crankshaft are shown in **Figure 12a** and **b**. Chemical elements such as C 20.86, Pb 60.05, Sn 3.89, and Sb 6.7 Wt% identified in the unworn surface.

Figure 12.
(a) Unworn rod bearing surface and (b) EDS analysis.
