A Survey of Physical Parameters and Natural Radioactivity in the Wooden Church of “Archangels Mihail and Gavril,” Draghia

*Ancuța Țenter, Marin Cotețiu, Alexandra Cucoș,
Bety Burghеле, Kinga Szacsvai and Verginica Schroder*

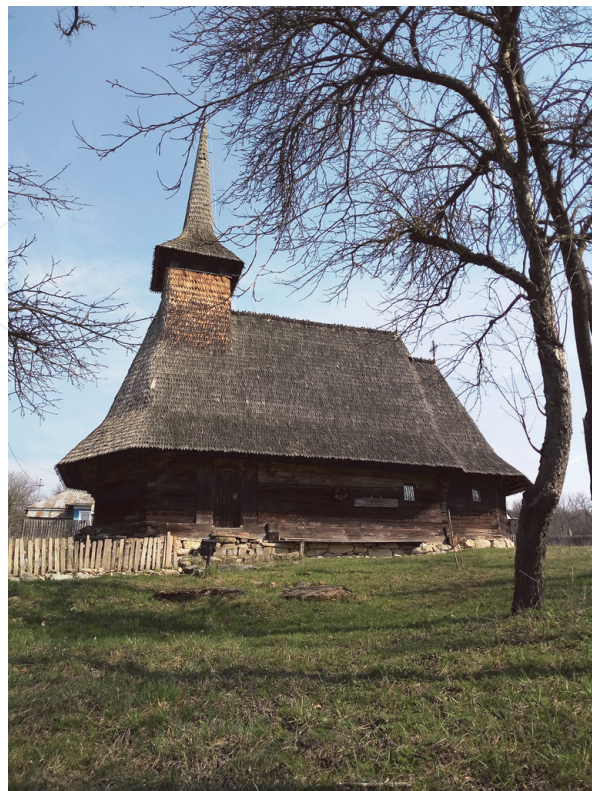
Figure 2.
The church “Archangels Mihail and Gavril,” Draghia.

The church is 12.40 m long, 4.45 m wide, 7.50 m high at the ridge, and 15.50 m high at the tower's spire. The base and the walls are all made of oak beams placed on a dry laid stone foundation [21] (**Figure 2**).

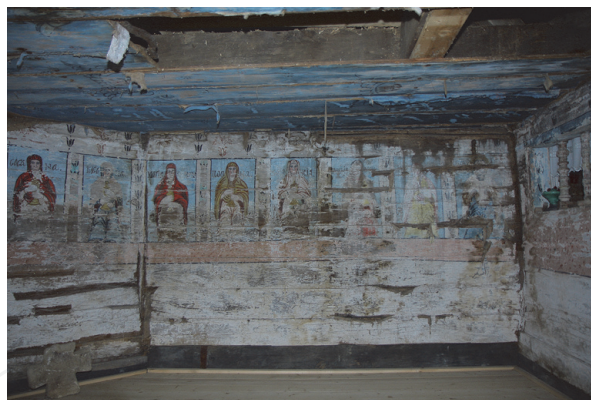
Figure 3.
Holy women with cups in their hands.

The building plan is similar to others found throughout the area; the church being divided into a narthex, nave, and altar [22]. The narthex has a polygonal shape, covered with a straight ceiling, above which the bell tower is situated. The ceiling is painted with cherubs, and the walls are painted with images of the Myrrhbearers, and of wise and foolish virgins from the Gospel of Mathew. The narthex was where the women would attend mass (**Figure 3**).

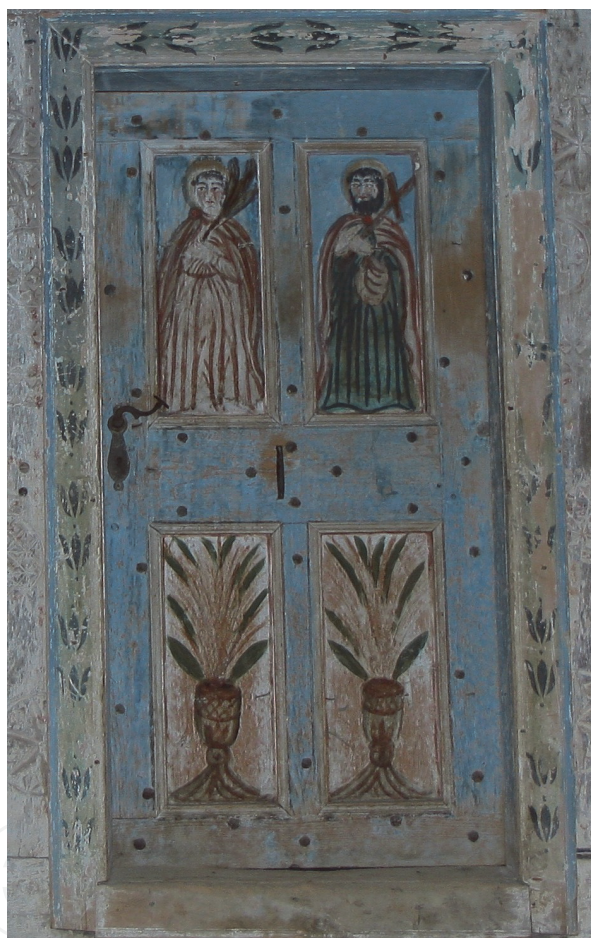
Figure 4.
The door with two saints.

According to the requirements of the Orthodox church construction, the nave is rectangular, with a large dome and separated from the rest of the area by a wall with a door [23]. This wooden door is painted on with two saints (**Figure 4**).

The lower half of the door is painted with the tree of life in a pot. The door frame is engraved with area-specific symbols and historical times rosette with six petals, honeycombs, and wolf teeth. The opening is provided with slightly turned columns

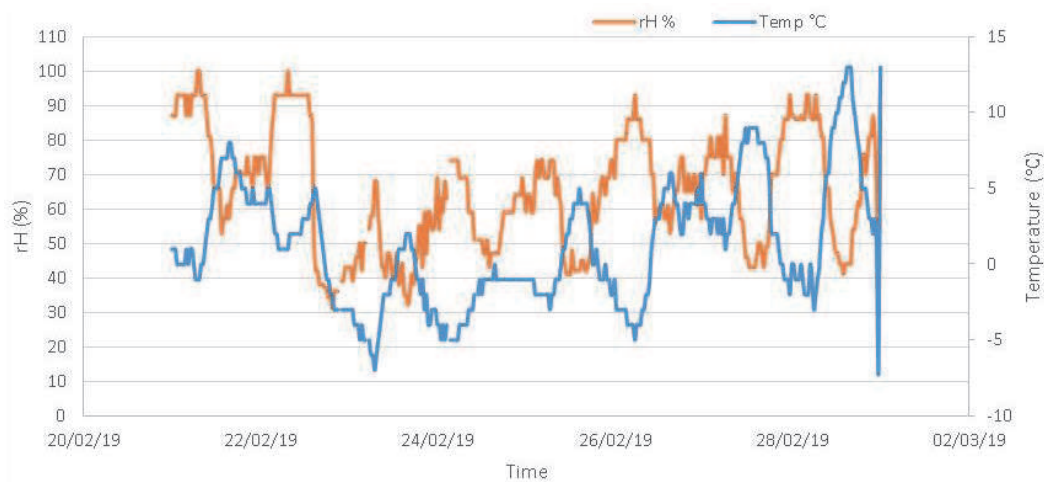
Figure 8.
Weather conditions in the area at the time of study (February 2019).

The data provided by the Baia Mare weather station for the time interval of interest showed the following outdoor conditions: an average temperature of 1.27°C, with a minimum of -7°C and a maximum of 13°C (**Figure 8**). This fact explains the naturally low temperatures recorded inside the church, which is not equipped with a heating system.

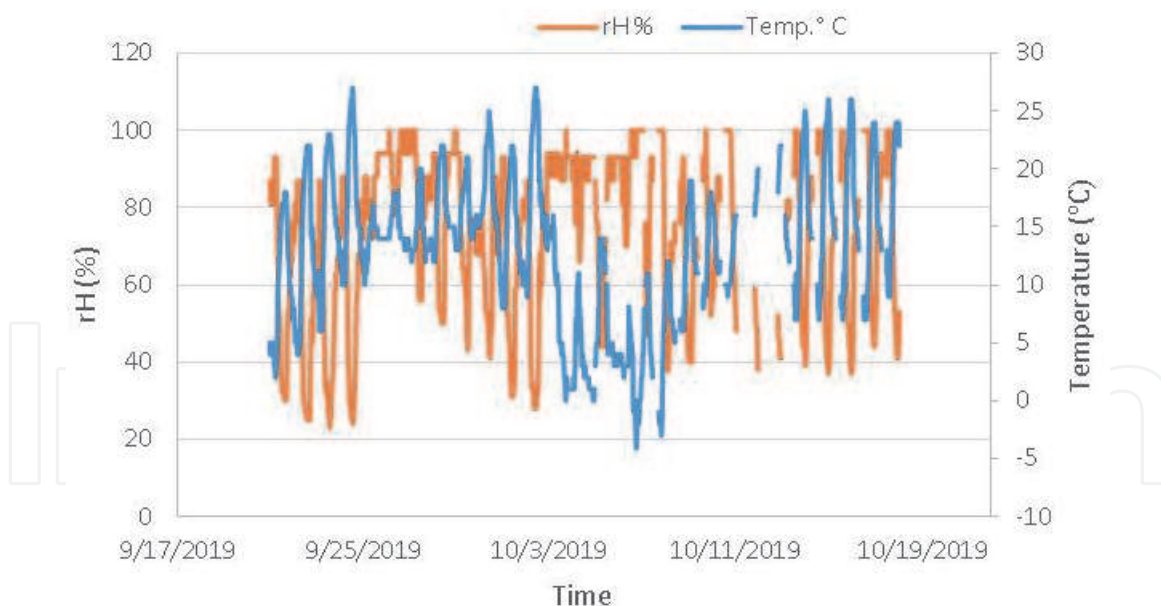
The data provided by the Baia Mare weather station for the time interval of the second measuring campaign showed an average temperature of 13°C, with a minimum of –4°C and a maximum of 27°C. On the other hand, the values of the relative humidity of the outdoor air had very high values during this period, with an average of 73%, which may have caused and maintained the high humidity inside the church (**Figure 11**).

Figure 11.
Weather conditions in the area at the time of study (September–October 2019).

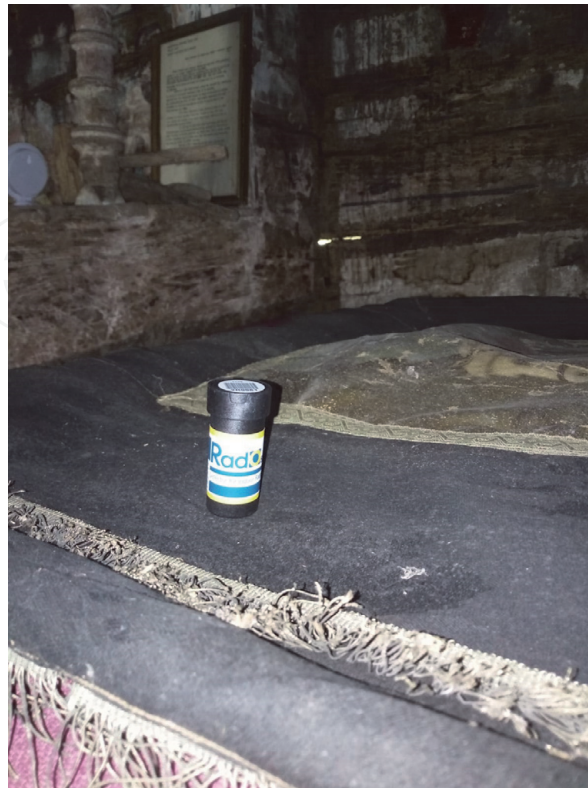
Figure 15.
CR-39 detector.

At the time of the second campaign, passive radon detectors were installed along the active monitoring system. Indoor passive radon measurements were performed by using CR-39 track detectors exposed for 1 month, in all three rooms of the wooden church (**Figure 15**), according to the NRPB Measurement Protocol [36].

Following the laboratory analyzes performed at the Constantin Cosma Radon Laboratory of Babeş-Bolyai University, an average concentration of 107 Bq m⁻³ was obtained for the monitored period. Taking into consideration the seasonal correction factors implemented through national regulations, the annual indoor radon activity concentration for the investigated public building was calculated to be 140 Bq m⁻³,
