Post-Tsunami Lifeline Restoration and Reconstruction

Yasuko Kuwata
Kobe University,
Japan

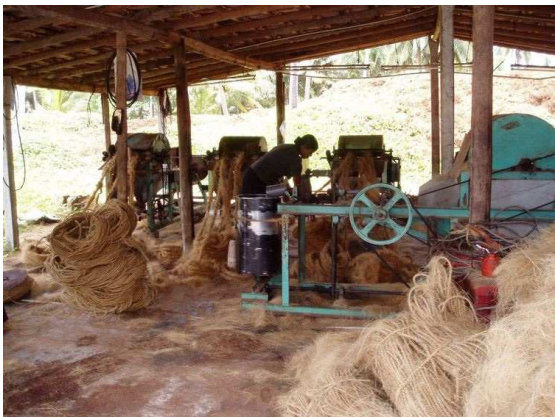
Photo 5. Rope production factory (Galle, Sri Lanka)

A survey on tsunami damage to a business base and the restoration process was carried out in Galle, southern Sri Lanka, in late September of 2005, 9 months after the 2004 tsunami. Interview respondents included company owners and other relevant people who have businesses from several industries around the coastal areas. The main industries in Galle are fishing and tourism, and each company is relatively small, with only a few employees (see Photos 5 and 6). The total number of responses in this survey is only 52, because the survey period was limited and the interviews were done face-to-face. The questions were on tsunami inundation levels, physical damages to buildings and equipment and recovery time in days, tsunami damages to lifeline services and recovery time in days, and business restoration processes with respect to the time since the tsunami.

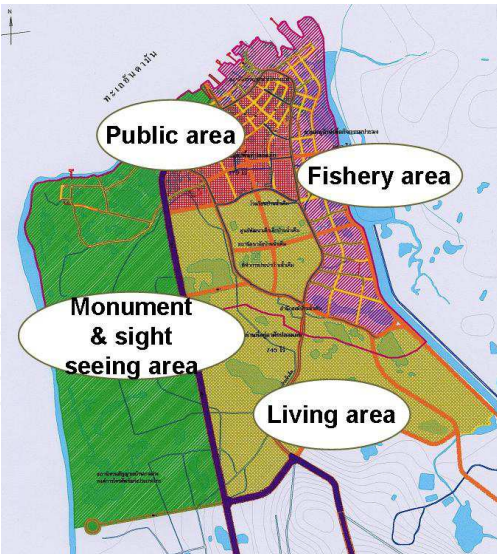
The tsunami damage to the underground water supply pipeline at Nam Kem village, Thailand was shown above. In addition to the water-supply pipeline, houses also almost collapsed near the coast. To secure the safety of residents and coastal property, the Department of Public Works and Town Planning (hereafter, DPT), Ministry of the Interior, Thailand proposed a town reconstruction plan for Nam Kem village shortly after the tsunami, as shown in Fig. 11. This plan divides the village into four types of land-use areas (public, fishery, living, and monument & sightseeing), and it provides new roadways, parts of which are suitable evacuation routes. It seems like an ideal land readjustment project from the point of view of land use planning. On the other hand, it would force local fishery residents to move far from the coast.

Since the land readjustment planning was accepted in the disaster restoration planning and the house rebuilding was fast, the lifeline recovery in the village was also installed in the same place as before. According to the DPT planning, the cost of the planned water-supply pipeline is estimated by the network map, as shown in Fig. 13 (2). When the repair costs of the damaged pipelines and the construction costs of the planned pipeline are compared, as shown in Fig. 12, the costs are 117 thousand USD and 105 thousand USD, respectively, which are not so different. Similarly, the costs for the electric power line are also not very different from each other. It is observed that the cost for lifeline facilities is not different between the new plan and the repair scenario.

Fig. 11. Nam Kem village reconstruction planning (Source: DPT, Thailand)

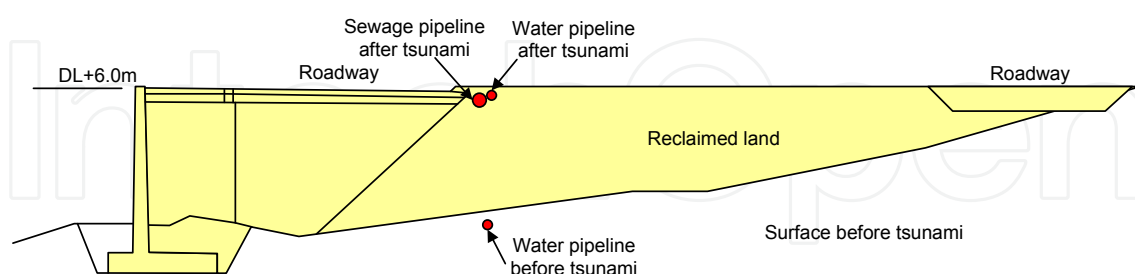
Based on the reclaimed land development and new roadway construction, the water-supply pipeline used before was left under the surface before the tsunami, and the new pipeline was constructed over it, as shown in Fig. 15. A polyvinyl chloride pipe (PVC) was adopted in the reconstruction work in spite of the ductile iron pipe (DIP), which was used before the tsunami. As shown in the plan of pipeline networks in Fig. 12, the pipeline in Aonae district was completely reconstructed. In contrast to the previous pipeline, the new pipeline draws streamline.

Fig. 13. High-raised tidal wall and reclaimed land development at Aonae district

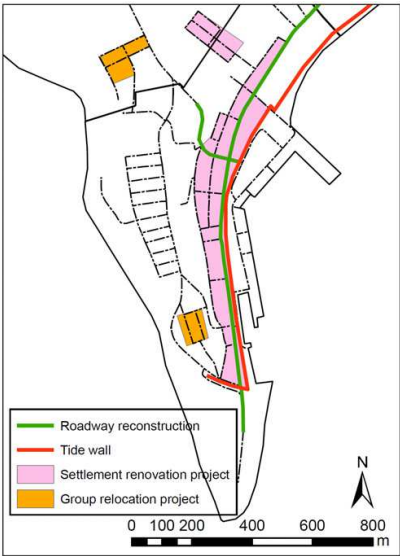
The victims evacuated the shelter after one and a half months, and they stayed in temporary houses for three and a half years, with 900 people in total. Okushiri town established a disaster restoration office three month after the tsunami and aimed to complete the disaster restoration planning in five years. Its disaster reconstruction planning was supported by the national government and the Hokkaido prefecture. The reconstruction project that was presented to the Aonae district consisted of four parts: the fishery village environmental renovation project, the roadway reconstruction project, the disaster recovery project (construction of a tide wall), and the group relocation project for disaster prevention. The tide wall, which was built to a height of 6 m after the tsunami in 1983, was reinforced with a height of 5 additional meters. The wall height of 11 m is the same as the wave height of the last tsunami. The fishery village environmental renovation project was responsible for the reclaimed land development behind the high-raised wall. New roadways, water supply, and waste water drains were constructed over the reclaimed land, as shown in Fig. 13. When constructing the reclaimed land, the local government bought all the lots from the residents and readjusted the roadway and the lots. After the lot readjustment, residents bought land from the government. This process requires land renovation for disaster prevention, financial contribution from the local government, financial support from the national government, and the patience of the residents during reconstruction. In parallel to the land development at the coastal area, the group relocation project led the victims (except the fishery people) to live on the hill, as shown in Fig. 14.

Fig. 14. Disaster reconstruction projects of Aonae district

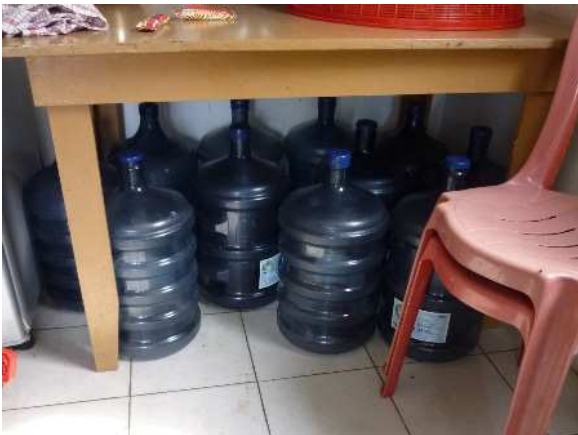
Photo 7. Drinking gallon-size bottle water

generally drinking from Gallon-sized bottle water (Photo 7) and living from PDAM water or domestic water (Photo 8). Indonesian residents rarely drink the pipe-water directly. The residential awareness on water use is examined considering disaster experience and difference between pipe-supply water and domestic water. Here, the residential satisfaction was asked in terms of water quality, water supply stability, emergency stability and water cost by 5 satisfaction options; (1) satisfy very much (2) satisfy (3) reasonable (4) dissatisfy a little and (5) dissatisfy. The response gives grating points from 5 (satisfy very much) to 1 (dissatisfy) for each option. Means of grating point for satisfaction was analyzed by one-way analysis of variance between three groups. Group I is the residents who use the PDAM water before and after the tsunami. Group II is those who started using the PDAM water after the tsunami. Group III is those who have not used the PDAM water. The grating point by Groups I and II is given about the PDAM water, and that by Group III is about the domestic water. Table 10 summarizes the variance analysis results for four questions.

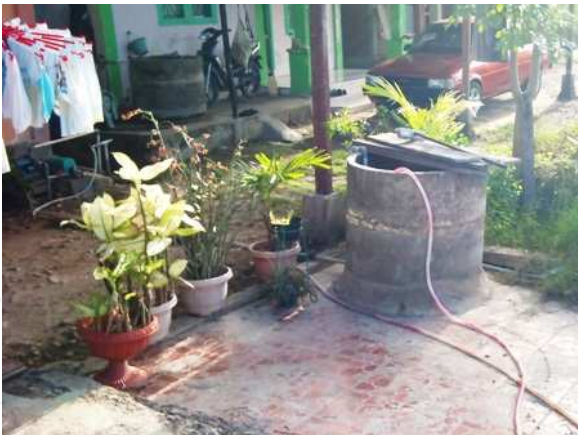
Photo 8. Shallow well in front of house
